# ENGINEERING MEMO #112

TO: D. H. Gurinsky  
FROM: C. J. Klamut, J. G. Y. Chow  
and A. P. Cendrowski  
SUBJECT: Metallurgical Examination of  
NRAO Brake Spring

Two pieces of a broken Stowbrake spring from the 140 ft NRAO telescope were received at BNL for metallurgical examination.

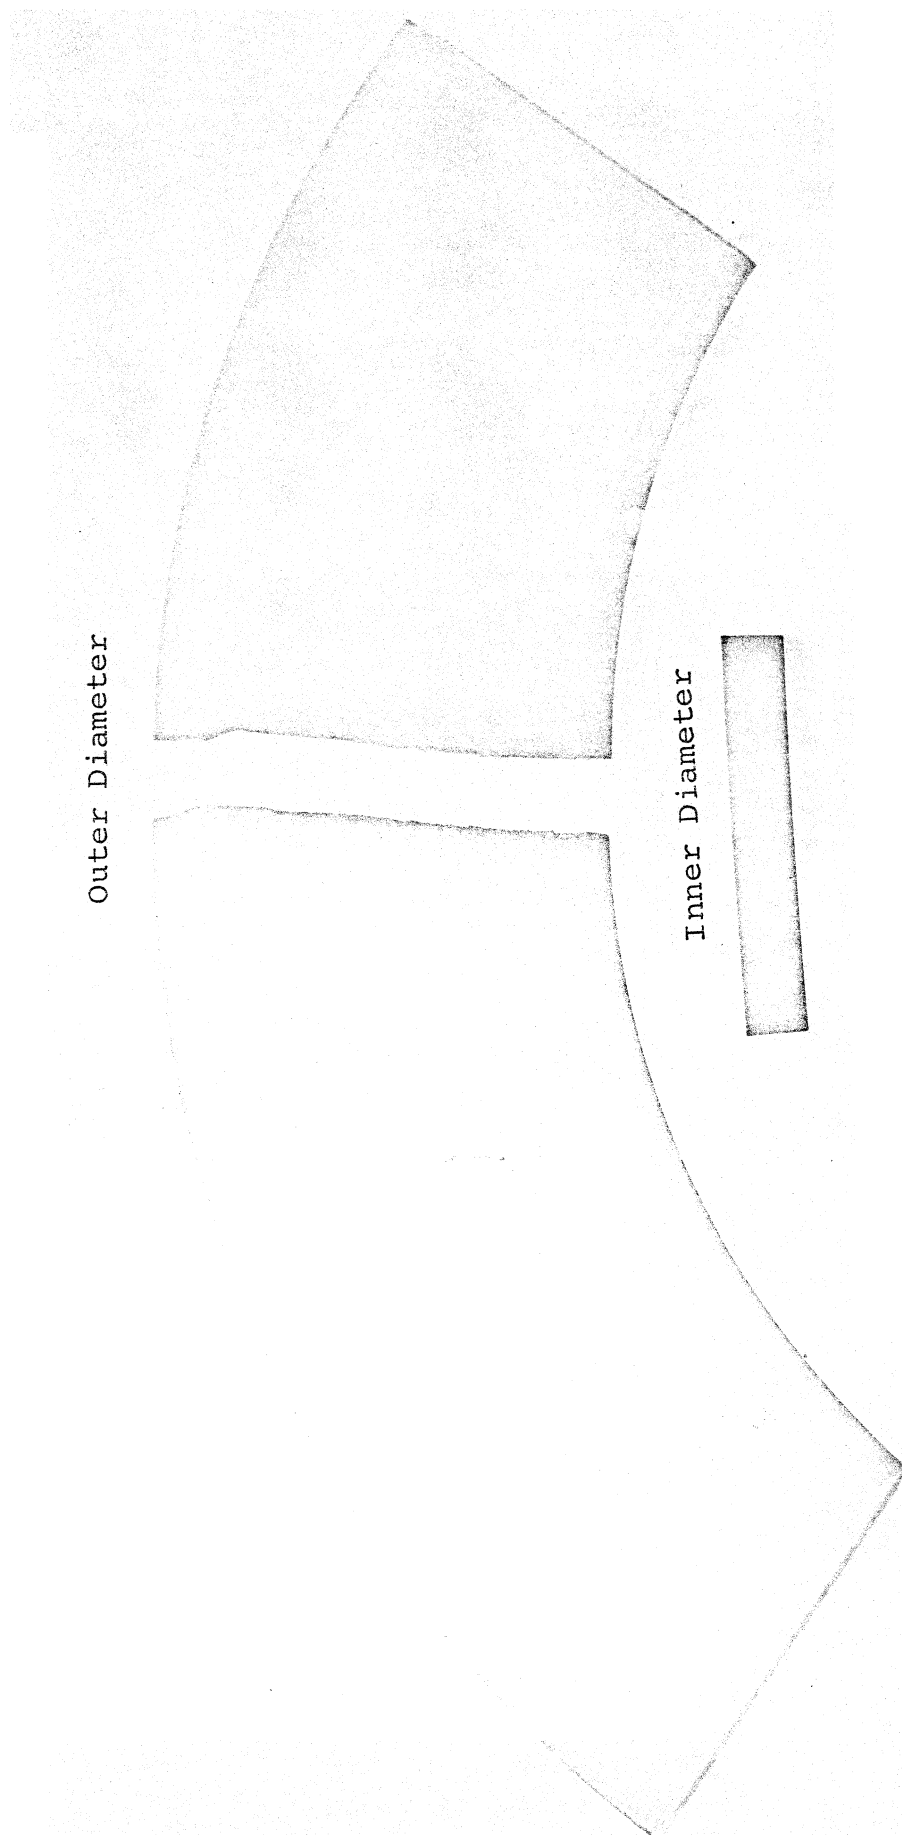
The two pieces weighed about 80 lb and are shown in Fig. 1. To facilitate the examination small sections about 3/4" wide were cut from the area adjacent to the crack.

Fig. 1. Broken segments of  
Stowbrake spring

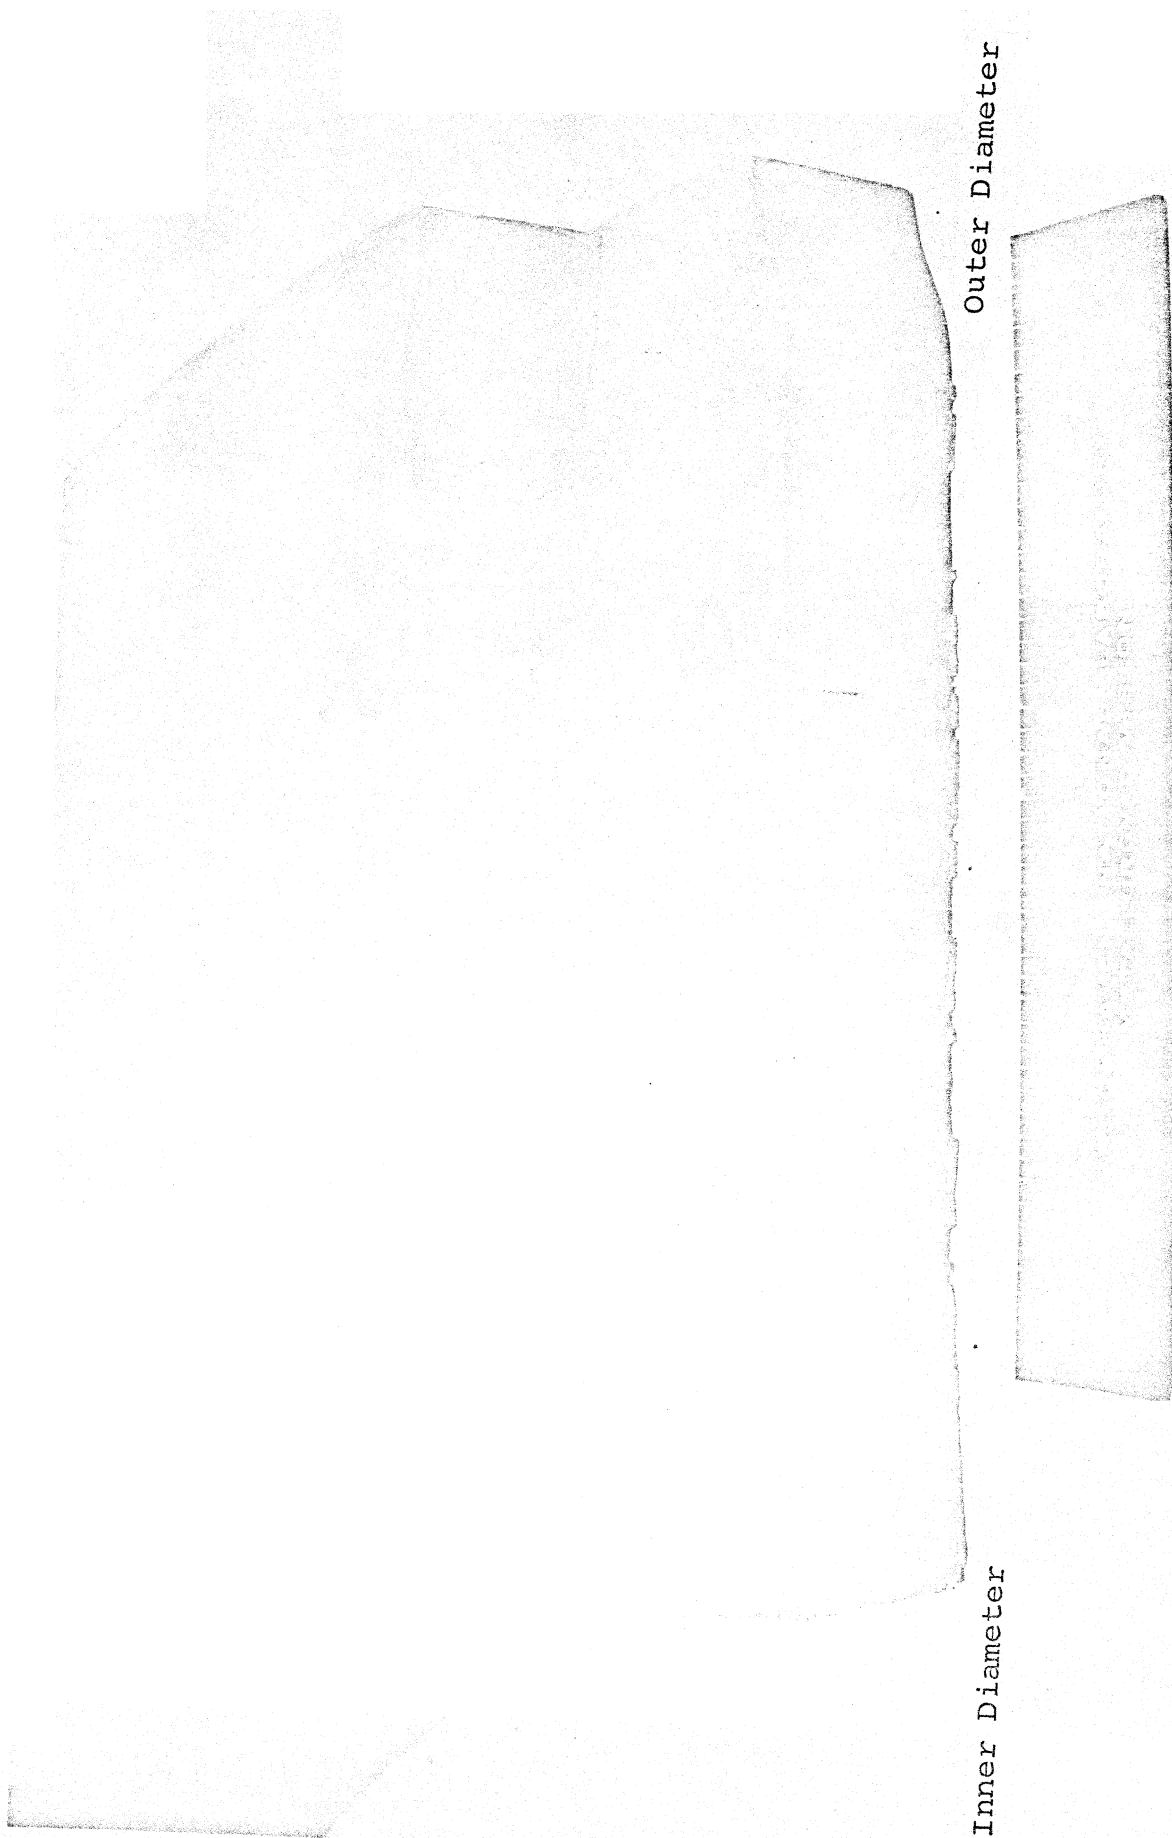
All external surfaces of the spring were coated with a thin, adhering oxide layer. The fracture surfaces were also oxidized with the surfaces closer to the inner diameter more oxidized than those surfaces closer to the outer diameter, Fig. 2. Appearance of the fracture surface is shown in the photograph, Fig. 3. It is a typical fatigue fracture, with the crack appearing to initiate at a corner of inner surface of the spring as indicated by the arrows in Fig. 3. The crack appears to have propagated through the spring toward the outer diameter with fracture finally occurring

Fig. 2. Surface oxidation and fracture surface of stowbridge spring

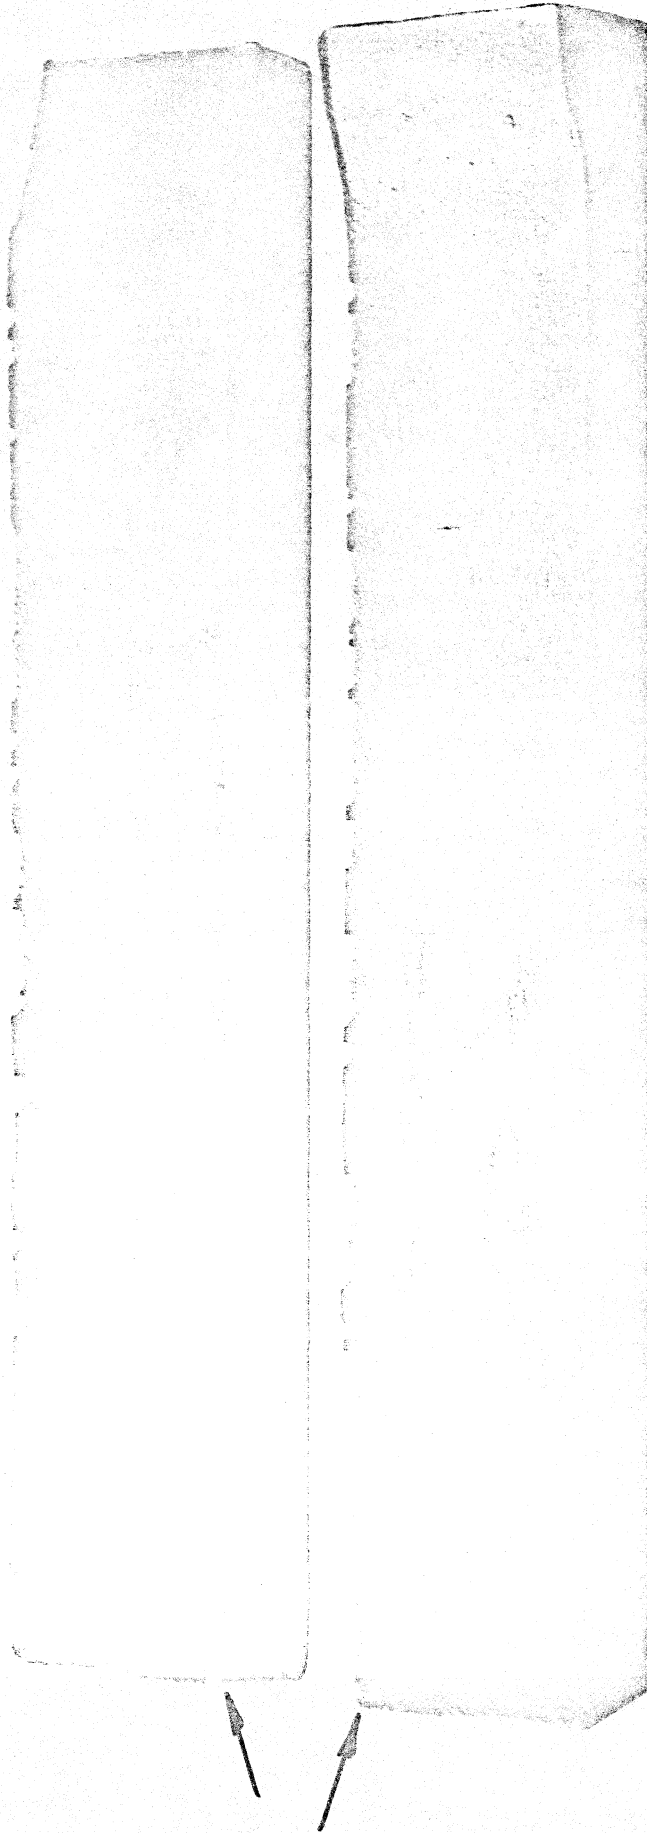
Visual examination of the fractured surface indicates fracture of the spring initiated at the inner diameter and near a corner.

Fig. 3. Appearance of fracture surface showing a fatigue type failure
