VLA Electronics Memo #245

Antenna 16 Failure and Repair Report

Doug Whiton (NRAO)

4/5/2007

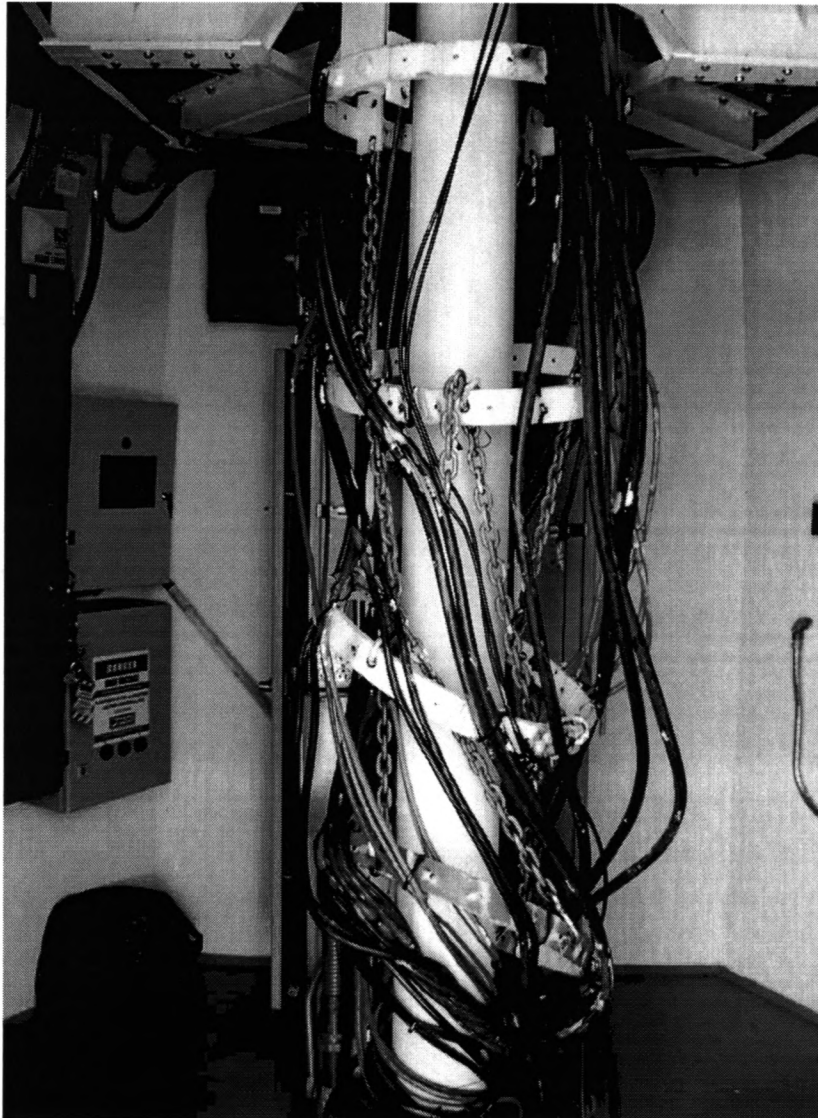
Damage to the antenna cable wrap. Damaged cables include: 1) W-101, the 15pr FRM data cable to apex, 2) W-104, the 15pr FRM data cable to apex, 3) W-45, the 3pr E-STOP cable, 4) W-301, the 13pr communication data cable, and 5), W-40, the AZ encoder data cable. The Vertex power cable that was broken and the two DC power cables had some minor insulation damage, Figure 1. More damaged cables may be found as the repair process continues. Four carabineers that connect the cable support chains to the guide rings were broken, Figure 2. Fortunately, there was no damage to the fiber wrap, Figure 3. This is only because the motion was CW, which fed the fiber into the tray, albeit, to excess. The fiber did loop back onto itself, but the integrity of the fiber was not compromised.

Figure 1. Maypole Cable Damage

Damage to the antenna was limited to the cable wrap and the limit tree. The four carabiners that connect the cable support chains to the guide rings will be replaced. The W-101, W-104, W-45, W-301, and W-40 Cables will be replaced. The Vertex power cable will be spliced. The two DC power cables which had minor insulation damage will be taped. The limit tree will be replaced with the spare. A thorough inspection of the other 27 limit trees will be made in the near future.

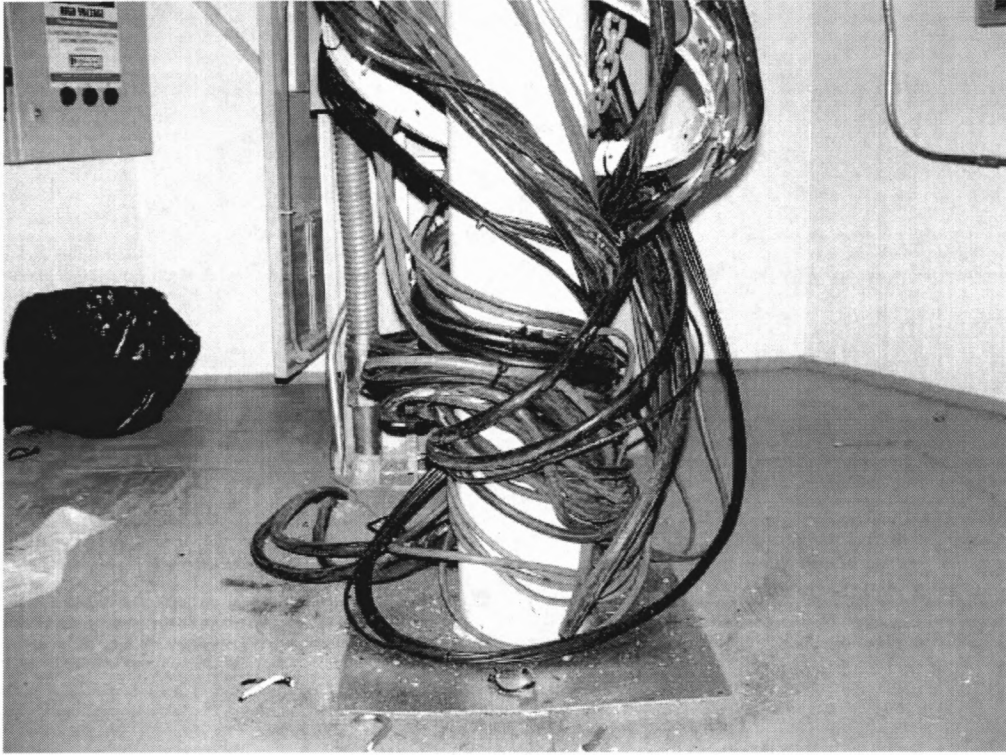
Figure 2. Carabineer Damage

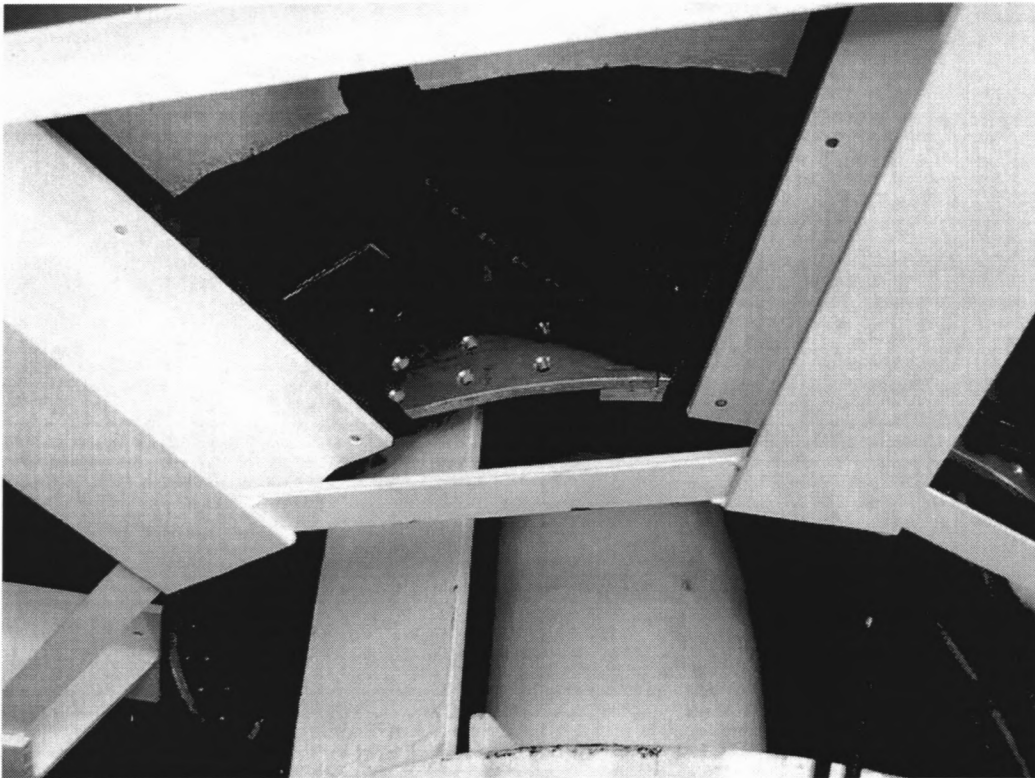
Figure 3. Fiber Cable Wrap

During the repair process, the cable trays in the pedestal room will be replaced. These trays were scheduled to be replaced during the next EVLA retrofit. Replacing the cable trays will allow a thorough inspect all cables. Fortunately, there was no damage to the fiber wrap.

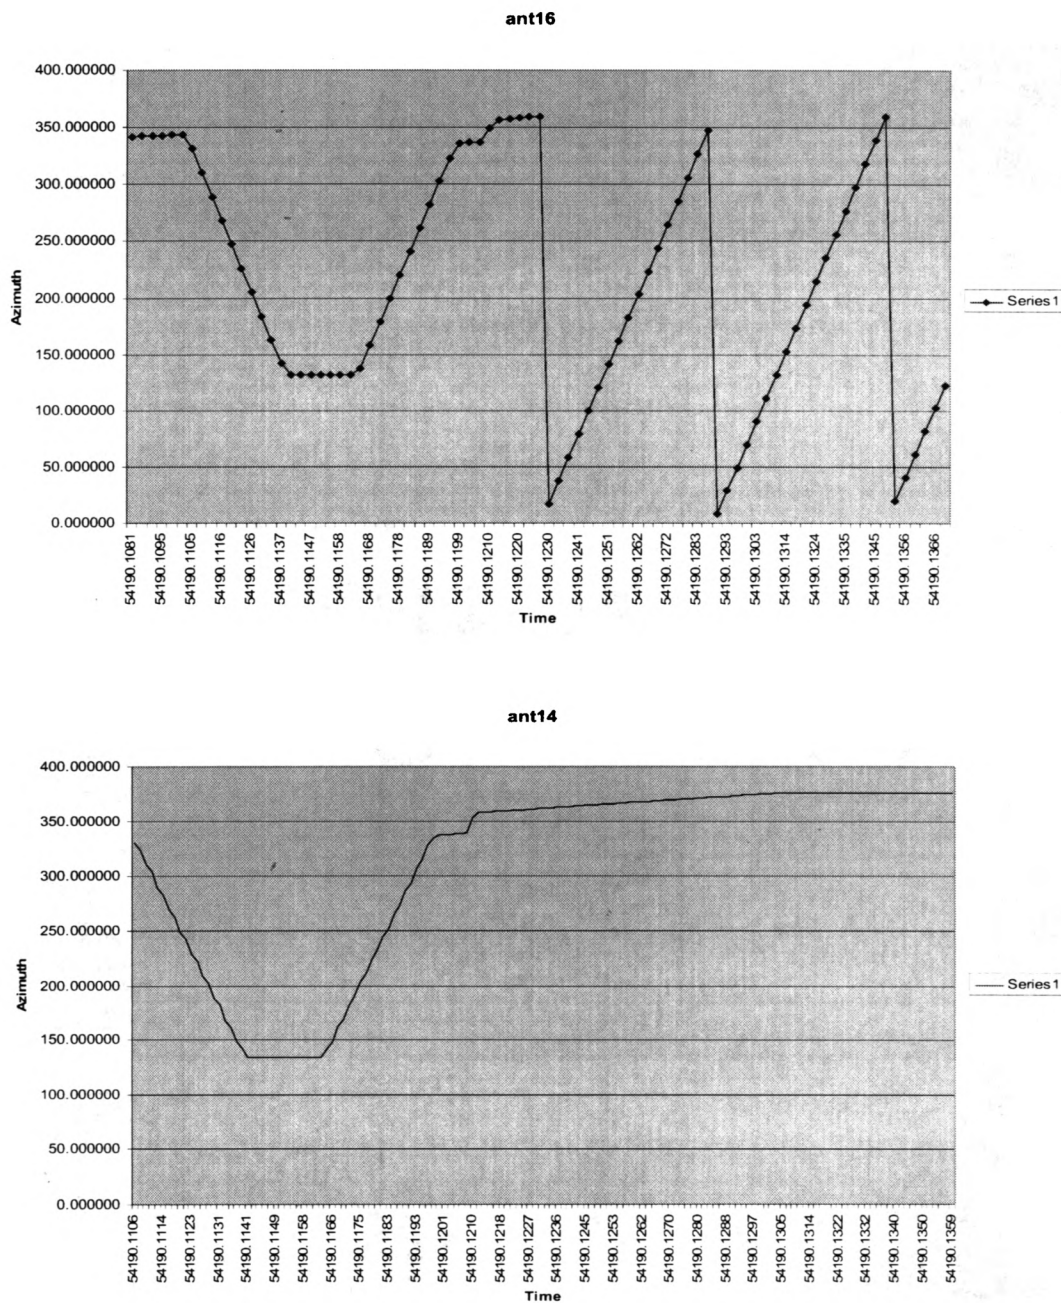
The archive data shows that the antenna failed before 7:57 pm MT. At 7:57 pm MT, the antenna rolled the encoder bits over and expected to see the MSB set. The data indicate that the lead/lag switch did not trip. When the bits rolled over to zero, the ACU thought it was at zero and sent the antenna running CW to get back to where it was supposed to be. The antenna ran at full slew for about 850 degrees before the cables failed. The Figure 4 show the azimuth data of antenna 16 compared to antenna 14.

Figure 4. Antenna 16 and 14 Movement

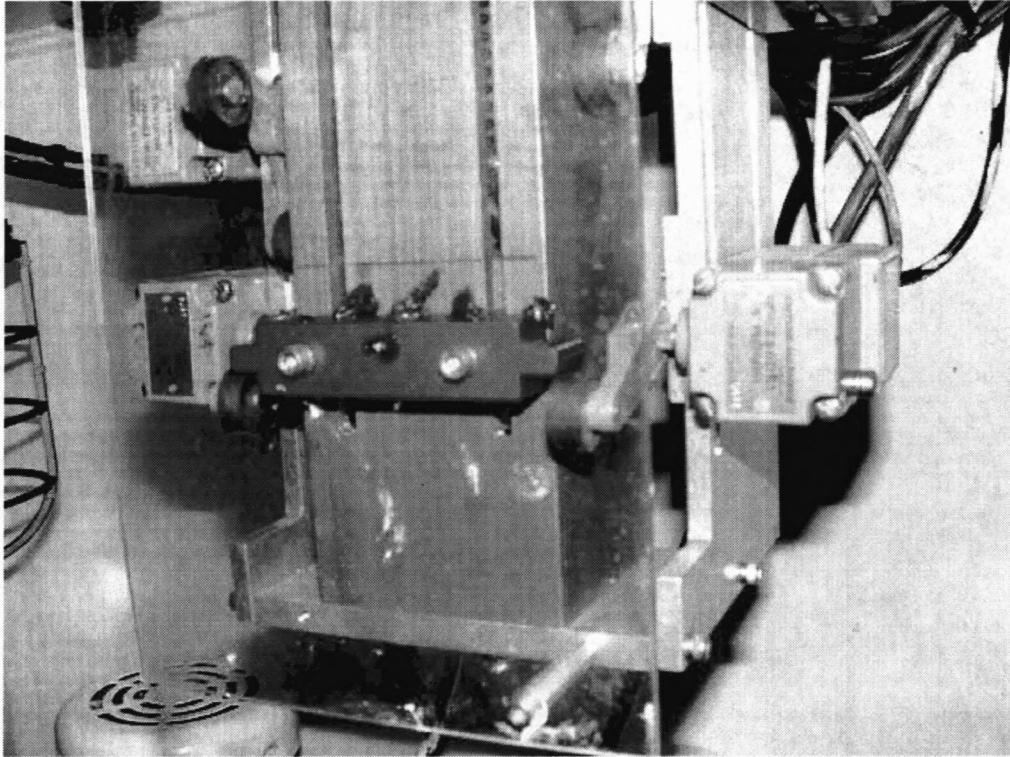
Initially it was thought that a power glitch or the reboot of the MODCOMP had played a role in the failure by causing a default ACU command to zero position. Analysis of the archive data clearly shows that the antenna just got lost and was trying to find the commanded position. This led to an evaluation of the limit tree. The limit tree was found inoperative and had failed near the lower limit of travel, Figure 5.

Figure 5. Failed Limit Tree Position

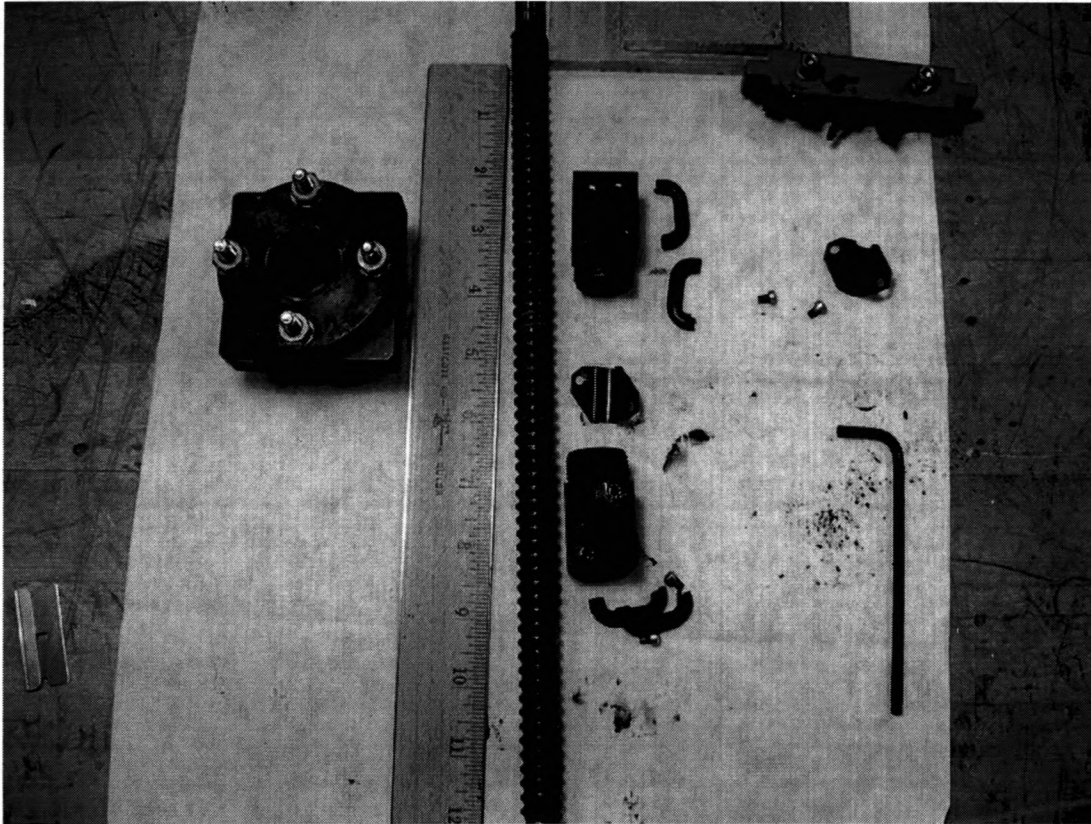
The limit tree internal assembly has two ball nuts that roll on a worm gear and guide an aluminum block that trips the lead/lag and limit switches. Each ball nut normally has several (~20 to 30) balls within the raceway. The ball nuts have an external tube that recirculates the ball-bearings onto and off of the worm gear, Figure 6. The tube has fingers that help guide the balls. This limit tree failure was a result of the roller balls being missing from the ball nuts. At some point in the past, the limit tree was assembled or reassembled without the roller balls. This left only the tube guide fingers to make contact with the worm gear. Overtime, the fingers were completely worn away, and the block began slipping on the worm gear.

Figure 6. Internal Limit Tree Assemblies
