VLA Electronics Memo #245

Antenna 16 Failure and Repair Report

Doug Whiton (NRAO)

4/5/2007

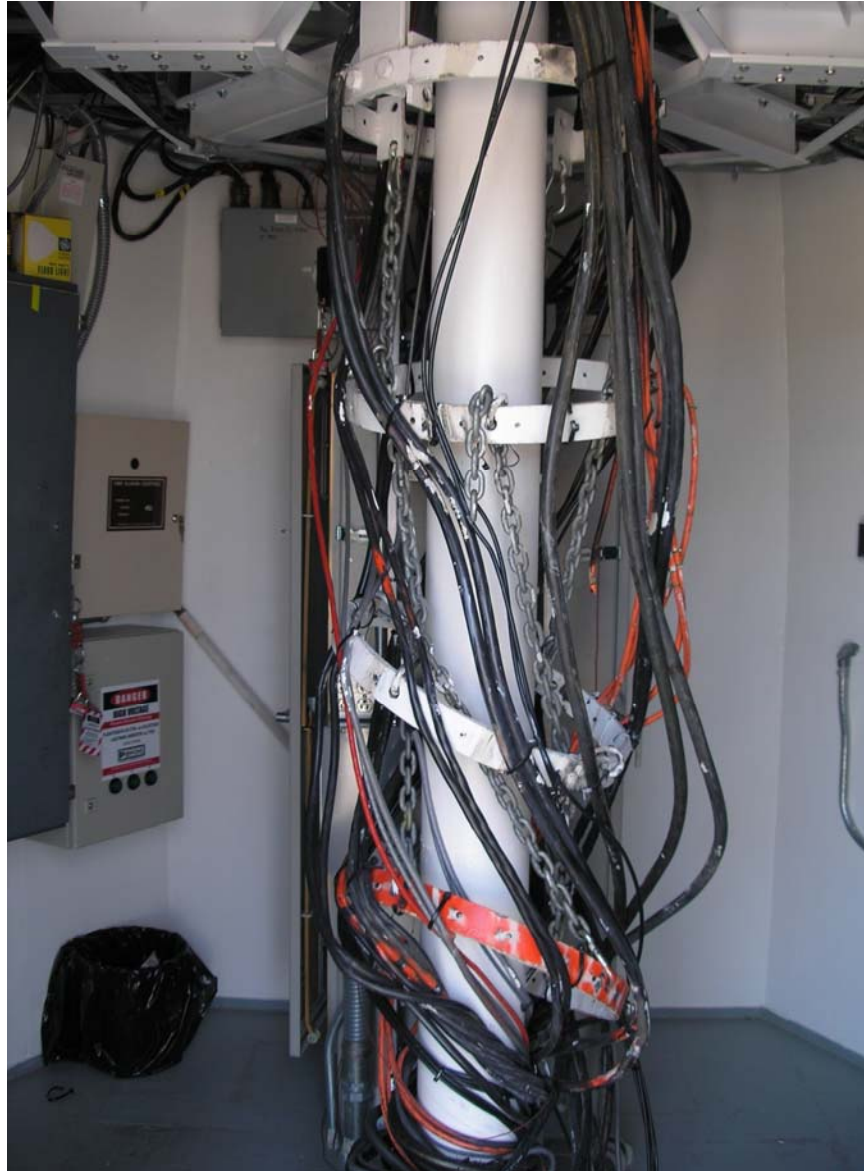
Damage to the antenna cable wrap. Damaged cables include: 1) W-101, the 15pr FRM data cable to apex, 2) W-104, the 15pr FRM data cable to apex, 3) W-45, the 3pr E-STOP cable, 4) W-301, the 13pr communication data cable, and 5), W-40, the AZ encoder data cable. The Vertex power cable that was broken and the two DC power cables had some minor insulation damage, Figure 1. More damaged cables may be found as the repair process continues. Four carabineers that connect the cable support chains to the guide rings were broken, Figure 2. Fortunately, there was no damage to the fiber wrap, Figure 3. This is only because the motion was CW, which fed the fiber into the tray, albeit, to excess. The fiber did loop back onto itself, but the integrity of the fiber was not compromised.

Figure 1. Maypole Cable Damage

Damage to the antenna was limited to the cable wrap and the limit tree. The four carabineers that connect the cable support chains to the guide rings will be replaced. The W-101, W-104, W-45, W-301, and W-40 Cables will be replaced. The Vertex power cable will be spliced. The two DC power cables which had minor insulation damage will be taped. The limit tree will be replaced with the spare. A thorough inspection of the other 27 limit trees will be made in the near future.

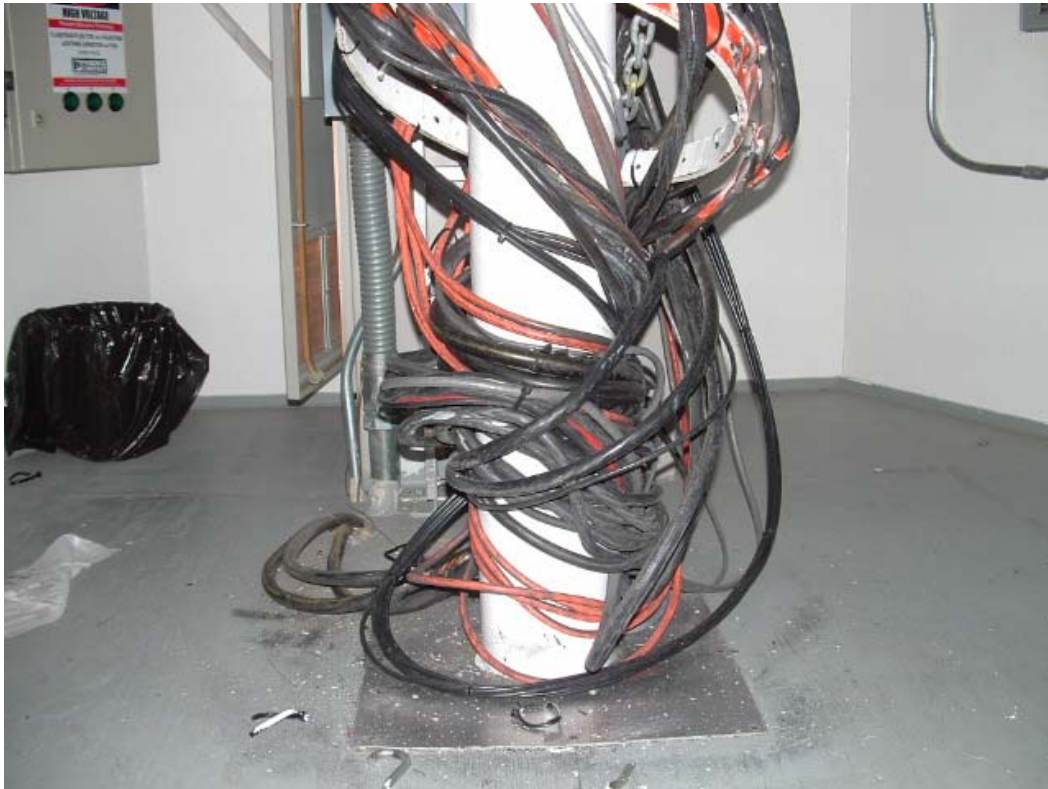
Figure 2. Carabineer Damage

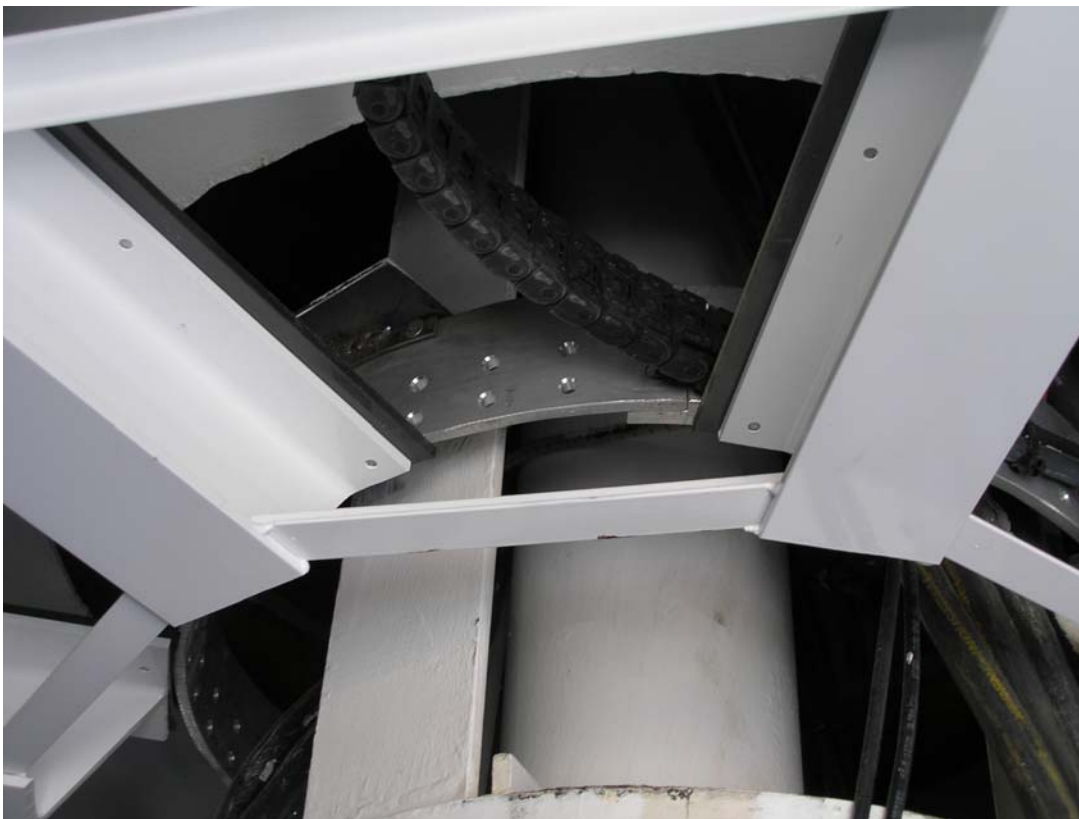
Figure 3. Fiber Cable Wrap

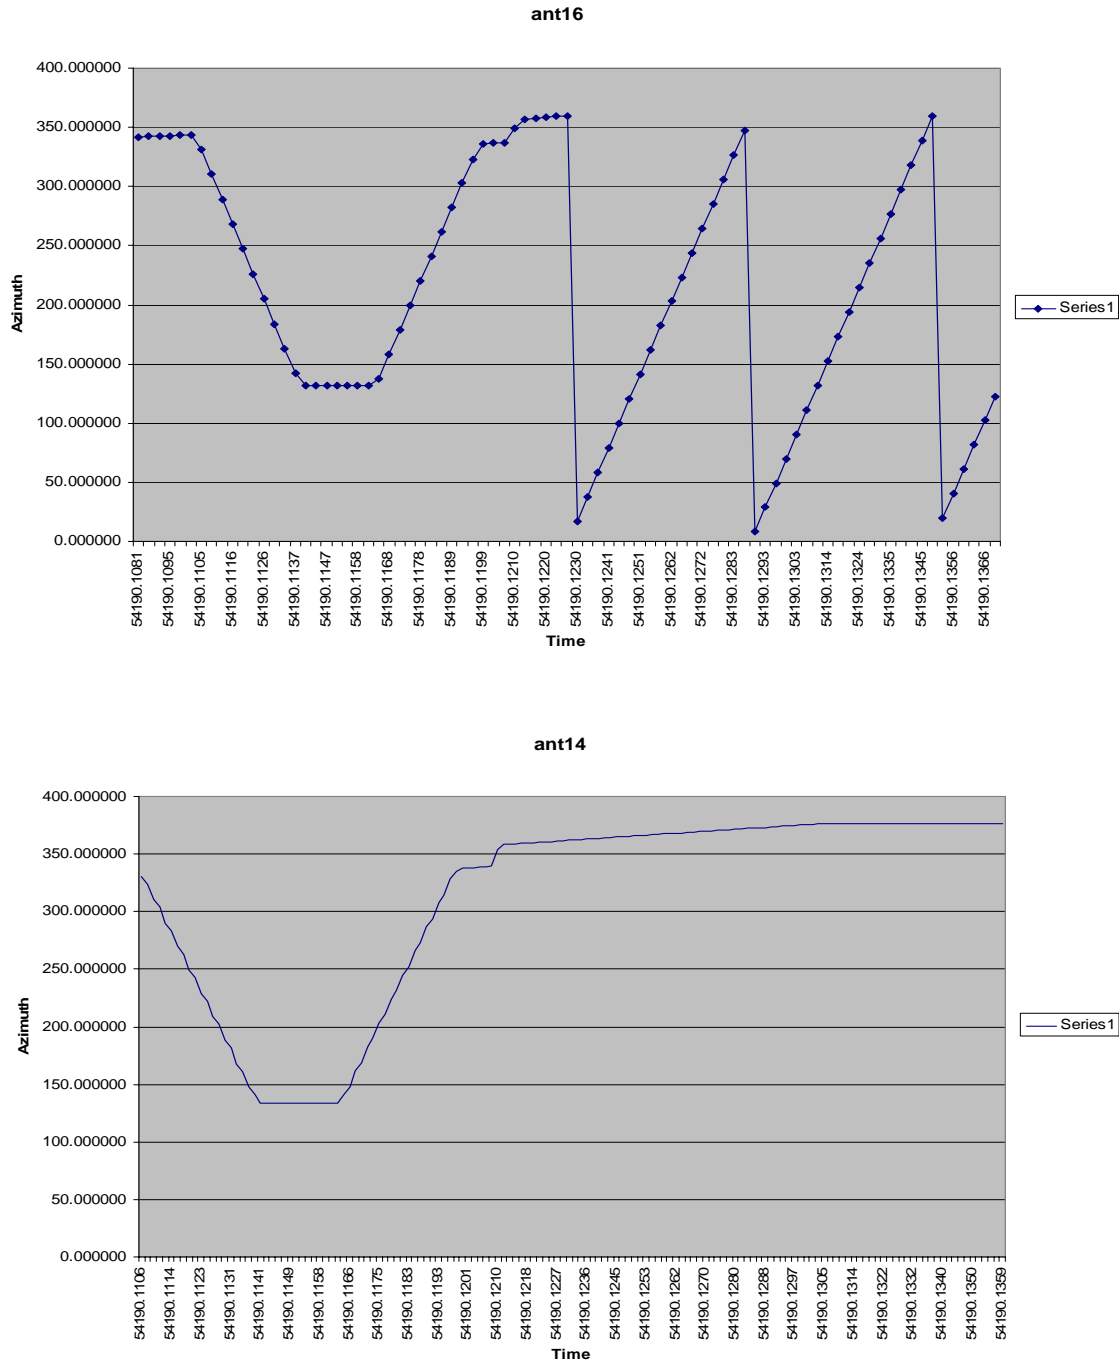
The archive data shows that the antenna failed before 7:57 pm MT. At 7:57 pm MT, the antenna rolled the encoder bits over and expected to see the MSB set. The data indicate that the lead/lag switch did not trip. When the bits rolled over to zero, the ACU thought it was at zero and sent the antenna running CW to get back to where it was supposed to be. The antenna ran at full slew for about 850 degrees before the cables failed. The Figure 4 show the azimuth data of antenna 16 compared to antenna 14.

Figure 4. Antenna 16 and 14 Movement

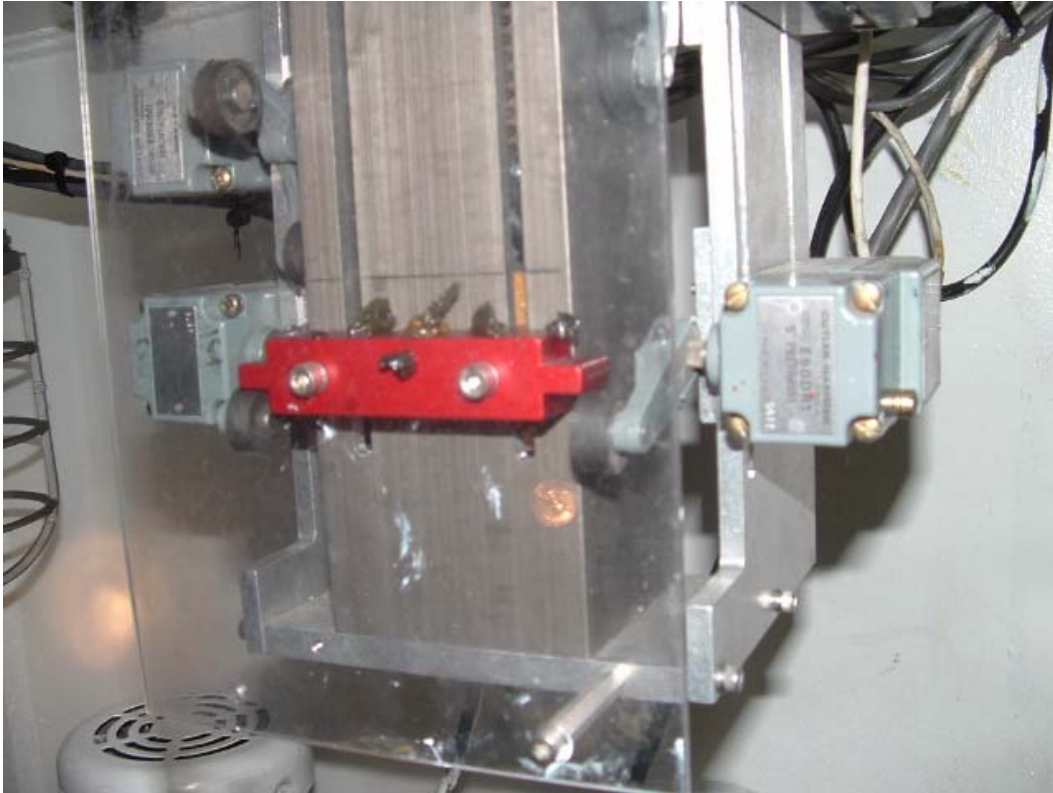
Initially it was thought that a power glitch or the reboot of the MODCOMP had played a role in the failure by causing a default ACU command to zero position. Analysis of the archive data clearly shows that the antenna just got lost and was trying to find the commanded position. This led to an evaluation of the limit tree. The limit tree was found inoperative and had failed near the lower limit of travel, Figure 5.

Figure 5. Failed Limit Tree Position

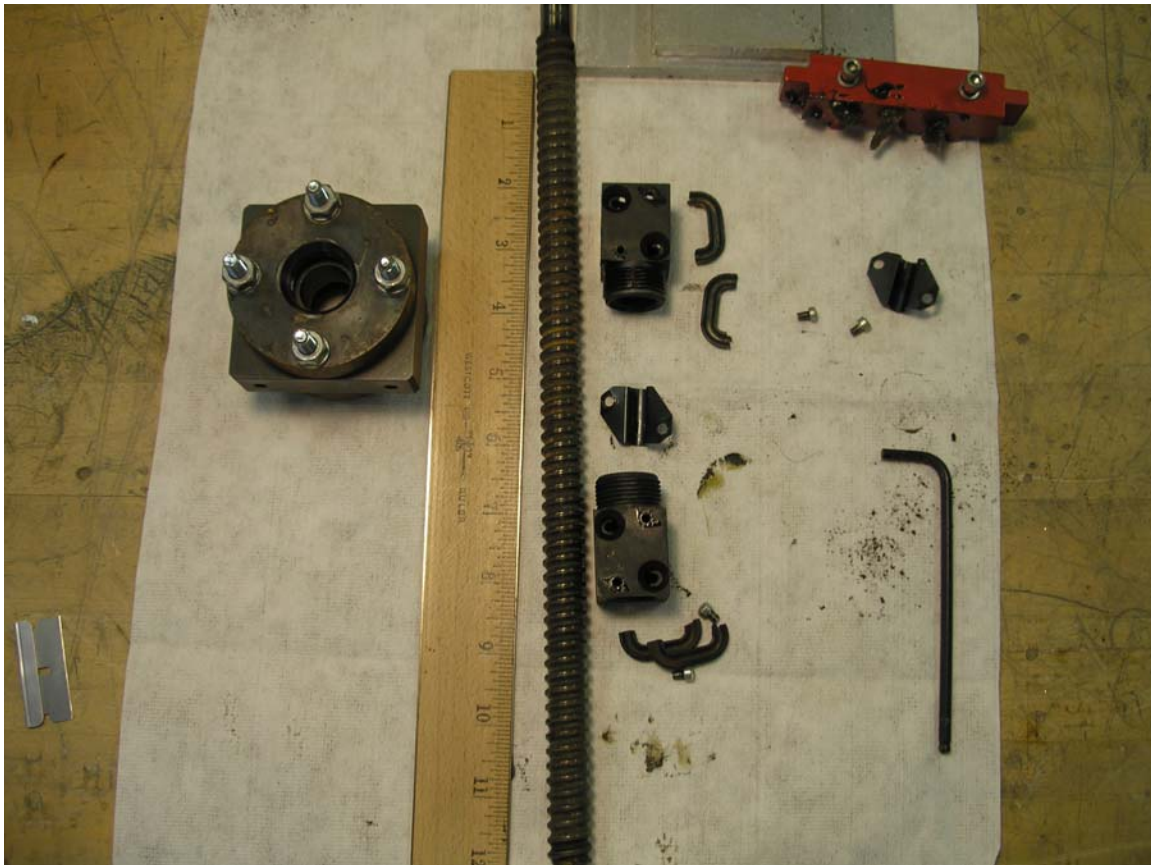
The limit tree internal assembly has two ball nuts that roll on a worm gear and guide an aluminum block that trips the lead/lag and limit switches. Each ball nut normally has several (~20 to 30) balls within the raceway. The ball nuts have an external tube that recirculates the ball-bearings onto and off of the worm gear, Figure 6. The tube has fingers that help guide the balls. This limit tree failure was a result of the roller balls being missing from the ball nuts. At some point in the past, the limit tree was assembled or reassembled without the roller balls. This left only the tube guide fingers to make contact with the worm gear. Overtime, the fingers were completely worn away, and the block began slipping on the worm gear.

Figure 6. Internal Limit Tree Assemblies
