6 arcsecond Pointing at VLA?

VLA Test Memo 218

B. Broilo, C. Janes, J. Thunborg

Updated Version, April 21, 1999
(Disregard Previous Version)

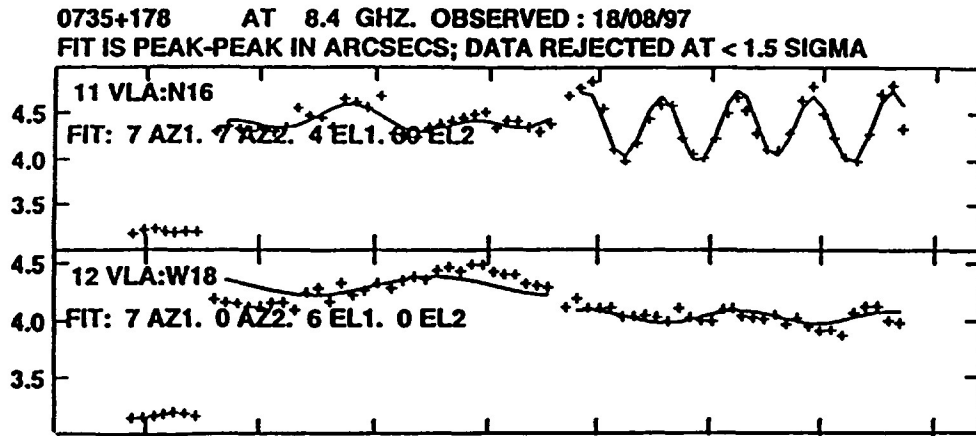
Figure 1 - Example PN3dB Test Results

Tracking tests performed routinely on each VLA antenna identify periodic encoder errors. Periodic errors on Inductosyn resolvers are common as a function of one times the number of poles, the so-called "512" error, and two times the number of poles, or the "1024" error. In the tests, called PN3DB, a source is tracked with an offset so that a periodic error in the encoder will show up as a source amplitude variation. Figure 1, an example of a PN3DB test, has four columns, AZ1, AZ2, EL1, and EL2. AZ1 is the amplitude in arcseconds of an azimuth encoder error that varies as the number of poles or 512 cycles per fine encoder resolution. AZ2 varies as twice the number of poles or 1024 cycles per resolution. EL1 and EL2 are comparable errors for the elevation encoder. The encoder errors cause antenna pointing errors.

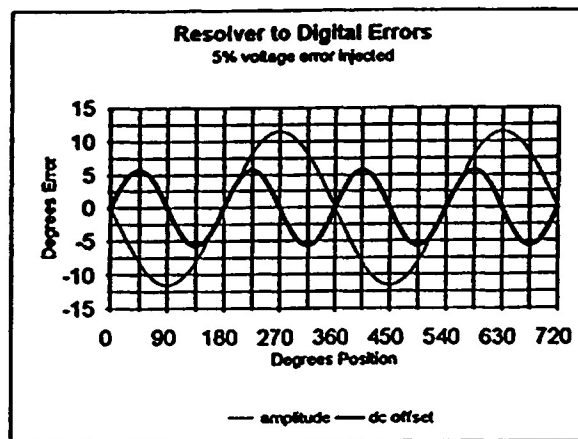
Figure 2 - Simulated 512/1024 Errors

Comparison of the amplitudes of the two sine wave outputs of a resolver provides the absolute encoding; the amplitudes vary as a function of position but 90 degrees out-of-phase. Each cycle of the sine wave corresponds to one pole on the resolver. Because the fine encoder has a very weak coupling between the rotor and stator, the small output signals must be amplified. If there is a mismatch in amplifier gains, the maximum amplitudes of the two signals will differ, and a periodic encoder error will be introduced. The resulting position error varies for every cycle of the sine wave, hence the name "512" error. The "1024" error is introduced by a DC offset between the two sine wave outputs, see Figure 2.

To correct the "512" tracking error, the maximum amplitudes of the sine waves must be carefully adjusted to be equal at a scale of 1.5 microvolts / arcsecond of error. The amplifiers in the current electronics package drift with time and temperature so that adjustment must be made as often as twice per year with seasonal changes. For both "512" and "1024" errors, correction is not attempted until PN3DB tests demonstrate an error exceeding 6 arcseconds; the threshold was 10 arcseconds until Q band receivers were installed.

A new encoder electronics design, initially proposed by Dusty Clark of the UA/SAO MMTO in Tucson, uses monolithic resolver-to-digital (R-D) converter chips. Ron Weimer of NRAO modified Clark's design and built a circuit using the R-D chips for the VLA encoders. The new design should dramatically reduce the 512/1024 periodic encoder position errors by having operations on both sine wave outputs on a single chip providing better temperature stability and equalizing of any amplitude variations. Bob Broilo has been assigned to develop a two-axis prototype of the Clark/Weimer circuit for testing on telescope by July '99.
