NATIONAL RADIO ASTRONOMY OBSERVATORY
Socorro, New Mexico

VLBA Antenna Memo Series No.6

Owens Valley Maintenance Visit, April 20 - 25, 1998 - Trip Report

J. E. Thunborg
May 8, 1998

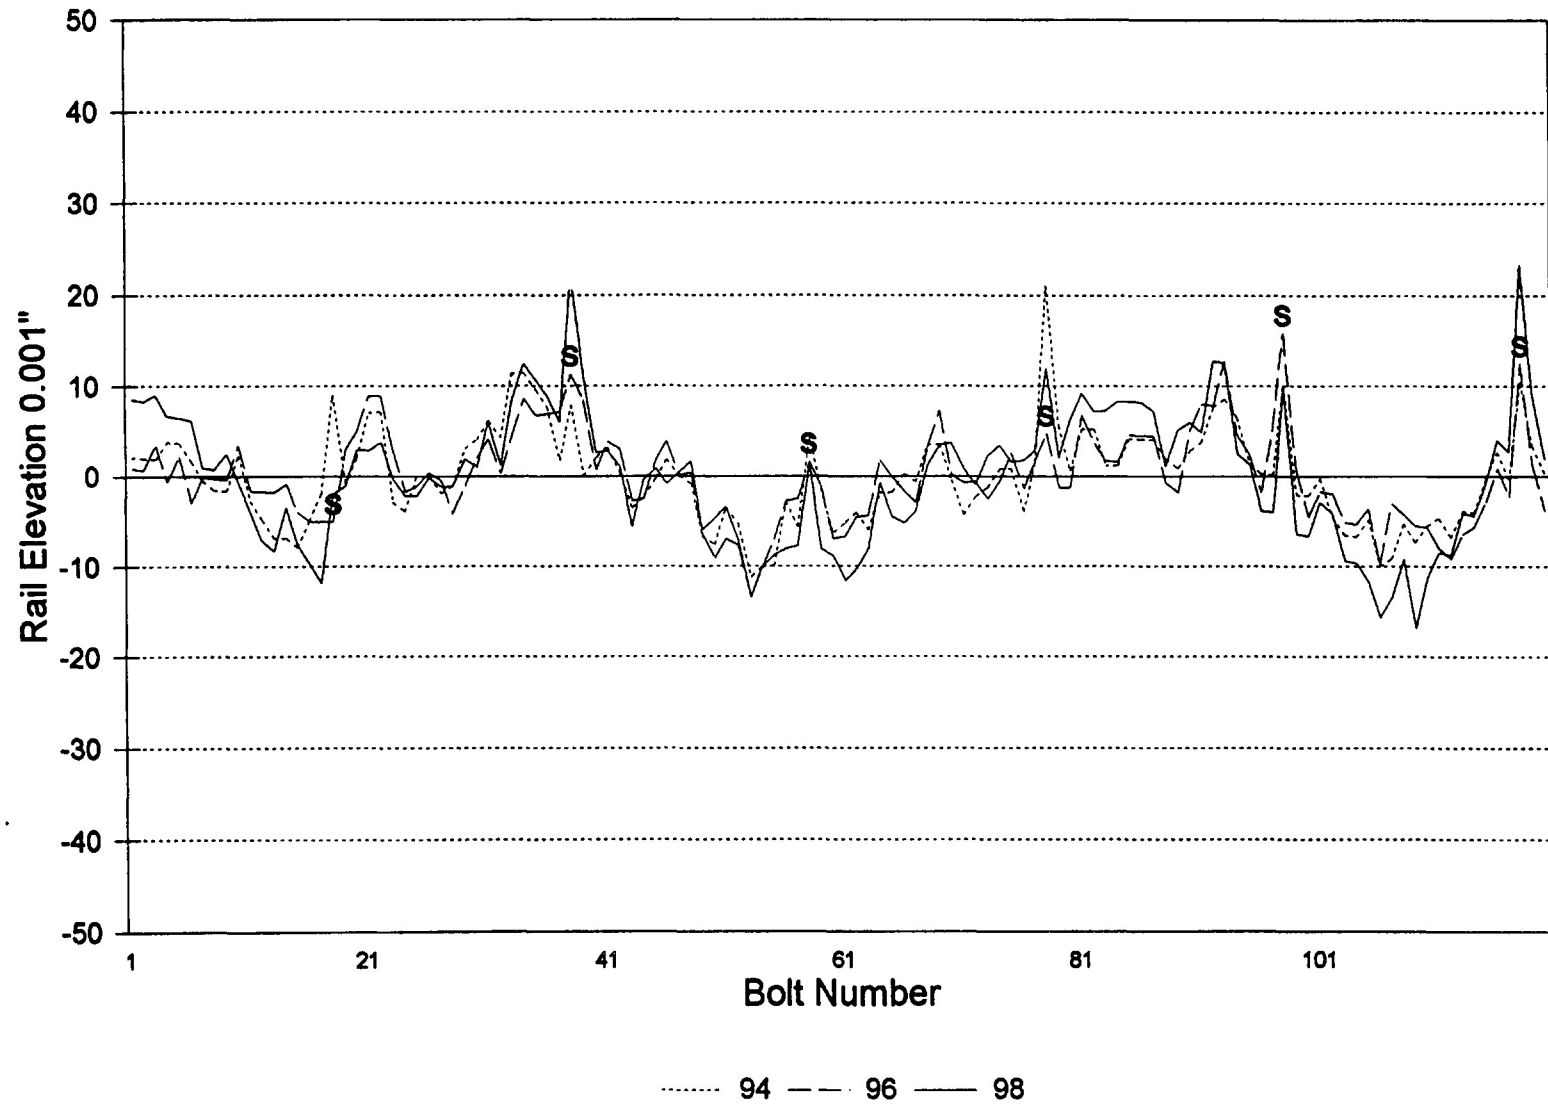
OV Azimuth Rail

Comparison 1994 to 1998

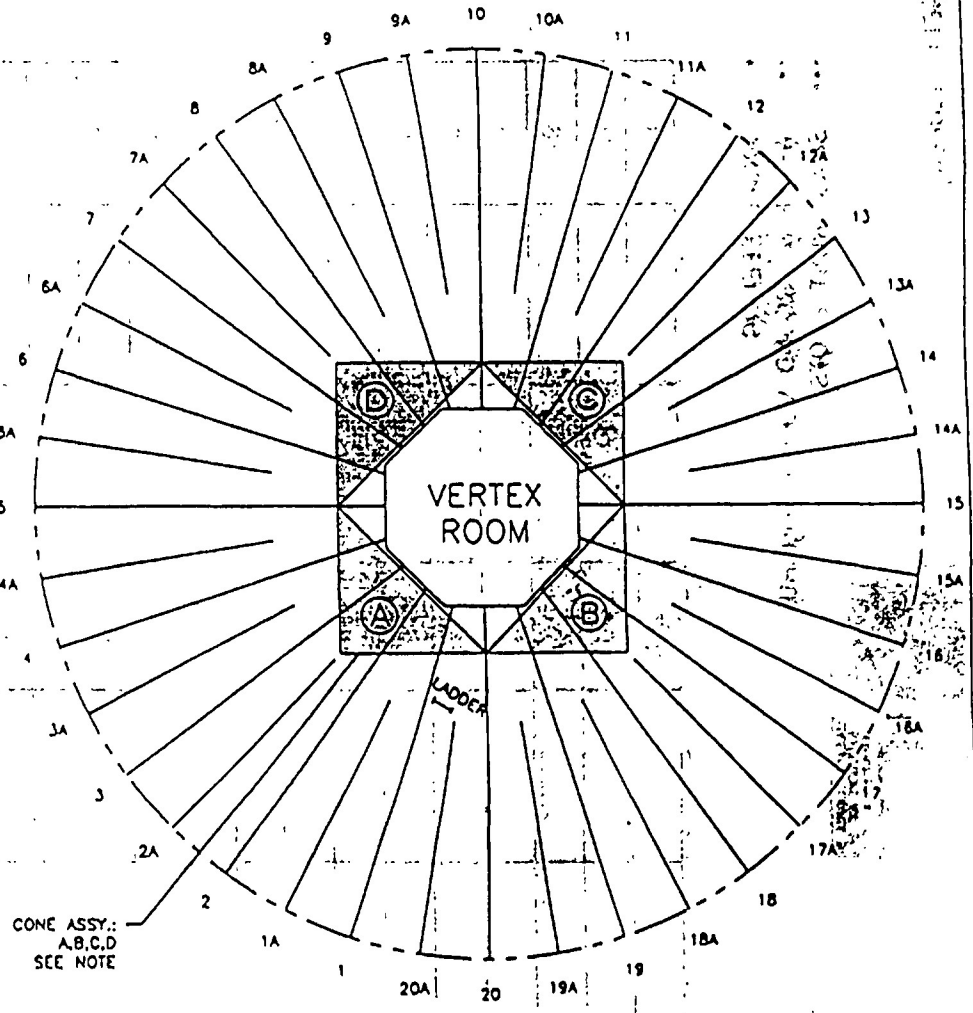
| | UNLESS OTHERWISE SPECIFIED DIMENSIONS ARE IN INCHES TOLERANCES UNLESS OTHERWISE SPECIFIED: 1 PLACE RECEIVES LUGS ± .005 2 PLACE RECEIVES LUG ± .01 3 PLACE RECEIVES LUG ± .05 | HANCOCK PAINT REPORT LOCATION OF DELAMINATIONS | NATIONAL RADIO ASTRONOMY OBSERVATORY NAME: C. GARCIA DATE: 12/2/98 |

Valley 4/22/98
Paint is in Excellent condition.
Very few spots where paint is peeling.

- ... ANGLE PEELING
- ... WF BEAM AROUND VERTEX TOUCHUP
- ... SMALL RUST SPOTS

NOTE: INSPECT CONE ASSY. INTERNALLY
REPAIR/PAINT AS REQUIRED.

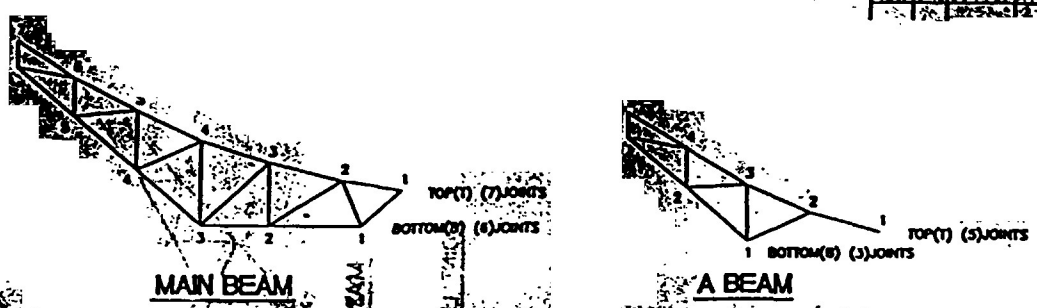
Backup structures in excellent condition ONLY PAINT chipped
 ARE from retightening bolts

- ANGLE PEELING
- WF BEAM AROUND VERTEX TOUCHUP
- SMALL RUST SPOTS
