VLBA  
Antenna Memo #7

**TO:** Clint Janes, Paul Rhodes, Jim Ruff, Lew Serna, Dick Sramek, Guy Stanzione, Jon Thunborg, LAVLBA  
**FROM:** Bob Broilo  
**SUBJECT:** Los Alamos, NM VLBA Site Azimuth Rail Inspection, February 19<sup>th</sup>

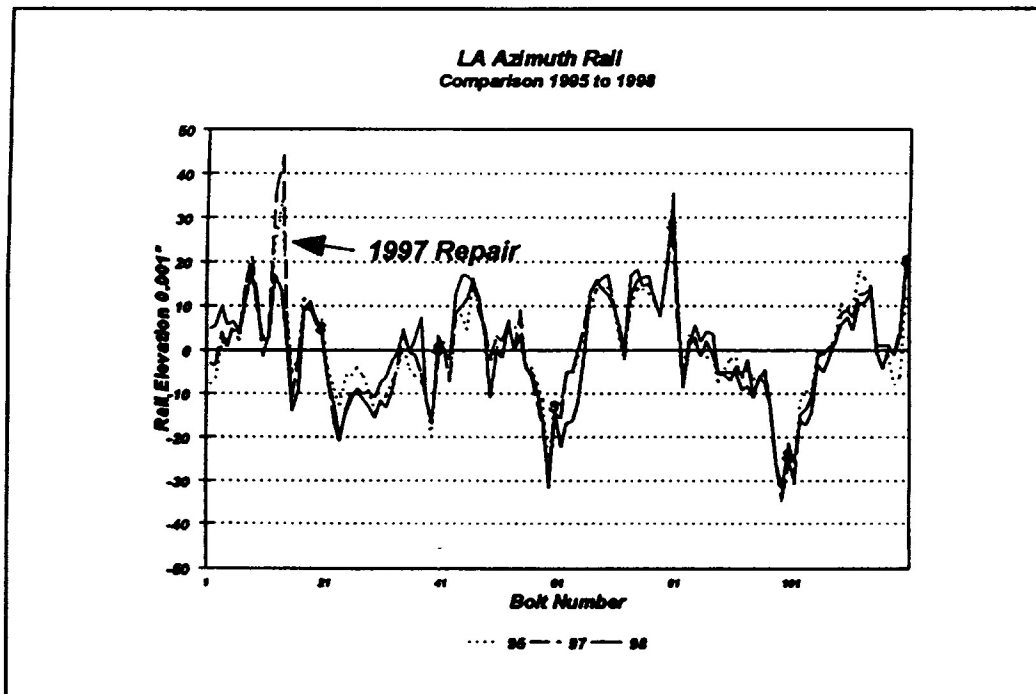
The most apparent feature on the chart is at bolts 12 and 13. This is the area where the grout cracked and was spot repaired in 1997. The development of the deepening hole was arrested and corrected by the spot repair. There may be deteriorating areas at bolts 1-5, 37, and 44, but the damage here is slight. We investigated these and other suspicious areas by removing the Vulkem for a visual inspection. We only found damage to the very top layer of grout. The damage

was similar but less extensive than that found at Mauna Kea, and consisted of loose, sandy grout immediately under the rail.

Due to the dramatic failure of the LA grout last year we wanted to check the integrity of the grout. We used a small hammer drill to compare the original grout in various areas to the new epoxy grout at the spot repair. The grout is mostly very hard and is difficult to drill. There are two areas adjacent to bolts 12 and 13 that seem weaker.

These results indicate that there are no large holes forming at Los Alamos. The grout appears to be strong, with some slight damage to the very top layer. We should perform some spot repairs at bolts 1-5, 37, and 44. These repairs should probably span three bolts and should be covered in Vulkem when complete.
