VLBA ANTENNA MEMO SERIES #9**TRIP REPORT****KITT PEAK PINTLE BEARING LEVELING****4-19-98 To 4-25-98****G.A. Stanzione**

Kitt Peak Pintle Bearing Summary

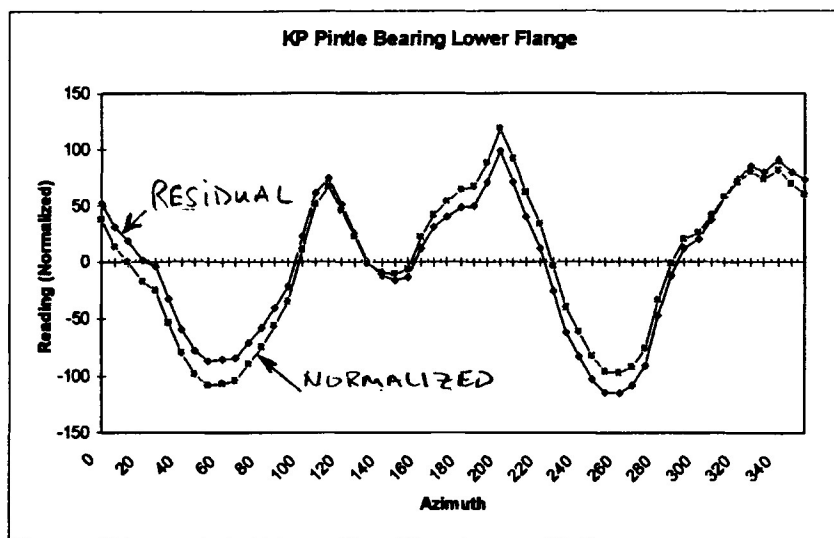
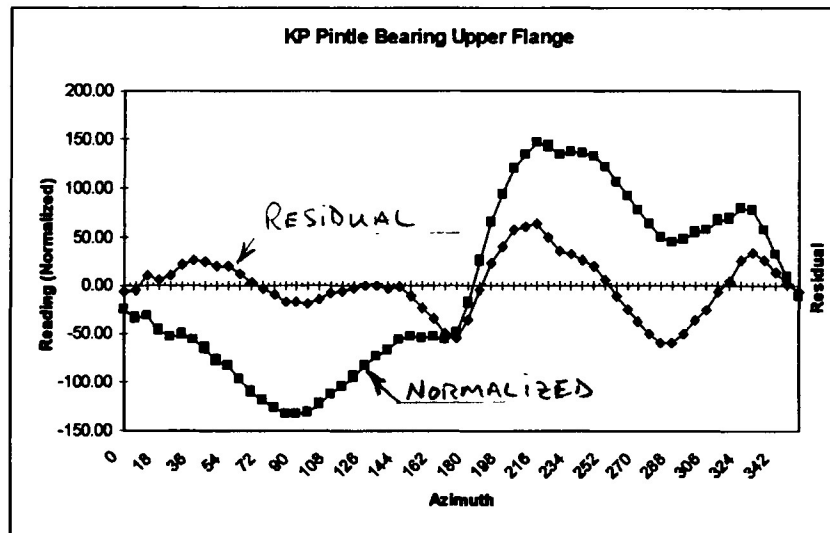
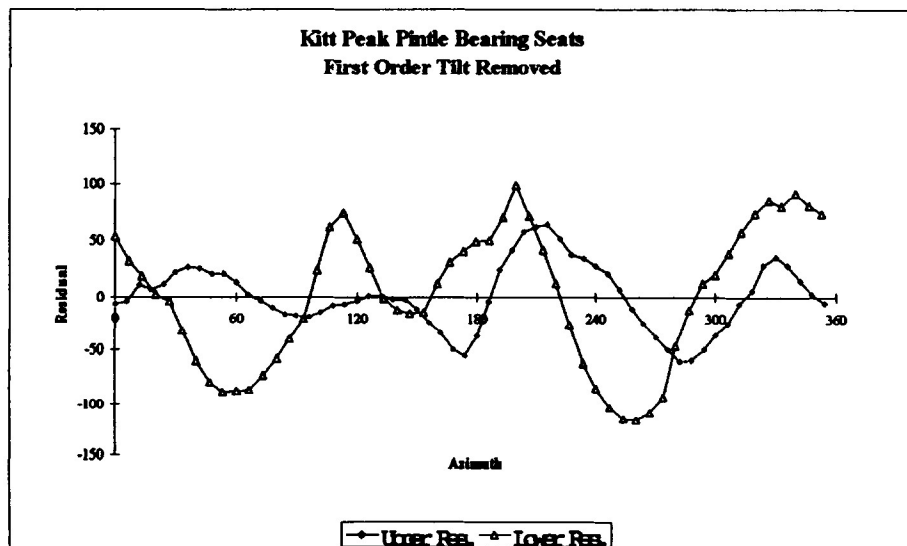
A table of shim placement (page 11) by bolt number top and bottom is attached. Additional plots (Page 10) were prepared checking for tilt associated with the lower and upper bearing seats. The lower seat did exhibit some tilt (.022") and is very wavy. Shim stacks ranging from 0-.228" were required to remove the tilt and seat waviness. The top seat exhibited more tilt (.117") than the lower seat. Shim stacks ranging from 0-.280" were placed to remove waviness and tilt from the upper seat.

A plot of the normalized readings (with tilt) and residual (waviness) are attached. Waviness in the lower and upper seats exceeds .125" over 90 degrees. The bearing manufacturer recommends that waviness not exceed .010" over 90 degrees. There is also approximately .022" of tilt in the bottom seat and .117" of tilt in the top seat. Waviness and tilt in the

bottom and top seats were removed relative to the bearing, with the shim stacks. The bearing is level to within an estimated .009" and loading will be more uniform through 360 degrees.
