VLBA Antenna Memo 100  
**Tiger Team, Mechanical Maintenance**  
**Kitt Peak, AZ**  
**October 10 – October 18, 2017**

Michael Romero  
November, 2017

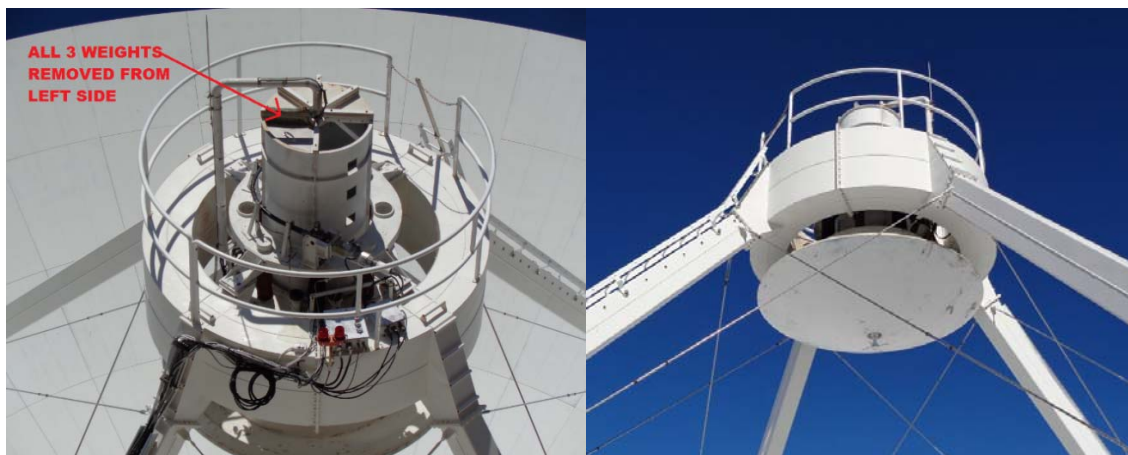
The FRM was inspected thoroughly. The flex shaft was replaced during the inspection. The INA bearing pull test was performed with readings of 15 lbs CCW and 17 lbs CW. In addition to the inspection, the FRM was balanced by placing sub reflector at both long and short axis and releasing the brake. A total of three weights were removed from the top of the barrel. Ray performed positioning tests which did not fault, as was previously seen. The sub reflector mounting, cabling, and drainage was also inspected. Overall, apex and subreflector are in good shape, including paint.

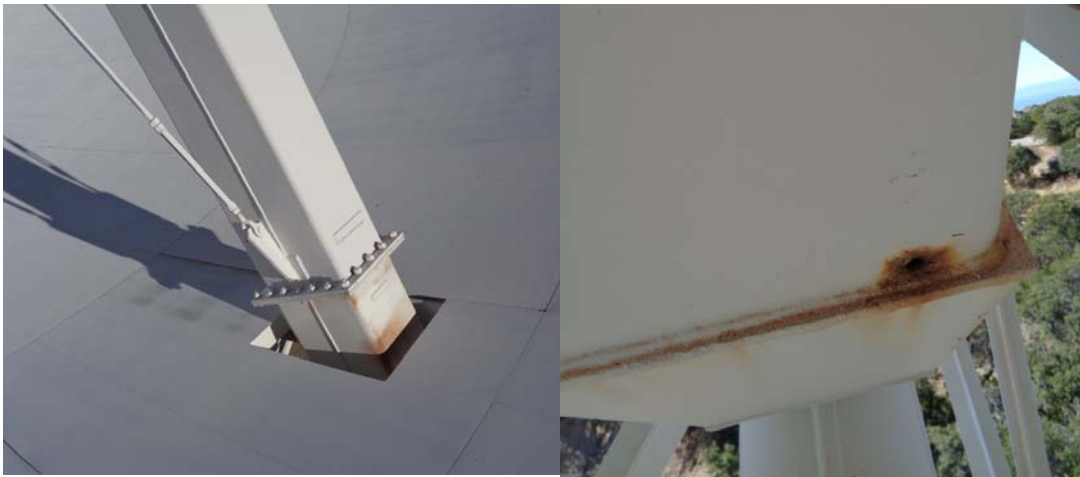
The quad legs and hardware were inspected along with checking the quad leg flange bolts. Rust inspection and “hammer test” were performed to ensure the mechanical integrity of the quad legs remained. As would be expected in a dry environment, the rust was minimal and concentrated around the bottom drain holes. Flange bolts were checked for tightness. The guy wires and turn buckles were also inspected. Guy wires were still taught with minimal corrosion on turn buckles.

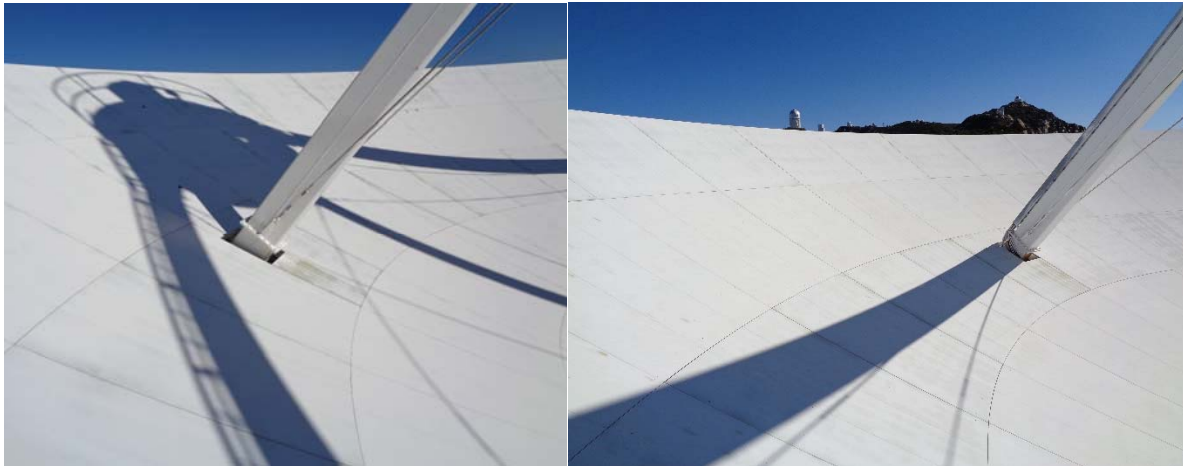
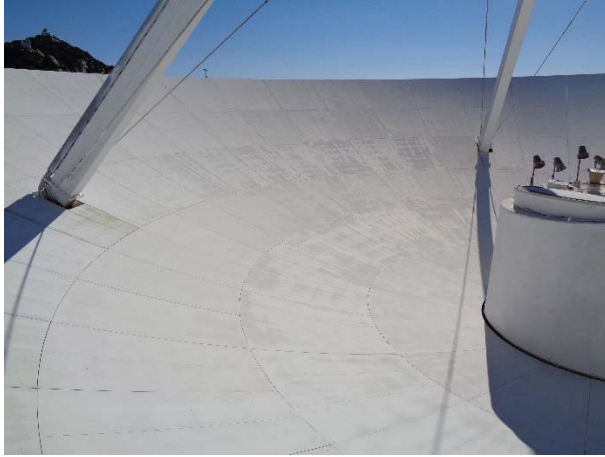
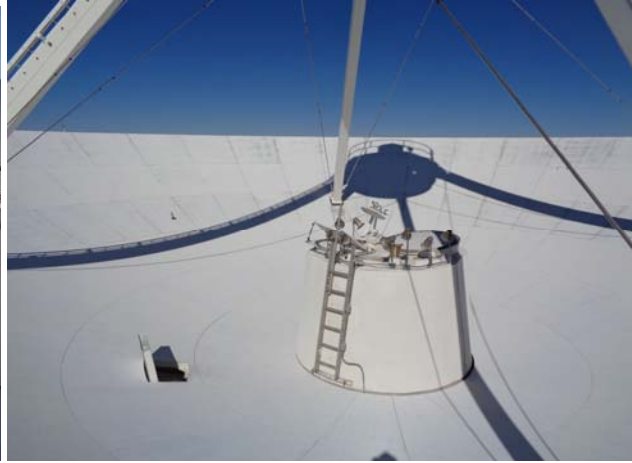
The dish surface was inspected and found to be free of major dents or holes. The paint is starting to fade in areas, as shown in pictures. Panel bolts were spot checked for tightness, all fasteners checked were still acceptable.

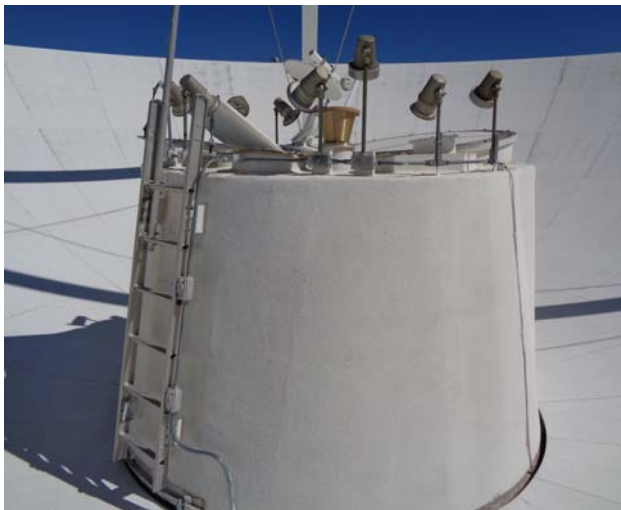
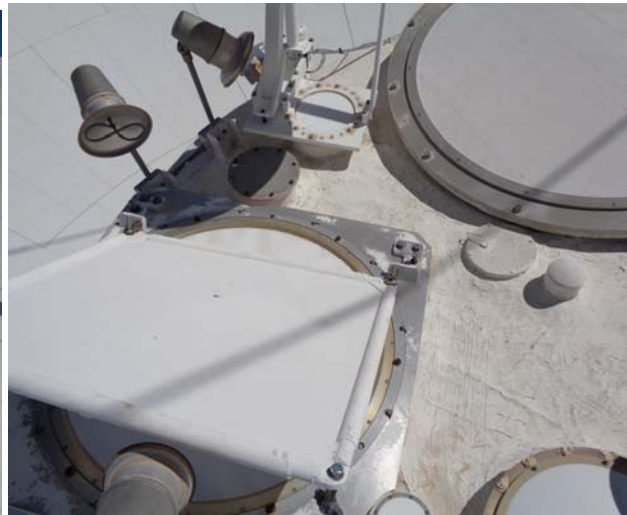
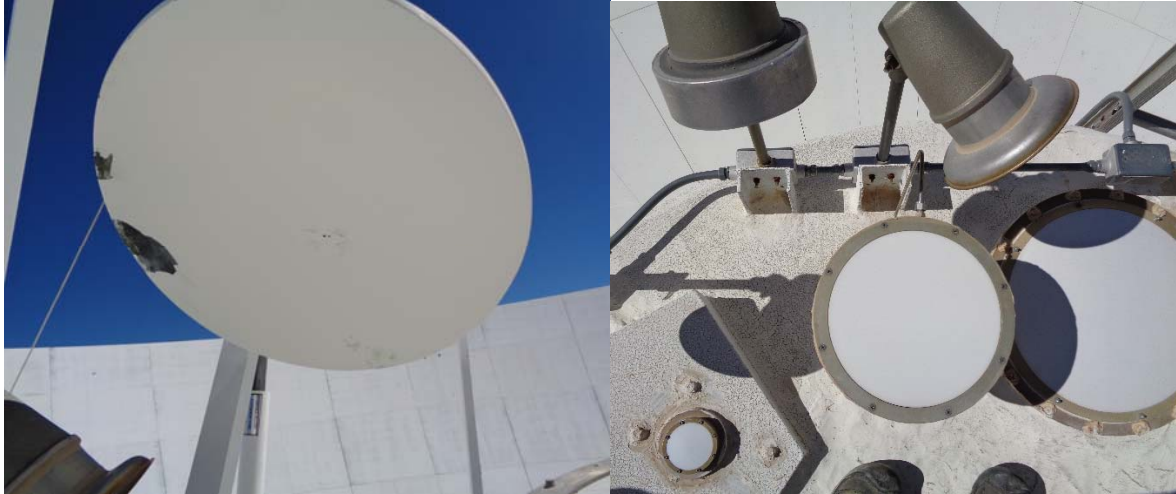
The dichroic panel was replaced because it was cracked in the corner. The feed cone hardware and windows were inspected and all looked in good condition. The ellipsoid paint is starting to peel as indicated in the images below. The feed cone insulation had a few cracks that were addressed with silicone. Ray McFarlin indicated that they plan on recoating the surface in the near future. The heater hardware and overall condition of the “dog house” was good.

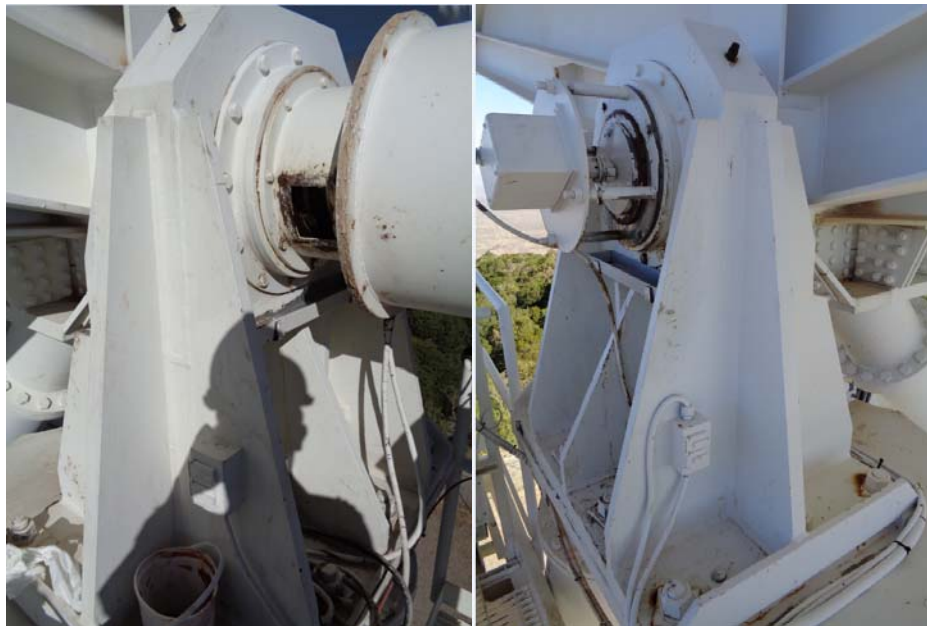
The elevation bearing grease was inspected for metal for both bearings. Both sides had very clean grease. The grease pans were cleaned and both bearings were re-greased. Both axles and surrounding structure was inspected for cracks or wear. Elevation was ran back and forth, no popping or grinding noises from the bearings.

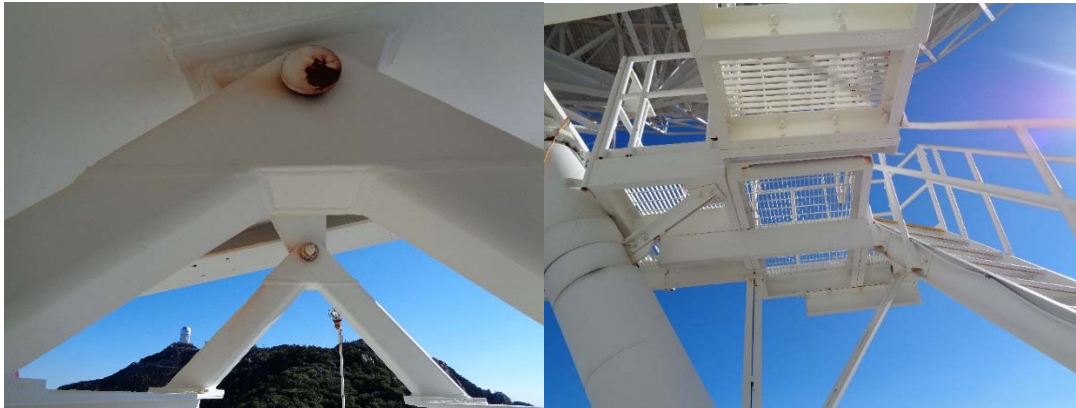
Both elevation platforms and catwalk were inspected. Overall in good condition. There are a few areas that can be touched up with paint, but structurally sound. Catwalk and pins, and all stairways on elevation platform appeared in good condition, other than could use paint as well. Jib-arm and joist looked in good condition, cable did not show excessive wear or frayed strands.

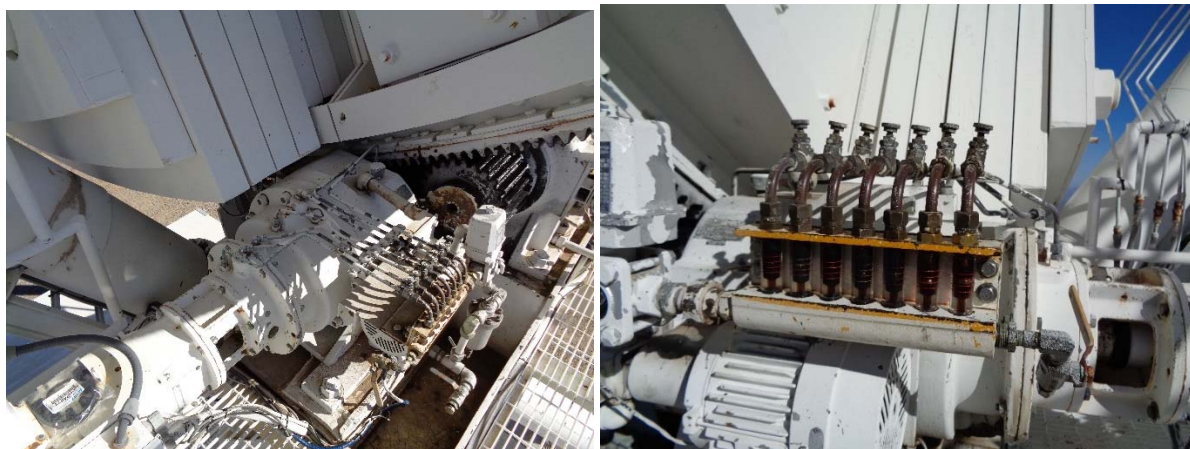
The bull gear, pinon gear, counterweights, and hardware were inspected on the elevation platform. Both bull and pinon looked good and were adequately lubed. Both elevation gear boxes were inspected and found to be in decent shape. There were no visible leaks and gearbox oil samples from both gearboxes did not show any signs of metal. Both gearboxes are scheduled to have oil changed in February. The gearbox to motor couplings were replaced for both gearboxes. Additionally, both lube pump couplings, and two leaking flow gauges were replaced. When running, no popping or grinding could be heard from either gearbox or bull gear.

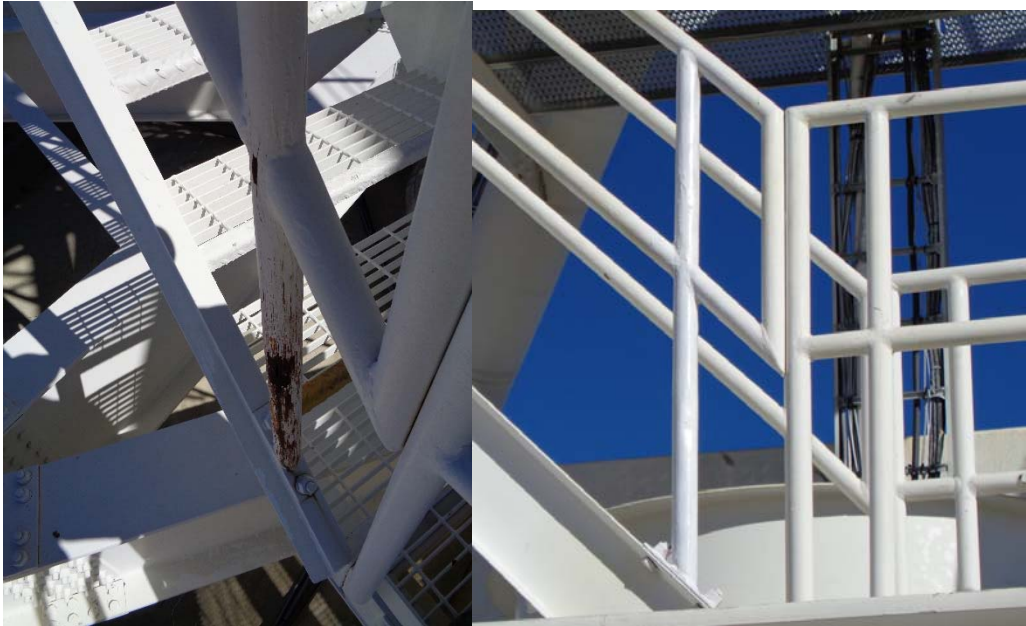
“tanks” all looked in good condition. One section of the stair case on lower structure was badly rusted so we repaired it as shown below (before left, after right).

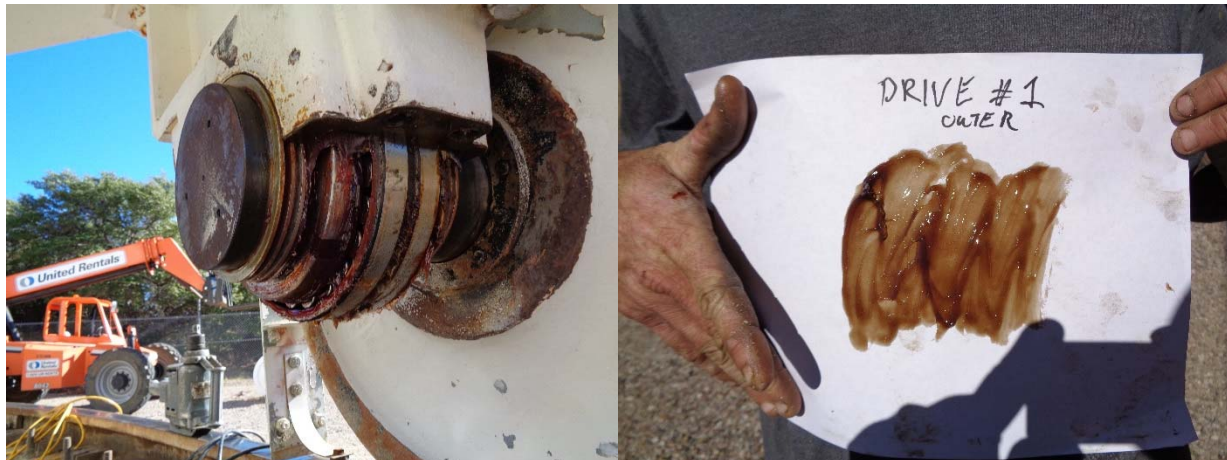
The idler and drive wheel bearing grease was inspected (except drive 2 being replaced). The idler grease was clean with no large particles or excessive metal flake. The bearing spanner nuts and lock rings were all still in place. The bearing grease from drive #1 did have some small metal flake but not an excessive amount. All wheel bearings were re-greased after inspection.

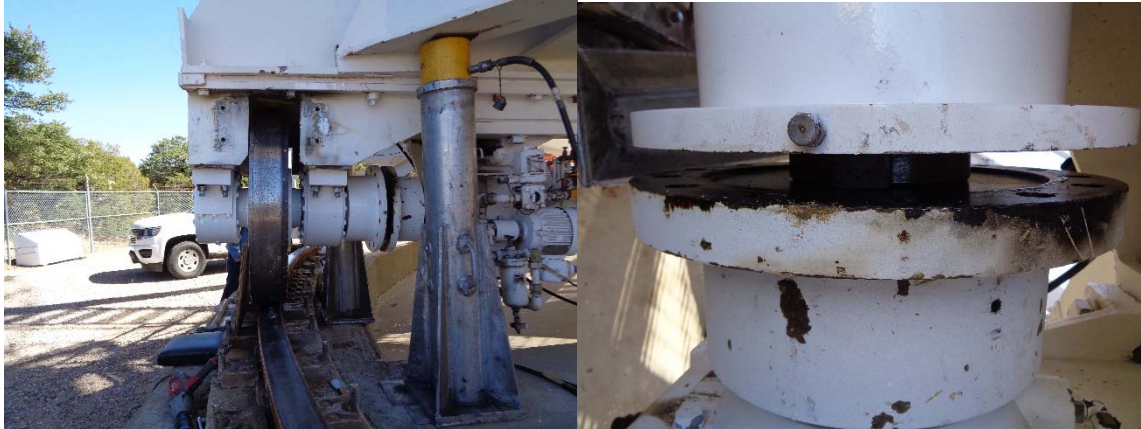
Drive wheel #2 was replaced during the maintenance visit. Once stubborn bolts were torched off, the old wheel was removed with ease but the new wheel was very difficult to install. Once installed, it was apparent the axle length was too long. After measurements and discussion with mechanic, it was determined the axle length was left too long. Additionally, the short coupling intended for Pie Town was installed instead of standard coupling. Images below show the position of wheel with axle butted up to gearbox output shaft.

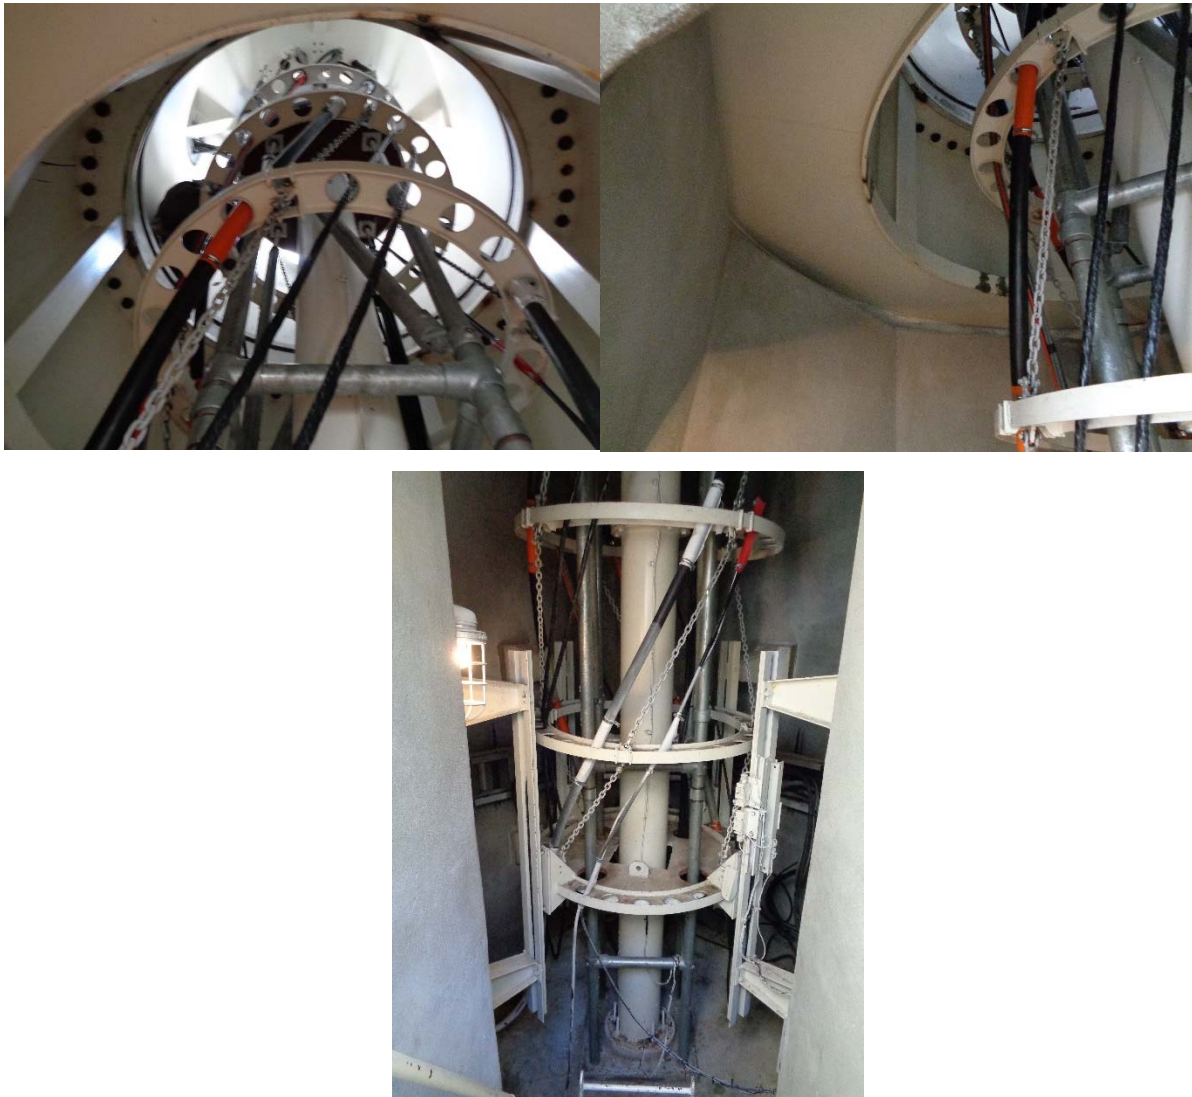
The pintle bearing grease trap was cleaned and grease inspected. Grease was in good shape, no large metal particles or excessive metal flake. Pintle bearing was re-greased after inspection. Cable wrap and cables were inspected along with cable wrap support structure. All looked to be in good operating condition. Plastic cable protectors were all in place. Bolts were spot checked, found no loose fasteners. The snake pit window was in decent condition and not replaced.

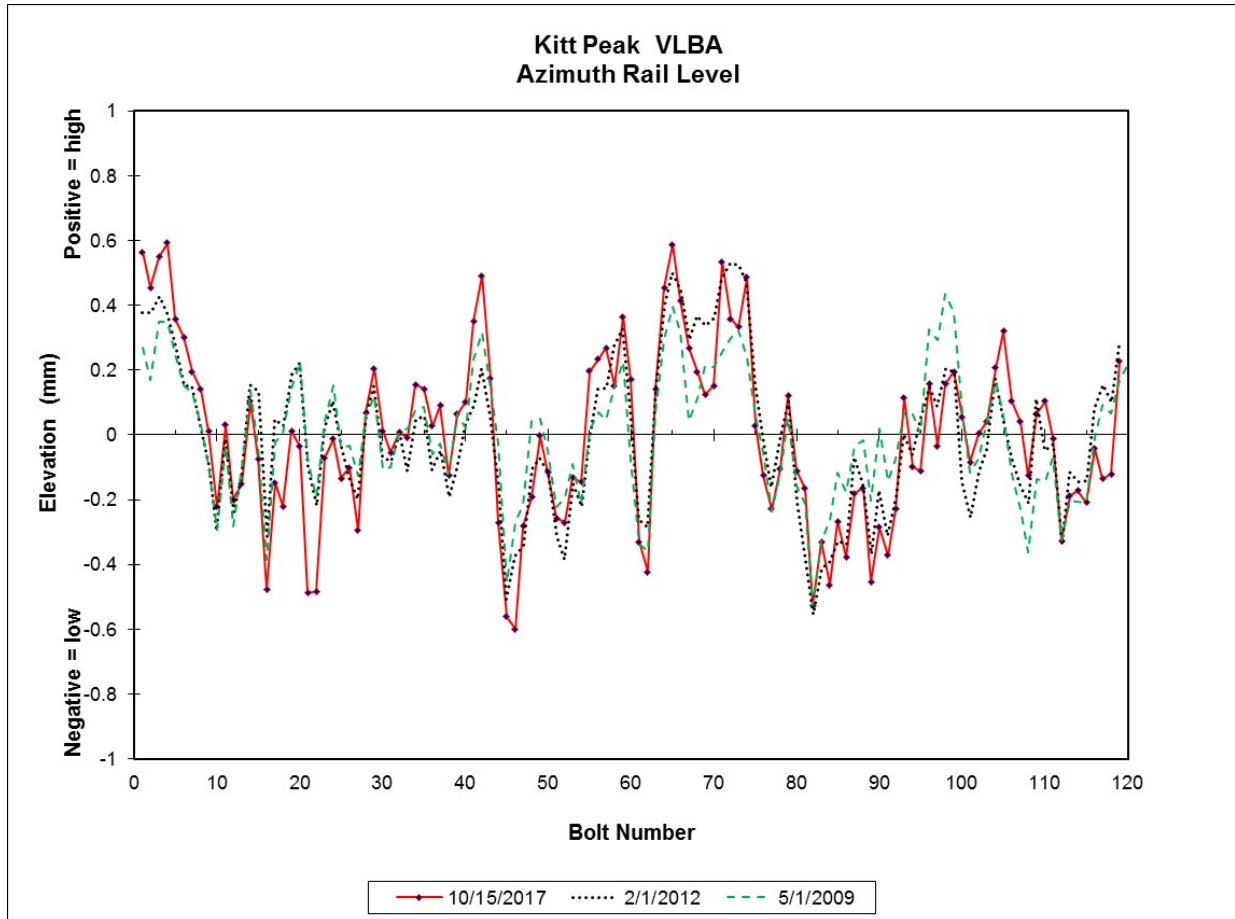
All the splice plate bolts were checked for tightness. Splice plate located at bolt #1 was relatively loose and was tightened. All splice plates were in decent shape. The rail grout looked to be in very good shape compared to other sites. The rail elevation was measured using the recently re-calibrated Wild N3 level.

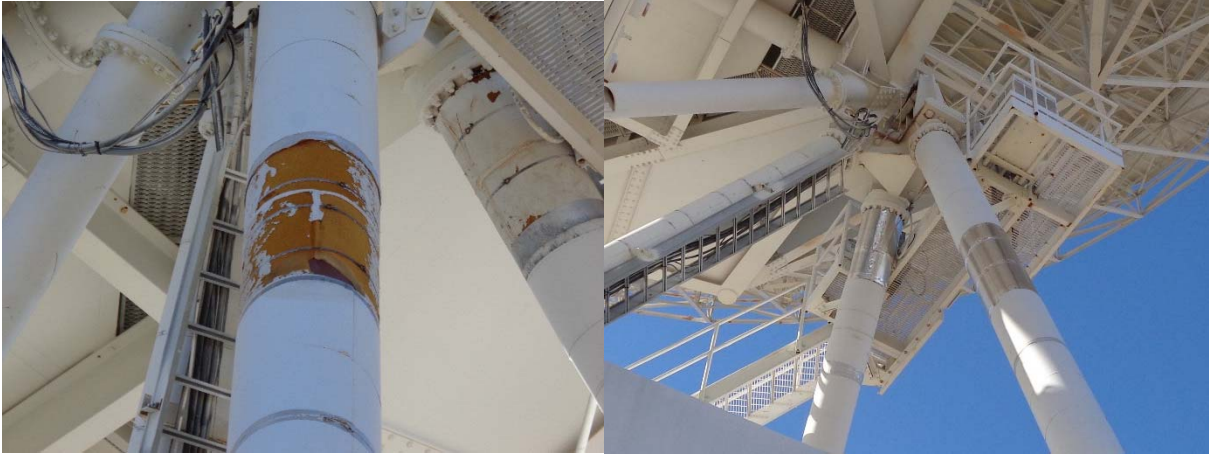
Two section of insulation covering was missing from the support structure. Aluminum flashing was installed to replace the damaged panels.

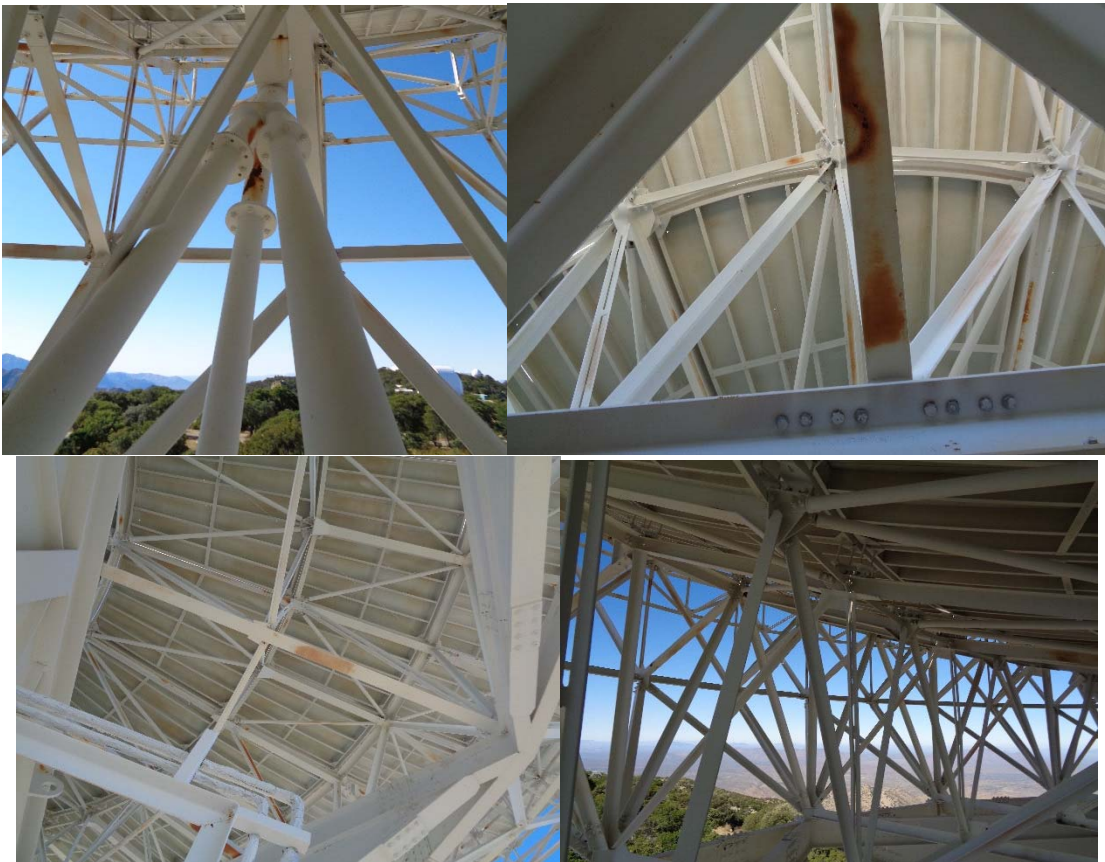
The antenna paint is in decent shape. There are some areas that need paint touch up as there is rust beginning to show through the paint.
