VLBA Antenna Memo 103

Azimuth Rail Grout Repair at Pie Town, New Mexico

December 28 – December 30, 2020

J. Gallegos
January 20, 2021

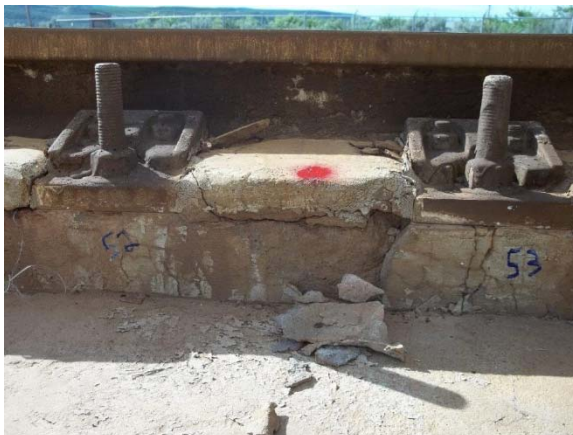
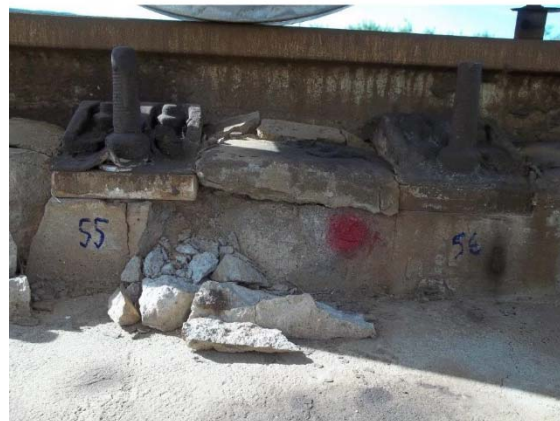
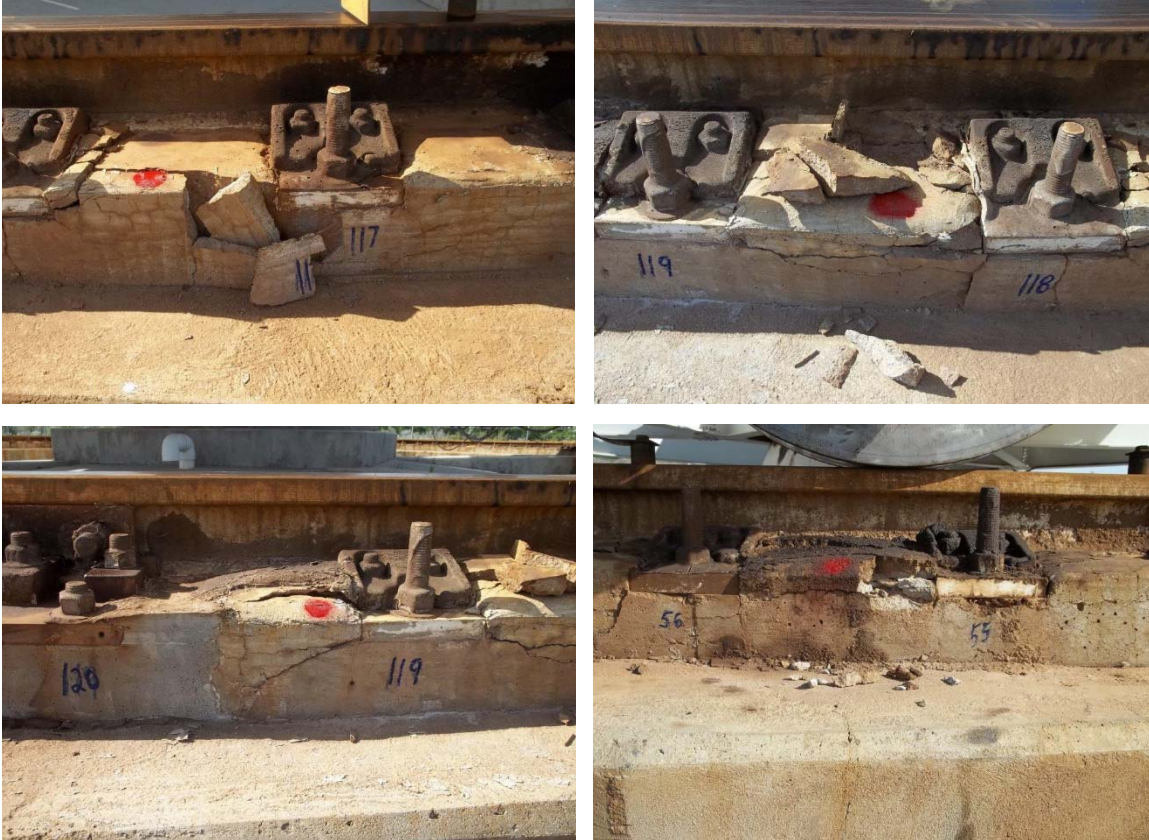
The grout directly below the Pie Town VLBA azimuth rail was cracked and degrading in multiple places. A total of 8 damaged grout sections were completely removed and replaced with a new grout. Spalling in the original cement grout used below the azimuth rail caused major cracks and voids between the rail and the grout. A new E-Chem epoxy grout was used in place of the old cement grout.

On the 23rd of May 2019, the site technician Jesse Fulmer reported that the grout beneath the rail was deteriorating and large cracks were forming as seen in the images below.

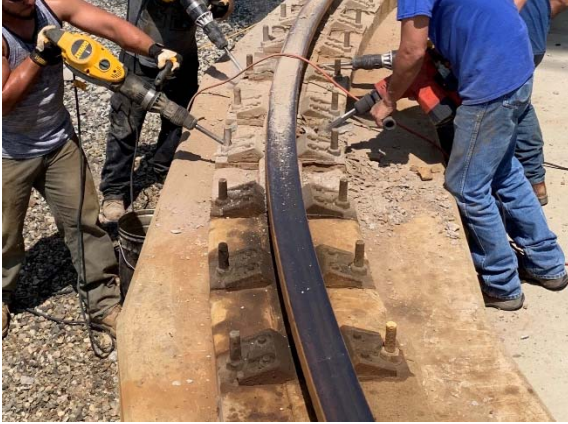
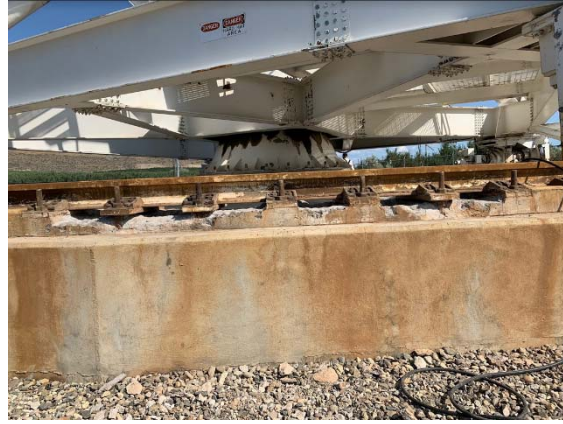
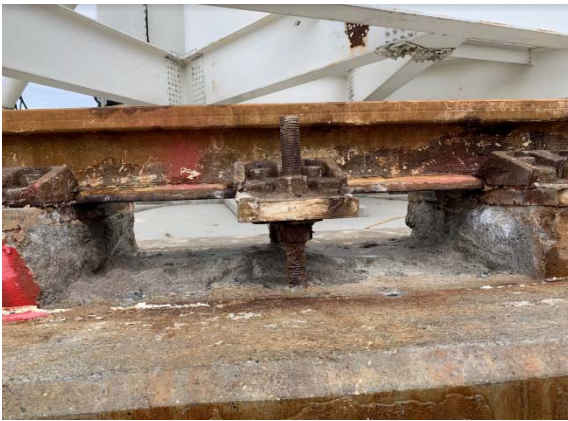
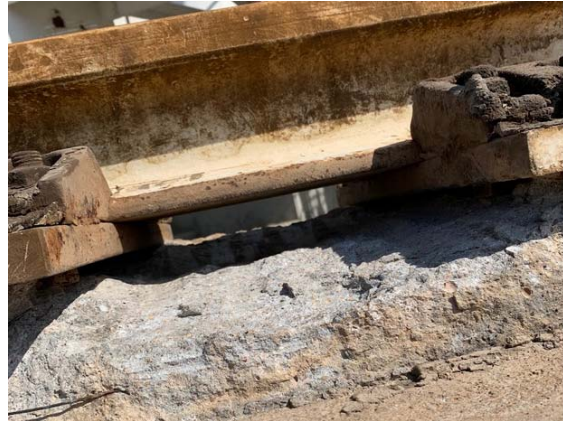
Demolition hammers were used to break out all grout sections needed to be replaced. In the worst places the grout was completely removed all the way to the lower foundation. The places where the grout was not cracked all the way through we only removed the top portion approximately 2 inches below the rail. All photos of the demolition can be seen below.
