National Radio Astronomy Observatory VLBA Antenna Memo Series – No. 104

TRIP REPORT – FORT DAVIS, FEBRUARY 14-17, 2023
ANTENNA INSPECTION AND GEARBOX INSPECTION

A group from the VLA traveled to the Fort Davis, TX VLBA station (FD) to perform an overall antenna inspection to include tear down of an azimuth and an elevation gear box and site inspection. Some observations were made for planning of future work activities.

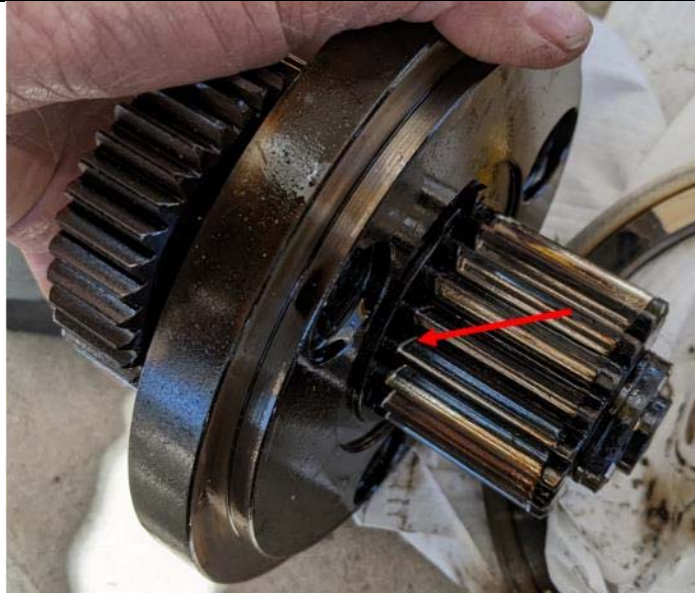
Inspection of the azimuth gears showed that the sun gears of all 4 stages had significant wear. The planets and ring gears showed little wear. See Figures 4 and 5.

Figure 4: Typical Sun Gear Wear

Overall condition of the FD antenna is good for its age and constant exposure to the elements. The gear boxes need parts replaced to prevent mechanical failures. The rail section replacement and paint work are scheduled in the next few months. Some small improvements can be made as identified in this report. It should be noted that the site techs are keeping up on regular maintenance and the site looks tidy and well kept.

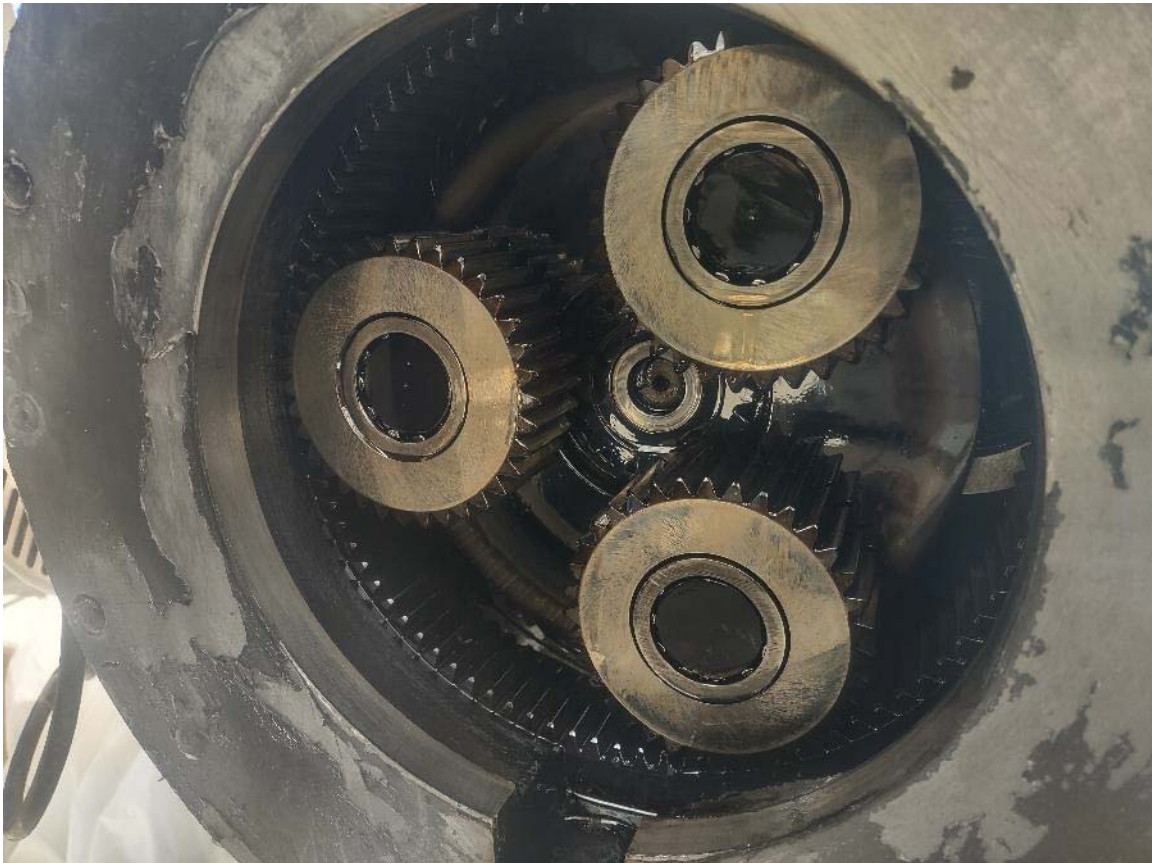
Figure 5: Planet and Ring Gear Showing Little Wear

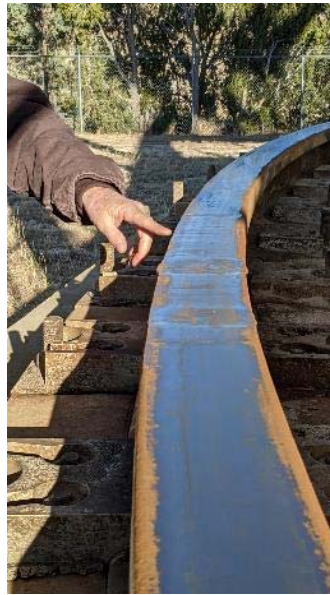
Grout volume was measured and calculated for rail section replacement at 21.4 cu ft. See Figures 6 & 7. When a wheel travels over the low spot some noise is heard with the assumption the azimuth drive system is experiencing some instability.

Figure 6: Rail Surface Deformation

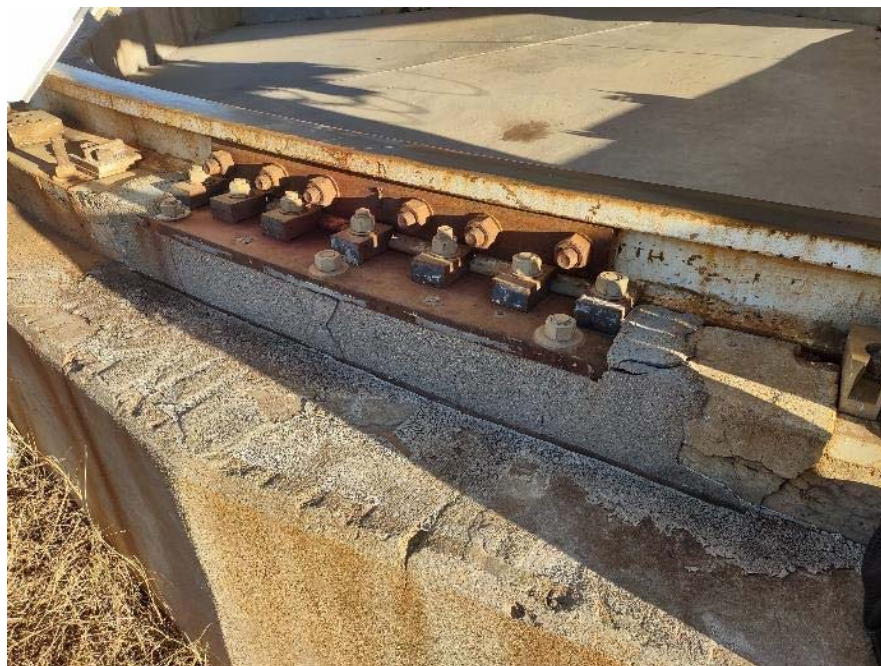
Figure 7: Grout Condition at Rail Splice

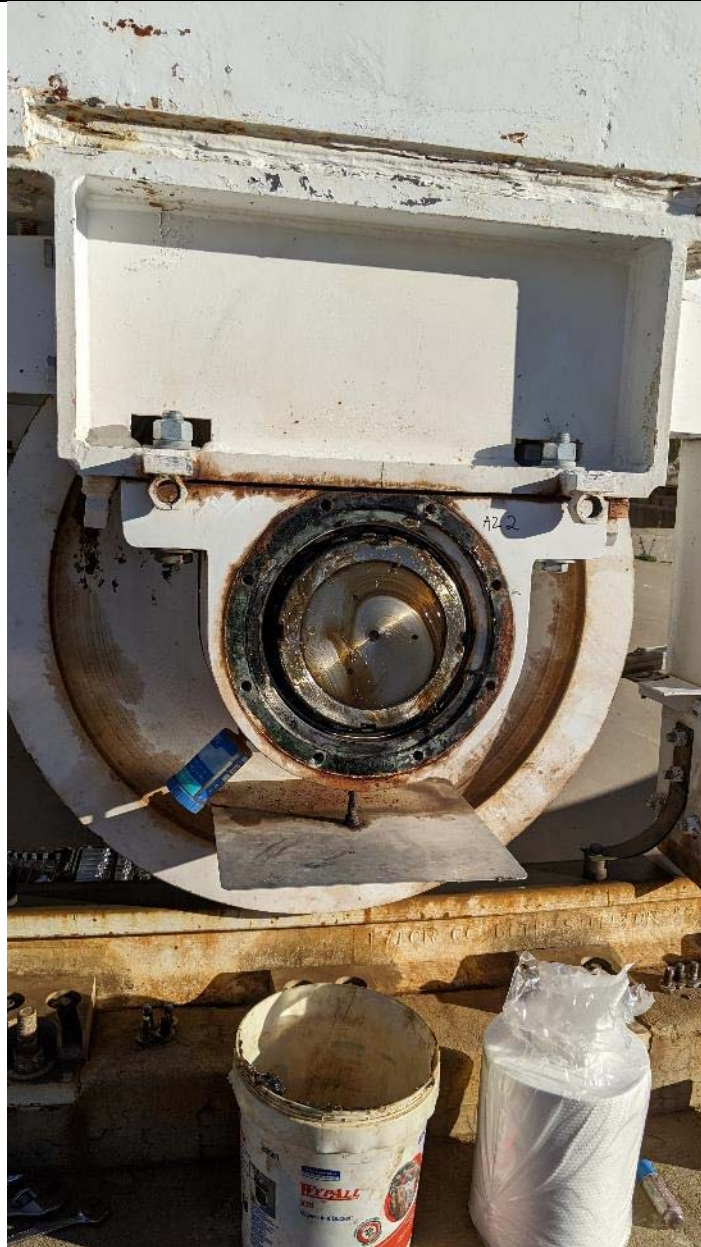
Bearing grease was inspected for the azimuth wheel shafts to see if significant metal flakes show up to indicate the bearings are starting to fail. In this case, little metal was found in the grease. The bearings were packed with new grease. New SKF grease cups were installed on the inner and outer axle bearing housings. See Figure 8.

Figure 8: Azimuth Drive Axle Bearing Grease Inspection

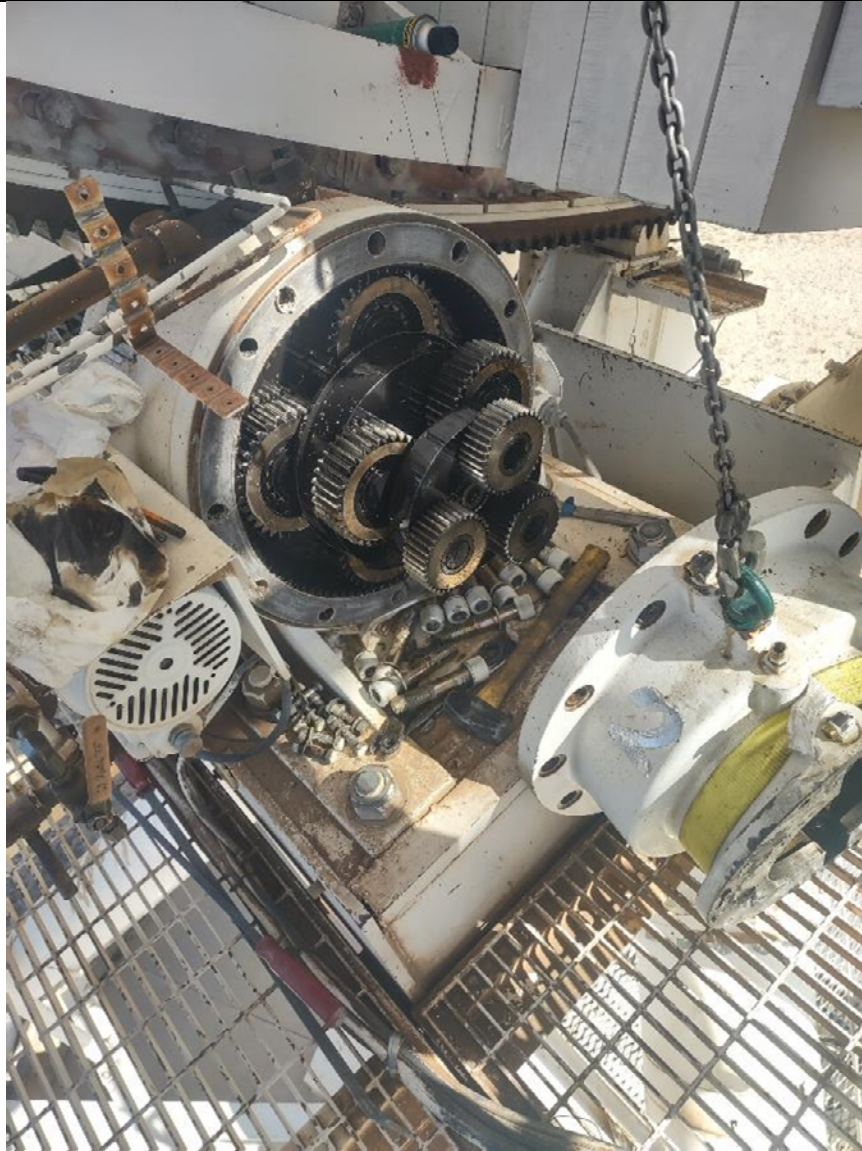
An elevation gear box was disassembled for gear wear inspection. The same sun gear wear was observed in the elevation gears.

Figure 9: Elevation Drive Gear Box Disassembly

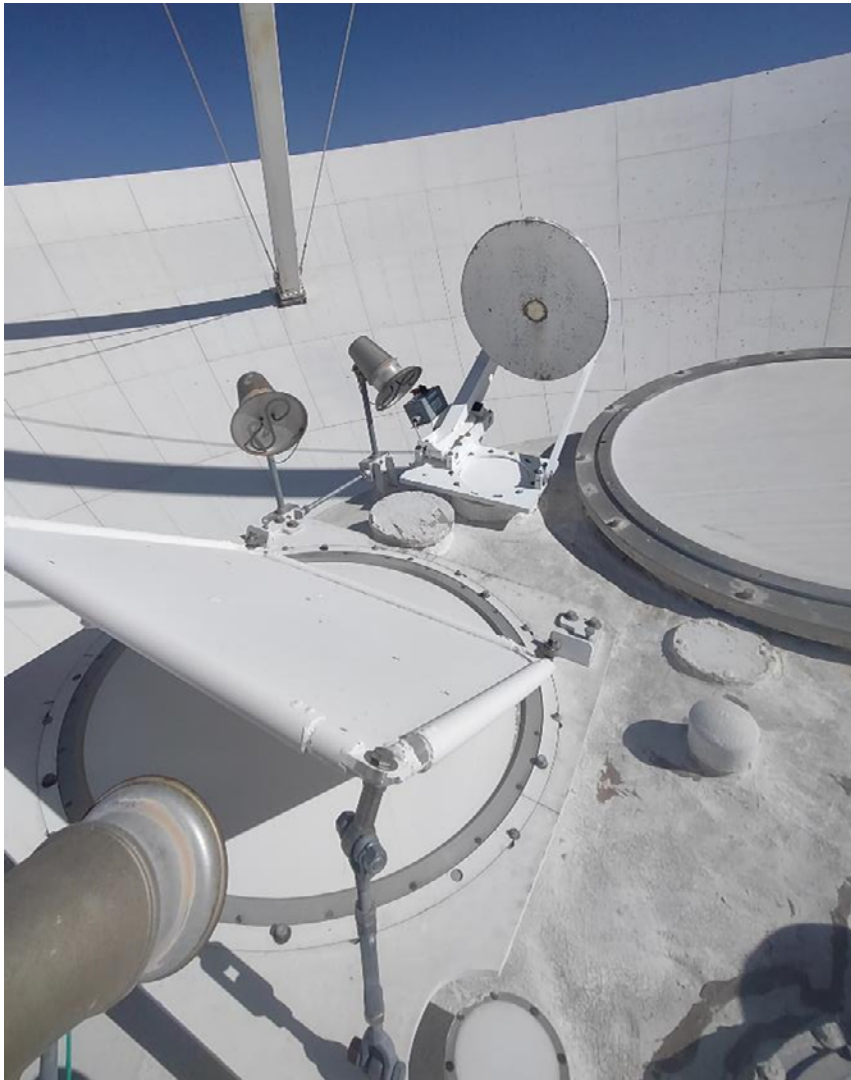
The ellipsoid and dichroic panel were inspected for overall condition. Overall they are in good condition. See Figure 12. The sub-reflector was inspected from a distance and it was concluded that it needs paint work during the track section replacement trip. See Figure 13.

Figure 12: Dichroic and Ellipsoid Inspection

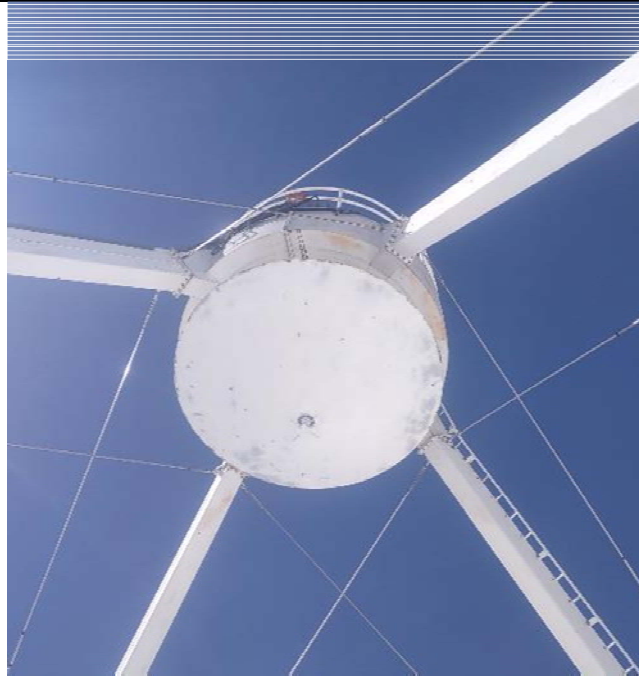
Figure 13: Sub-reflector Condition

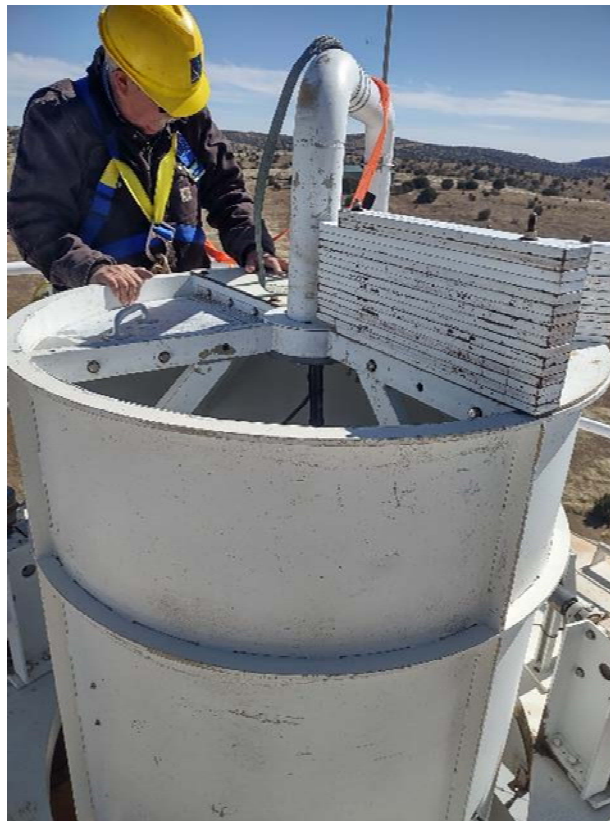
The FRM was inspected for overall condition and no serious defects were found. The rubber bumpers are deteriorated and alternate part materials will be researched for better service in full outdoor exposure conditions. See Figures 14 & 15.

Figure 14: FRM Inspection

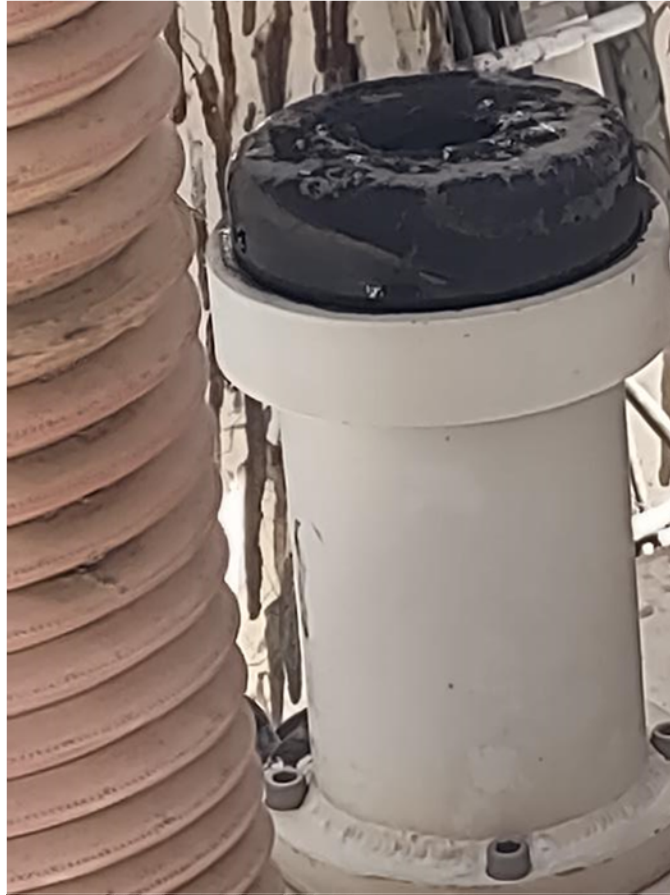
Figure 15: FRM Rubber Bumper Condition
