National Radio Astronomy Observatory

VLBA Antenna Memo Series – No. 105

TRIP REPORT – FORT DAVIS, April 19-24, 2023

RAIL SECTION REPLACEMENT

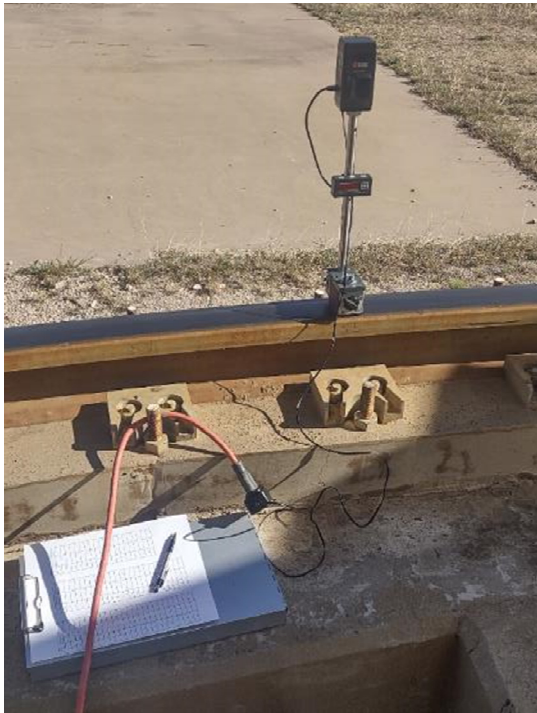
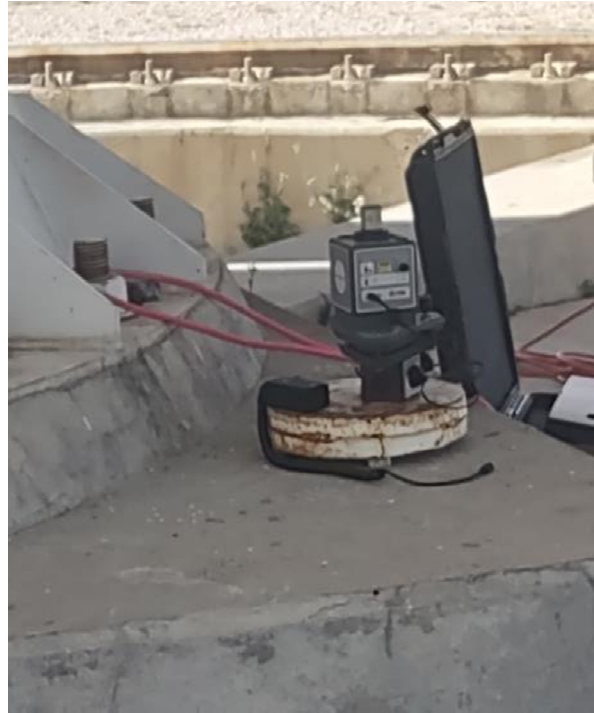
Figure 2: Hamar Height Setup

Unloaded trucks and started shooting existing rail elevations. Measurements were taken with the Hamar laser on the idler wheel and on the rail. Several issues were found using the Hamar system. All of the existing instrument mounts are setup for the Wilde and are too tall for the Hamar. (see Figure 2) Measurement readings jump around a lot due to distance and bright sunlight. Even when using the prism filter on the reader. The on-rail target doesn't remain still during windy conditions and the magnetic base doesn't set flat on the worn rail (rail isn't perfectly flat). New rail was unloaded and one end cut for the angled splice interface. The rail elevations were re-shot with the Wilde due to Hamar issues detailed above.

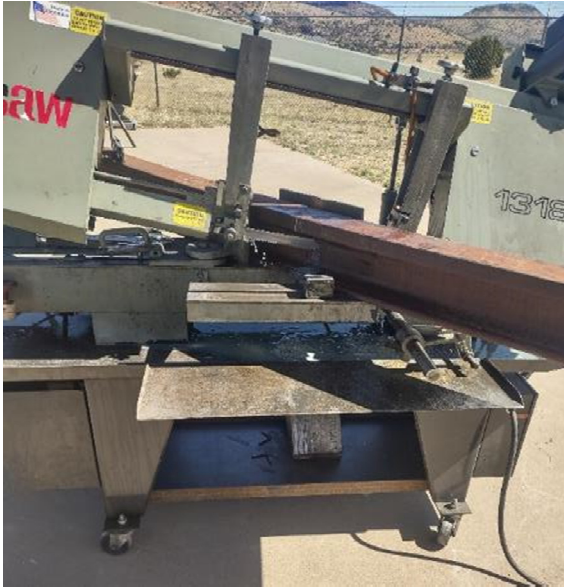
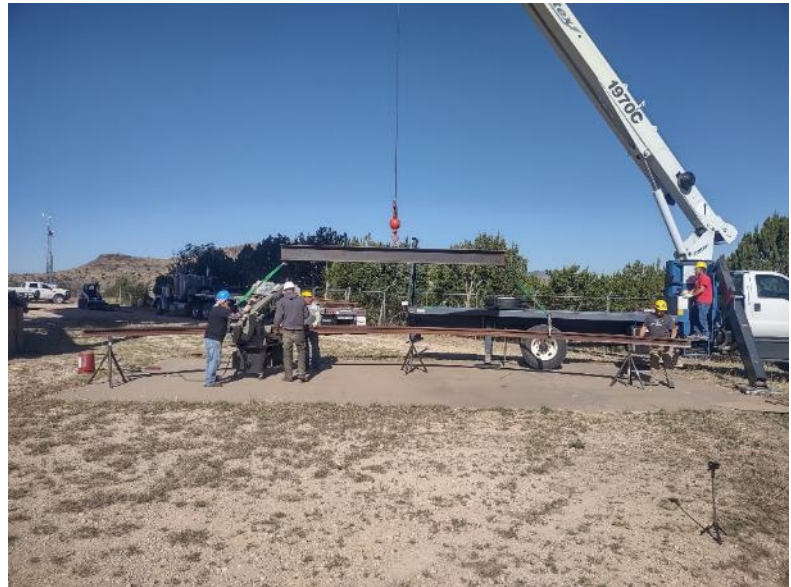
Figure 3: Saw cutting on concrete slab

Cutting the rail with a carbide bandsaw blade and coolant takes about 1.5+ hours. The time required depends on the hardness of the rail in the cut location. We setup the saw and support stands on the

site's concrete pad to have a solid planar surface to work. (see Figure 3) It does take some additional time due to moving, setting up and taking down the boom truck for each rail lift.

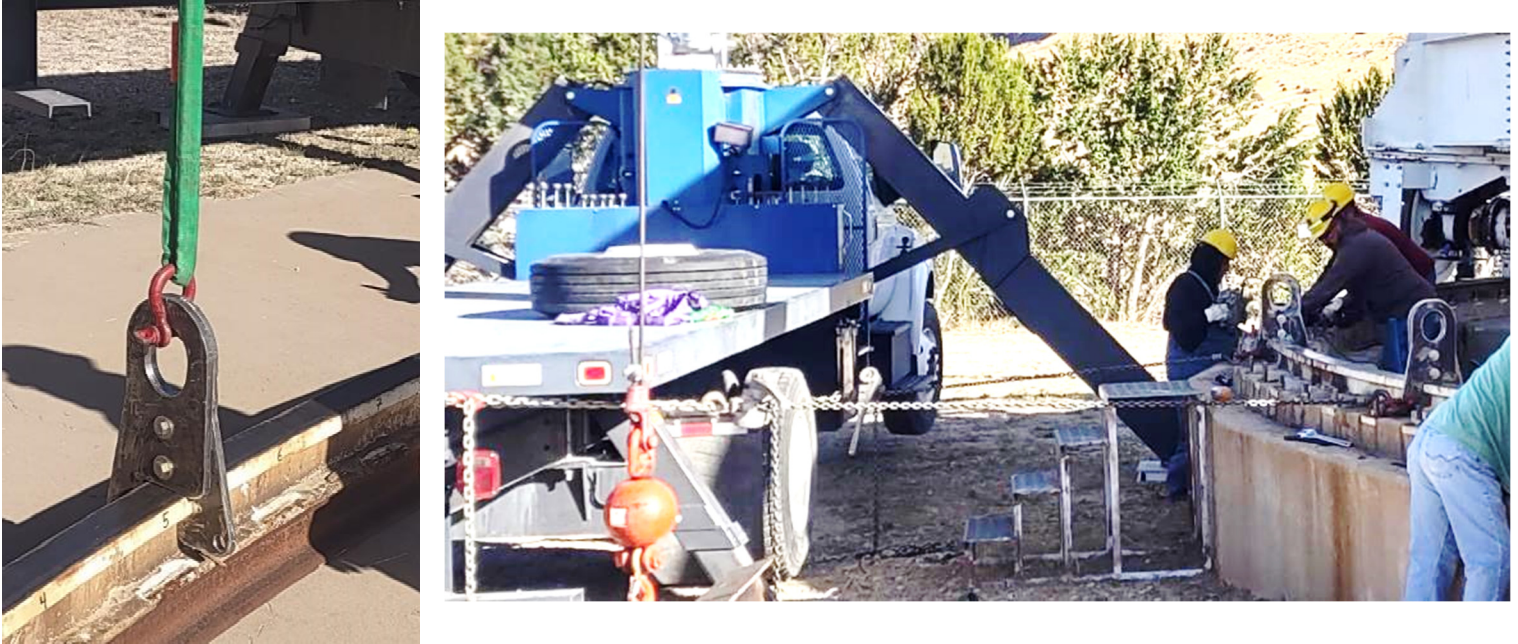
Figure 4: Rail Lifting Plates and Lever Puller Attachment

The old rail section was used as a template to mark the new rail section cuts. After both ends were cut the new rail piece was fit and the splices pulled together. It was found, however, that the center of the section's radius wouldn't fit within the hold-down clamps by about $3/4$ inch. The rail had to have about $3/16$ - $1/4$ inch cut off to fit properly. Some new rail crane lifting plates were made for this trip that clamp the rail more securely. The plates have a hole near the bottom for the attachment of tag lines while lifting. These holes are useful for attaching a shackle and lever type chain puller to pull the rail into place. (see Figure 4)

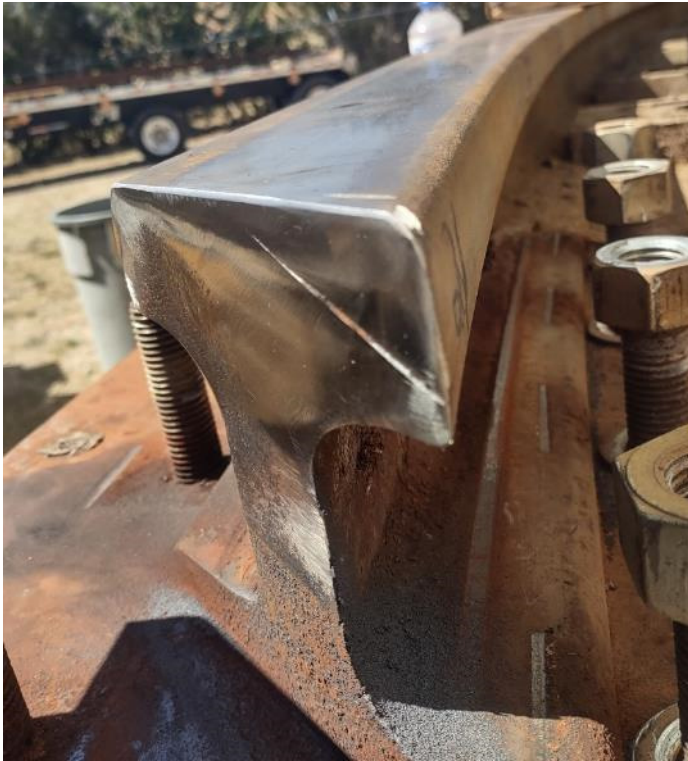
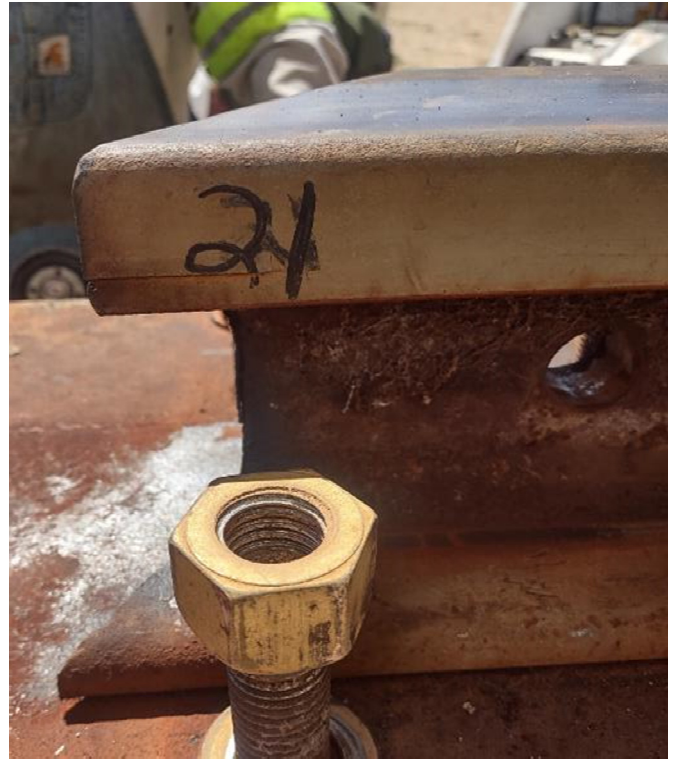
While fitting the new section of rail a “gouge” was noticed in the cut face of the old rail. Upon further investigation it was found that the inner surface of the rail has a horizontal crack that tied into the crack on the cut face. We inspected all of the rail for these horizontal cracks on the inside and found that only the two sections of rail that were replaced in 2018 have these cracks present. It appears that when that batch of rail was manufactured there was a lamination or imperfection in the material. (see Figure 5 & 6) (See Isaiah Acevedo report for subsequent visit for more details)

Figure 5: Delamination Cracks in Existing Rail

Engineering created an inspection sheet for the site techs and has asked that they inspect the rail monthly for any crack growth and keep the forms locally. Engineering is to be informed if either crack growth or any other changes occur.

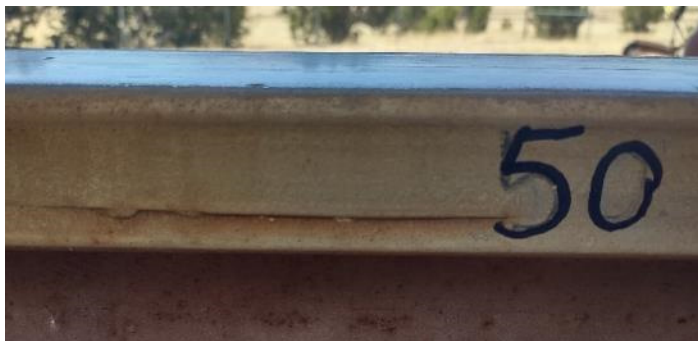
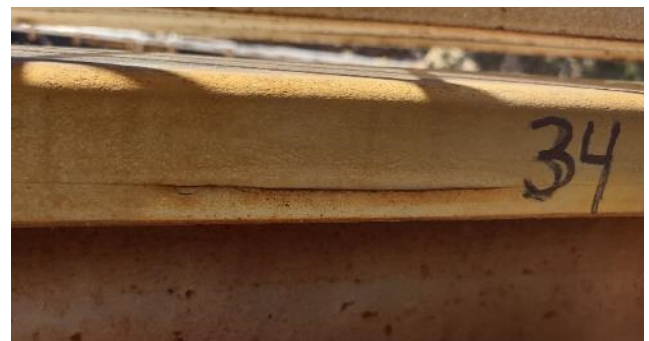
Figure 6: Delamination Crack Examples

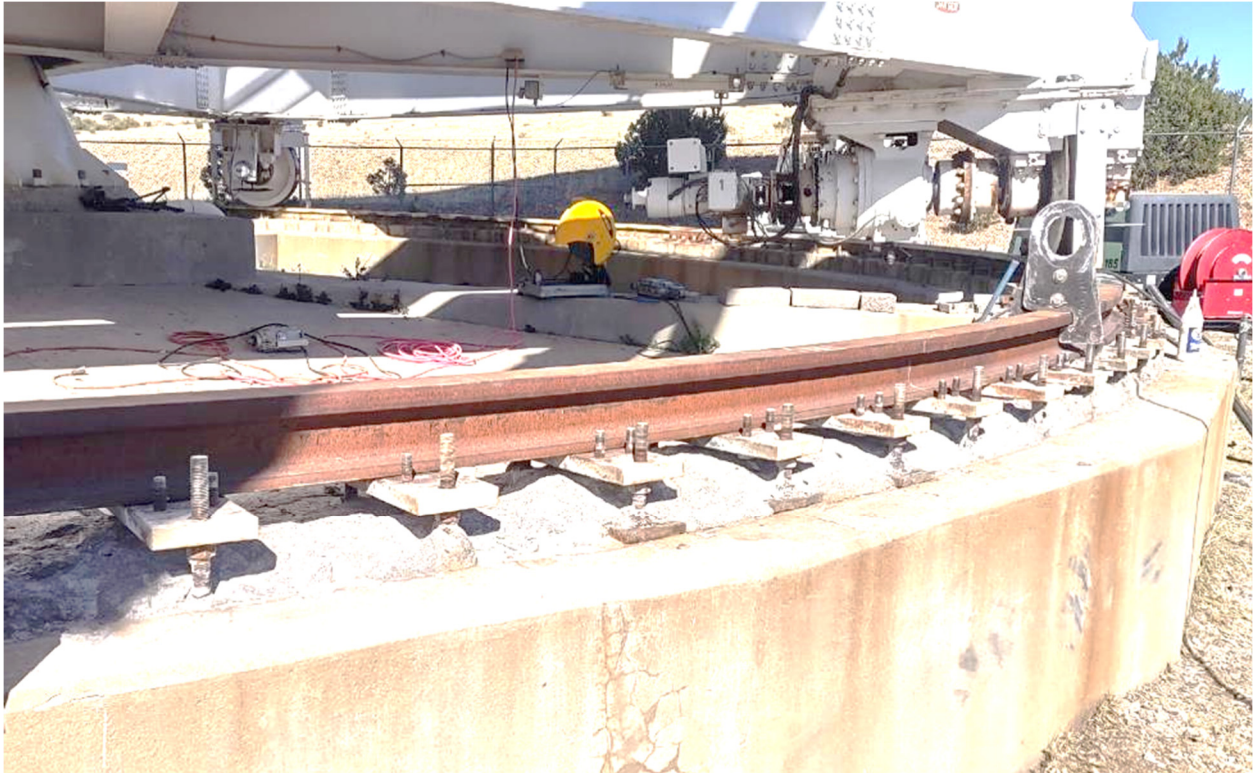
Figure 7: Old Grout Removed and Support Plates Exposed

The old grout was removed using electric jack hammers and a hydraulic jack hammer on the skid steer. The grout has to be removed under the support plates so the nuts under the plates are accessible for adjusting the rail height.

moved to match the new elevation values. This is achieved by adjusting the nuts on the underside of the support plates. (see Figure 7)

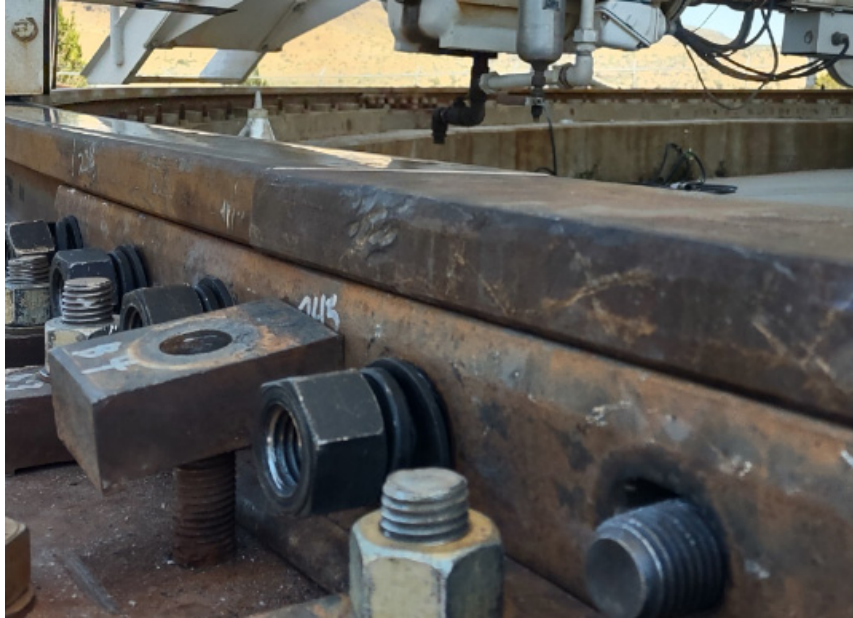
While fitting the new rail and tightening the clamps and splice bars it was discovered that the new piece of rail differed in height as compared to the replaced rail and the original rail. We spent several hours loosening the bolts on the clamps and splice bars then shimming under the “short” new rail with brass shim stock to make up for the difference in height. The difference is approximately 0.055 inch. (see Figure 8) When the splice bars were installed again the difference in height re-appeared due to the bars sandwiching on the taper of the rail flanges. Everything was tightened down and the mismatched height was blended using an angle grinder.

It should be noted that after the antenna was put back into service for a few days one of these splices (bolt 21) appears to have come loose and the height difference has reappeared. A follow-up visit is required to investigate and correct the problem.

Figure 8: Rail Height Difference

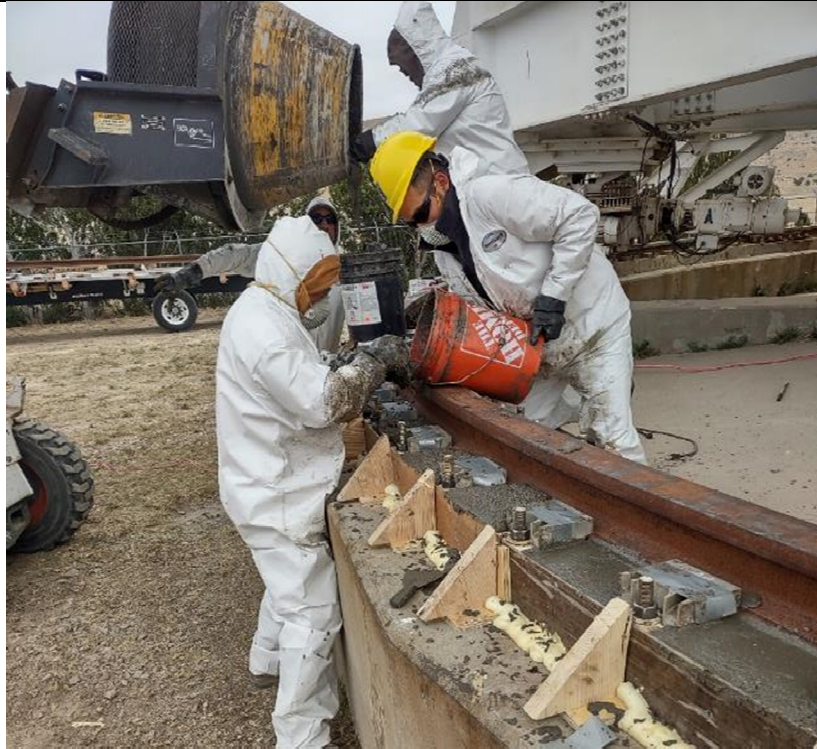
Figure 9: Pouring Epoxy Grout and Grout Forms

Grout forms were made of Masonite with triangular outside supports. The inside of the forms is lined with clear packing tape for easy release when the grout is setup. The for supports are Tapcon screwed to the concrete. Any gaps were filled with NeatStuff foam and/or caulking. Several hours set time were required before the grout could be poured. (see Figure 9)

Ambient temperature has to be watched closely as the cure time for the grout is very temperature depended. Our temperatures were low so we waited over 24 hrs before doing the final elevation measurements.

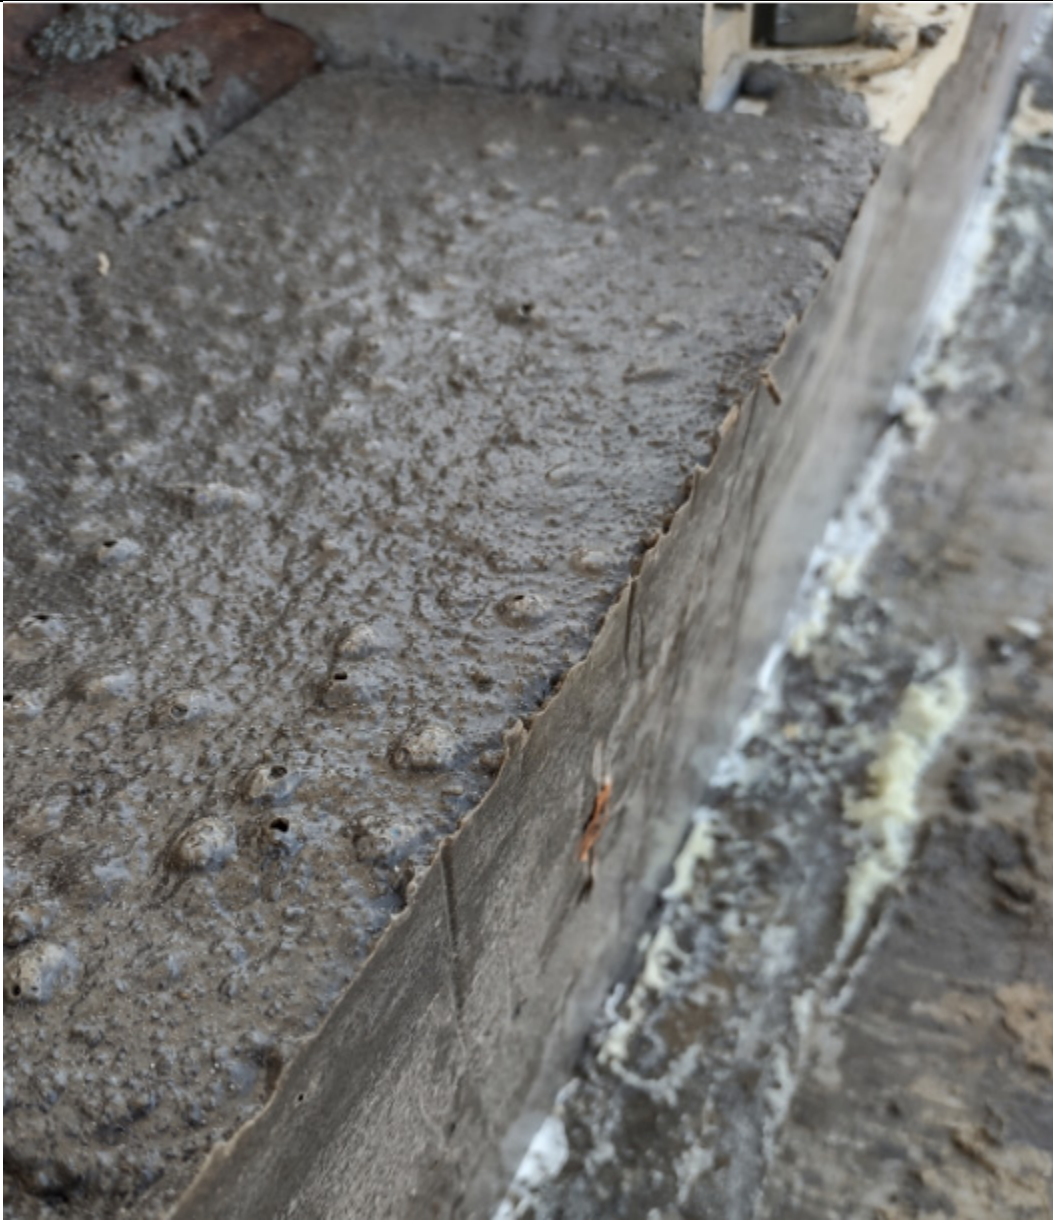
The eCHEM EP-15 grout has very specific instructions on mixing equipment and mixing time. These were followed but there are some areas for improvement. Not a cement mixer but a stucco mixer is specified by eCHEM to reduce the amount of air entrainment in the mix. Our cold temperature (~40F) could likely have exacerbated the air problem. It was noted by the crew that the grout usually flows a lot more easily than we saw during our pour which was attributed to the low temperature. After pouring and some time passed it was observed that air was working its way out of the grout. (see Figure 10)

Figure 10: Cure Grout and Air Entrainment
