## VLBA Antenna Memo Series – No. 106

TRIP REPORT – MAUNA KEA, May 9-17, 2023

DISH PANEL REPLACEMENT

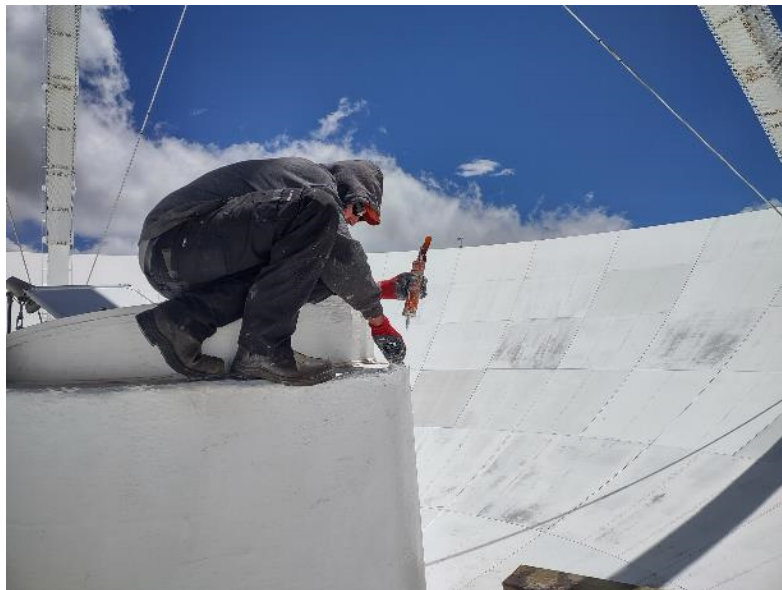
*Figure 2: Repairing Ice Damaged Spots on Feed Housing*

The feed housing in the dish had several damaged spots in the surface down to the aluminum structure. The spots were filled with silicon caulking and smoothed with a putty knife. The whole housing was painted with Henry silicon white roof coating. (see Figures 2 & 3)

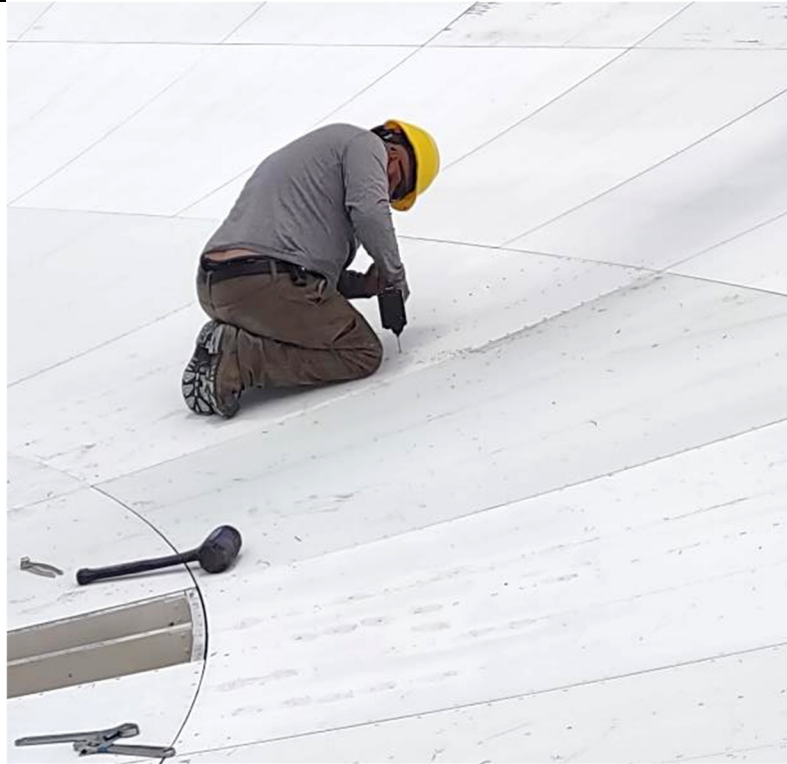
Damaged aluminum dish panels were replaced in tiers 1, 2 and 3. The existing rivets were center punched using an automatic punch. All of the existing countersunk head solid aluminum aircraft rivets were drilled out. Each panel has 100+ rivets so spare drill bits were needed due to breakage and dulling. (See Figure 3)

Figure 3: Drilling Out the Old Rivets

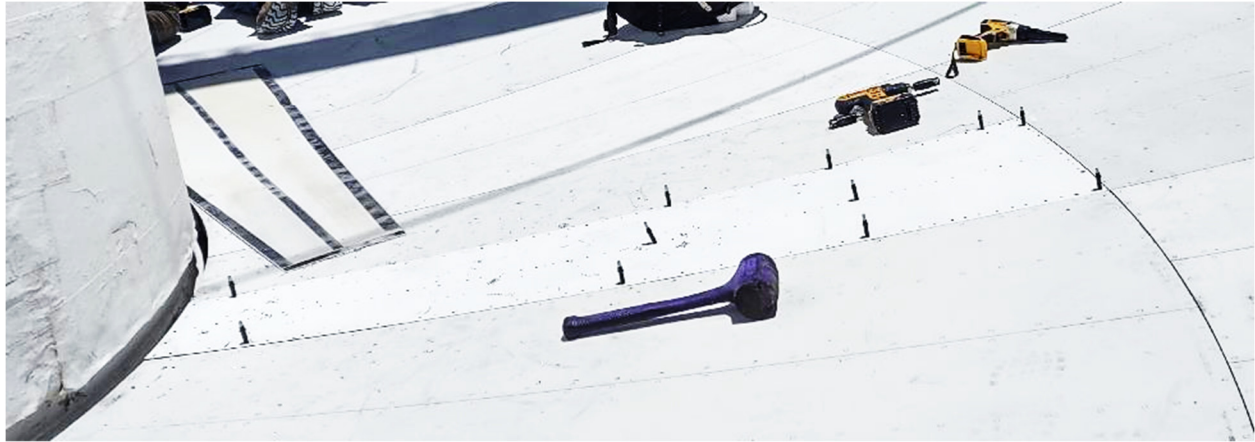
Figure 4: New Panel Retained with Clecos

The new panel was checked for fit then the old panel was laid over it and the old rivet holes were marked with a Sharpie. The panel was placed in its new location in the dish and new holes drilled between the old marked holes. (#19 drill bit) The new panel was held in place with Cleco temporary fasteners while the rest of the holes were drilled. (see Figure 4) The new holes in the skin were countersunk so the head of the new rivets set flush. A depth adjustable aviation counter sink tool was used in a drill motor to create the countersink.

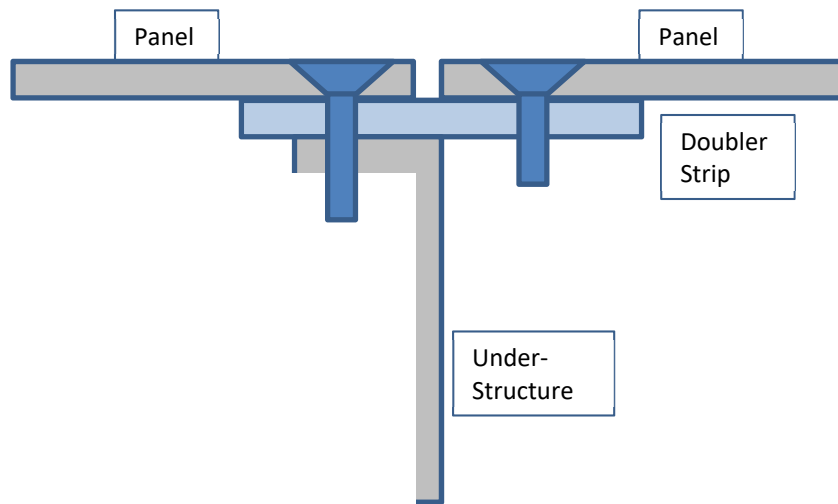
Figure 5: Panel and Under Structure with Doubler Strip

The rivets used are Cherry (pop rivet style) part numbers CR3212-5-03 and CR3212-5-04. The -03 vs the -04 is the grip length. The -04 with the longer grip length was used where there are three thickness of aluminum to rivet. The under-support structure flange only has enough space to rivet one panel. To attach the adjacent panel a doubler strip is used. (see Figure 5)

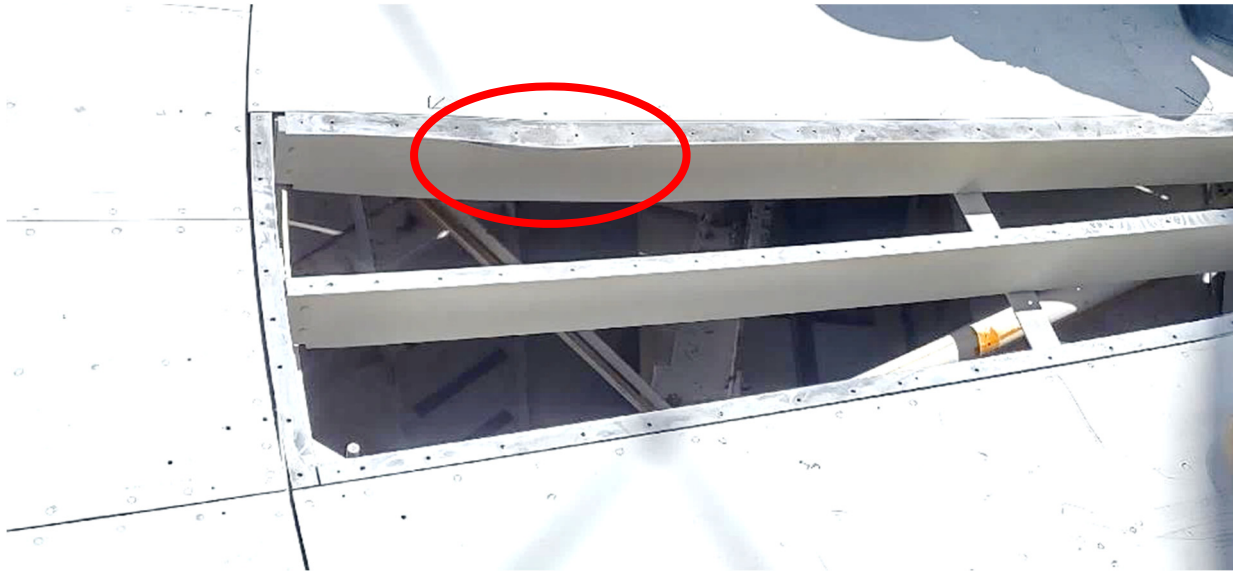
In one case the damage to the panel translated into the under-structure and the formed aluminum C was deformed. Using an adjustable wrench, hammers and a block of wood the C was straightened the best possible. There is about a 4 inch section that we didn't attach to the C to allow the panel to stay in the correct shape. The two panels are attached to the doubler-strip. (see Figure 6)

Figure 6: Doubler strip and Deformed Under-Structure

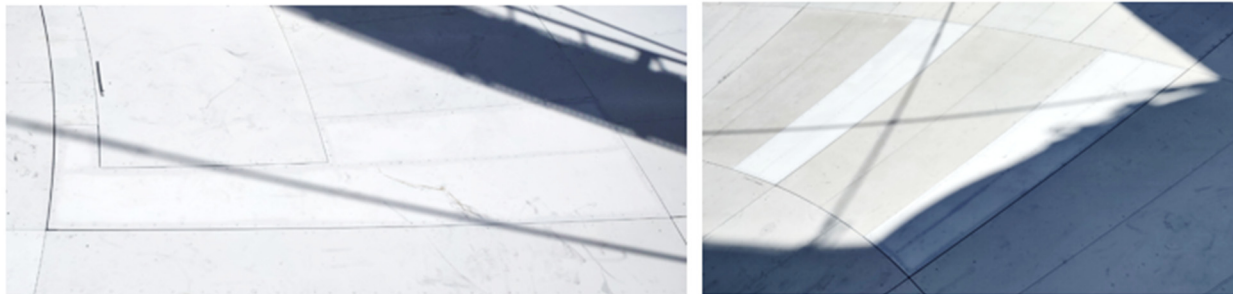
Figure 7: New Installed Panels

The rivets were painted white when installation was complete using white spray paint. The panels look very good. (see Figure 7)

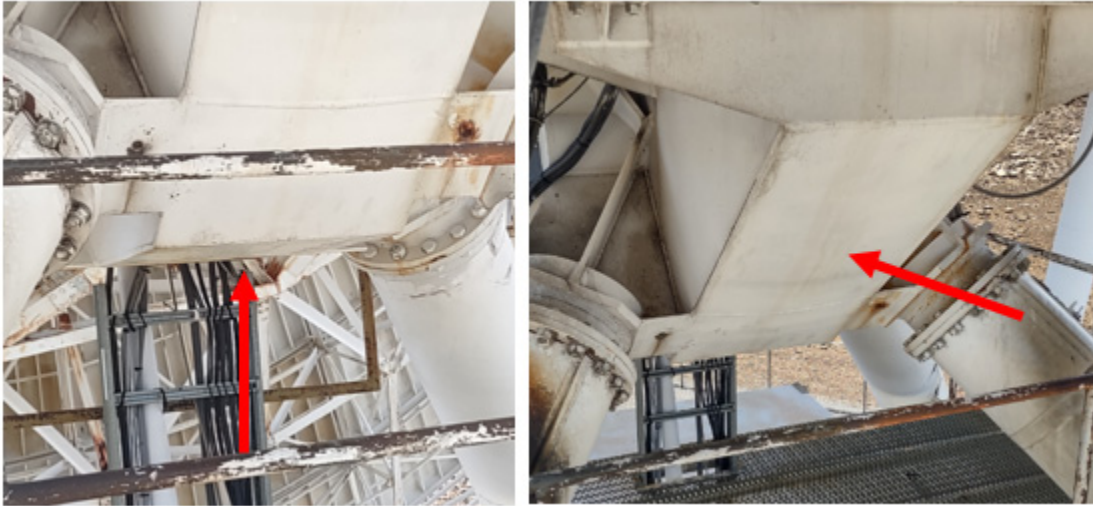
It was found during a structural inspection that part of the antenna structure which creates an enclosed box using flat plates was bulged. (see Figure 8)

Figure 8: Bulged Plates

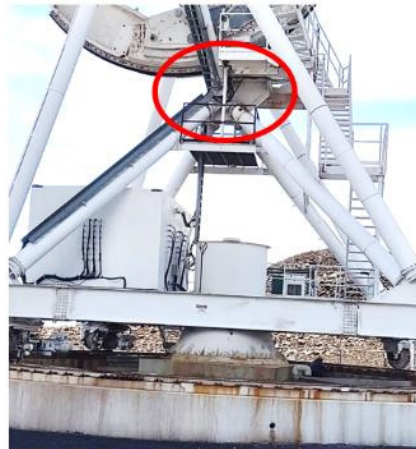
Figure 9: Boxed Area of Lower Structure

A 1/2 inch hole was drilled in the center of the bottom plate. A small amount of sludge came out and water drained out for 1 hour. The enclosed box was full of water and had frozen during colder weather which bulged the plates. The sludge is elevation gear moly grease lubricant and made a mess. It was decided that the long term solution would to drill and tap the bottom to 3/8 NPT thread and install a plug. The site techs will take a bucket up there once per month and drain it. Based on how much comes out will determine the long-term frequency for draining. (see Figure 9)

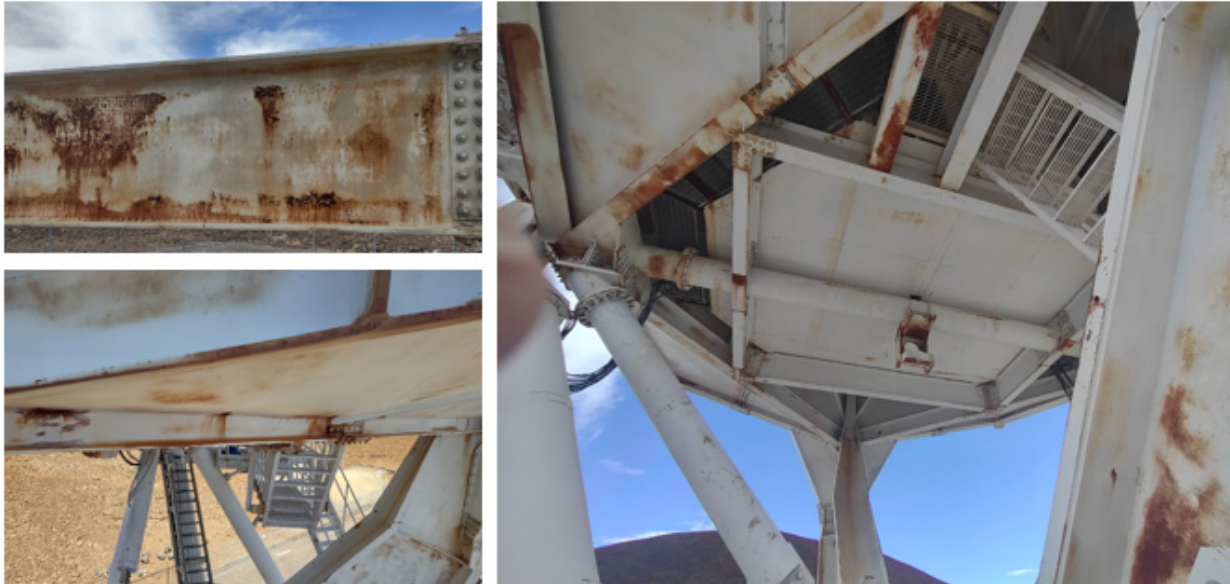
Overall the condition of the antenna is good. There is some rust but it is only surface scale. The techs would like to paint but they are nervous about the environmental constraints of this location. I believe they could use Zero-Rust or POR-15 and apply it with a brush. These paints are made to go over rust and seal it up. (see Figure 10)

Figure 10: Corrosion Examples

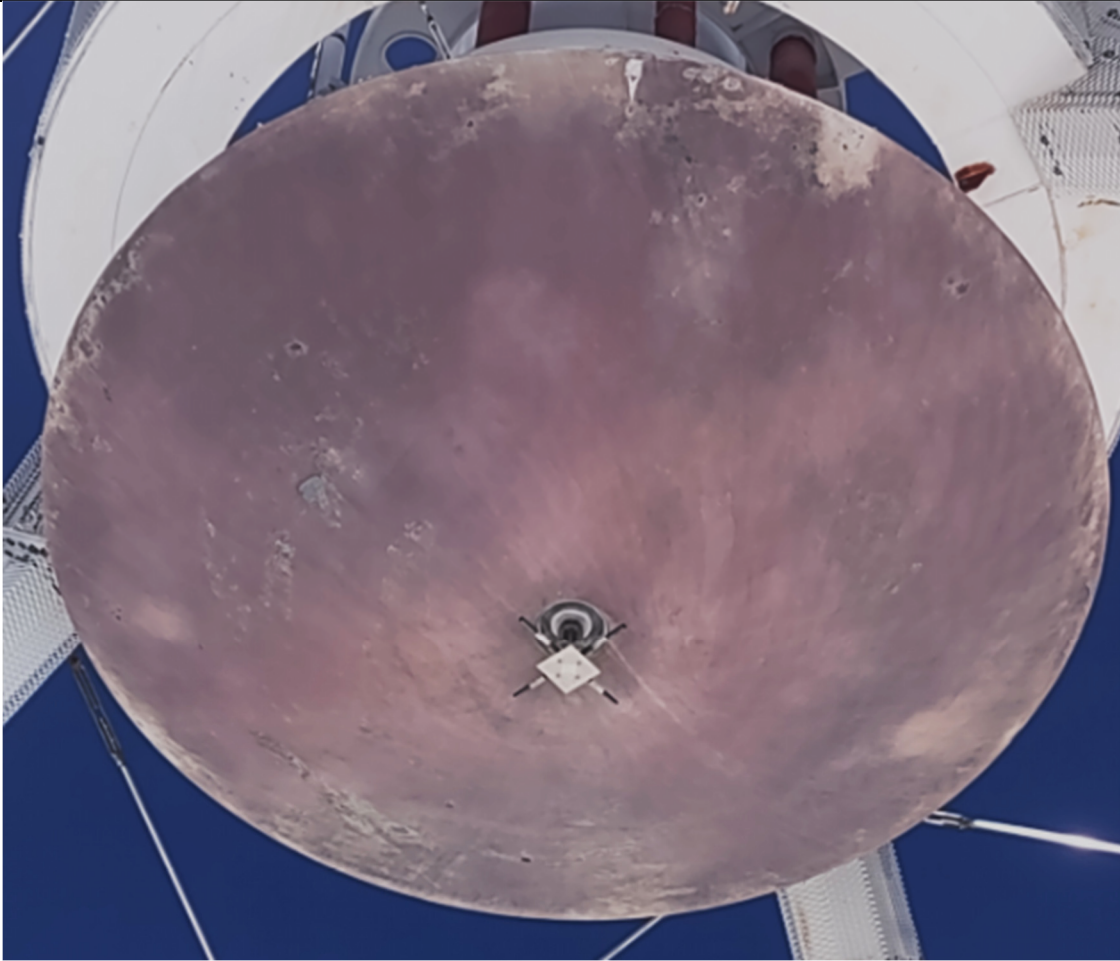
The sub-reflector on this antenna is in pretty rough shape. The fiberglass is exposed in a couple spots. (see Figure 11) Due to the environmental concerns about painting it may be best to refurbish the spare sub reflector at the VLA and swap it out. This would require hiring a crane locally and NRAO Technicians to align and calibrate the replacement. This refurbish and swap cycle could be used on all of the VLBA.

Figure 11: Sub-Reflector Condition

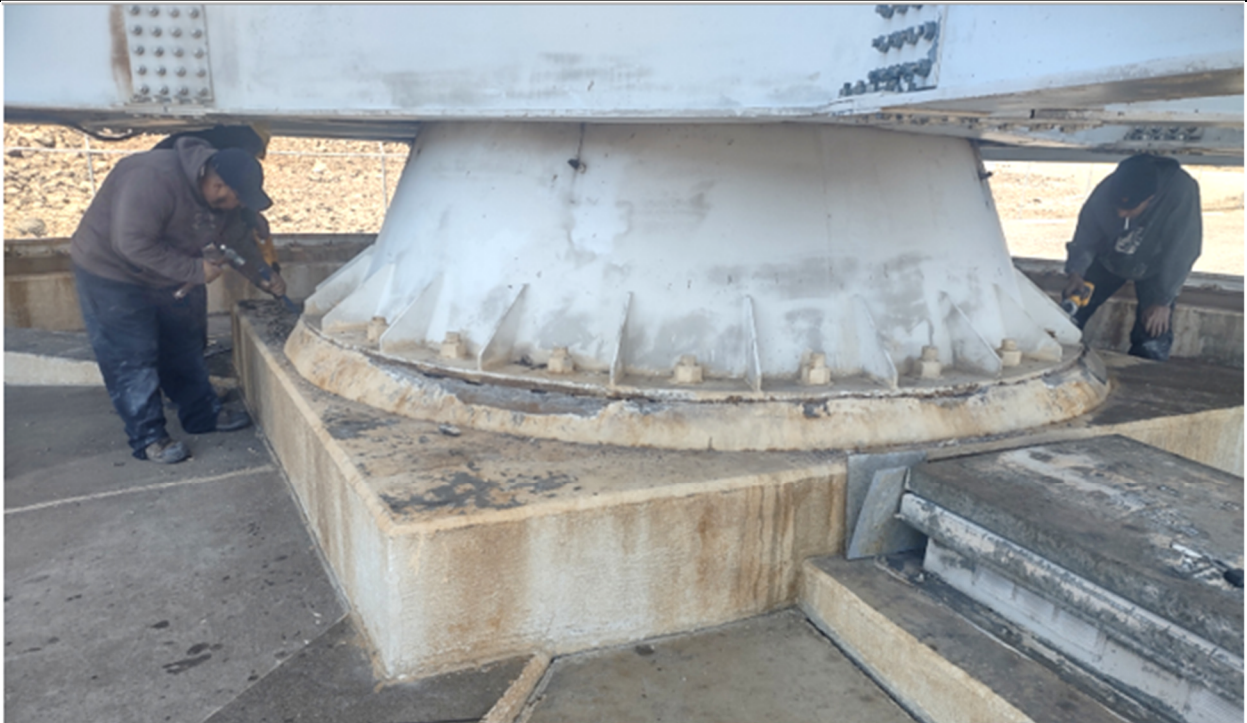
The grout around the pintle bearing lower housing was cracked and separated. The loose material was removed down to solid and replaced with some new quick setting grout/mortar. (see Figure 12)

Figure 12: Mortar Fix Around Lower Pintle Bearing Structure
