National Radio Astronomy Observatory

VLBA Antenna Memo Series – No. 107

TRIP REPORT – St Croix, June 21-22, 2023

ENGINEERING INSPECTION

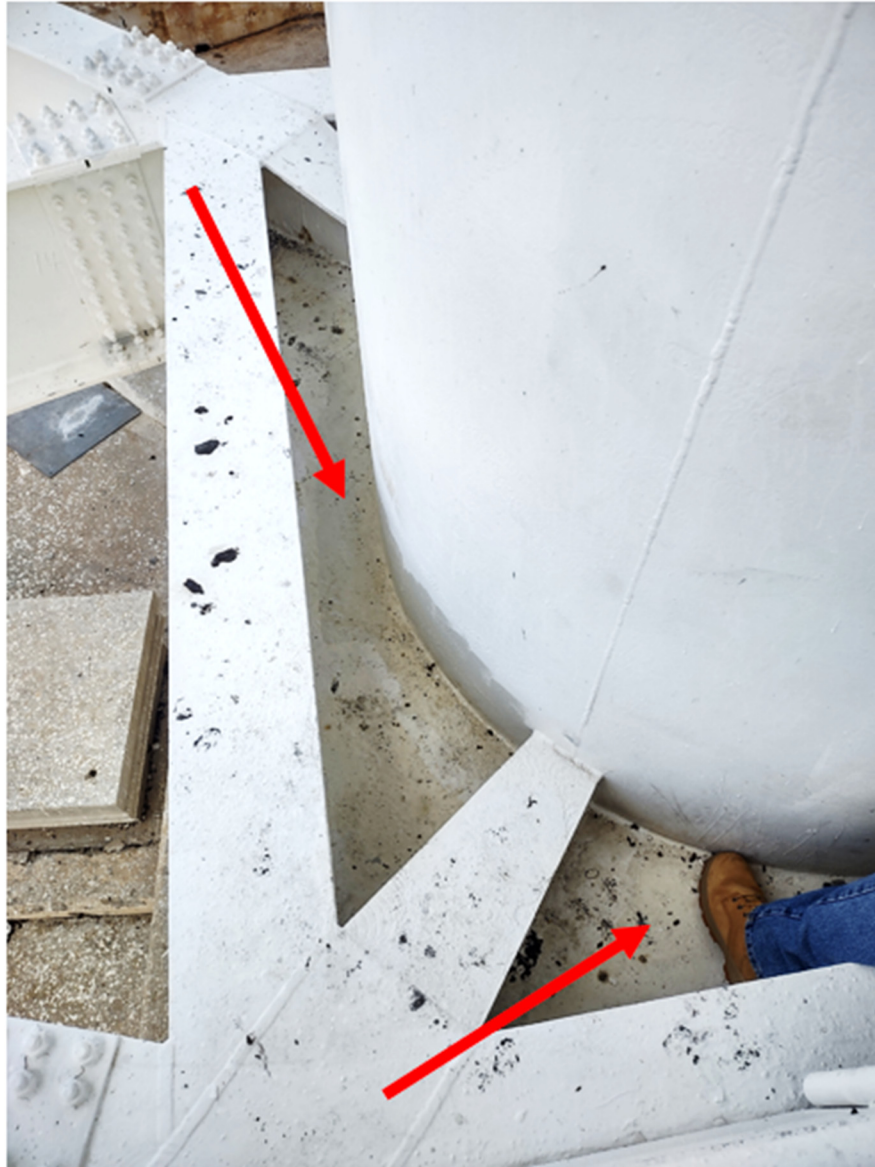
Due to the antenna's location in a tropical marine environment and past experience in maintaining this antenna, corrosion is a serious concern. Past work on this antenna has included cutting out and replacing rusted away areas of the structure and it has been UHP water jetted and painted twice. We were pleasantly surprised with the overall condition of the antenna. Del Correa has put forth a lot of effort in cleaning and painting on the accessible areas below the elevation bearings. He uses a pneumatic needle scaler to clean the rusted areas, applies 2-part epoxy primer and a urethane top coat. Work was also done to repair with fiberglass and resin then paint in the upper center pintle area. See Figures 2 and 3.

Figure 2: Upper Center Pintle Area Rust Repair

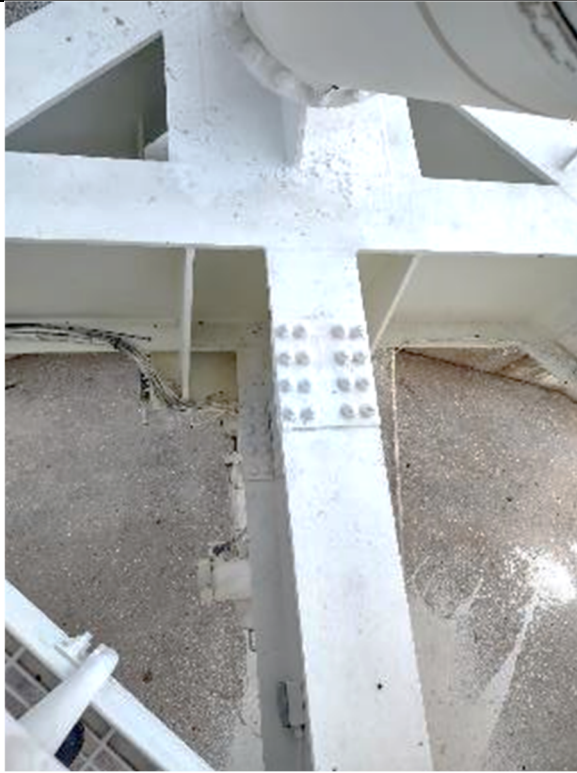
Figure 3: Example of Lower Structure Paint Maintenance

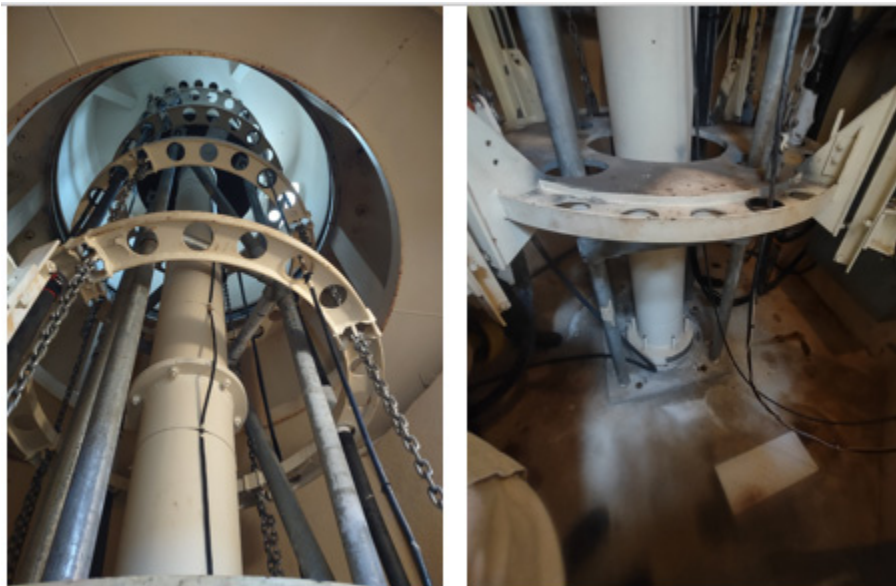
The lower (snake pit) and upper pintle area was found to be dry and in good condition including the cable wrap structure and the associated mechanism. See Figure 4 & 5.

Figure 4: Snake Pit Condition

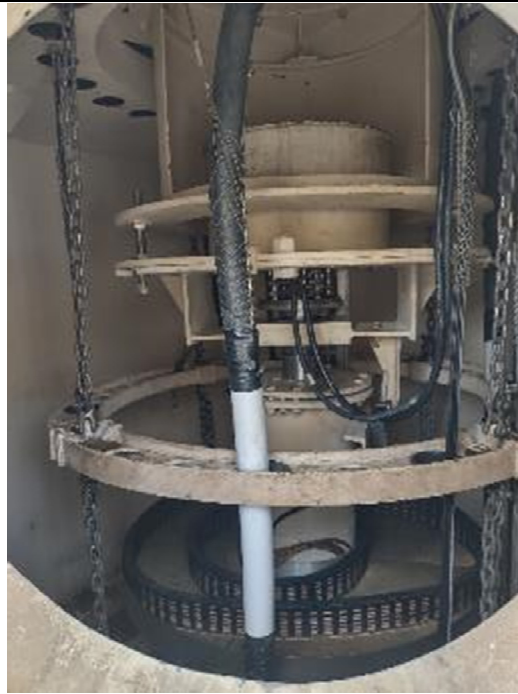
Figure 4: Upper Pintle – Cable Wrap Area Condition

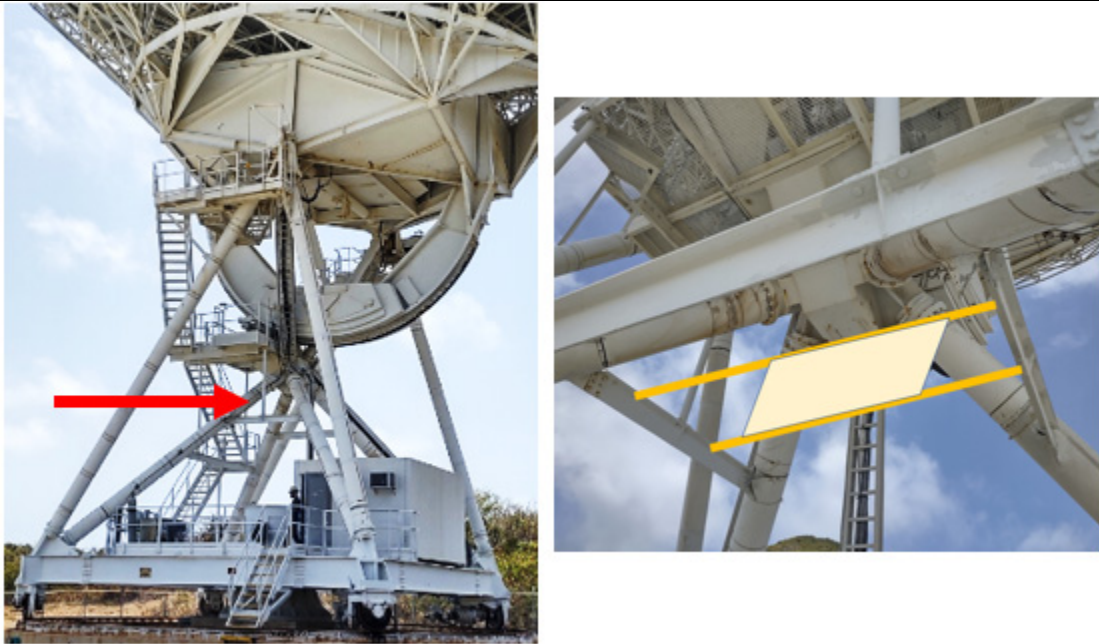
Figure 5: Lower Service Platform Needs Replaced

The site technicians requested that the lower service platform be rebuilt to facilitate access for performing service activities to this area of the antenna. There was a platform here originally but was removed in years past due to excessive corrosion. New platform should be made with galvanized heavy angle and bar grating. It can be attached to the two existing large angle sections. See Figure 5.

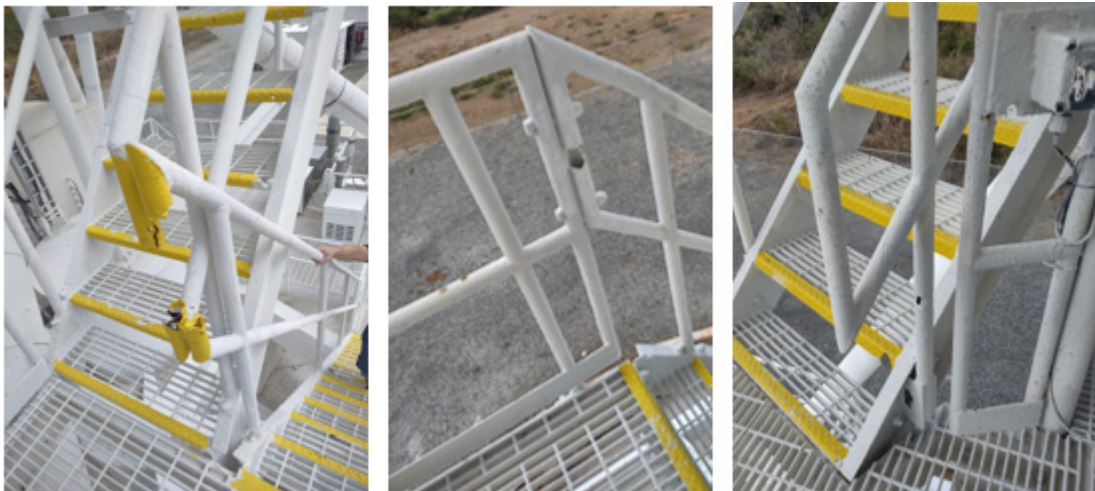
Some portions of the walk way hand rail have corroded away. Some of the under-structure for the walkways has significant corrosion. See Figures 6 & 7.

Figure 6: Hand Rail Corrosion Examples

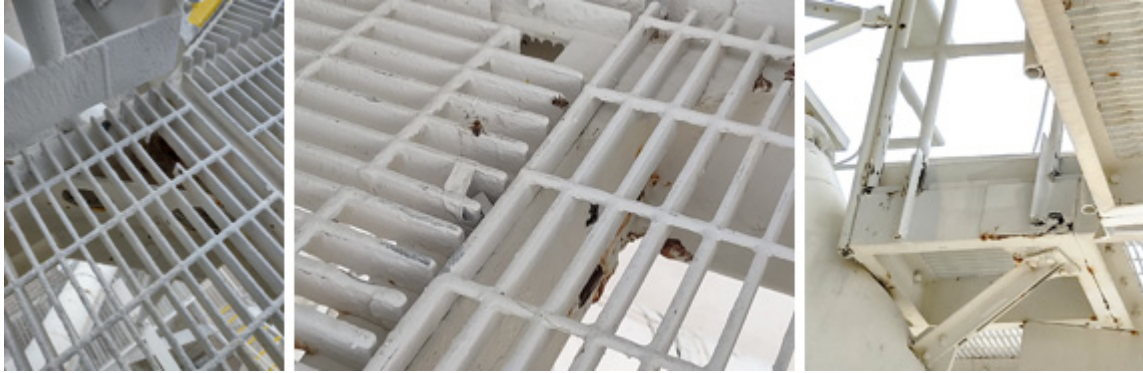
Figure 7: Walk Way Under Structure Corrosion Examples

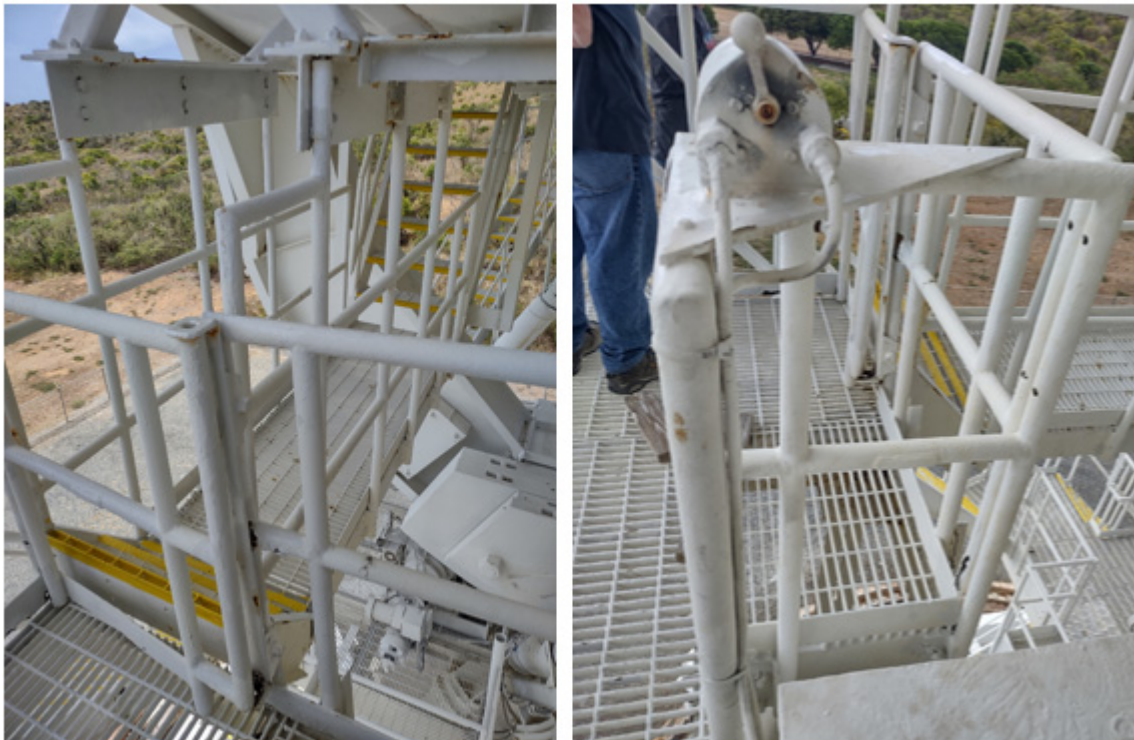
The gate and adjacent hand rail near the swinging catwalk needs to be rebuilt. The lower gate pivot is gone and some of the uprights have rust holes. See Figure 8.

Figure 8: Swinging Catwalk Gate and Adjacent Hand Rail

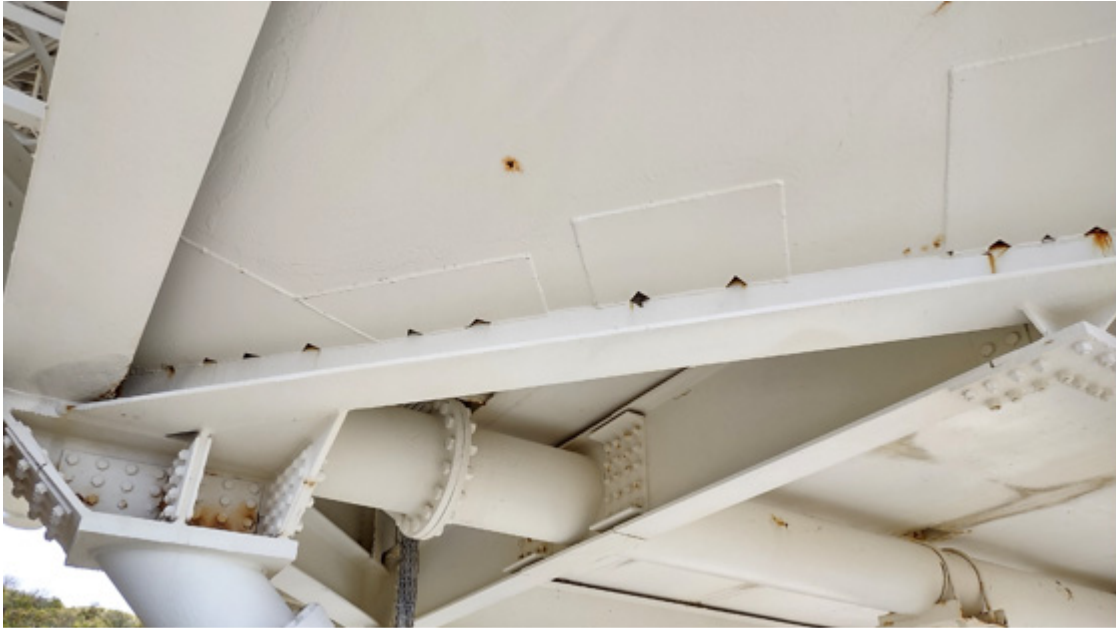
Figure 9: Condition of Past Repairs to one of the Box Areas

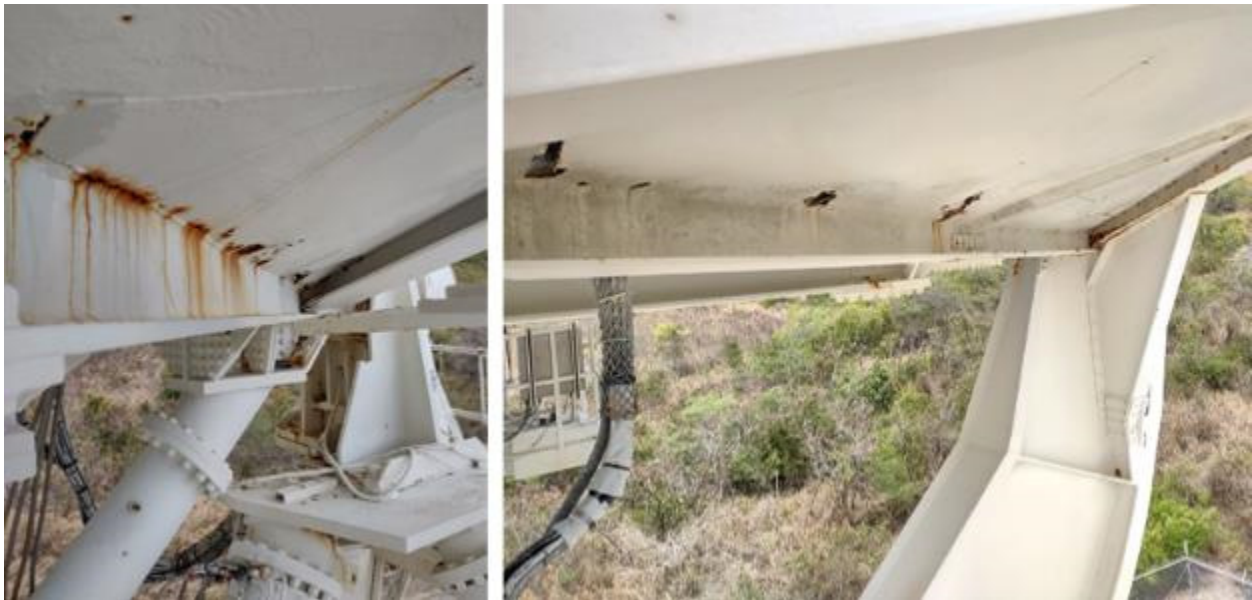
The large boxed in portions of the structure have been repaired in the past which looks good. See Figure 9. Other portions of the big boxes need repaired and drain holes added. See Figures 10 & 11.

Figure 10: Box Areas that Need Repaired

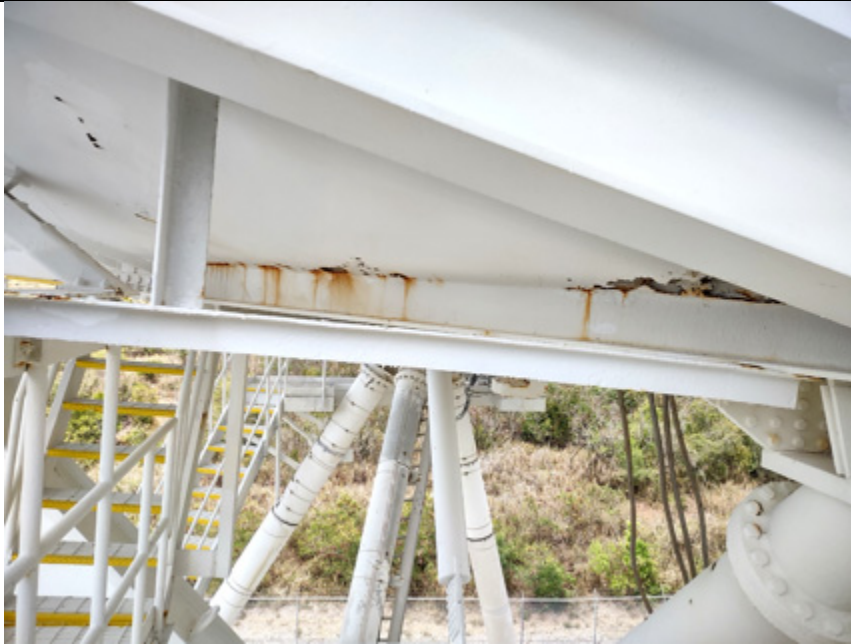
Figure 11: Box Areas that Need Repaired

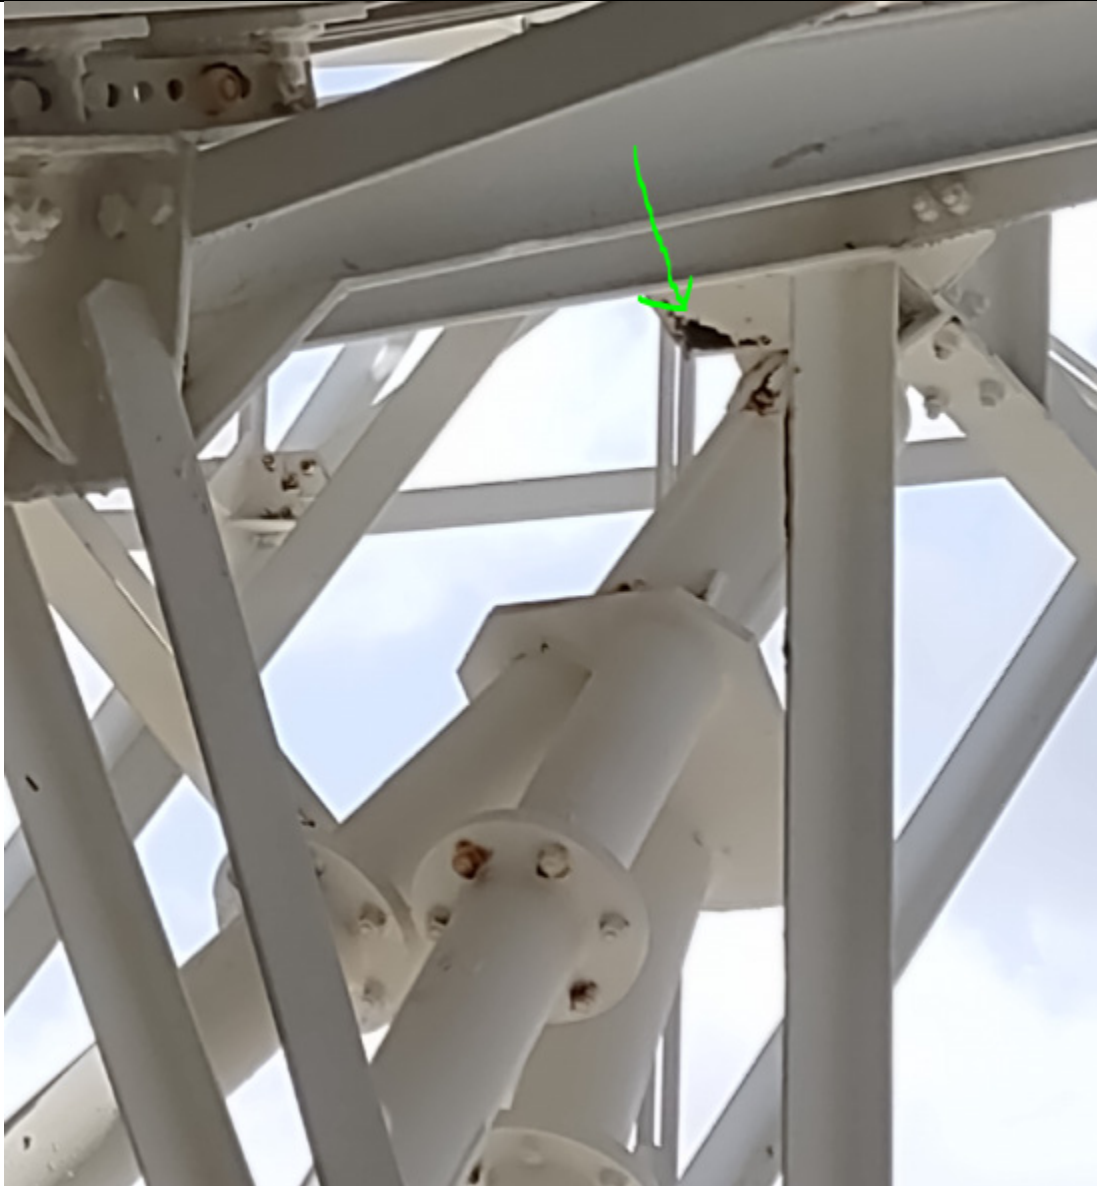
The structure at the base of the quad legs that support the FRM have been repaired in the past. Some of these repairs were accomplished by putting new steel over the original. Overlapping of plates creates a moisture trap and those areas are severely rusted out. Repairs to these areas will have to be planned and executed carefully to remove sections for replacement while leaving enough structure remaining for support. See Figures 12 & 13.

Figure 12: FRM Quad Leg Support Structure Rust Out

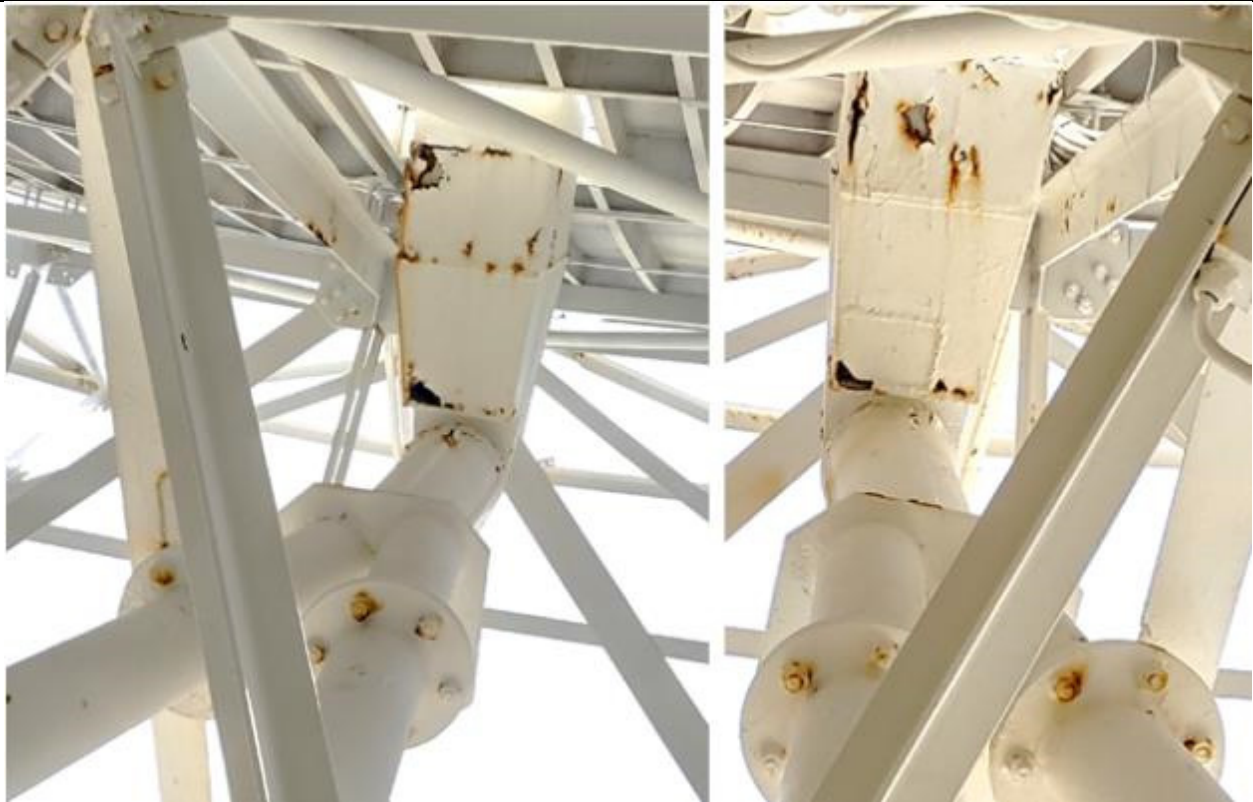
Figure 13: FRM Quad Leg Support Structure Rust Out

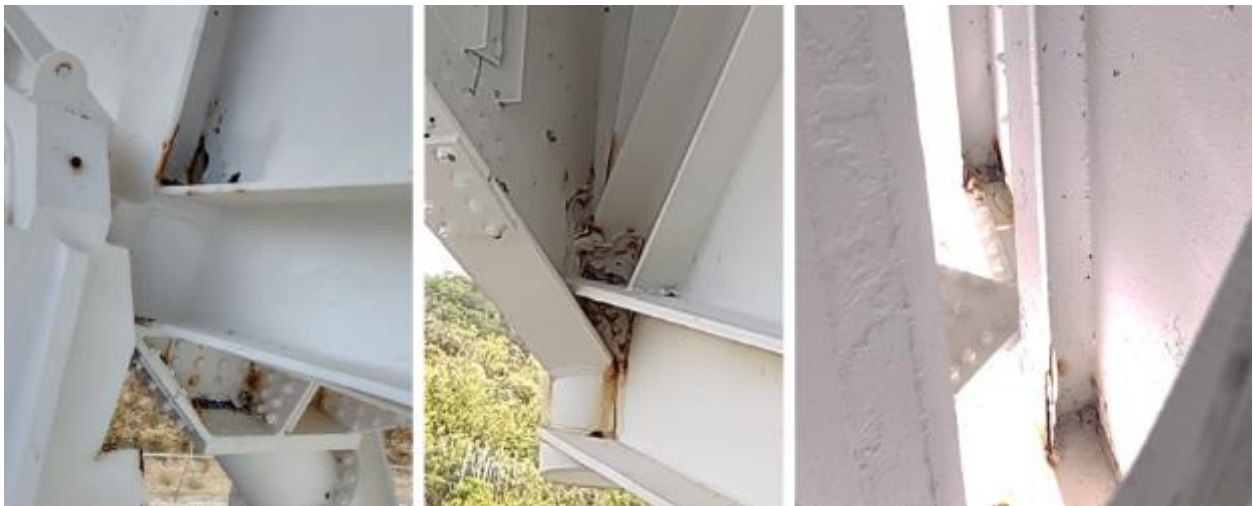
Some of the corners of the structure show concentrated rust and need to be checked for holes when an aerial work platform is available. See Figure 14.

Figure 14: Structure Corners that need Closer Inspection

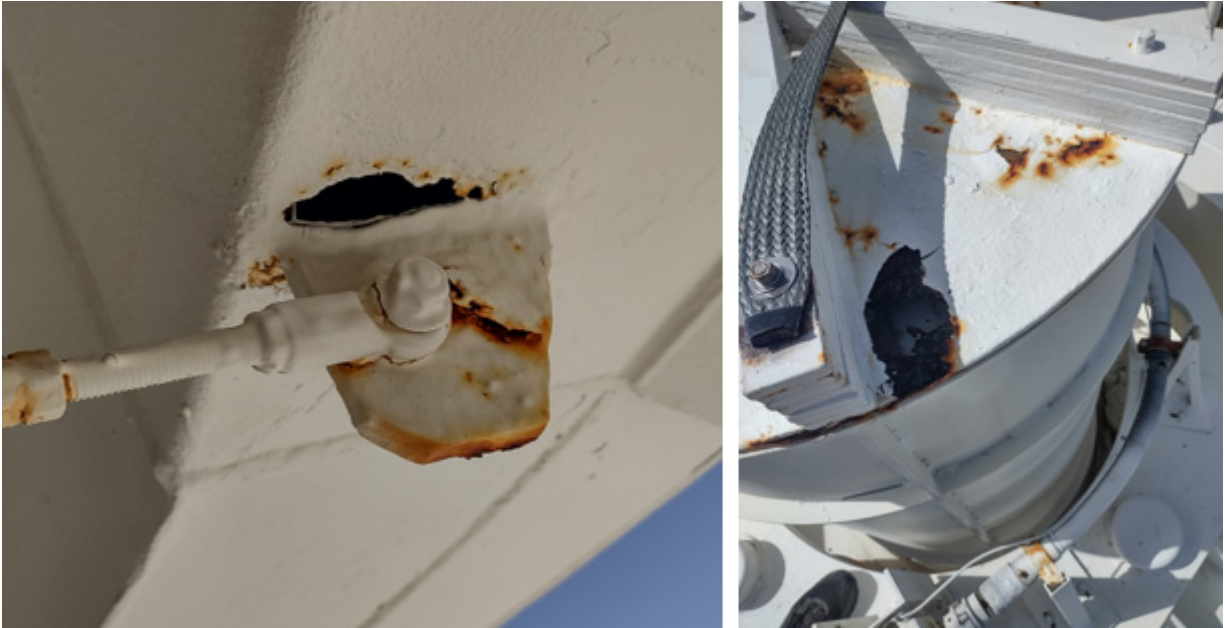
There are some rusted out areas on the FRM/Apex structure. See Figure 15.

Figure 15: Apex Structure Rust Out

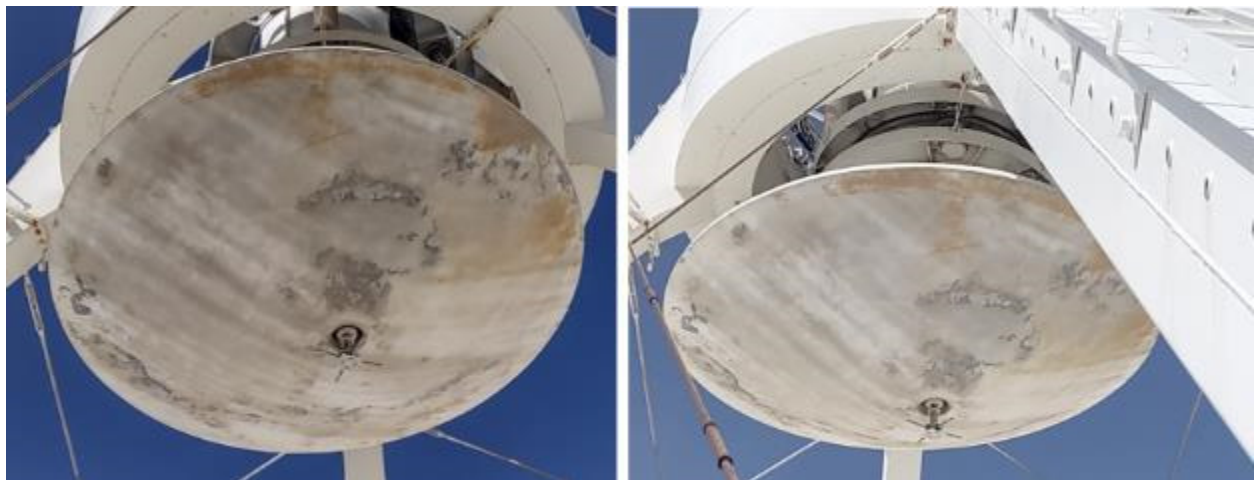
The Sub-Reflector surface doesn't look very good. A lot of the paint is missing and the fiberglass is showing in a few places. See Figure 16.

Figure 16: Condition of the Sub-Reflector

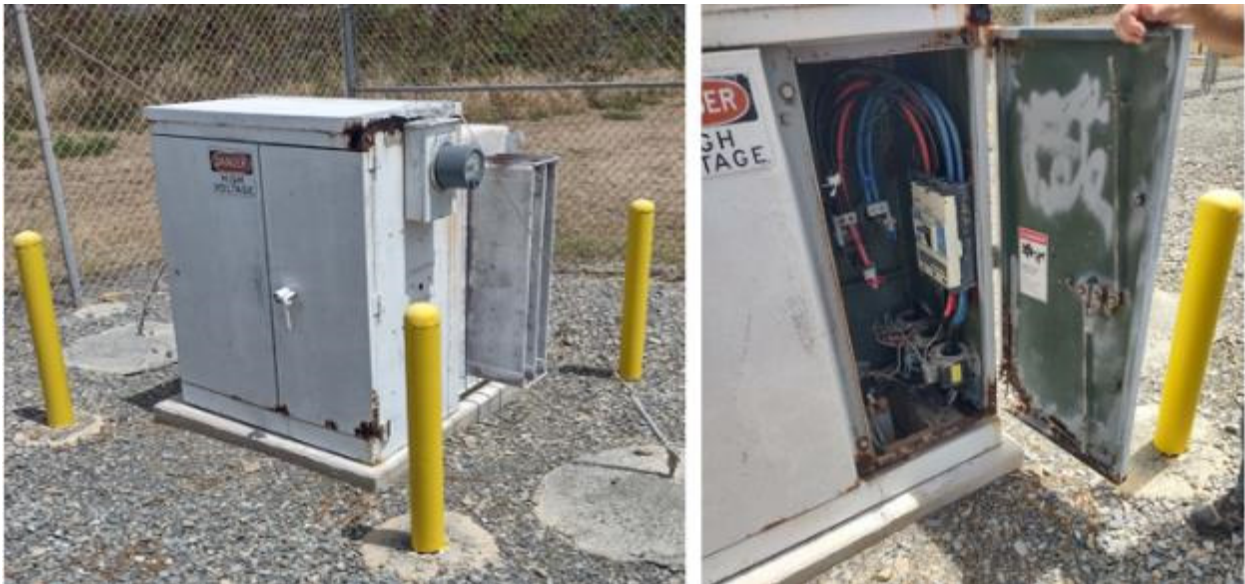
The transformer for the site that conditions the public power service is in very poor condition. The oil filled portion of the transformer does not have holes in it but corrosion has started to attack the top cover. Preliminary investigation indicates the transformer is owned by the public power provider. A notification will be sent to them reporting the condition and our desire to have it replaced. The power meter associated with the transformer is un-readable so it is assumed our power billing is based on estimates and not actual readings. See Figures 17 & 18.

Figure 17: Site Transformer Condition

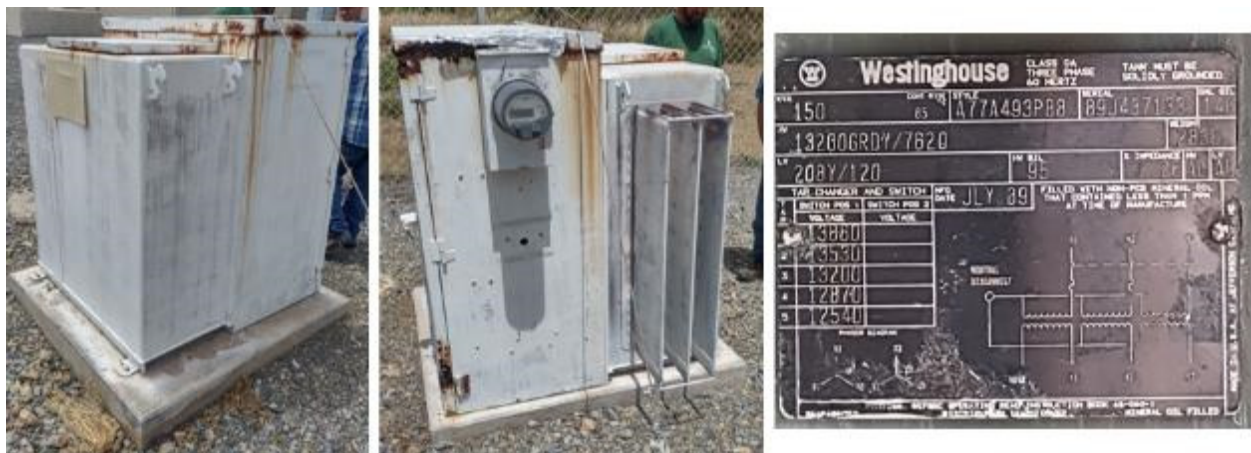
Figure 18: Site Transformer Condition

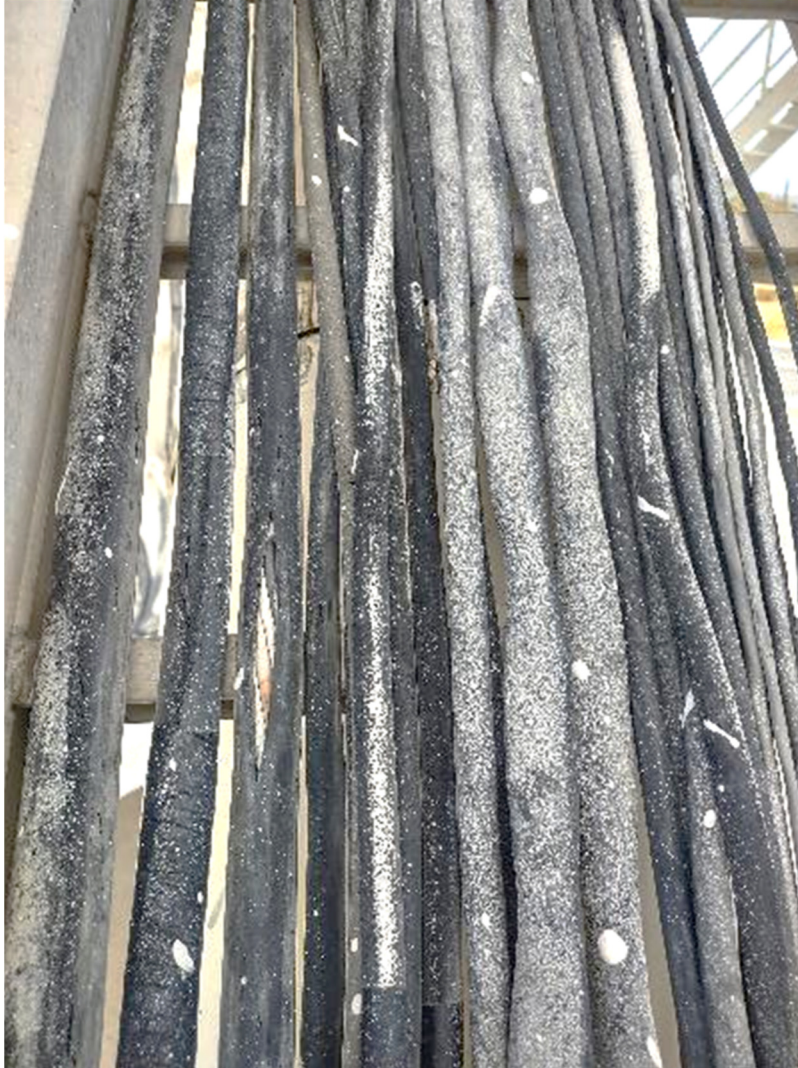
The power cables and other cables and wires on the antenna are severely deteriorated. The outside cable jacket is split open and the inside insulated conductors are exposed. See Figure 19.

Figure 19: Antenna Wire Condition

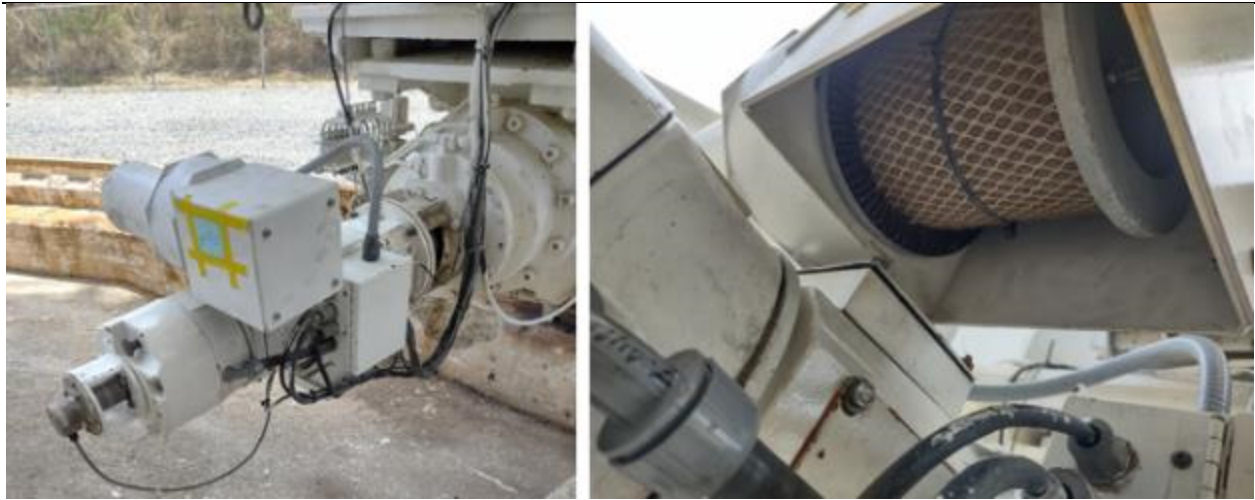
The site technicians brought it to our attention that the Az and El motors' cooling air supply is utilizing a cobbled together filter. See Figure 20. In some cases the cable may need to be replaced. It is recommended that additional protection be added in the form of flexible corrugated conduit or sleeving.

Figure 20: Az Motor Cooling Air Filtration

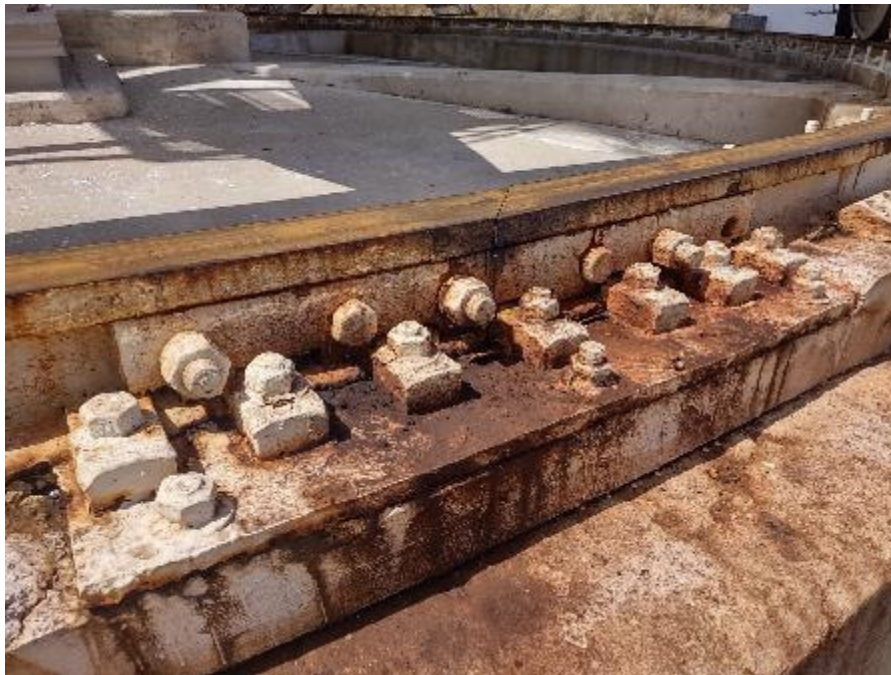
Rail inspection identified cracked splice bars and one splice at bolts 118 & 119 with about one quarter inch of vertical rail movement. This splice needs disassembled, rail raised and cleaned then new shims installed and clamped back down. See Figure 21.

Figure 21: Splice with Significant Vertical Rail Movement

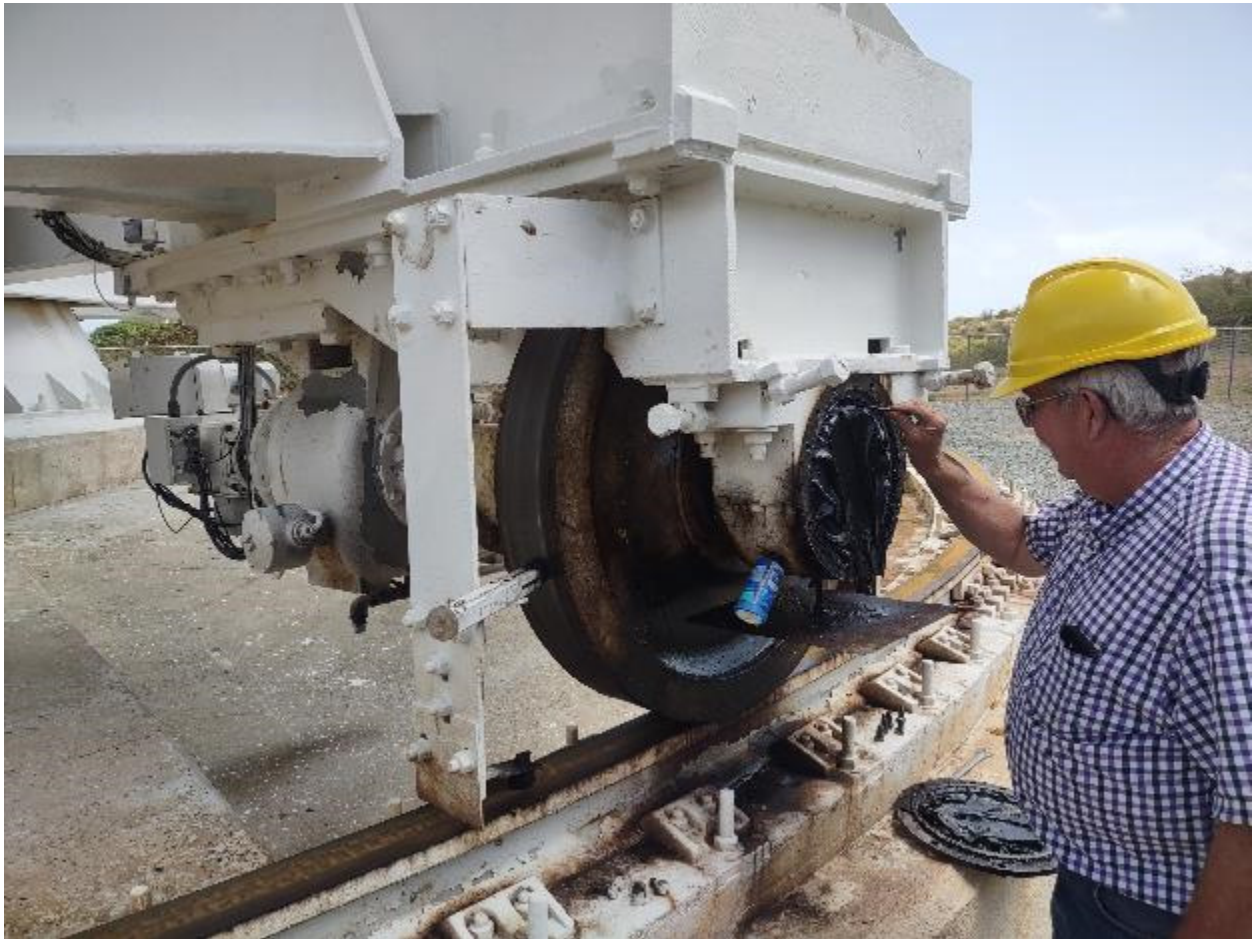
Grease inspection of the azimuth drive wheel bearings identified that the Az 2 outer wheel bearing is consistently generating metal in the grease. A pick was used to feel the outer race near the top and damage could be felt. See Figure 22.

Figure 22: Az 2 Outer Wheel Bearing Inspection
