VLBA Antenna Memo Series No.14

**Brewster Maintenance Visit, August 17 - 22, 1998 - Trip Report**

J. E. Thunborg  
September 10, 1998

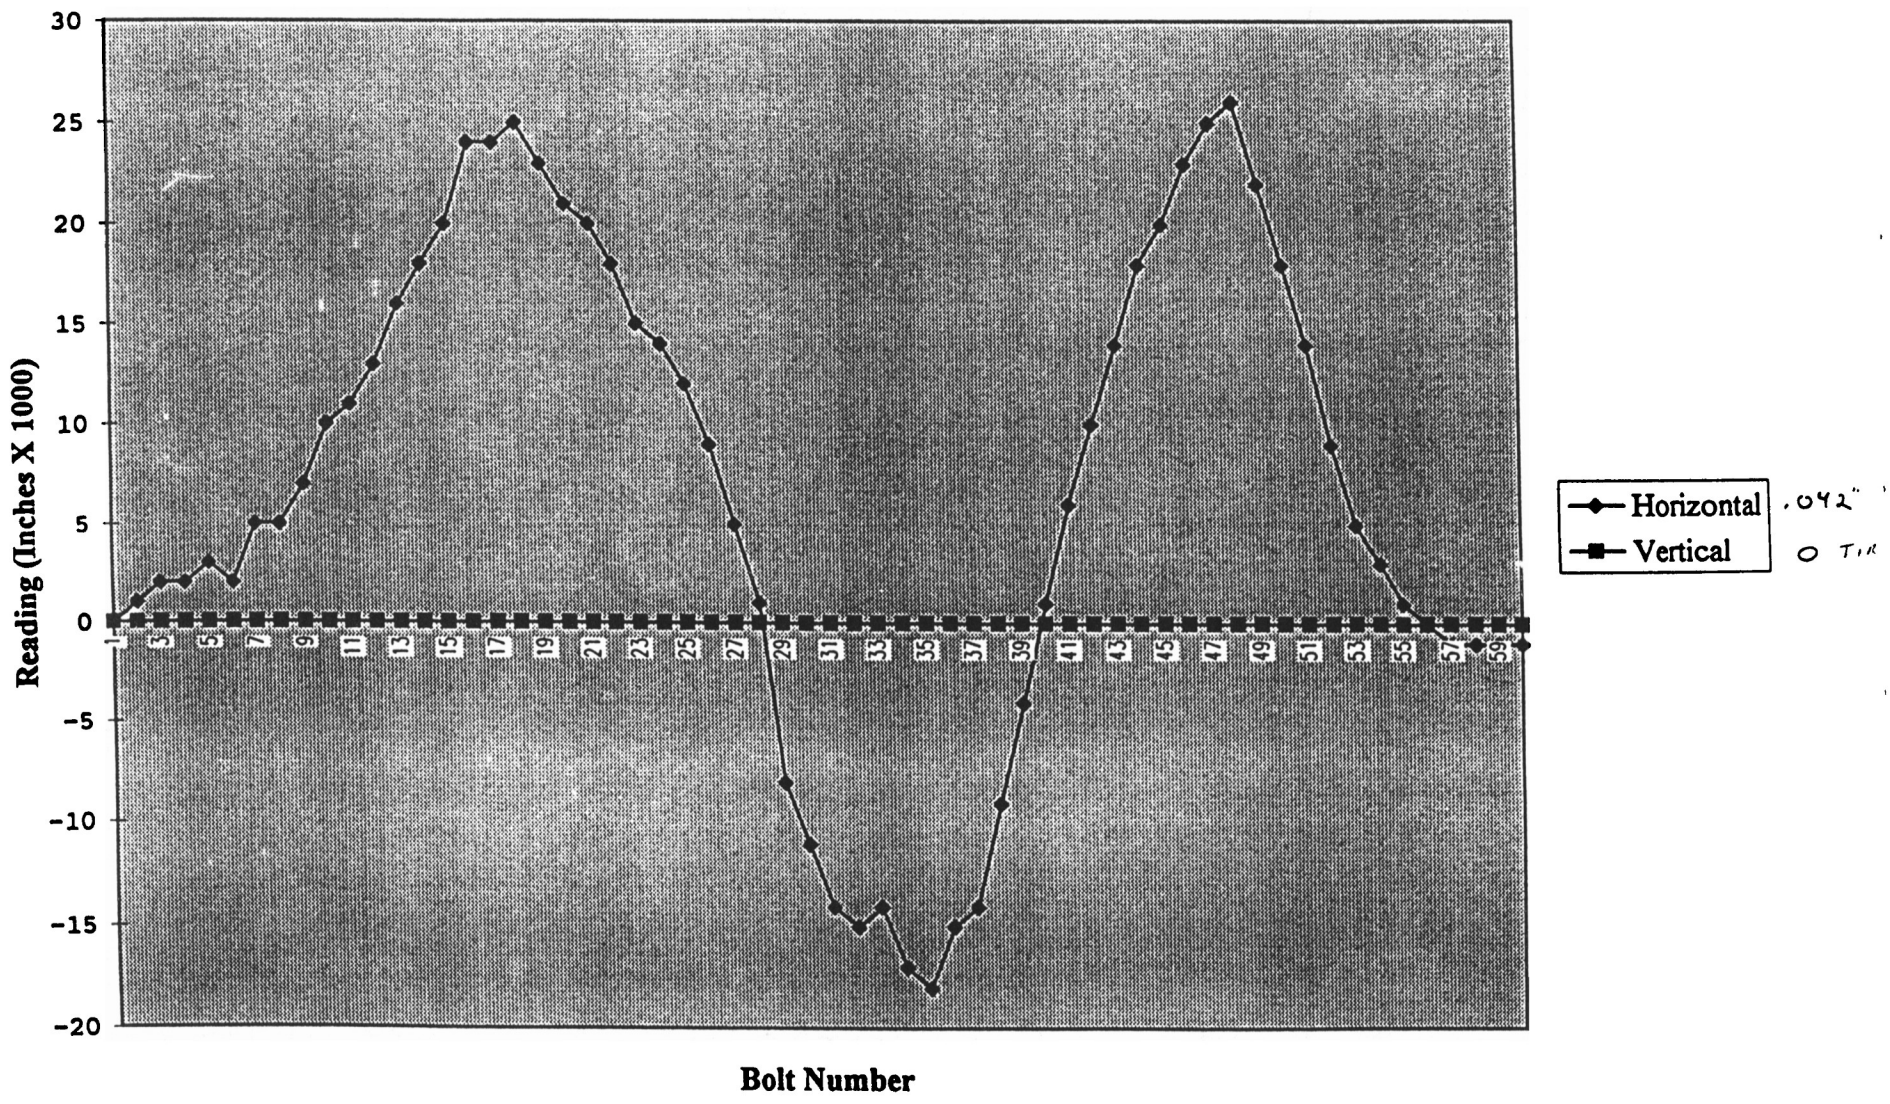
# VLBA Pintle Bearing Measurements

A hydraulic wrench was used to loosen 18 pintle bearing bolts. Dial indicators were then placed on the bearing and the antenna was rotated. The horizontal and vertical runout were 0.042" and 0", respectively as shown on the attached chart. These runout numbers are acceptable and no further action is required.

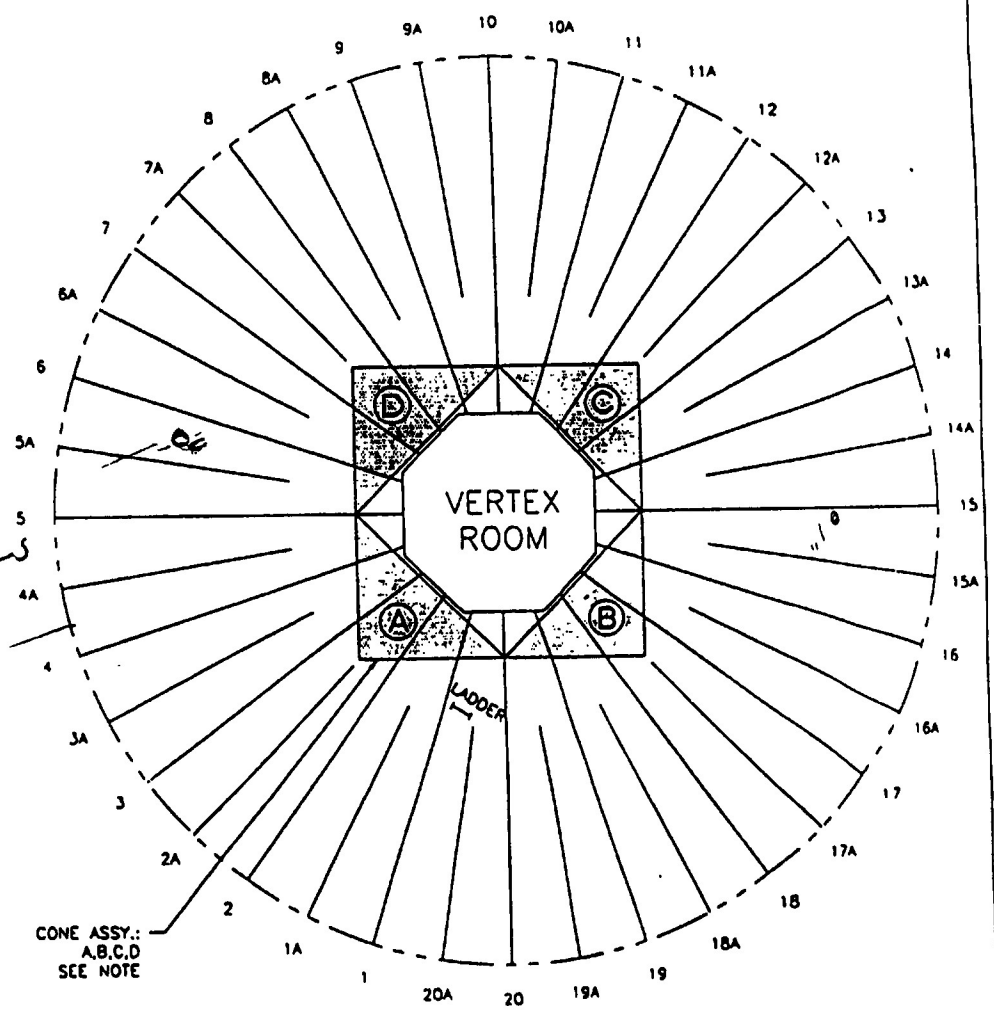
*1/4 - 3/4"  
PAINT PEELS*

*Some splice plates on large steel beams have peeling paint, up to 10" x 10" spts*

- ANGLE PEELING
- WF BEAM AROUND VERTEX TOUCHUP
- SMALL RUST SPOTS

NOTE: INSPECT CONE ASSY. INTERNALLY  
REPAIR/PAINT AS REQUIRED

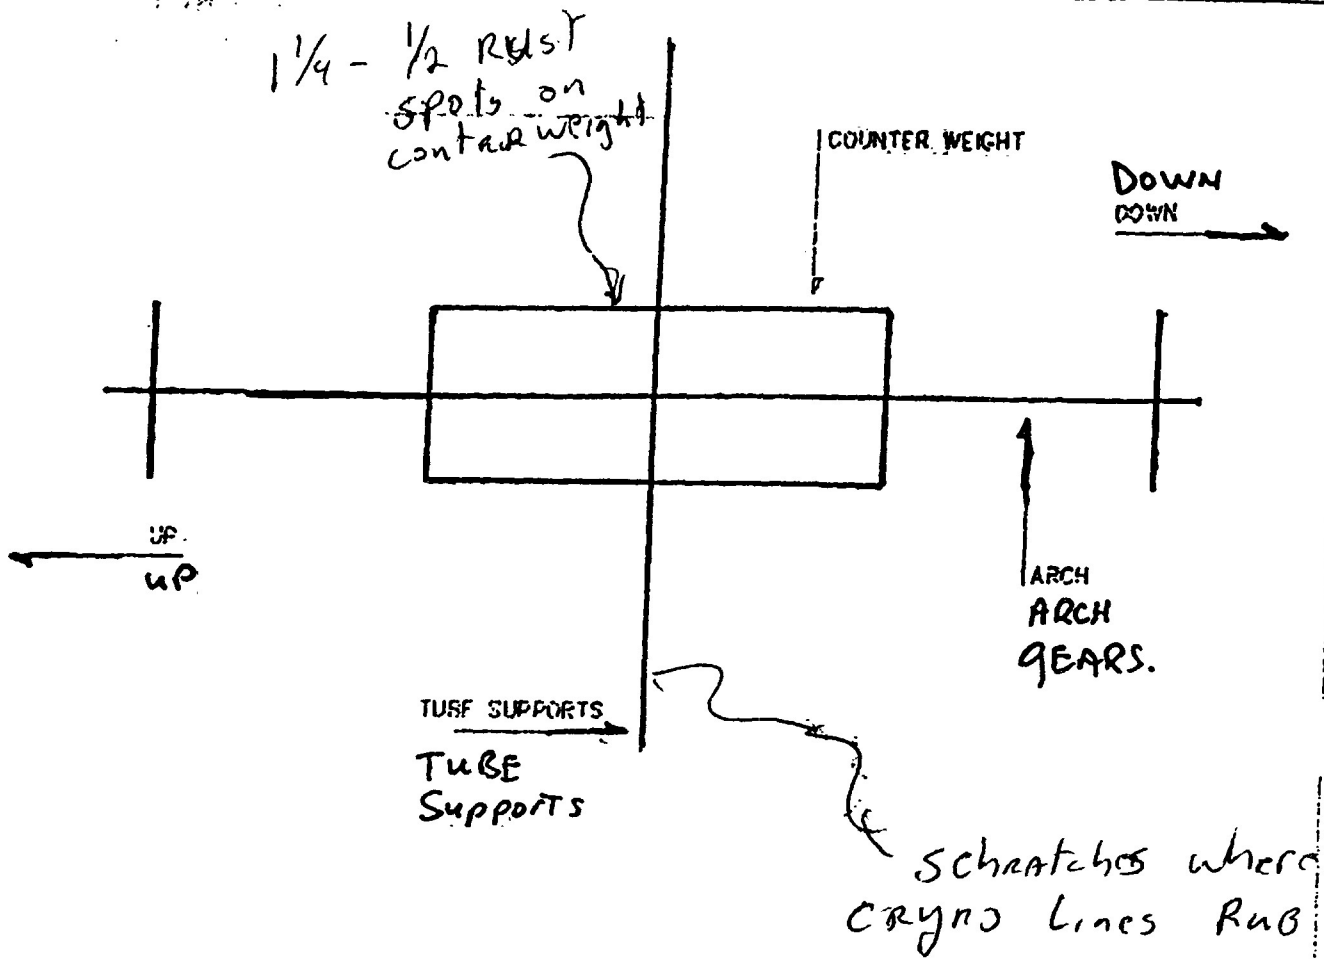
# COUNTERWEIGHT PAINT CONDITIONS

Paints is in General Good condition

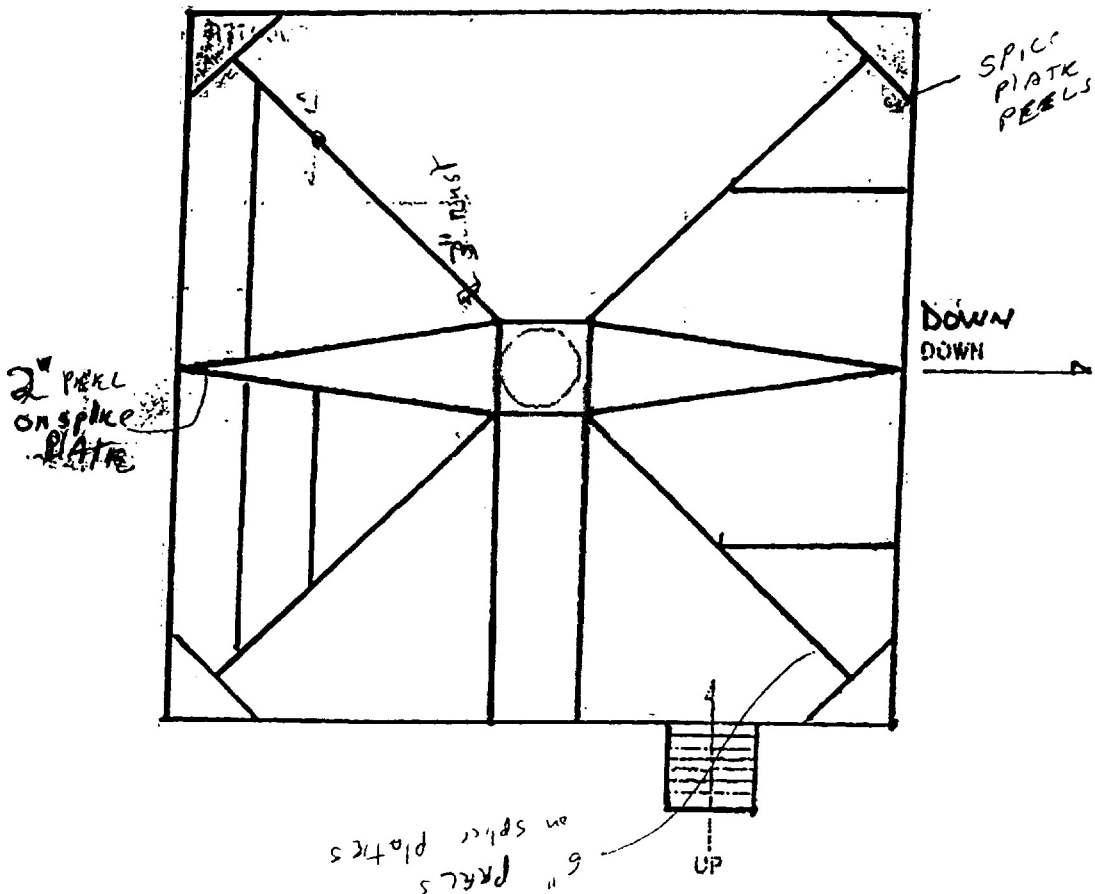
AZIMUTH LEVEL PAINT CONDITIONS - DATE:

PAINT IS PEELING OFF SEVERAL OF THE GALVANIZED SPICE PLATES
