NATIONAL RADIO ASTRONOMY OBSERVATORY
Socorro, New Mexico

VLBA Antenna Memo Series No.16

Mauna Kea Maintenance Visit, March 22 - 27, 1999 - Trip Report

J. E. Thunborg
April 6, 1999

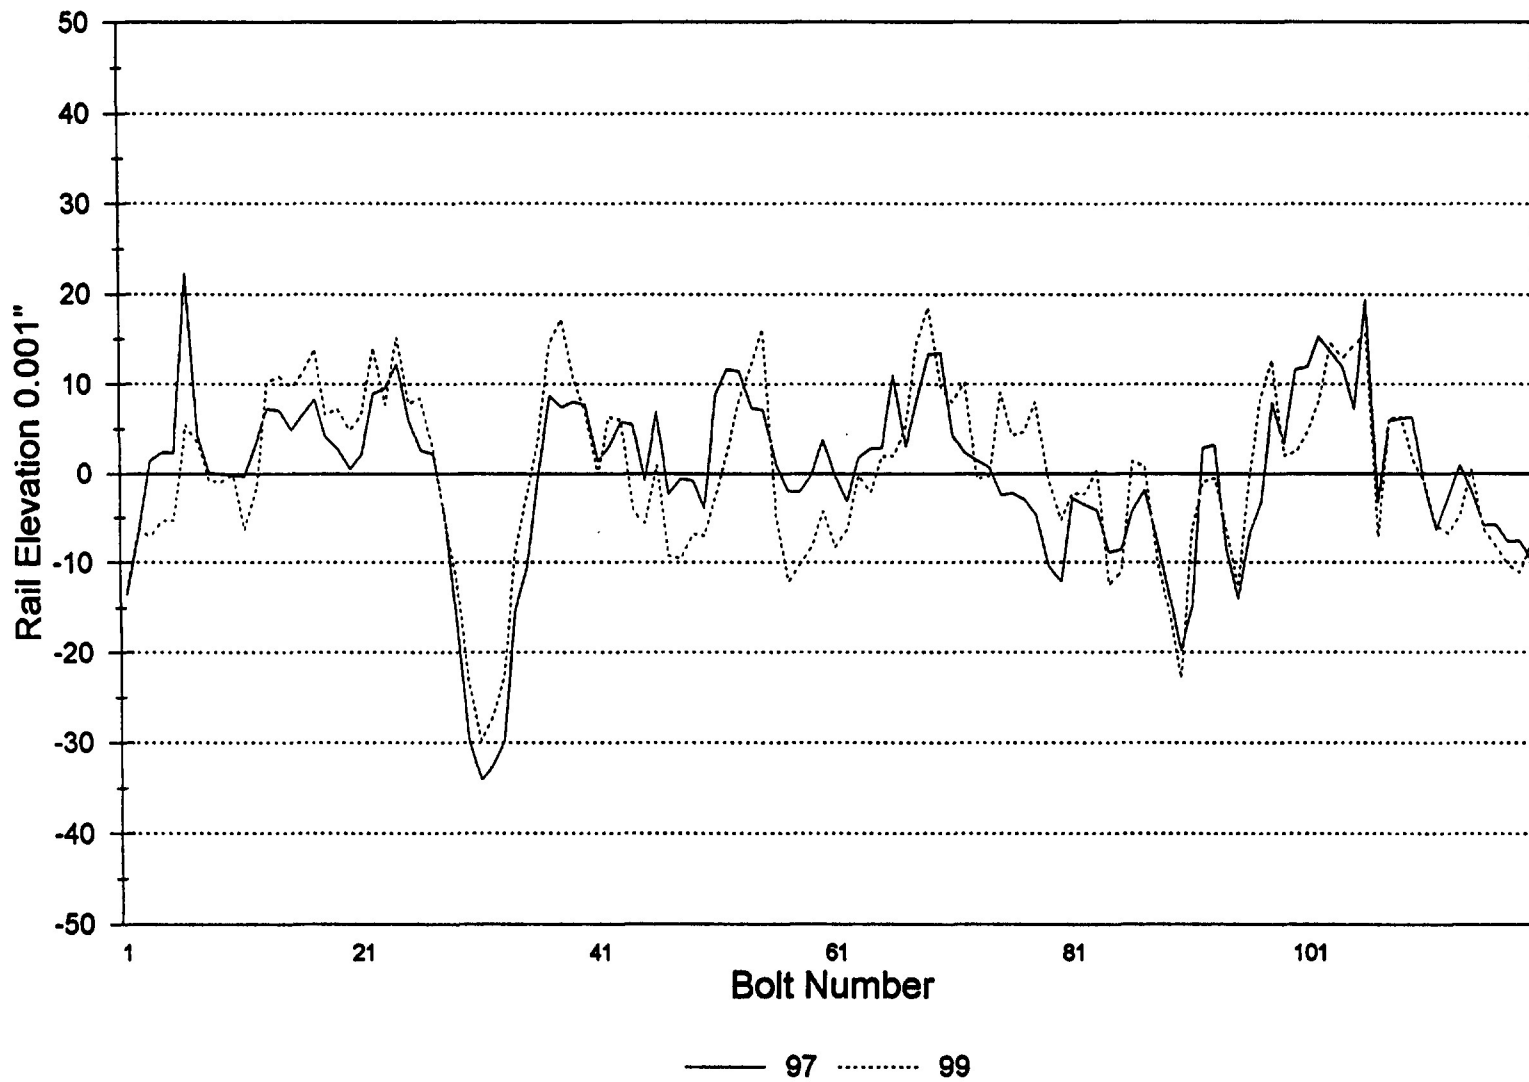
MK Azimuth Rail

Comparison 1997 to 1999

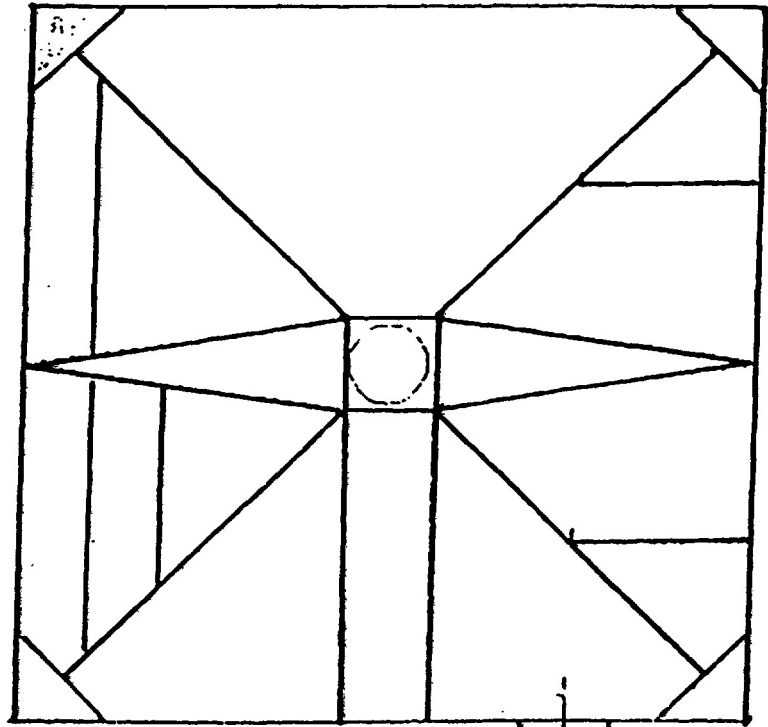
AZIMUTH LEVEL: PAINT CONDITIONS -- CHIT DATE:

The lower backup structure shows very little rust but the second layer of paint is peeling like an onion. The first layer of paint seems to be holding up very well. Rust is beginning to leach through the paint on the counterweights. There are numerous 2-6 inch spots where the paint has chipped off the primary reflector backup structure. This is not a structural problem but it is not very aesthetic. The paint is peeled to the 50% level on 4 primary reflector panels and 10% peeled on 6 others. The paint on the subreflector is very thin. Because of this the subreflector is almost brown in appearance.

The second coat of paint is peeling in numerous places. First coat seems to be holding up. Second coat is just peeling like an onion.

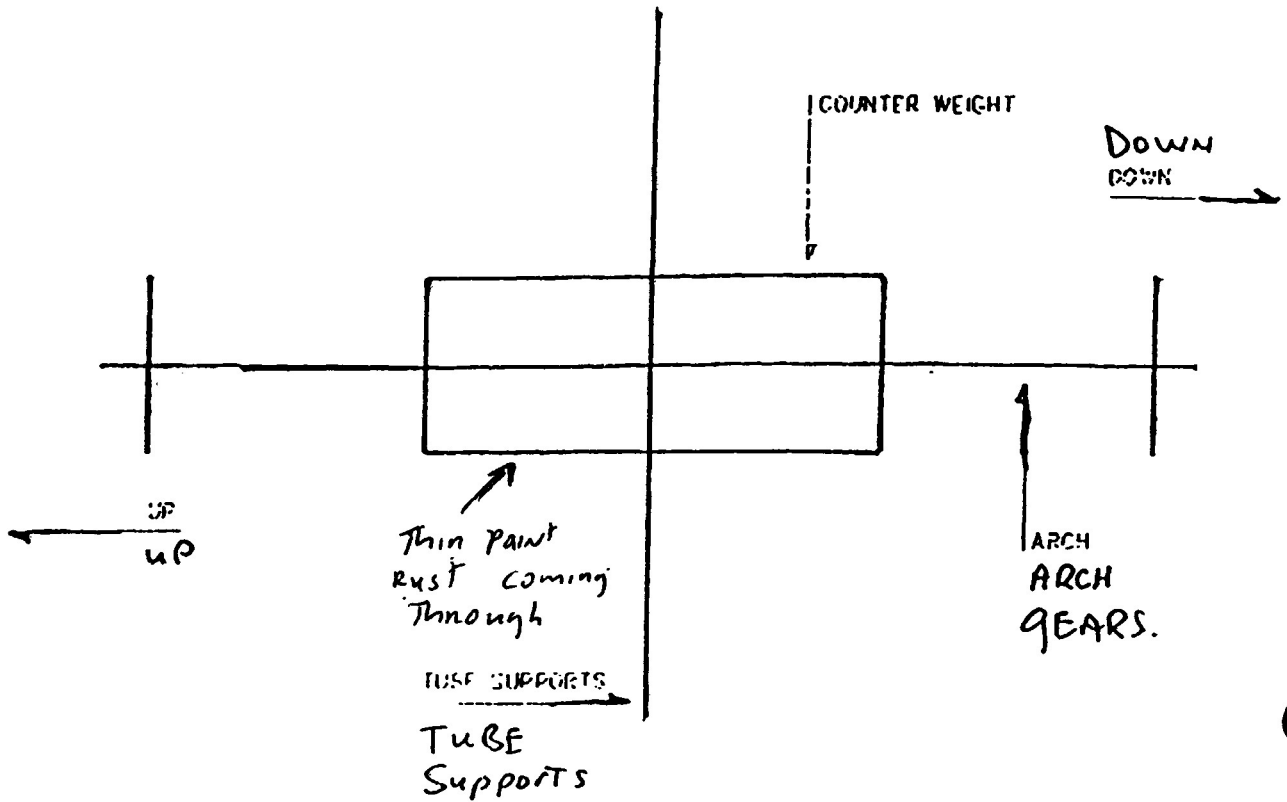
COUNTERWEIGHT PAINT CONDITIONS

COUNTERWEIGHTS VERY RUSTY.
 PAINT on ELEVATION platform NEEDS to
 BE Touched up AFTER welding

1. The elevation hard stops were not installed. The stops were left on site and will be installed during the next tiger team visit.
2. Some paint on the elevation platform was removed to facilitate installation of the platform extensions. The paint needs to be touched up. The site techs will accomplish this task during scheduled maintenance periods.

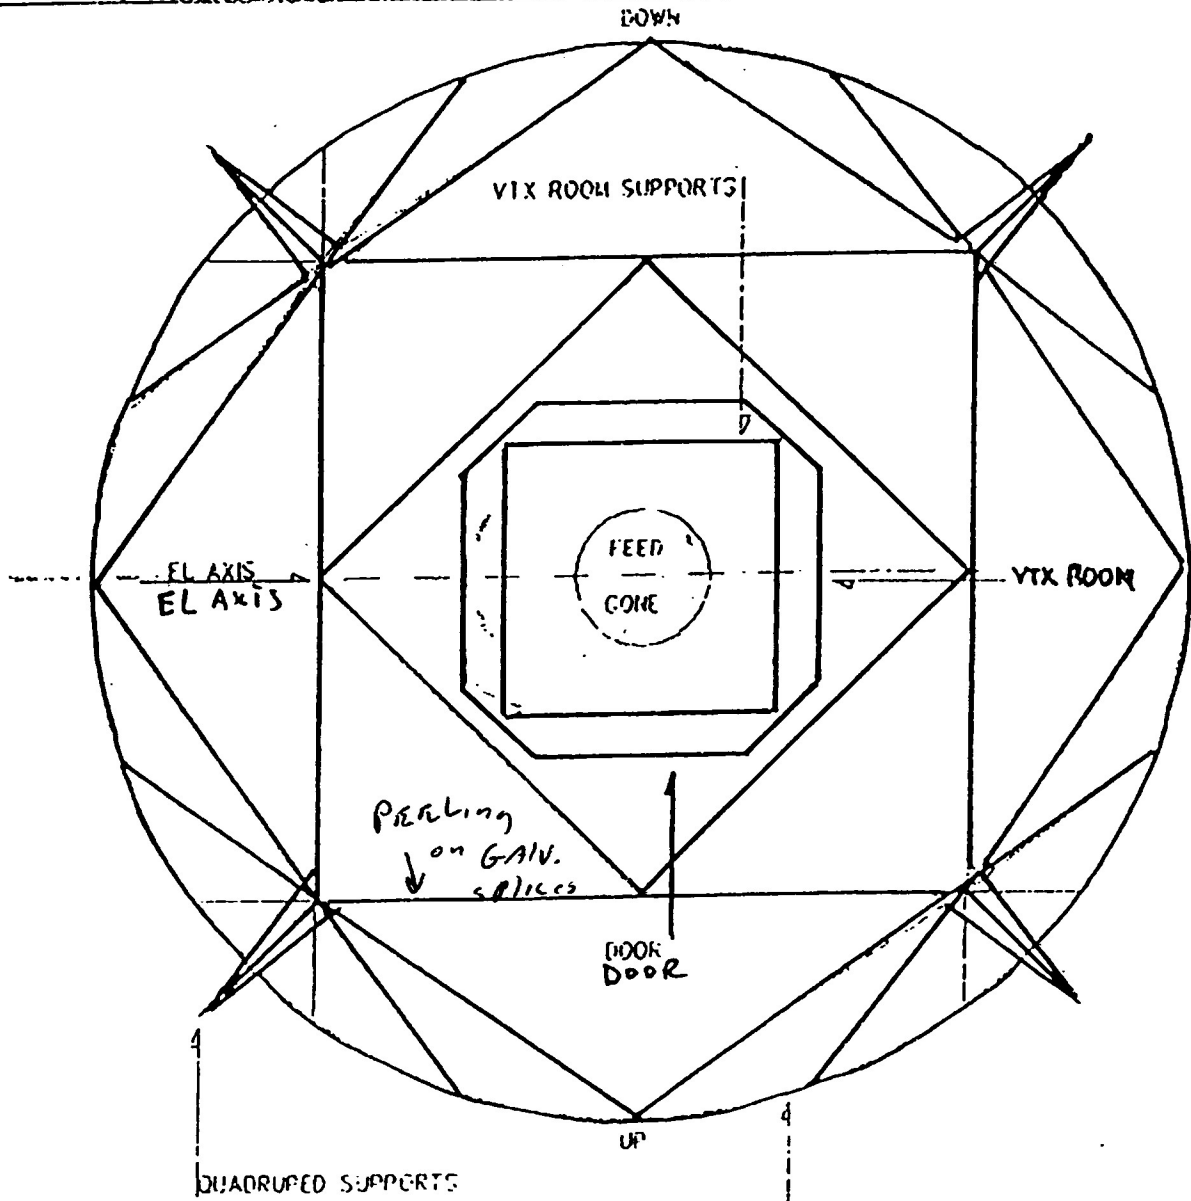
VERTIX LEVEL PAINT CONDITIONS AS OF DATE:

PAINT on the CAVITIES
is PEELING of GALVANIZED
SPLICES

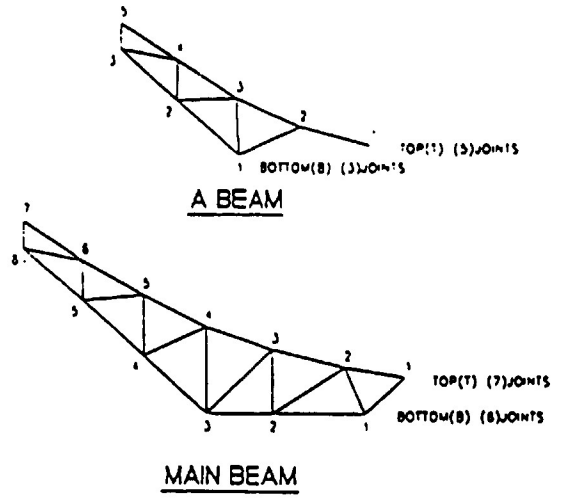
JOINT LISTING REQUIRING REPAIR
(NOT INCLUSIVE)

NUMEROUS 6" PRELS WITH RUST. NOT STRUCTURALLY A PROBLEM BUT VERY UGLY.

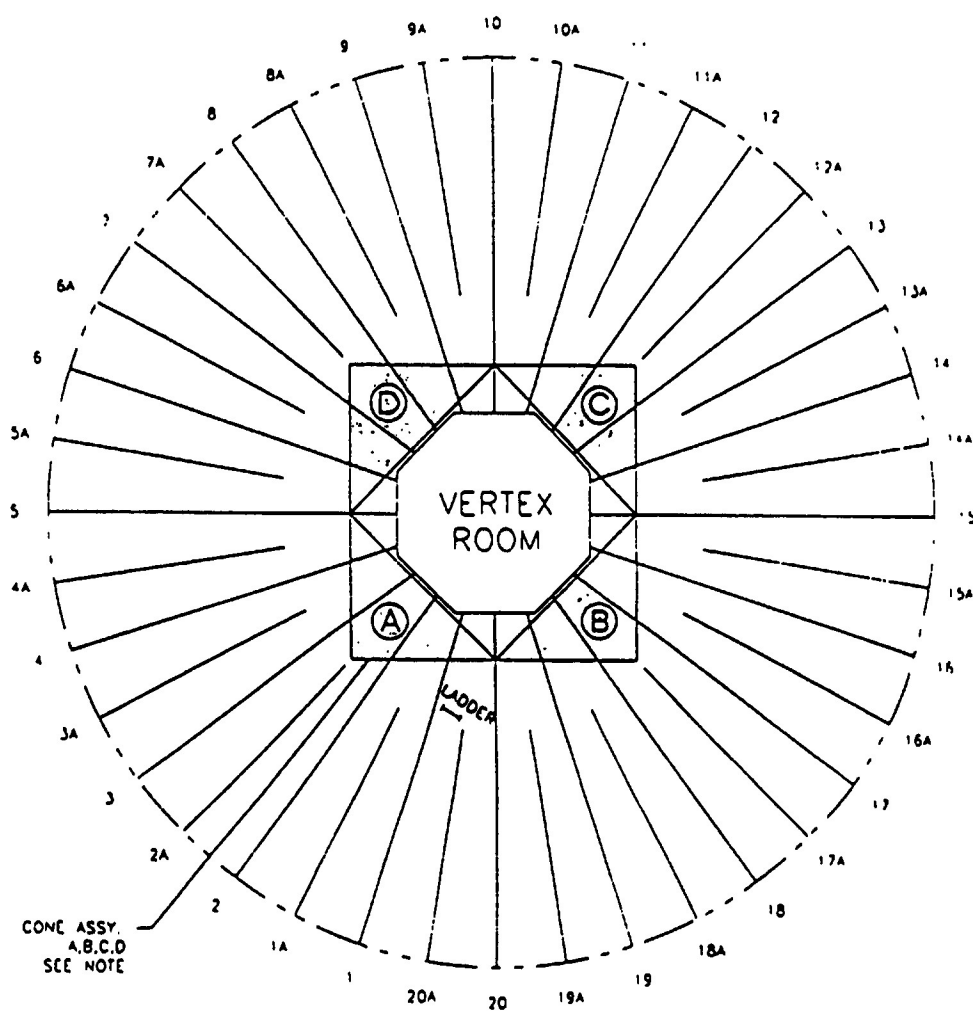
- ANGLE PEELING
- WF BEAM AROUND VERTEX TOUCHUP
- SMALL RUST SPOTS

NOTE INSPECT CONE ASSY INTERNALLY REPAIR/PAINT AS REQUIRED

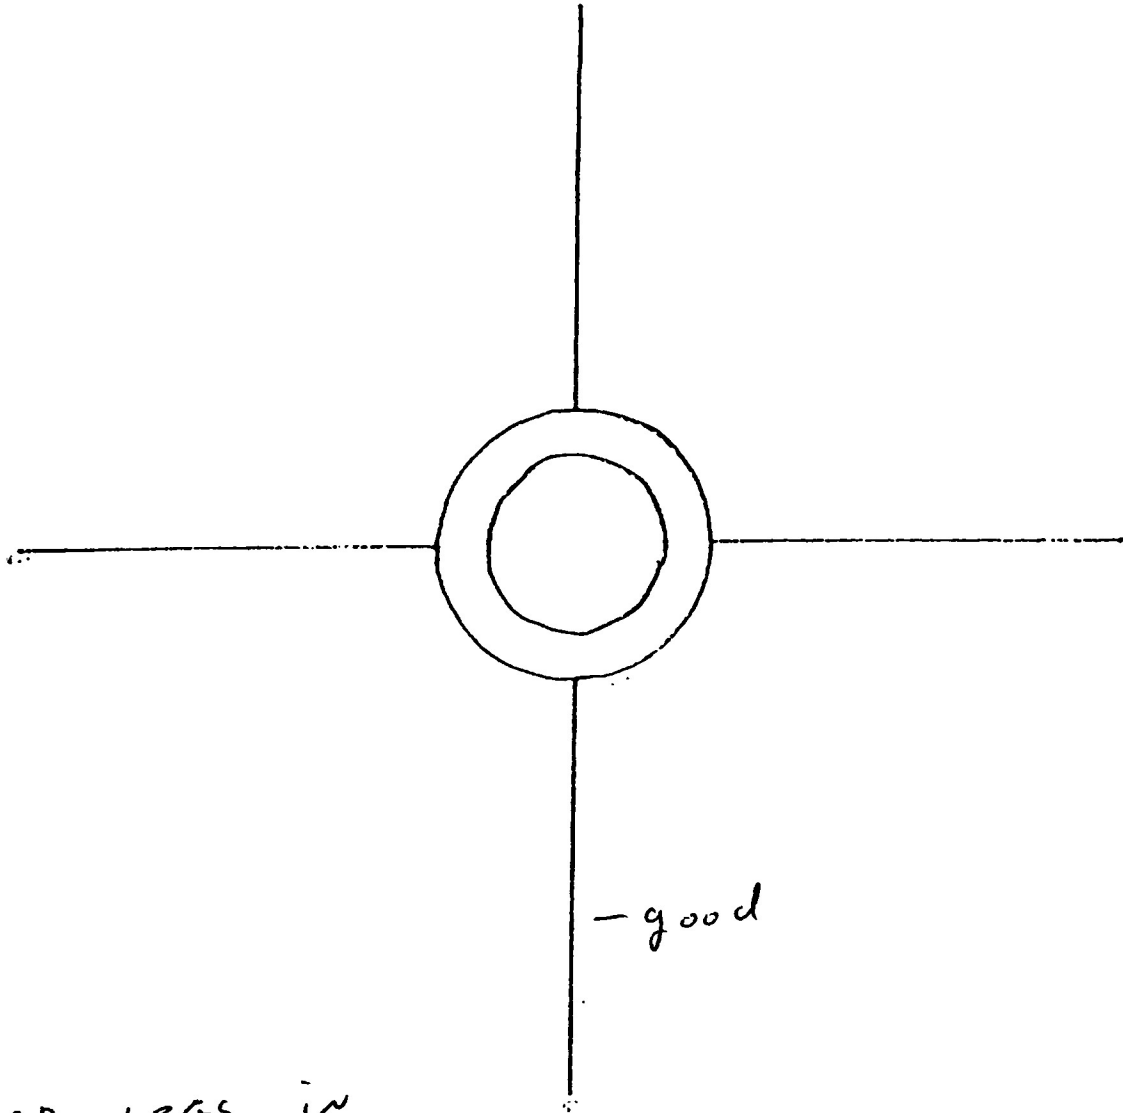
QUADRUPED PAINT CONDITIONS

QUAD LEGS in good condition.
