VLBA Antenna Memo Series No.22

**Hancock, New Hampshire- Maintenance Visit, June 22 - 28, 1999 - Trip Report**

J. E. Thunborg  
September 2, 1999

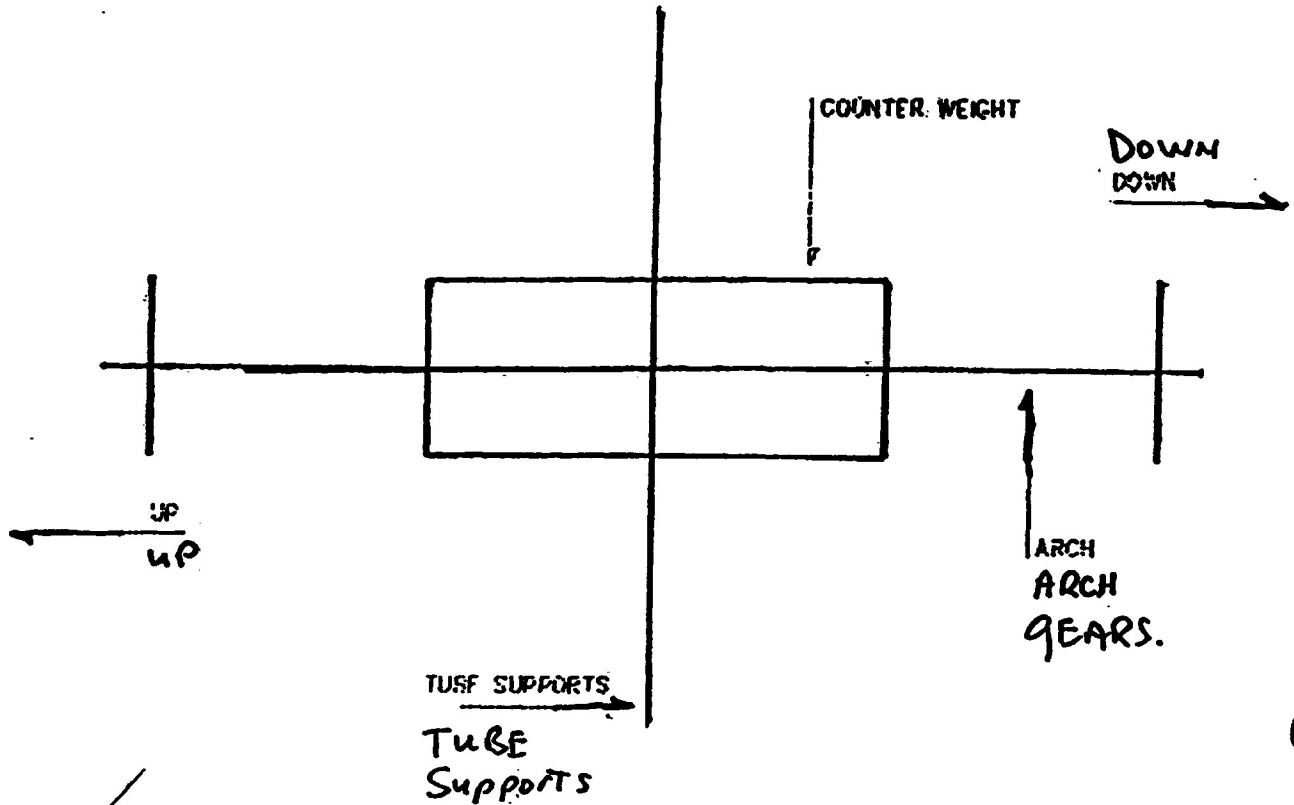
# COUNTERWEIGHT PAINT CONDITIONS DATE:

NRRDs some  
PAINT on  
splices

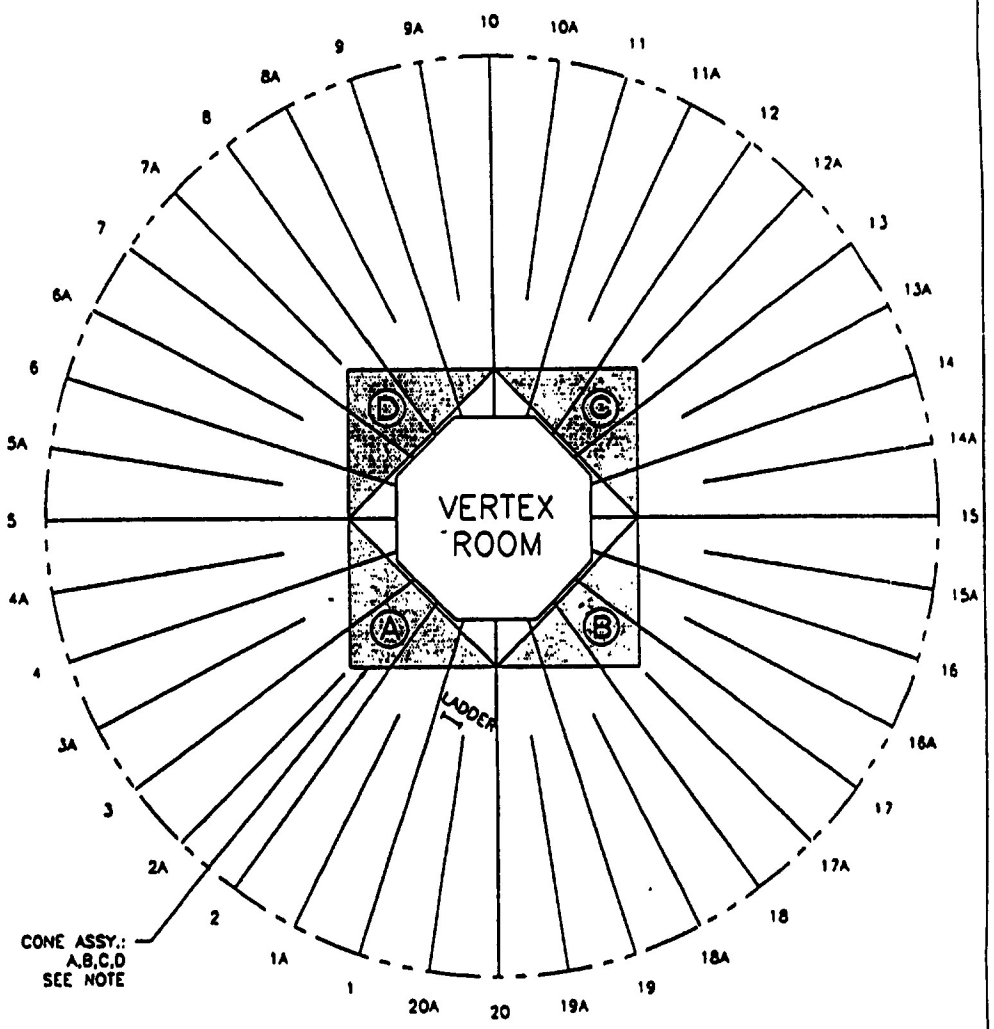
*Pretty Good  
A few Missed spots*

- ANGLE PEELING
- WF BEAM AROUND VERTEX TOUCHUP
- SMALL RUST SPOTS

NOTE: INSPECT CONE ASSY. INTERNALLY  
REPAIR/PAINT AS REQUIRED
