**National Radio Astronomy Observatory
Socorro, NM**

VLBA Antenna Memo Series #25

North Liberty Maintenance Visit
April 14th through 19th, 2000
Trip Report

Jim Ruff
05/17/2000

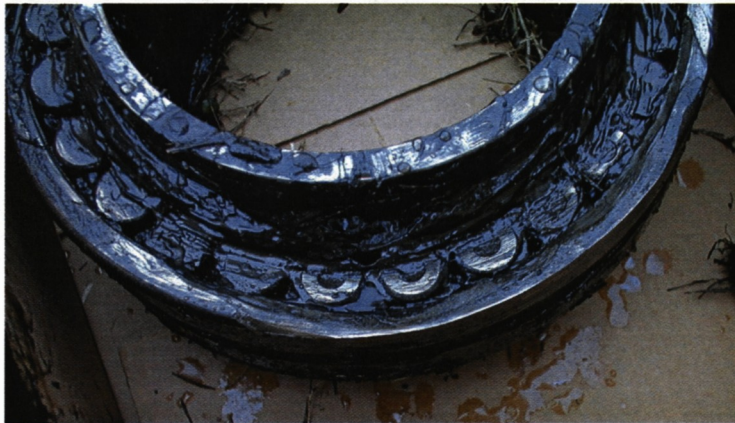
Figure 1: Failed Azimuth Bearing

Two azimuth bearings were replaced: Outer drive #1 And outer idler #2. The drive bearing showed severe thrust failure. (Figure 1) The idler bearing had pitting in its outer race. The outer races of the remaining azimuth bearings were rotated 180°. There were outer ring spacers in all eight azimuth pillowblocks. We left the spacers out of the pillowblocks in which bearings were replaced.

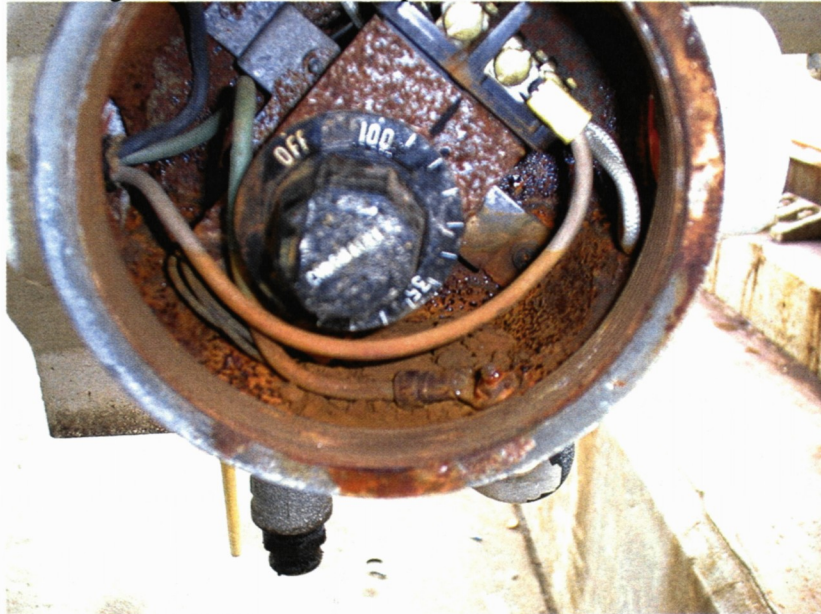
Figure 2: Gearbox Heater

The gearbox heaters were inspected. Three of the enclosure covers were very hard to remove, the fourth (inside elevation) could not be removed at all. The three thermostats we were able to inspect were severely corroded but appeared to function properly. (Figure 2) Weep holes were drilled in the three enclosures we opened. Three new heater assemblies (all that were available) were left at the site for replacement during the next gearbox oil change. In the future, we will drill weep holes in these enclosures and apply Nev-Seez to the cover threads. Note that the Chromalox thermostat, costing \$180, can be replaced with Grainger #2E552 for \$30. A spare thermostat has been added to the container.

T-Stats corroded. Bring spares. Left 3 complete units for installation @ next oil change.

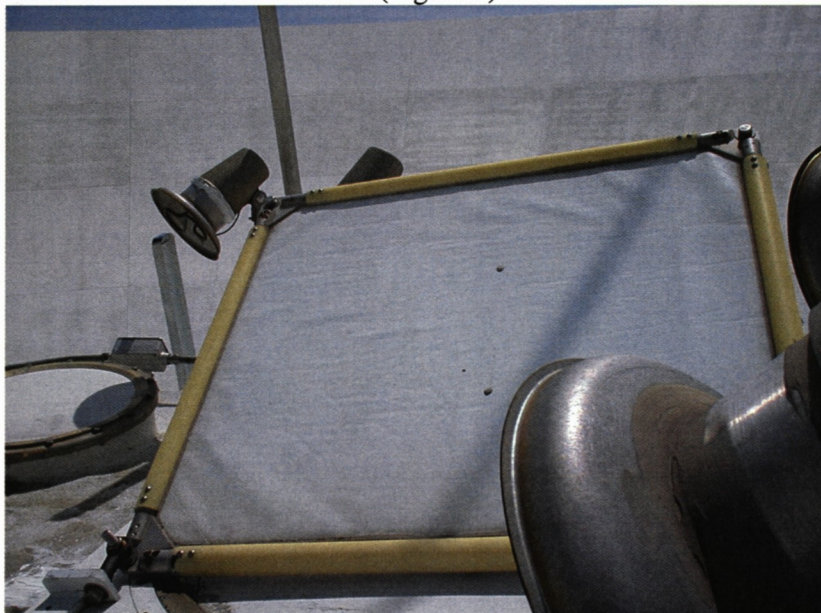
Figure 3: Dichroic Panel

The dichroic panel is delaminated in the corners. (Figure 3)

9. The Dichroic Panel appears 50% delaminated, although no problems have been seen by Operations. Peggy Perley is aware of the condition. No action is required at this time.

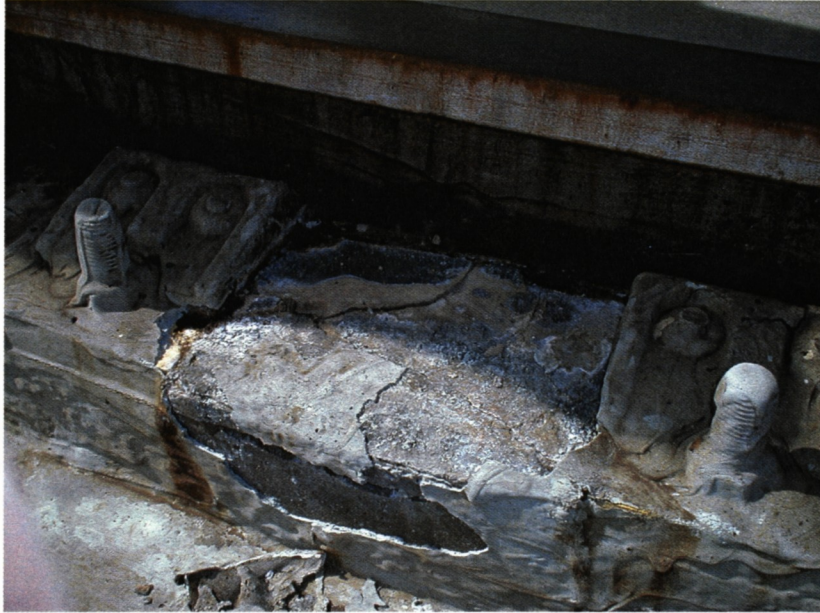
Figure 4: Grout Failure

The azimuth rail grout is failing in an area on the southwest side. (Figure 4) This should be monitored and repaired on the next tiger team visit, or sooner if warranted. See page 6 for more on the azimuth rail.

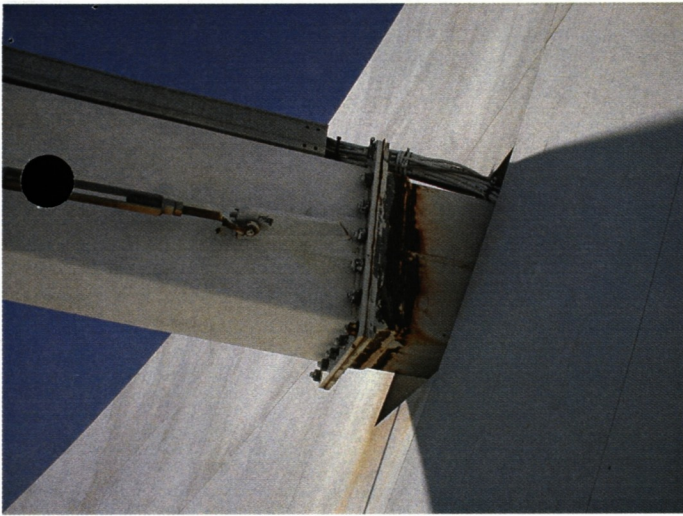
Figure 5: Quad Leg

The antenna structure paint was in good overall condition, but had flaked off in several areas. (Figures 5-11) The subreflector, feed cone, and main dish panels were stained black. (Figures 12-15)

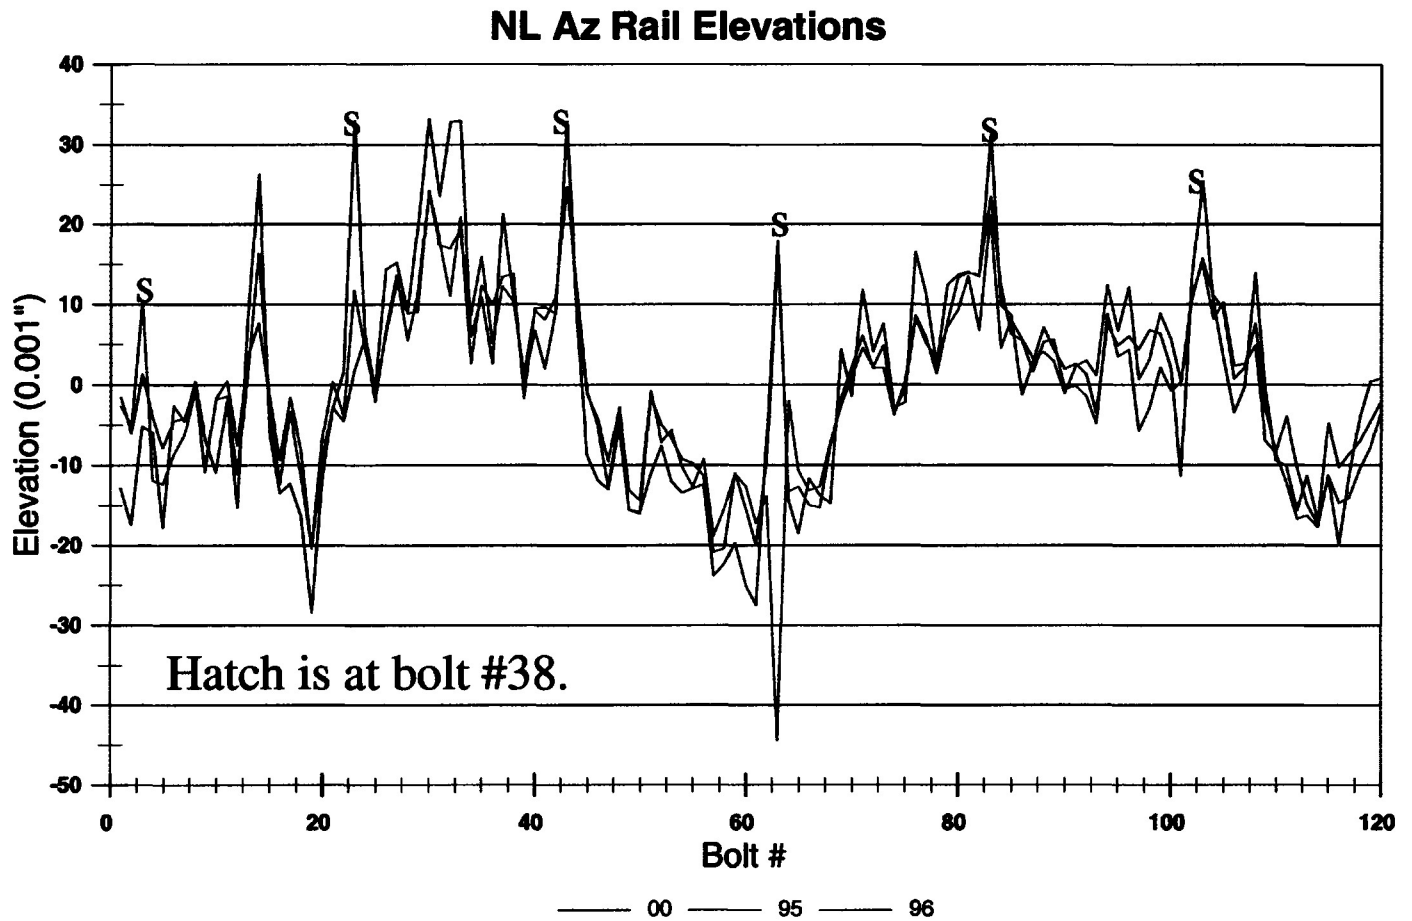
Note apparent grout failure at bolt #15. The splice at bolt #23 may also be failing. Other spots to check are bolts 30-35 and splices at 83 and 103.
