**National Radio Astronomy Observatory
Socorro, NM**

VLBA Antenna Memo Series #27

**Fort Davis Maintenance Visit
August 14th through 19th, 2000
Trip Report**

**Jim Ruff
8/22/00**

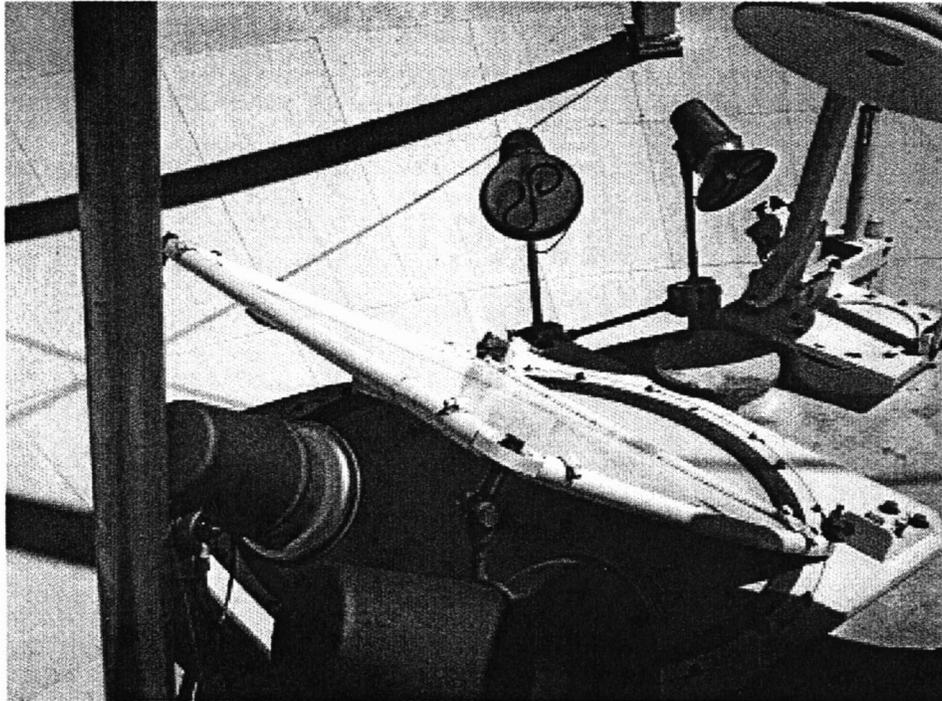
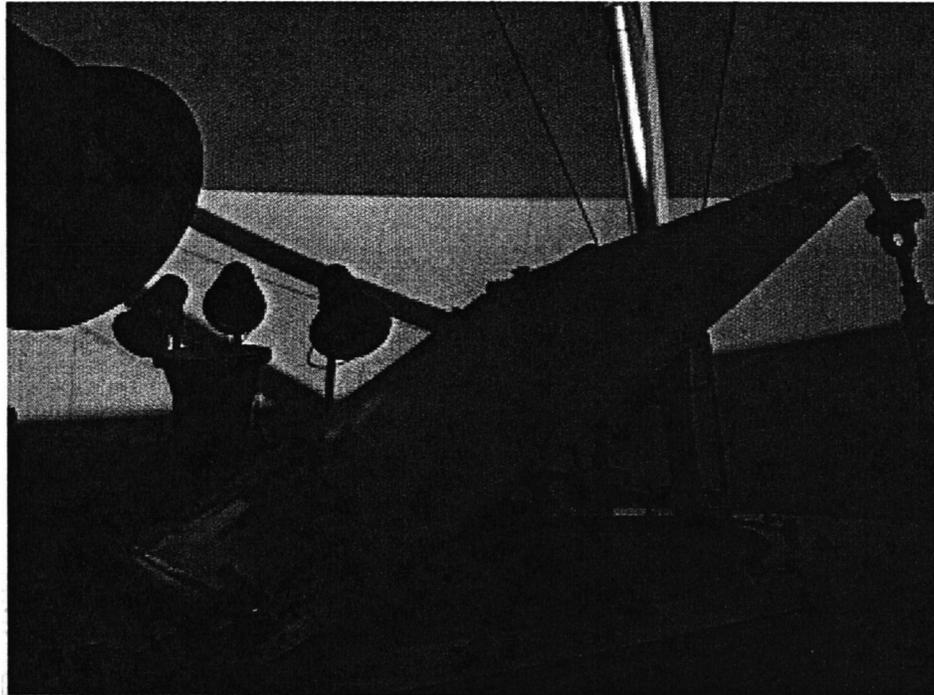
The dichroic panel is delaminated in the corners and sagging. It appears a feed heater partially melted the top tube. (Figures 1 & 2). This dichroic should be replaced when a new plate becomes available.

Figure 1: Dichroic Reflector

Figure 2: Dichroic Reflector

- FRM 2-year PM done
- FRM INA bearing check done
- Install apex guardrail done
- Subreflector
- Check for peeling, delamination Done
- Check spider bolts, backside,etc Done
- Check Donut Bolts Done
- Feeds & Dichroic
- Inspect feeds,mounts,htrs,etc done
- Repair dichroic reflector, check panel panel 40% delaminated. Top tube damaged.

- V. The Dichroic needs to be replaced; Jim Ruff is aware of the wear problem.
- VI. The upper room of the Vertex room, inside the feed cone, hatch has some styrofoam insulation on the door sill that is loose and should be repaired or replaced; the Site Techs are aware of the problem. Some large feedcone bolts have some old evidence of corrosion, snd the Site Techs assure me that they have been aware of it and they are monitoring it; there has been no change since they arrived at the site. There is no other evidence of leakage at this time.

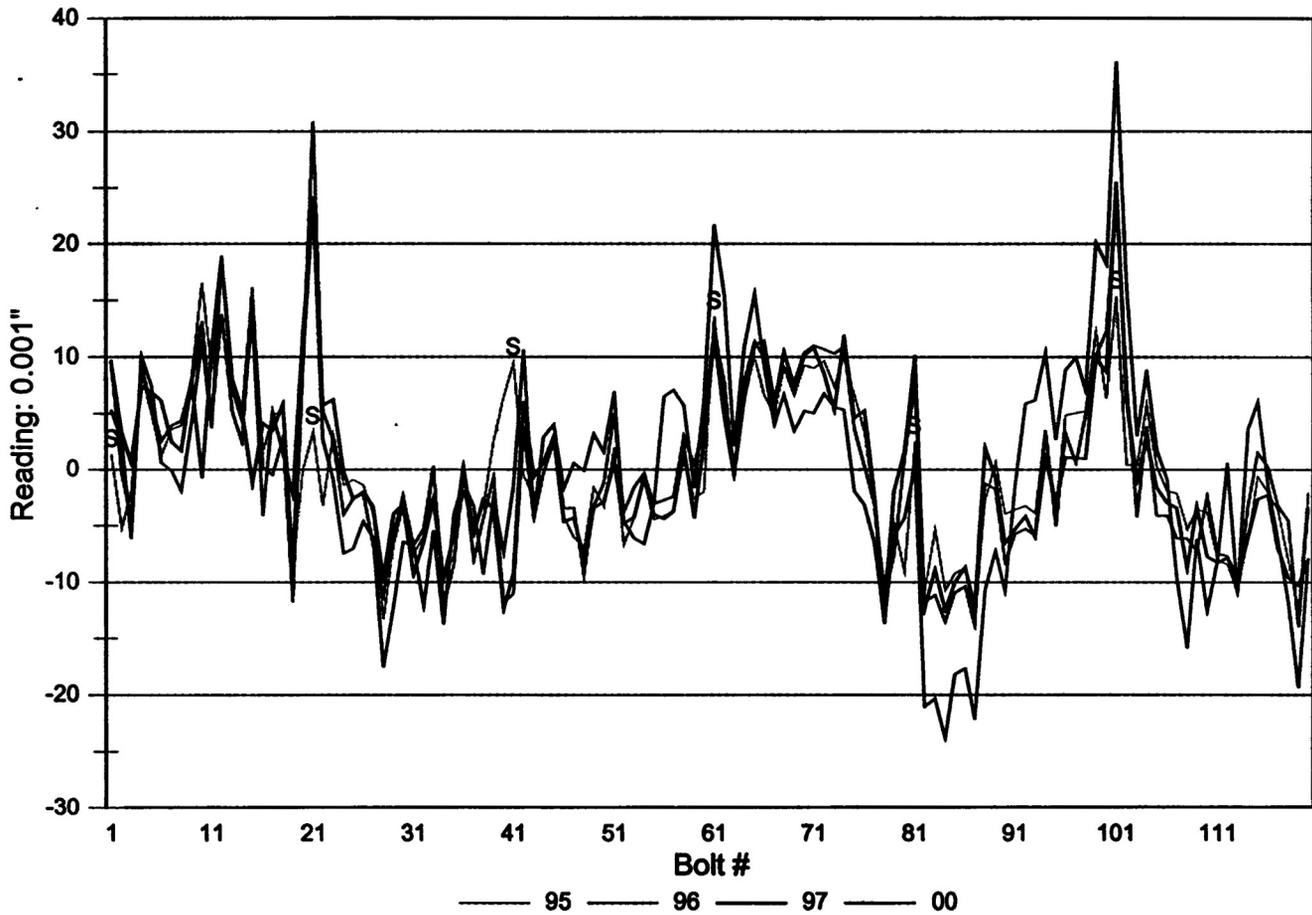
FD Azimuth Rail Elevations

The azimuth rail and grout were in good condition. Elevation readings appear to be stable. The course focus on the Wild level was not working properly and may have caused some error in the readings.

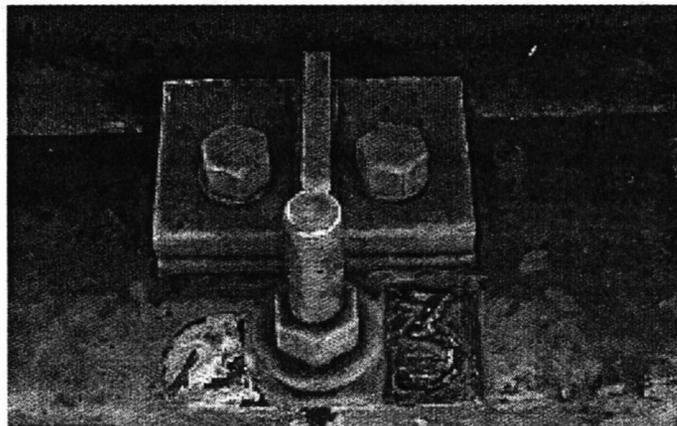
An original RSi bolt ID was located. It is a numeral 3 welded on the rail support plate.

Figure 3: Az Bolt ID

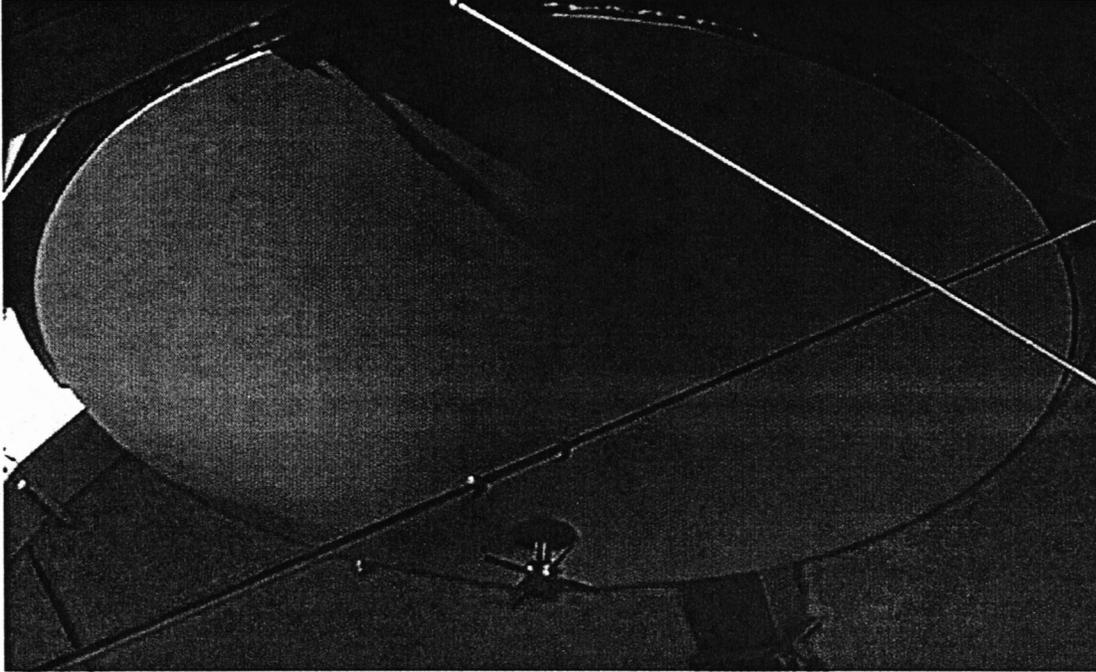
The subreflector appears to be in excellent condition.

Figure 4: FD Subreflector

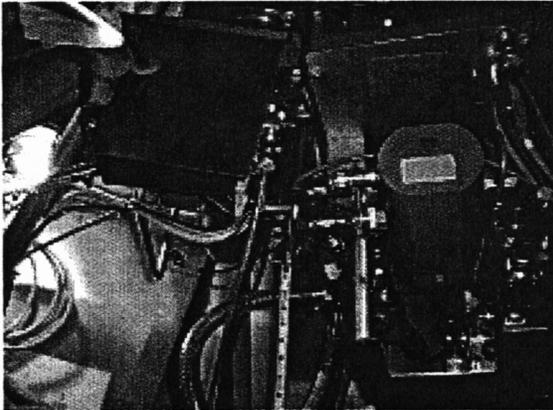
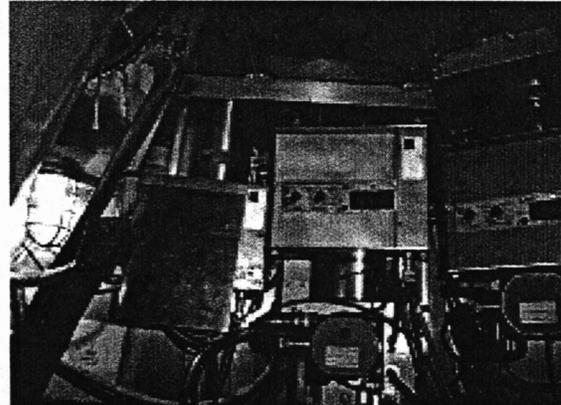
The 3mm receiver was checked for clearance. Clearance is adequate.

Figure 5: 3 mm receiver

Figure 6: 3 mm receiver

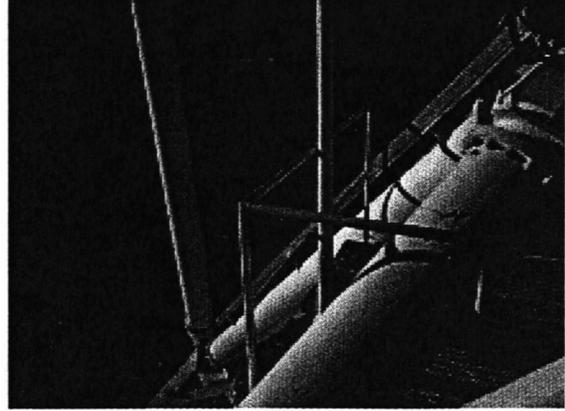
Figure 10: Mid-level handrail before painting

The mid-level handrail was repainted. (Figure 10)

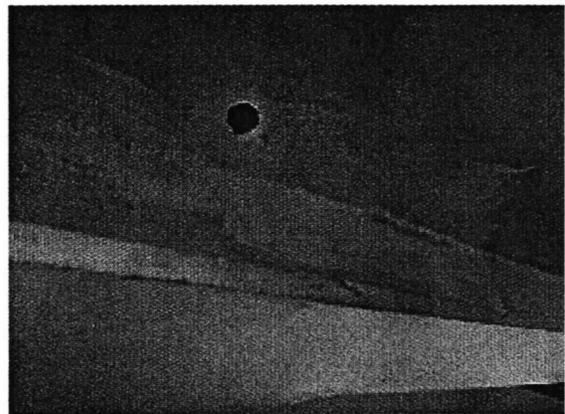
A structural crack was found over the EI encoder-side bearing and re-welded. (Figure 11)

Figure 11: Repaired weld over El bearing

Inspect ant structural welds Done Re-welded a crack above RH el bearing.

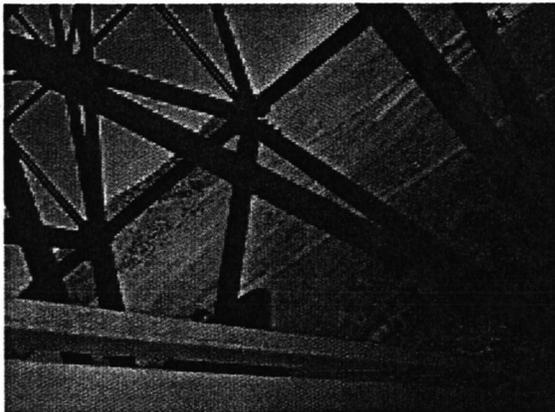
The paint on this antenna is in excellent condition. There is very little rust, and most failures are flaking of paint from galvanized metal. (Figures 8 & 9)

Figure 8: Paint failure

Figure 9: Paint failure
