VLBA Antenna Memo #28
Los Alamos Drive #2 Wheel Replacement
Jim Ruff
12/19/00

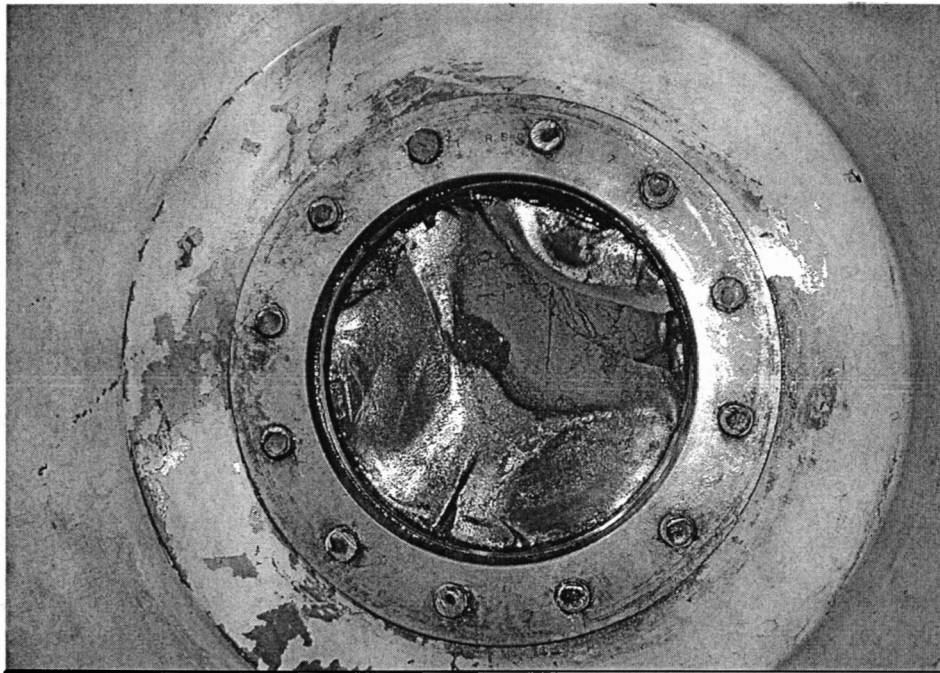
Figure 2

The wheel showed severe skidding damage, with gouges up to about 1/32 inch deep on the OD. When the wheel was disassembled at the VLA, it was found that the axle had broken in fatigue approximately 2 inches in from the outside edge of the wheel. (Figure 2).

The new wheel went in without problem, except that the incorrectly placed gearbox-side hub made it necessary to use a seal spacer ring. We also note that the outside pillowblock required more shim than the inside, indicating that this wheel, which has a history of “popping” , was probably not well aligned.
