**NATIONAL RADIO ASTRONOMY OBSERVATORY**  
Socorro, New Mexico

VLBA Antenna Memo Series No.50

**North Liberty – Drive #2 wheel/bearing replacement**

**October 20 – 23, 2003 - Trip Report**

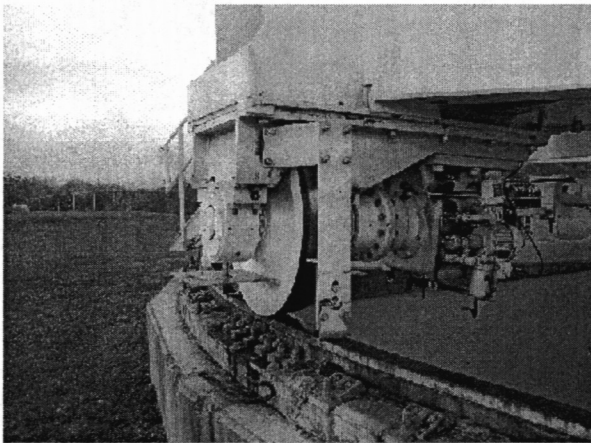
Metal particles were found in the grease on the inside drive #2 azimuth bearing during the North Liberty maintenance visit. The drive assembly was then scheduled for replacement. A team consisting of Steve Aragon, Eric Carlowe, Ramon Gutierrez and Jon Thunborg traveled to North Liberty on October 20 –23, 2003 to replace the wheel assembly.

<u><b>BEFORE</b></u>	
	<b>Measured</b>	<b>Specified</b>
Conic radius	300.024"	300" $\pm$ ¼
Coupling runout	N/A	Not Specified
Axle Vertical Slope	93° 23' 14"	93° 26' 23" $\pm$ 1.4'
Axle Horizontal error	3' 08"	< 1.4'

The new wheel/axle assembly was installed and aligned. After two days of operation, the following alignment parameters were recorded for the new axle/wheel assembly. The antenna rotated smoothly without popping sounds.

<u><b>AFTER</b></u>	
	<b>Measured</b>	<b>Specified</b>
Conic radius	299.894"	300" $\pm$ ¼
Coupling runout	0.001 TIR	Not Specified
Axle Vertical Slope	93° 25' 35"	93° 26' 23" $\pm$ 1.4'
Axle Horizontal error	43"	< 1.4'
