**National Radio Astronomy Observatory
Socorro, New Mexico**

**VLBA Antenna Memo #51
North Liberty, Iowa VLBA Maintenance Visit September 10th thru 16/03.**

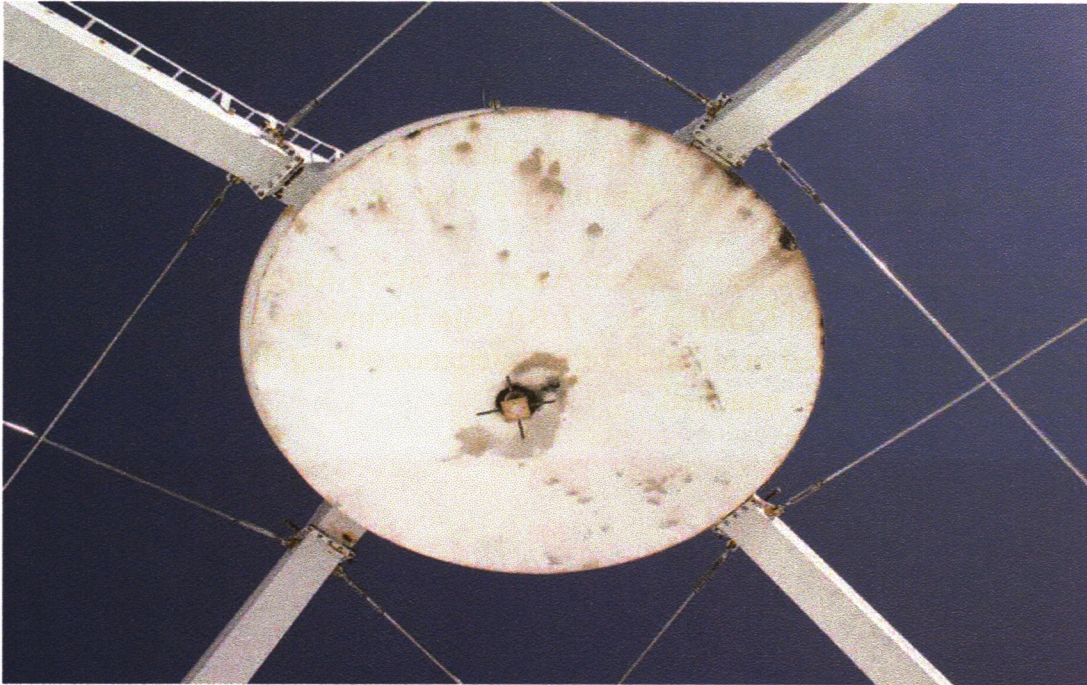
Subreflector paint is stained but otherwise in good condition.

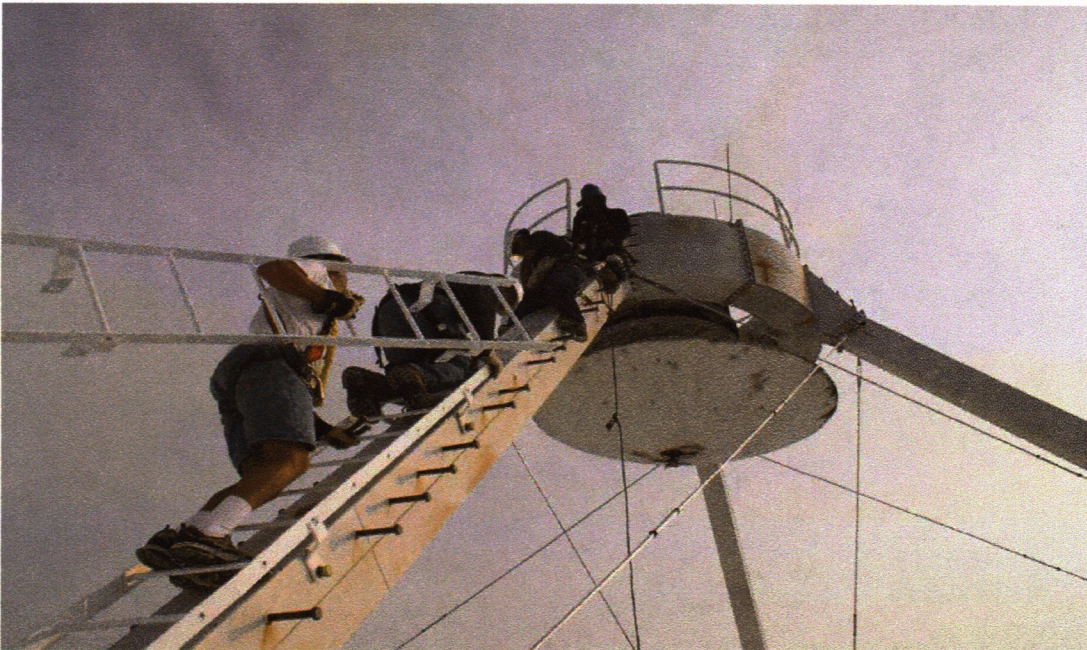
A new ladder and fall arrest was installed. Techs were trained on using the new fall arrest. Quad legs have a lot of surface rust.

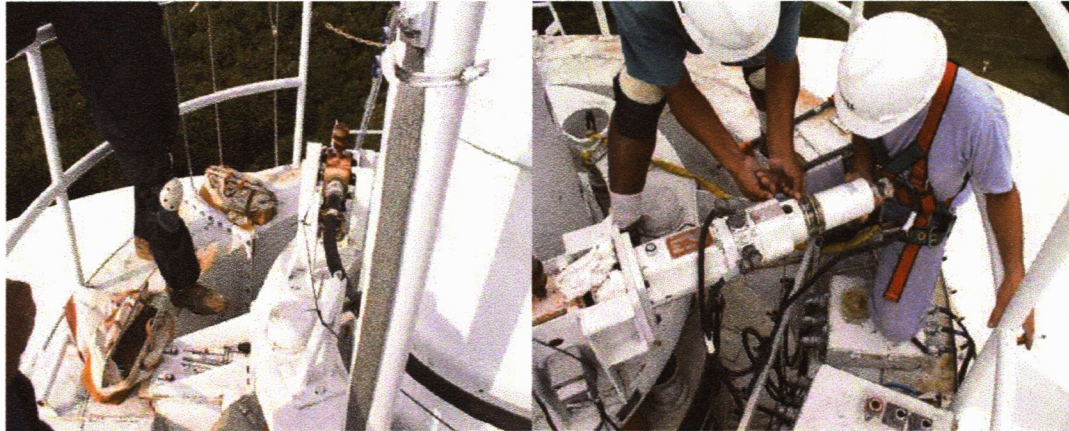
The FRM INA bearing zirks were installed. A 2nd screw and guide rod bellows were replaced during the FRM PM. Both focus motor encoder couplings were broken. These were replaced with the new encoder coupling modification. Apex j-boxes and cables are in good condition.

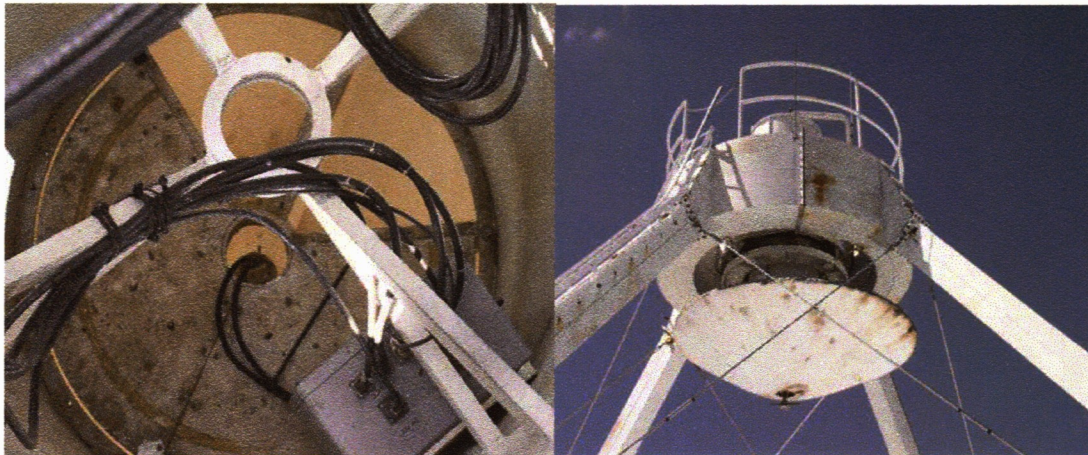
90/50 FE cables and connectors are in good condition. Subreflector drain holes are clear. Dipole is in good condition. Apex has lots of surface rust.

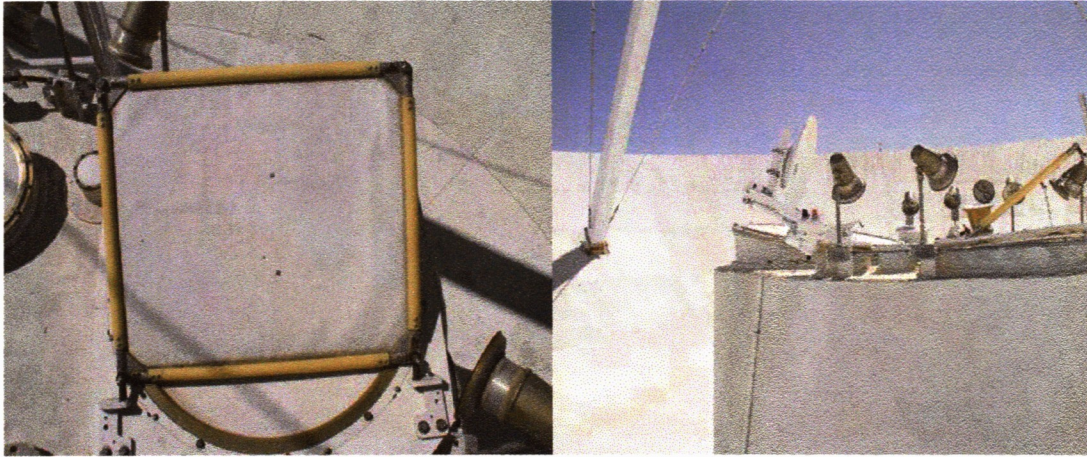
Dichroic reflector needs to be replaced. Elipsoid is in good condition.

Dichroic reflector condition. Bubbling out on corners should be replaced.

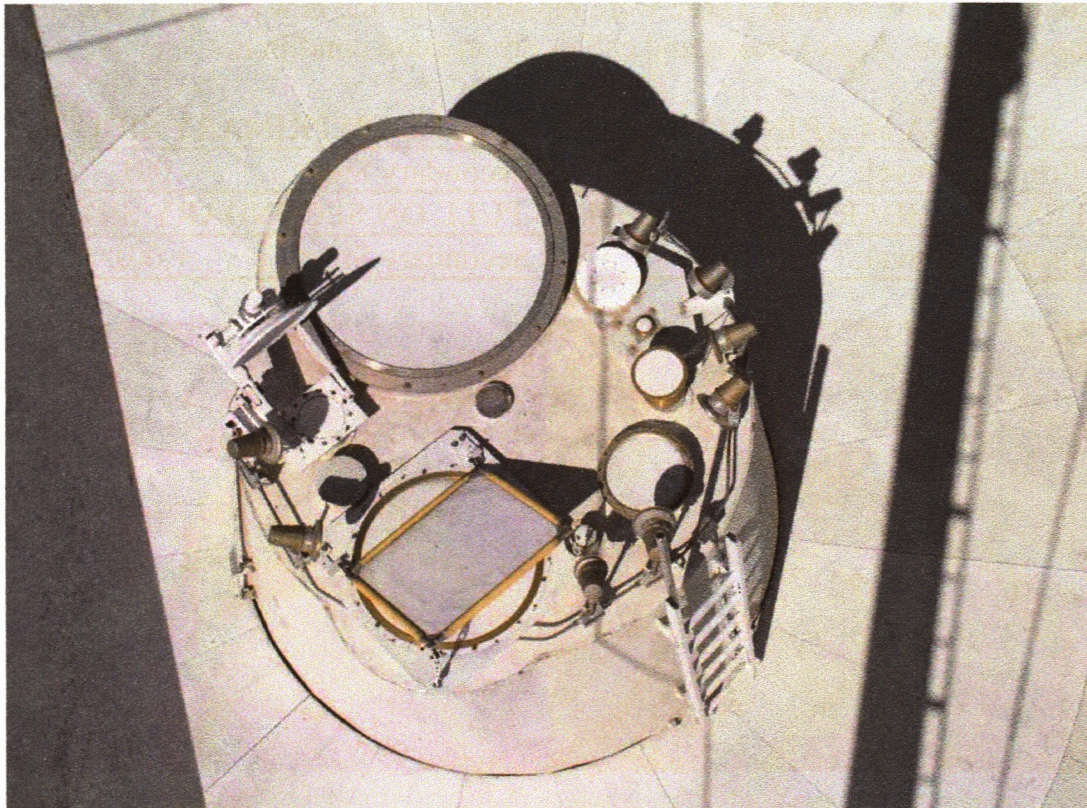
Feed cone needs spot sealed and painted. FE windows are in good condition. Insulation on top of the feed cone has been removed by the site techs. The insulation was retaining water and leaking into the vertex room.

Feed cone surface & insulation. Needs spot sealed and painted with elastomeric!

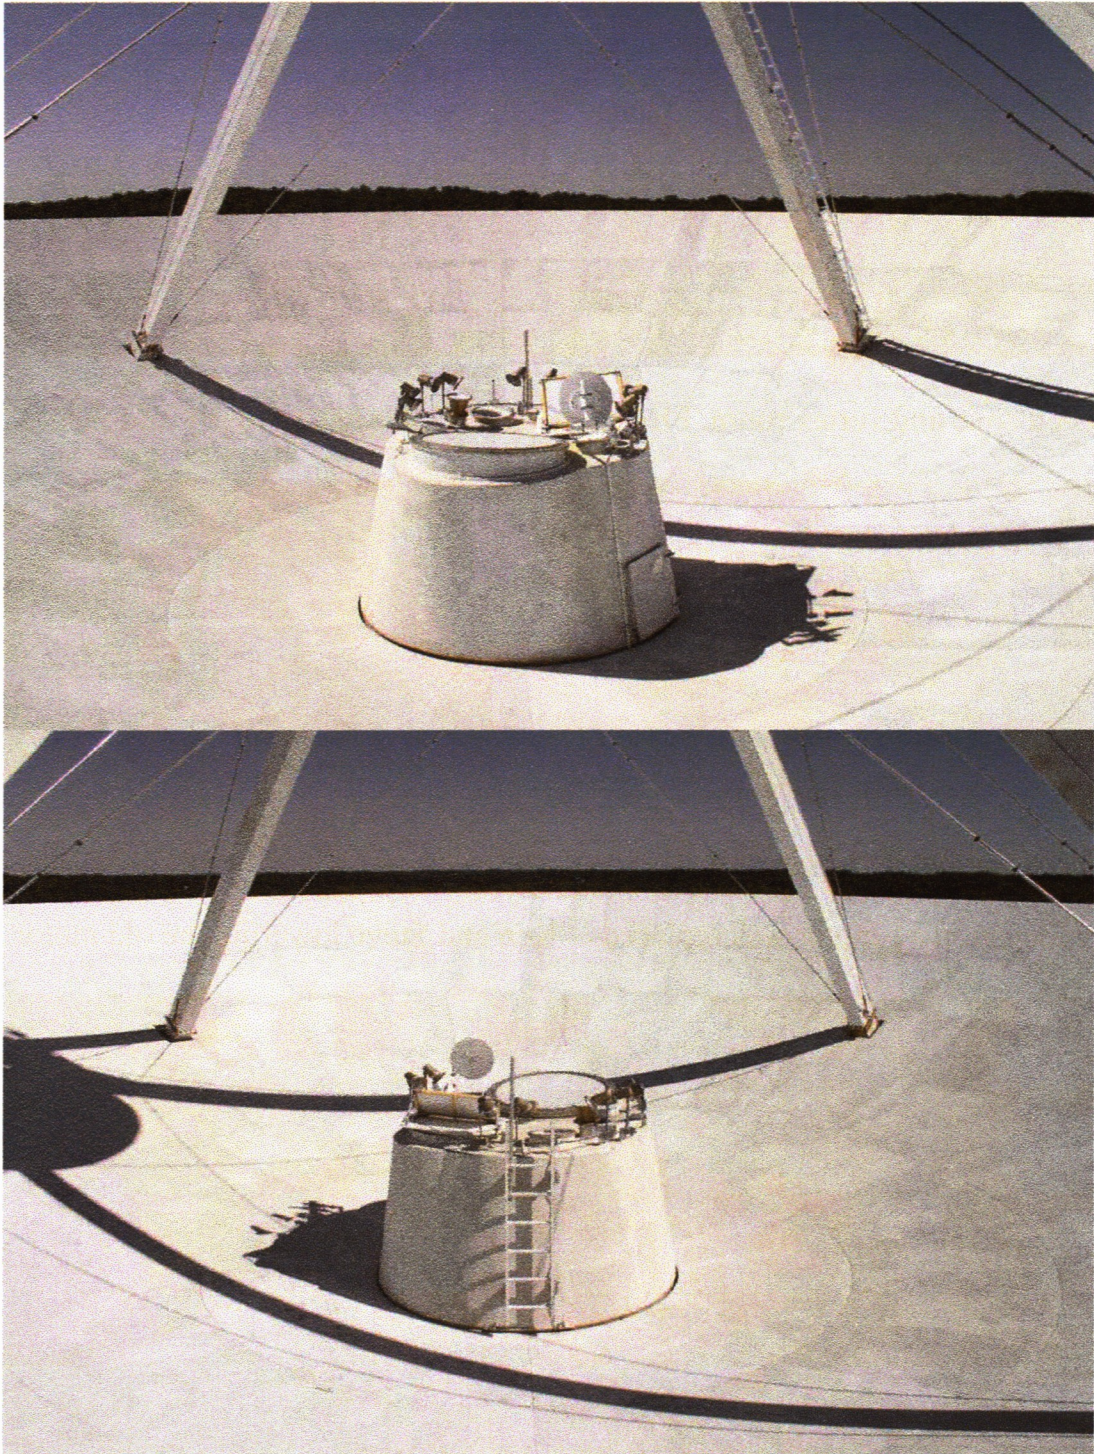
Dish panels are in good condition. Quad legs and guys wire have surface rust. Quad leg bases should be wire brushed and painted with chem-prime.

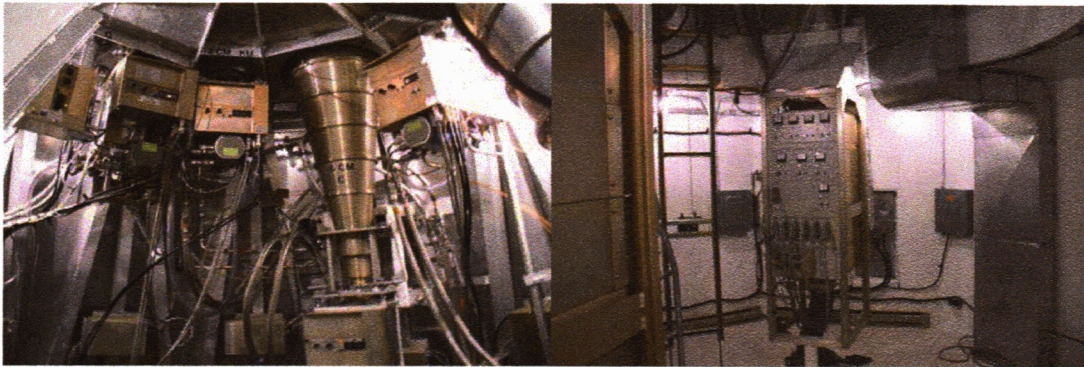
Feed cone and vertex room. FE and rack cables are neat, orderly and secure.

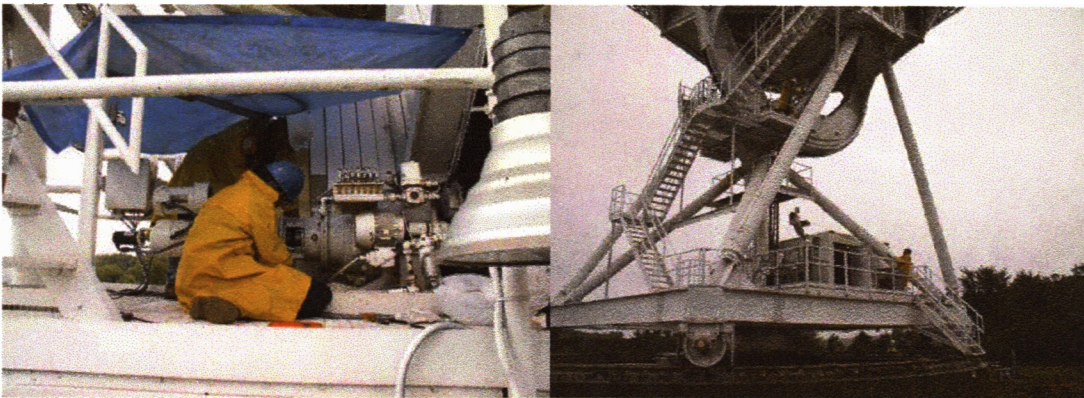
Elevation #1 motor was replaced. Ken and Steve lowering the old motor.

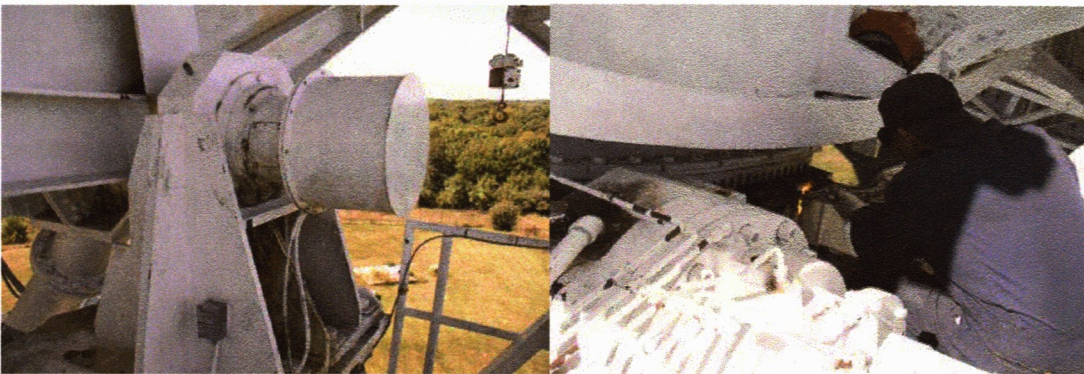
Elevation bearing grease trays were installed. A new stow pin tray and interlock switch were installed.

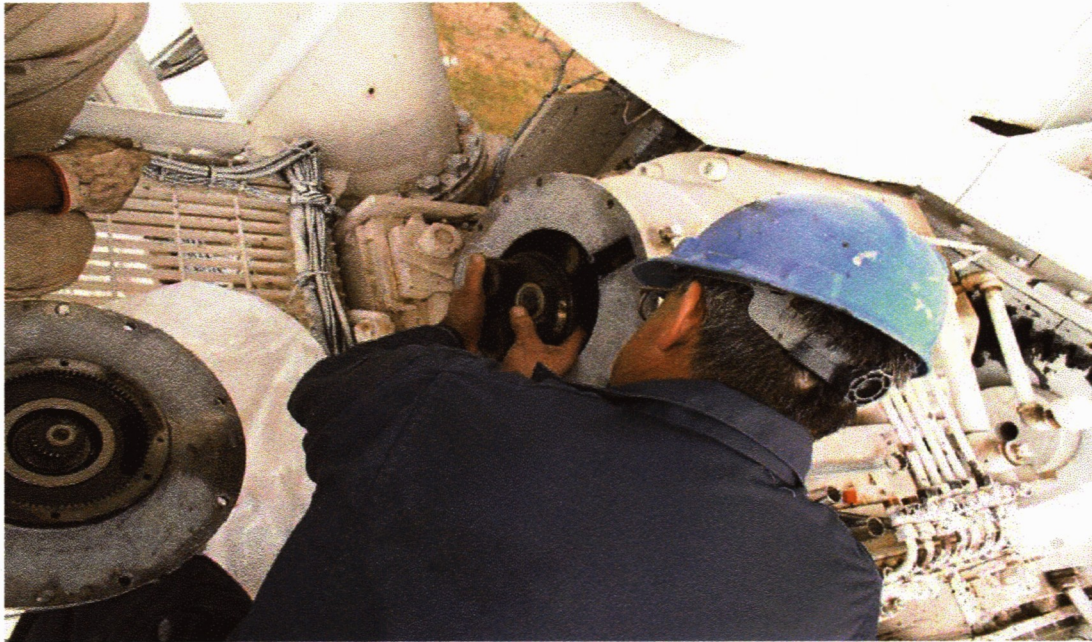
Elevation #1 gearbox, 1st and 2nd stage gear inspection.

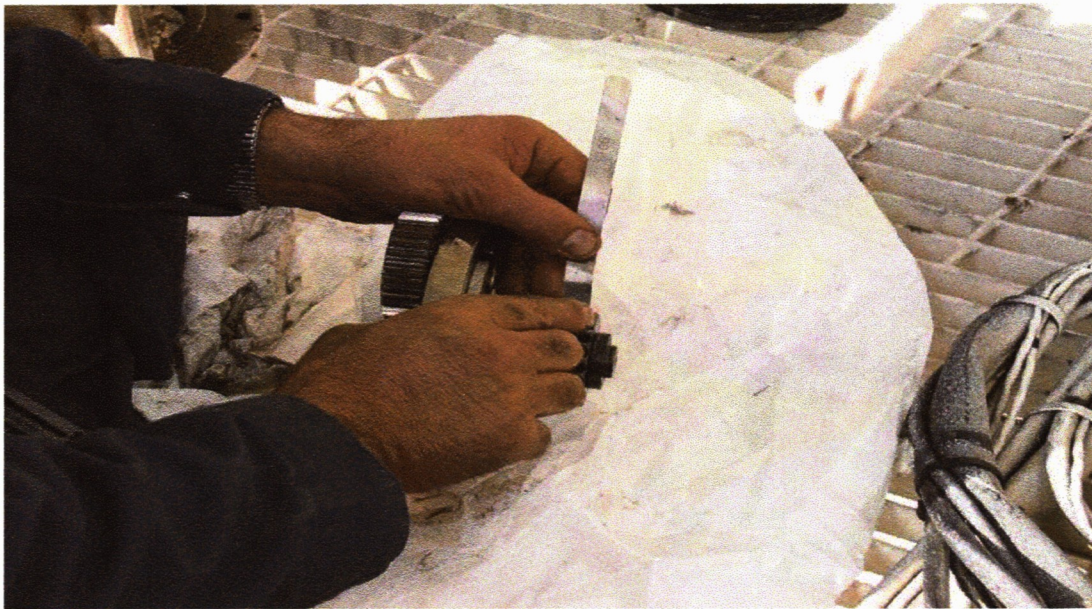
Steve measures $\sim .0015$ of wear with a feeler gauge. Elevation #1 gearbox is in good condition. Both elevation gearboxes oil was changed. Fish eyes and flow gauges were cleaned. Elevation #2 was not opened for inspection.

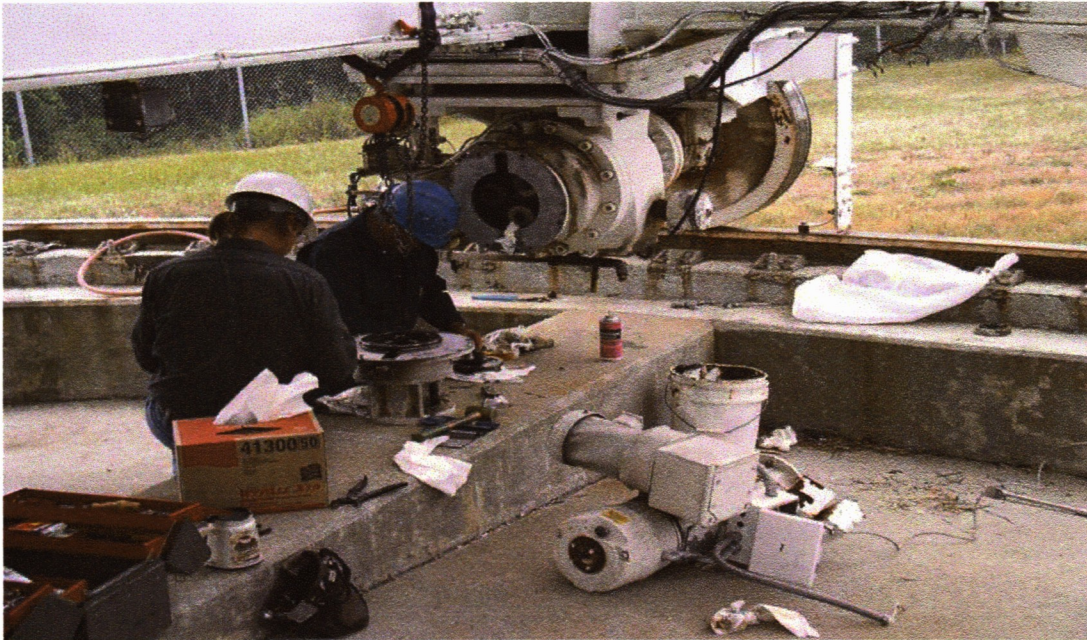
Azimuth #2 gearbox, 1st and 2nd stage gear inspection.

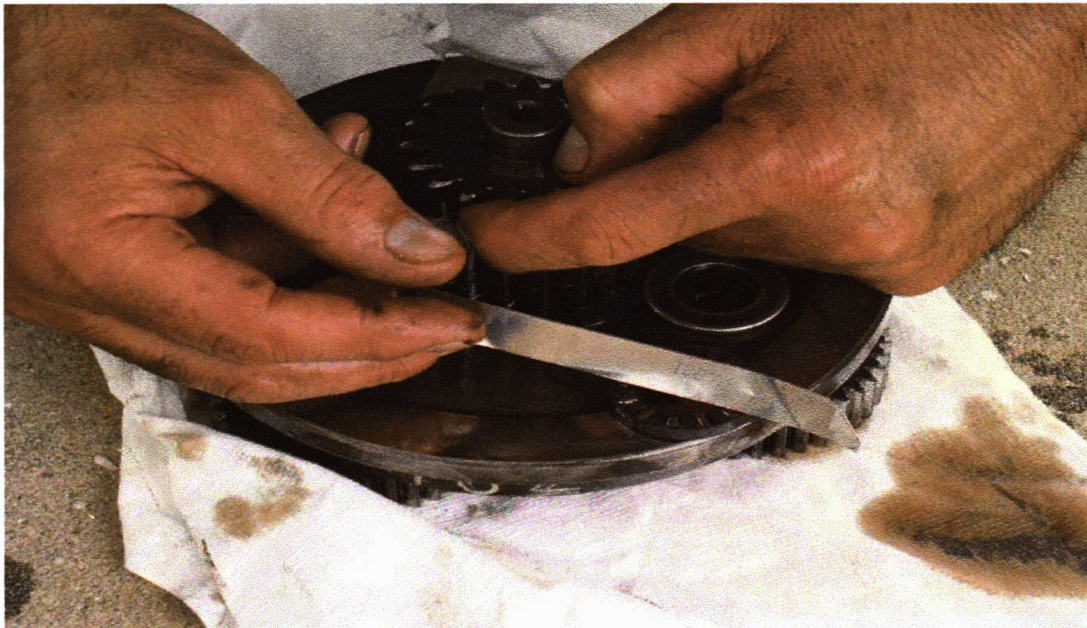
Steve measures ~.001 of wear with a feeler gauge. Azimuth #2 gearbox is good condition. Both azimuth gearboxes oil was changed. Fish eyes and flow gauges were cleaned. Azimuth #1 was not opened for inspection.

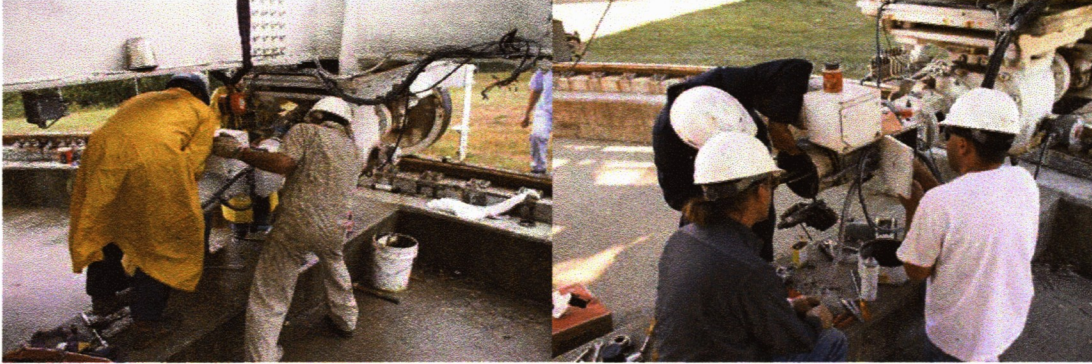
AZ #2 motor was replaced. AZ# 1 rear motor bearing seal was replaced.

INNER BEARING	OUTER BEARING
D1	Clean, smooth races.	Clean, a few metal flakes.
D2	Dark, with metal glitter.	Dark, with metal glitter.
I1	Clean, small hole in race.	Clean, smooth races.
I2	Clean, linear scratches on race.	Clean, smooth races.
Azimuth drive #2 wheel assembly needs to be replaced.

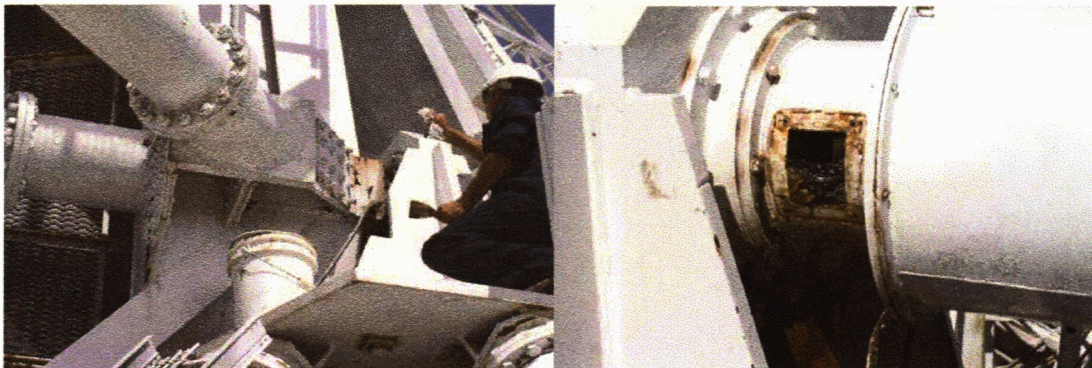
Elevation bearings are well lubricated. Site Techs should remove grease from the encoder side bearing more frequently to keep grease out of encoder electronics. Elevation axle has no visible signs of cracks. Pintle bearing is well greased with no metal flakes.

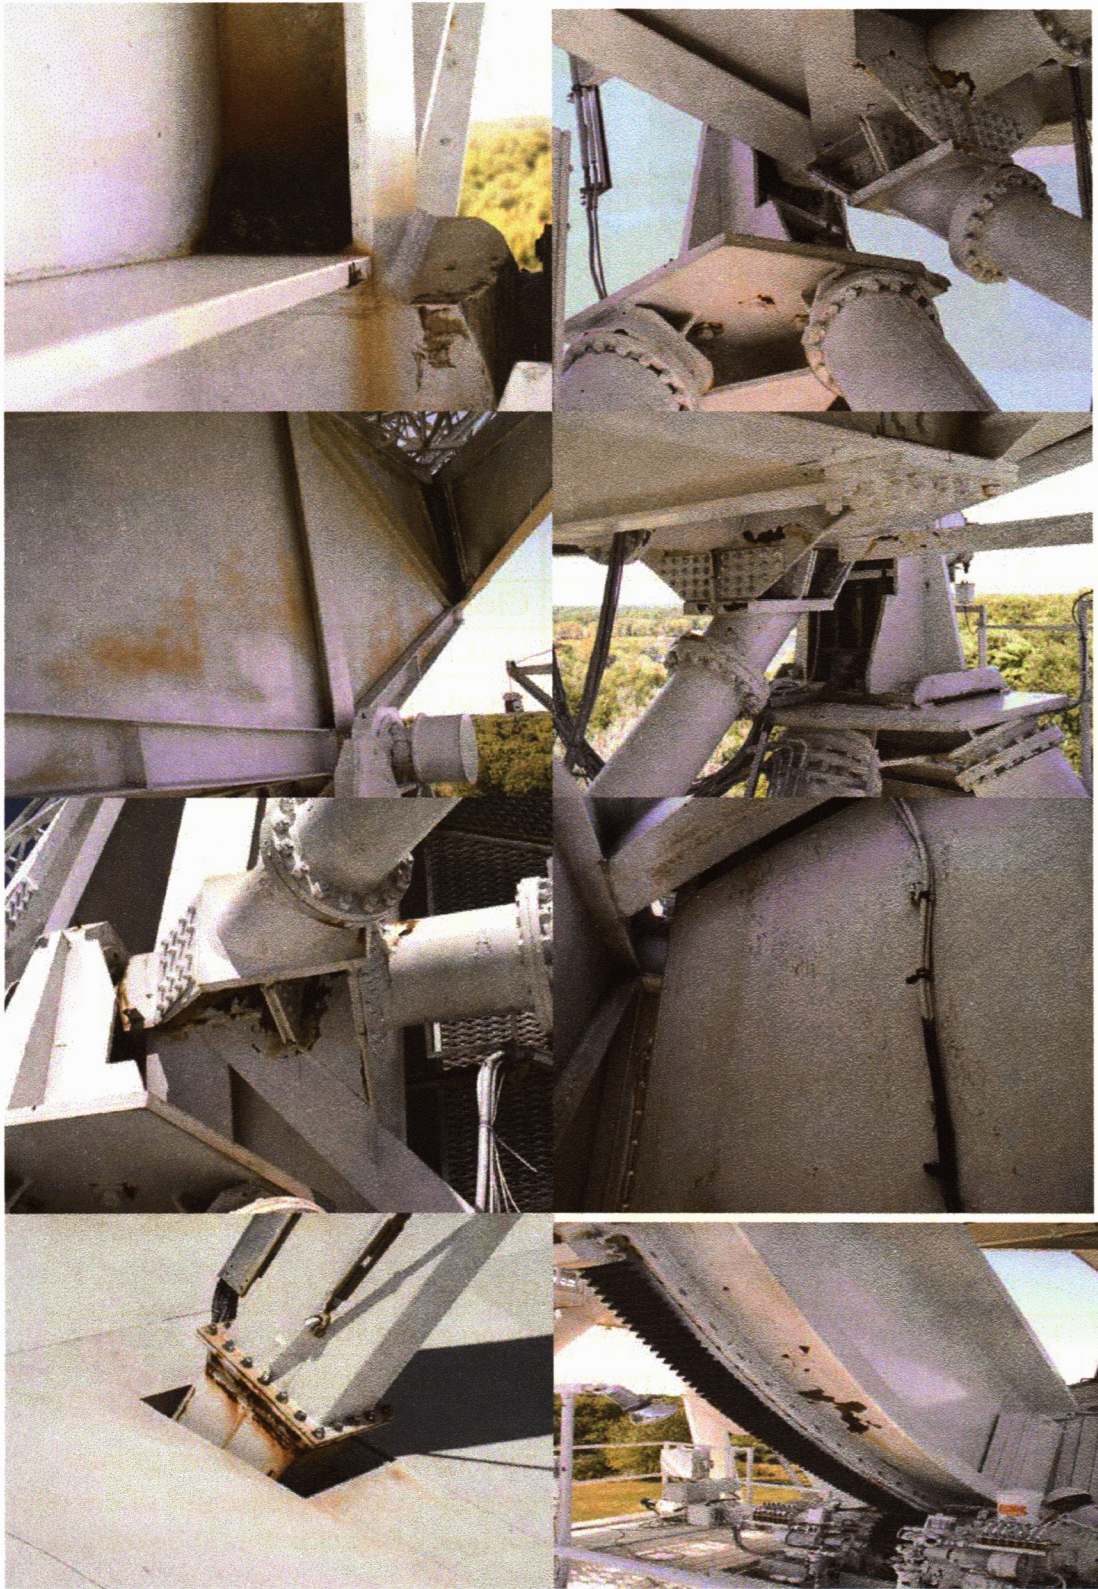
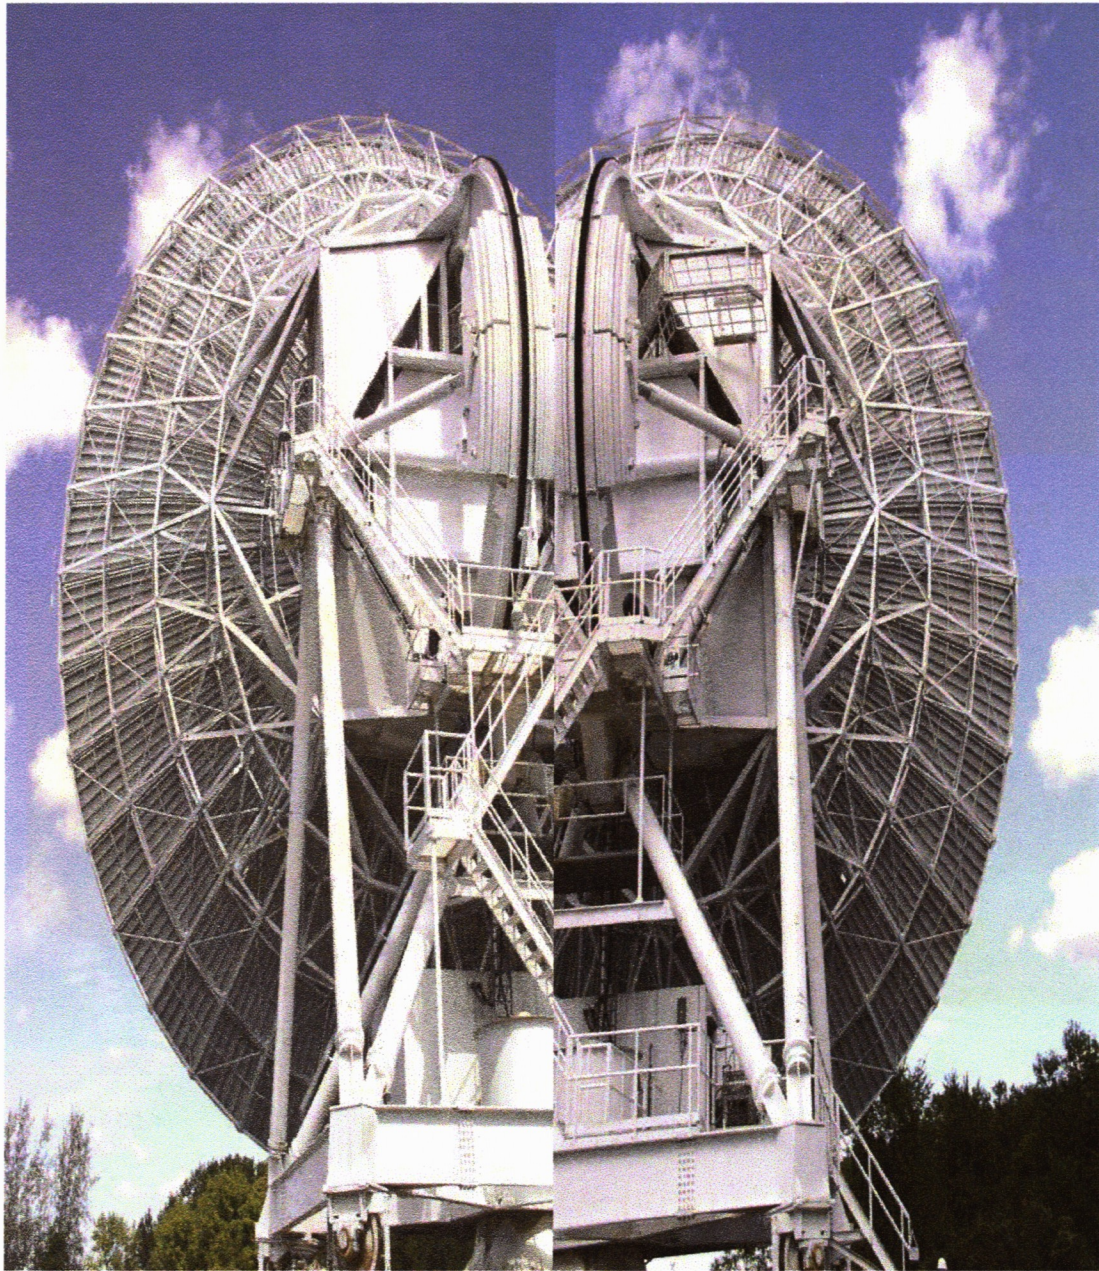
The antenna has alot rust and peeling paint almost everywhere you look. This summer the Site Techs should clean up and spot paint affected areas they can safely get to with chem prime. VLBA OPS should also dump water out of the antenna before an observation as recommended by Ramon and Jon for the SCVLB antenna.

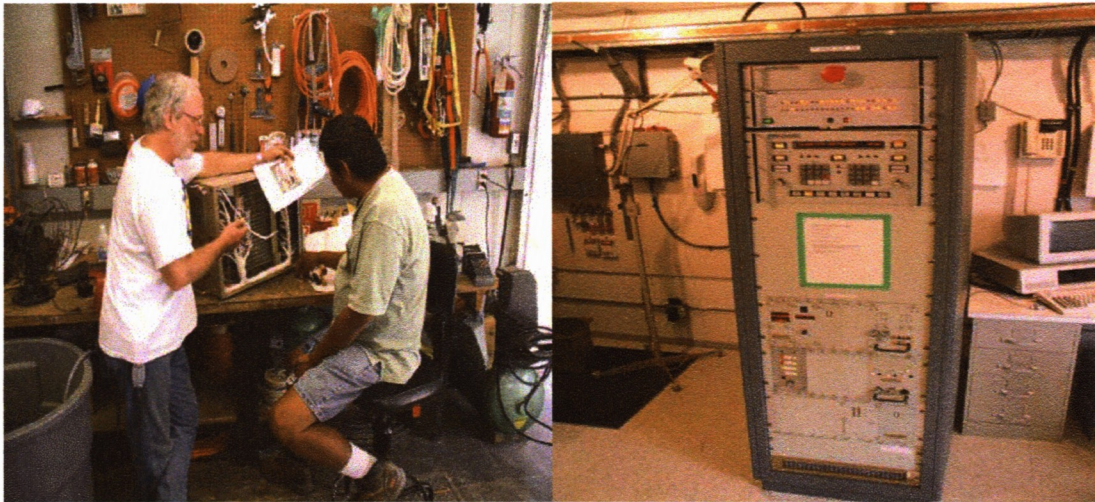
DJ and Nelson retrofitted the ACU with the new power supply upgrade.

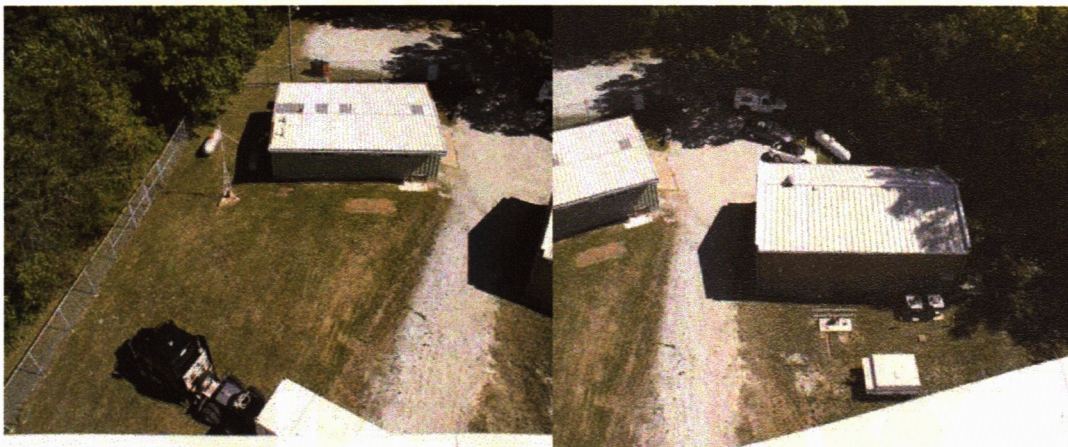
The area inside the fence is neat and orderly.

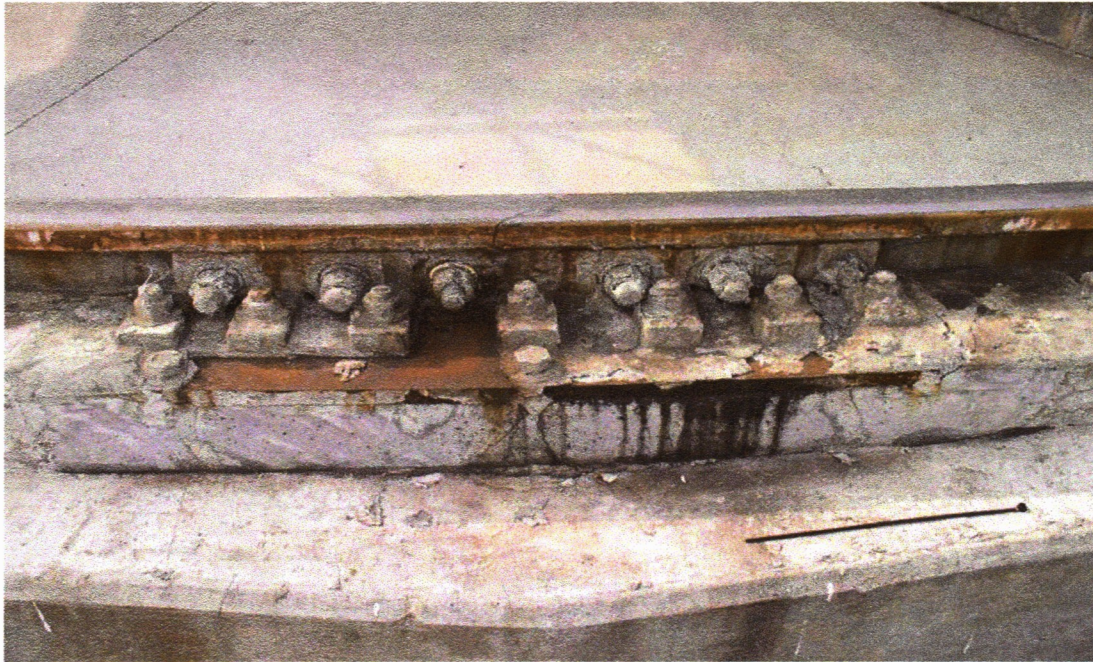
Vulchem is rapidly deteriorating from this rail splice and all the others.

Antenna foundation/grout/vulchem. Vulchem should be removed and the rail chemprimed.

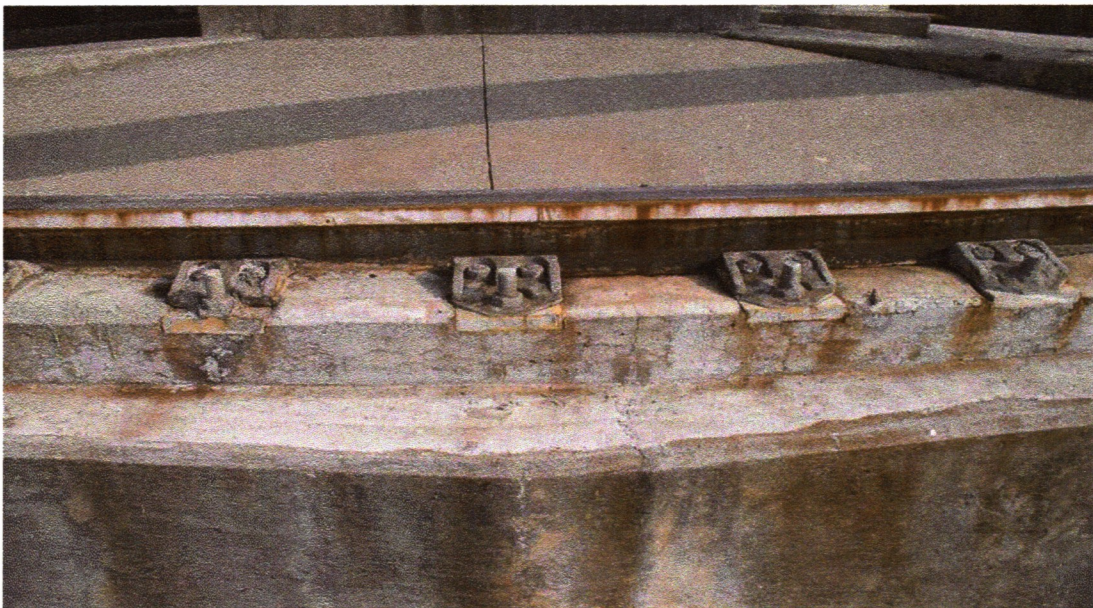
Rail is in good condition. Vulchem is deteriorating off all of the rail clips.

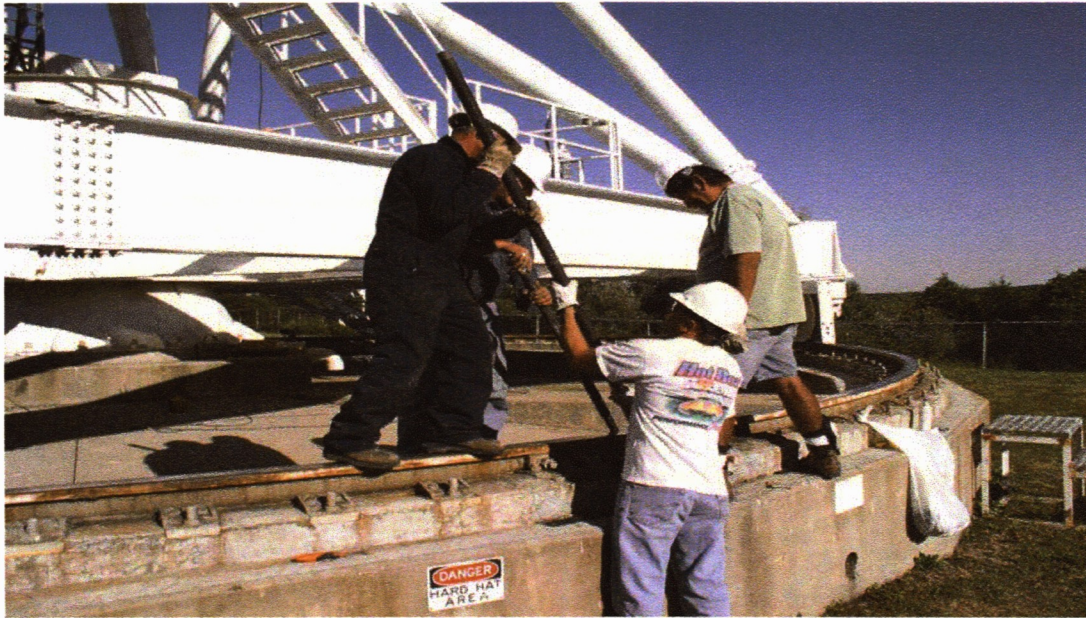
The guy's tightening loose rail splices. All splices were loose.

Joint bars and clips. All were loose.
