National Radio Astronomy Observatory  
Socorro, New Mexico  
VLBA Antenna Memo #61

North Liberty, IA. VLBA Maintenance Visit September 20-27<sup>th</sup> 2005.  
Team members consisted of Steve Aragon, Nelson Atencio, Eric Carlowe,  
Kelly Greene, Ken Lakies and Phillip Sanchez. VLBA Site Technicians  
Mike Burgert and DJ Beard assisted in all areas of antenna maintenance.

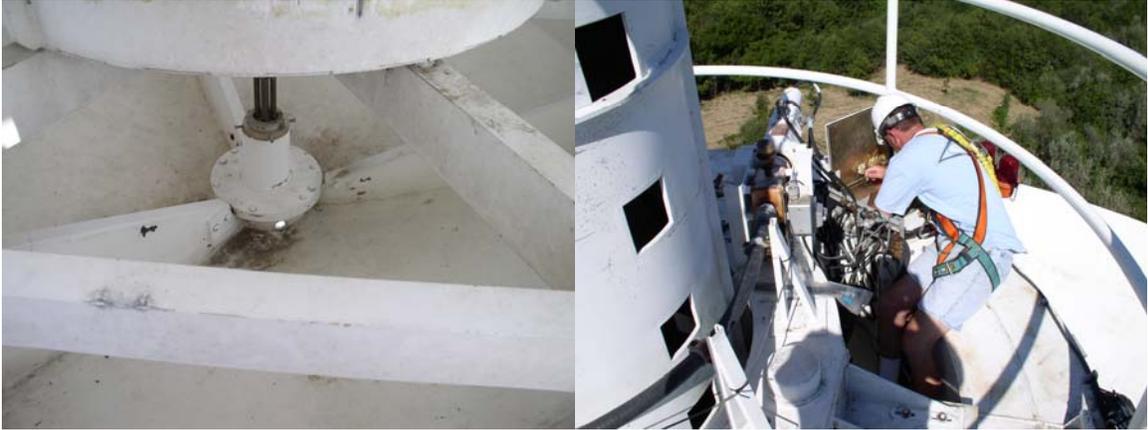
FRM was given a thorough inspection and the focus flex shaft was replaced. Rotation was modified to operate on the West position feedback motor only. The sub reflector did not need rebalancing. The snow tarp was removed and three 1 inch drain holes were drilled in the center on the sub reflector.

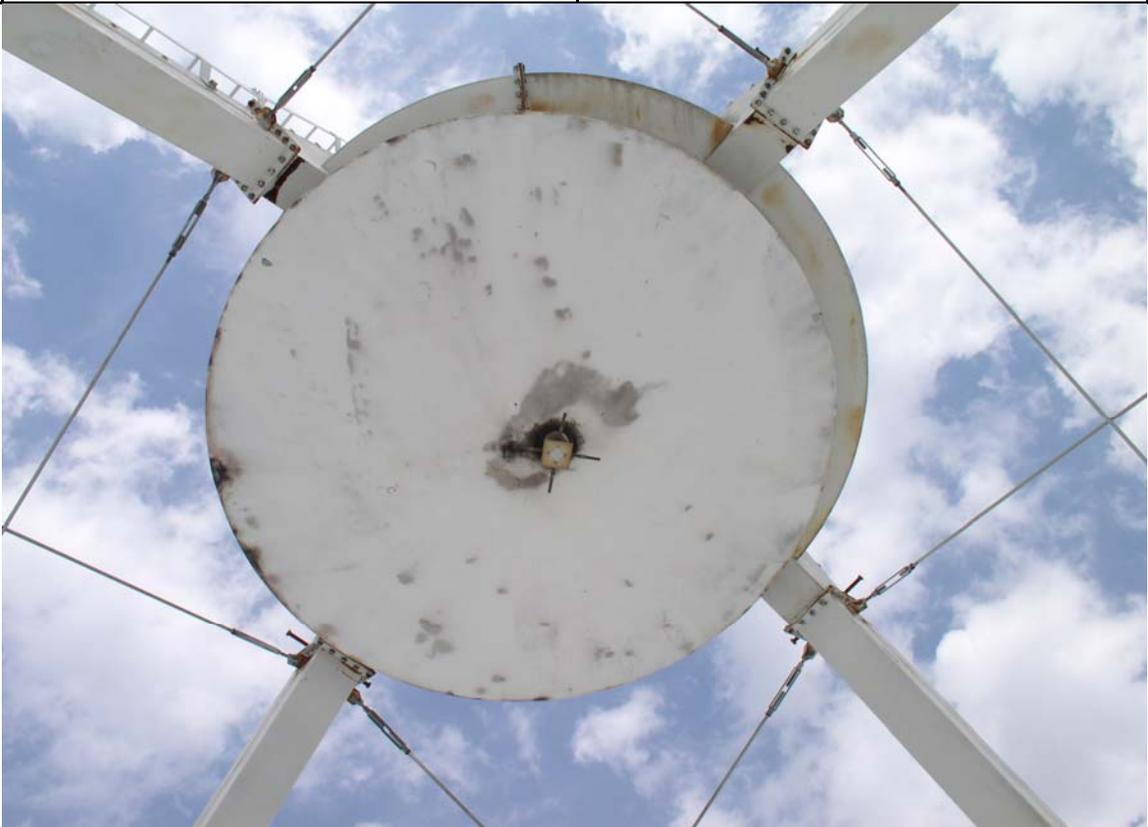
Sub reflector is stained, but otherwise in good condition

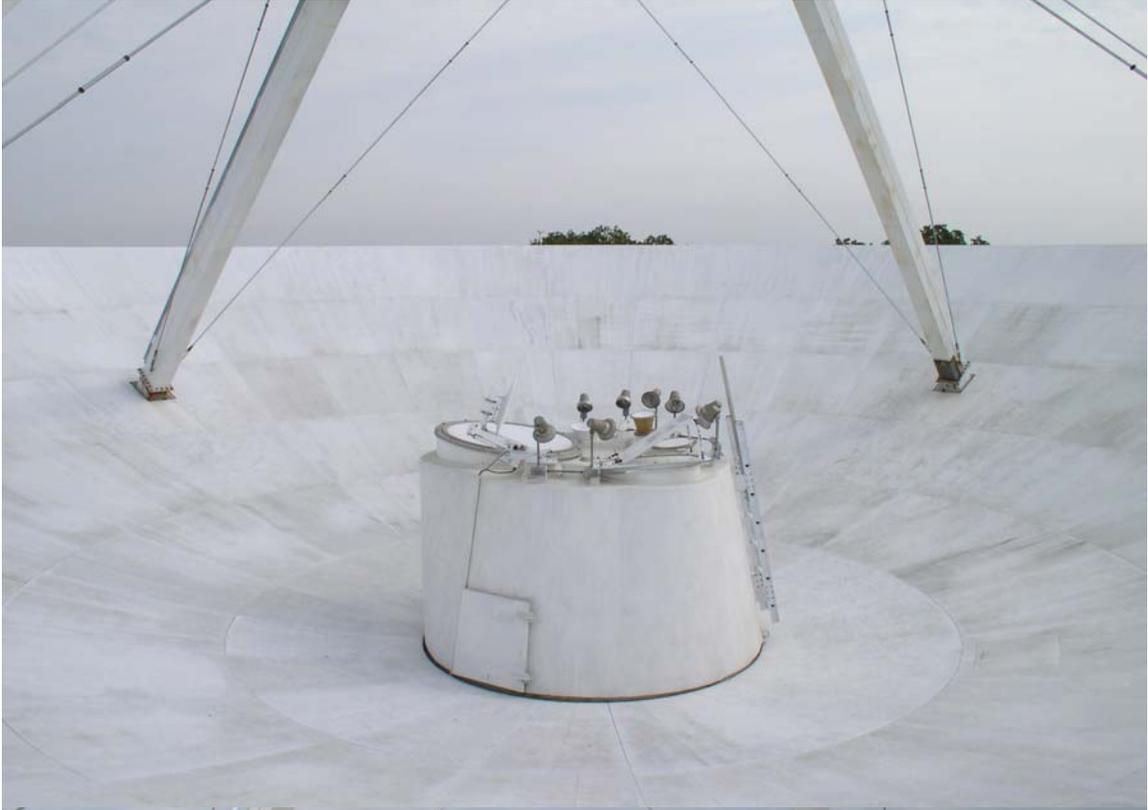
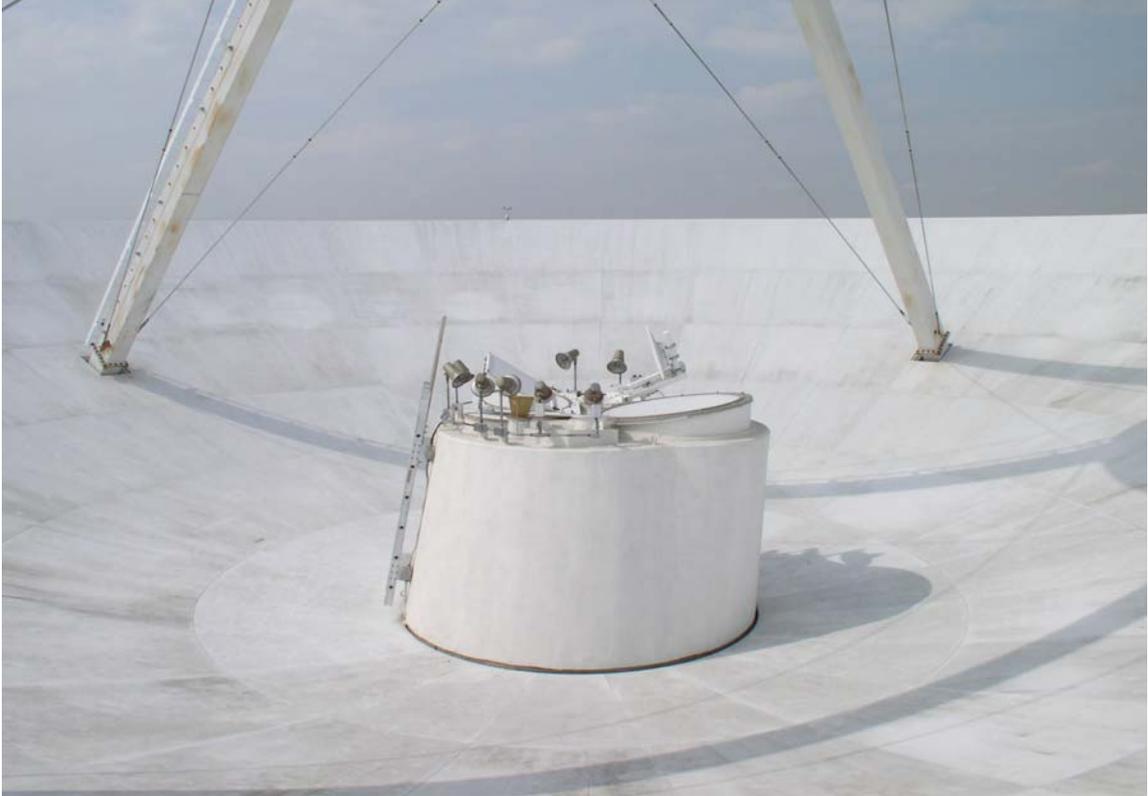
Stained dish panels are in good condition. Feed cone is in good condition.

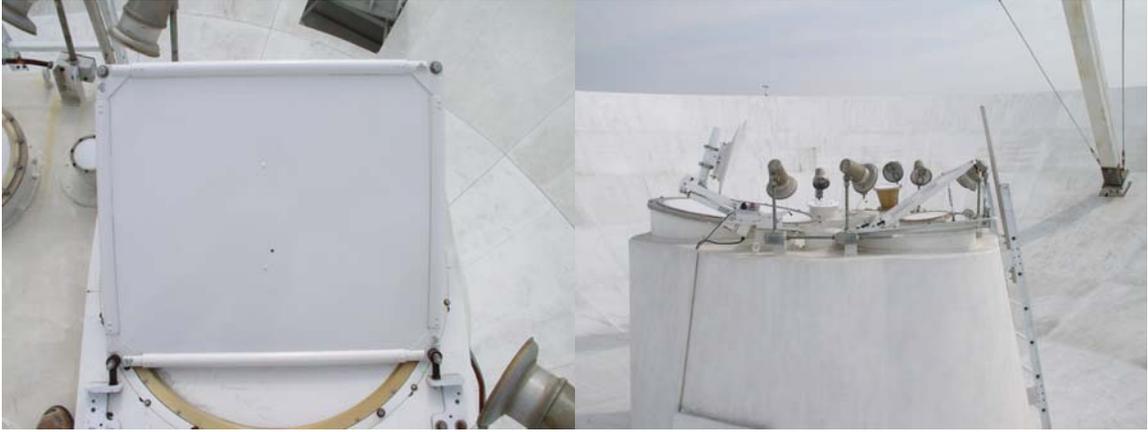
Dichroic reflector is good condition. Elipsoid reflector is in good condition.

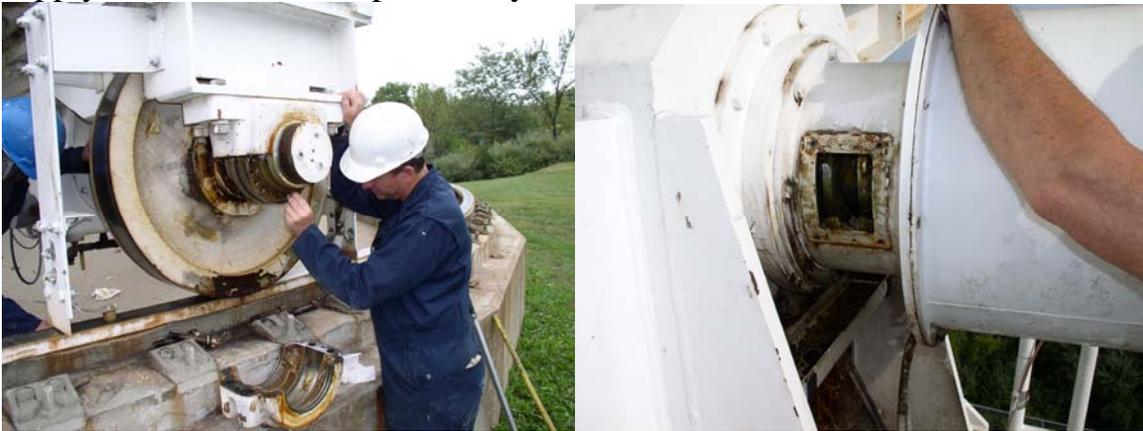
Azimuth wheel bearings were inspected. Site Techs should remove excess grease from the elevation encoder bearing more frequently.

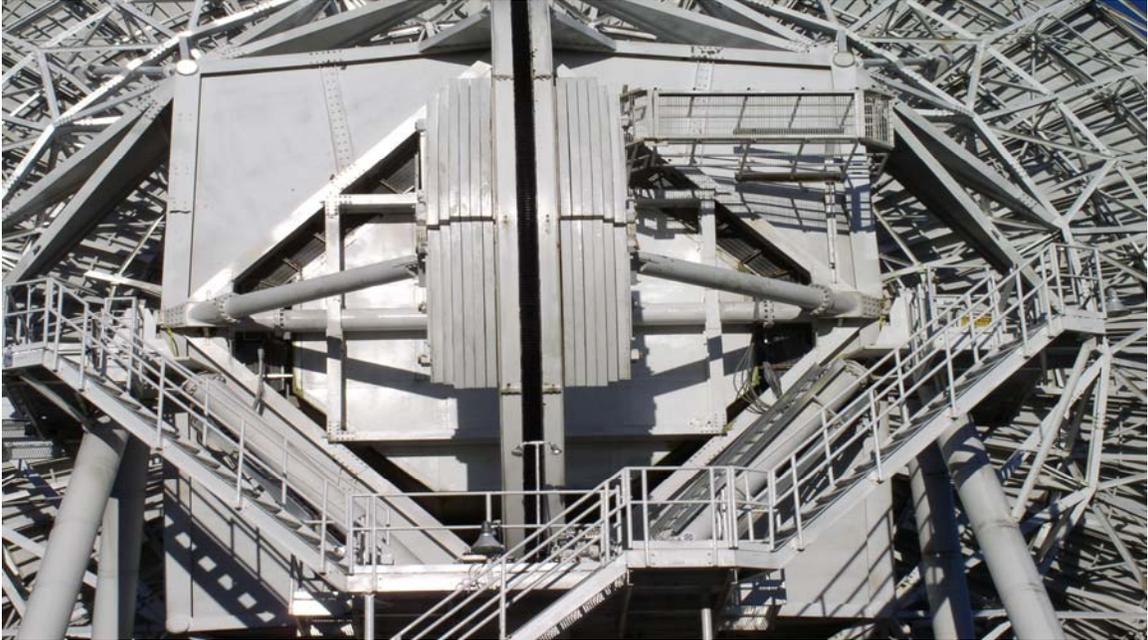
Elevation axle has no visible signs of cracks. Paint is in Fair condition.

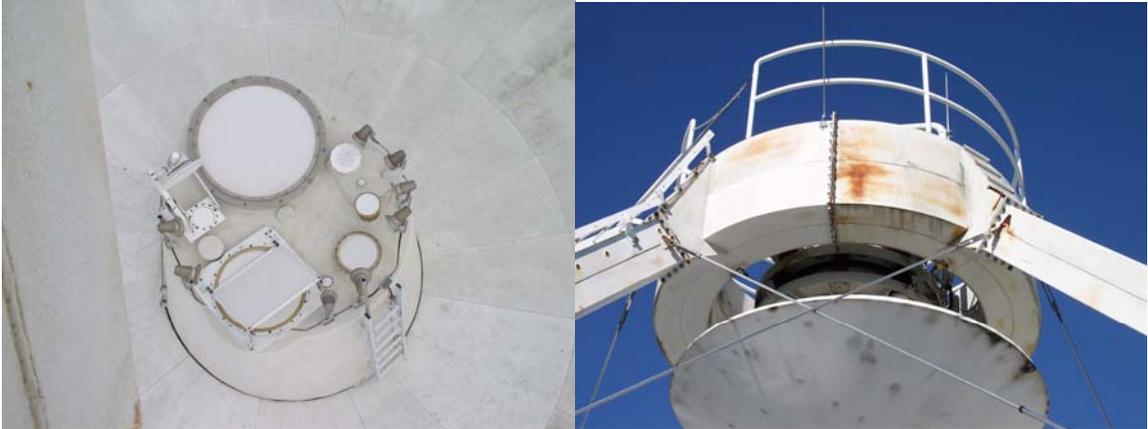
Feed windows & heaters are in good condition. Apex paint is in fair shape.

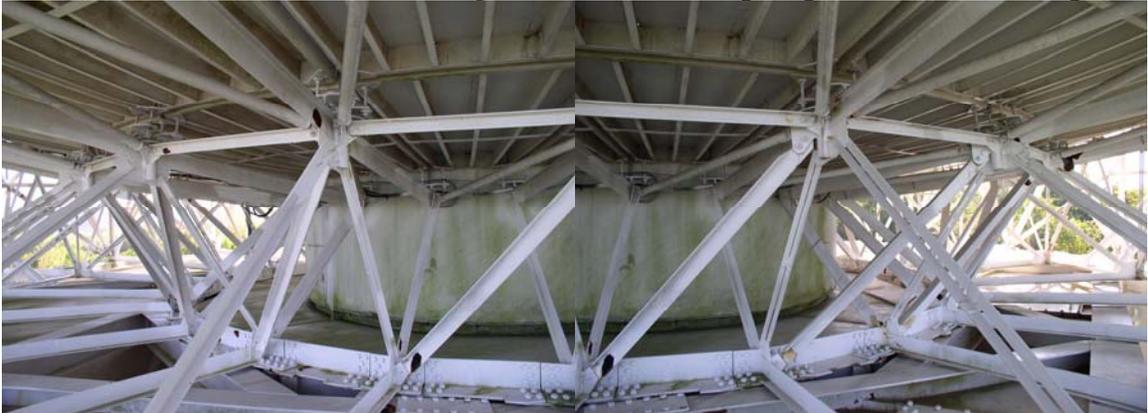
Panel backup structure is in good condition. Paint is in fair condition.

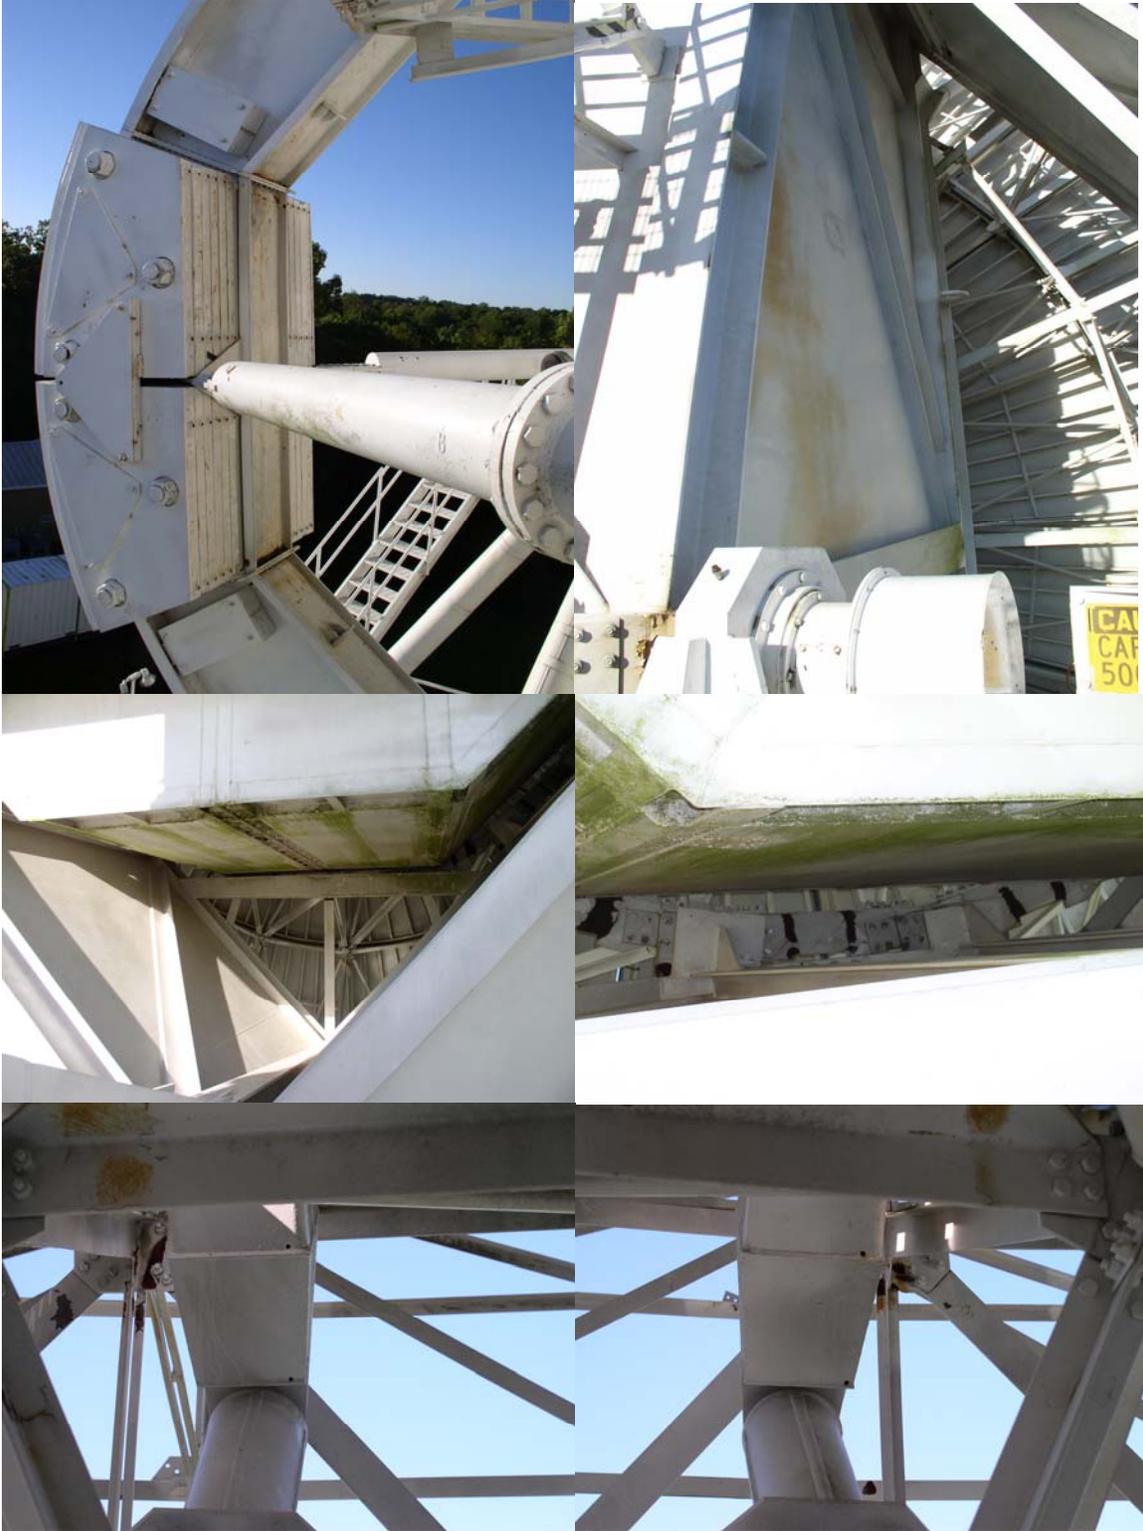
Overall paint on the North Liberty antenna is in fair condition. Notice the drain holes drilled in the quad legs.

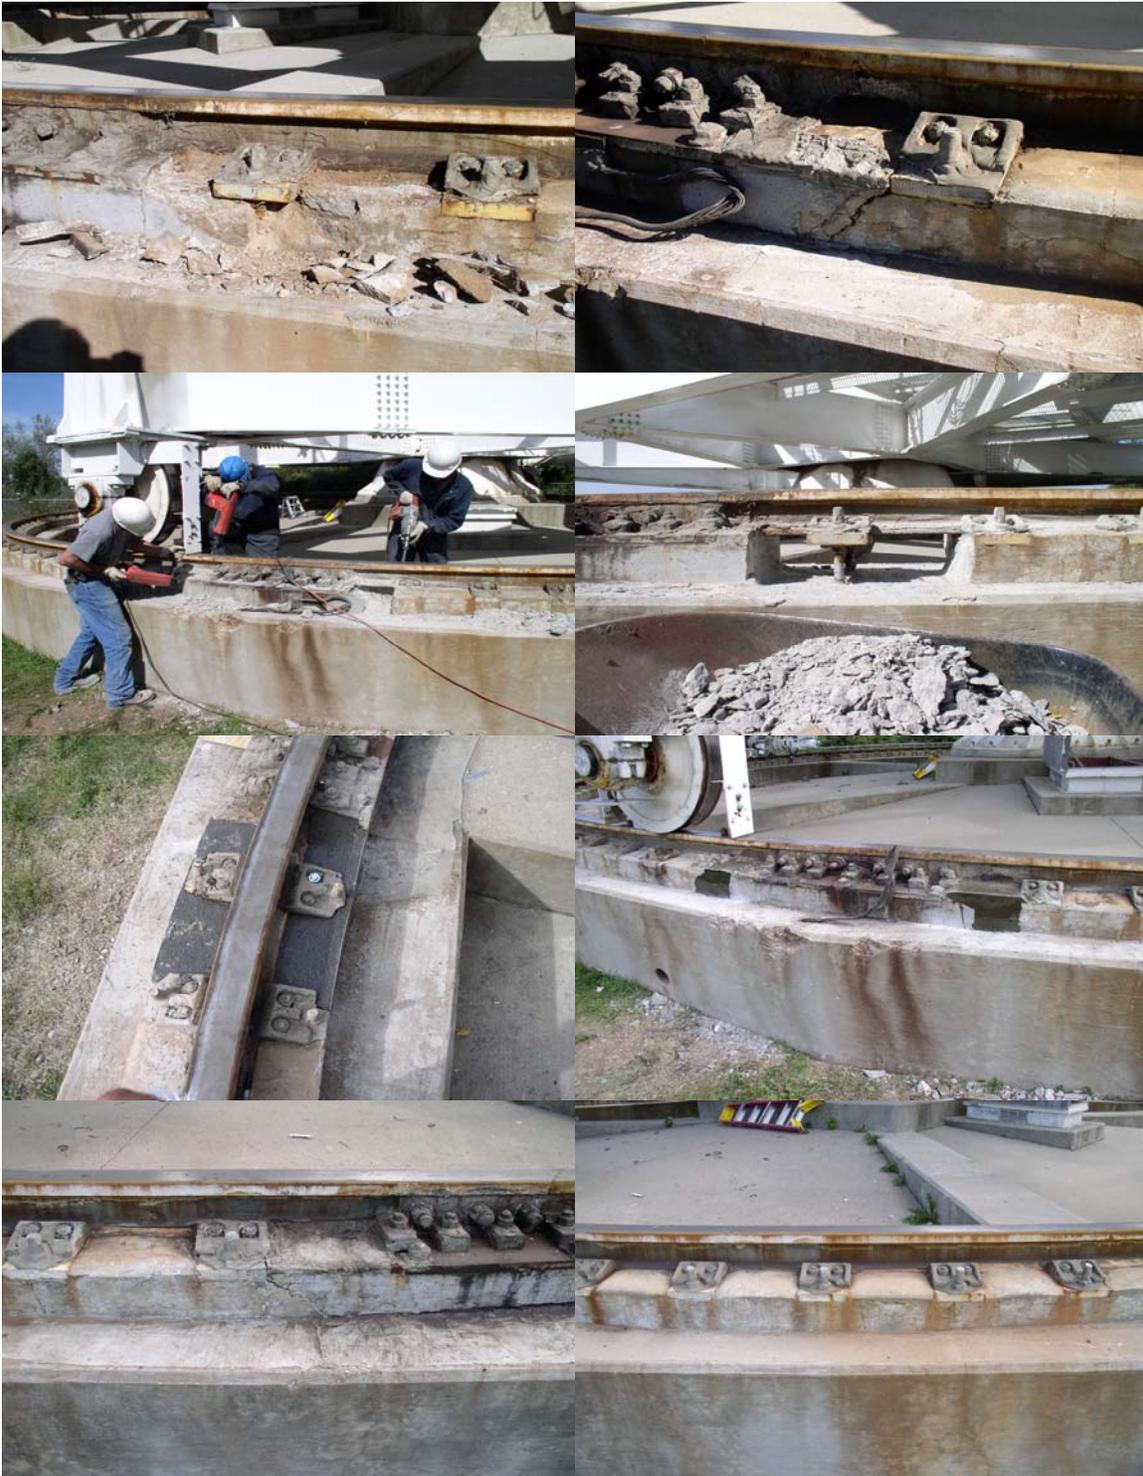
Grout was replaced at bolt numbers, 21, 25, 41 and 45. Grout at bolt numbers, 61 and 65 is degrading. The remaining grout around the rail is in good condition.
