National Radio Astronomy Observatory
Socorro, New Mexico
VLBA Antenna Memo #66

Hancock, New Hampshire VLBA Maintenance Visit September 20-27 2006. Team members consisted of Steve Aragon, Eric Carlowe, Kelly Greene, Ken Lakies, Ray McFarlin and Phillip Sanchez. VLBA Site Technicians Tom Baldwin and Don Haenichen assisted in all areas of antenna maintenance.

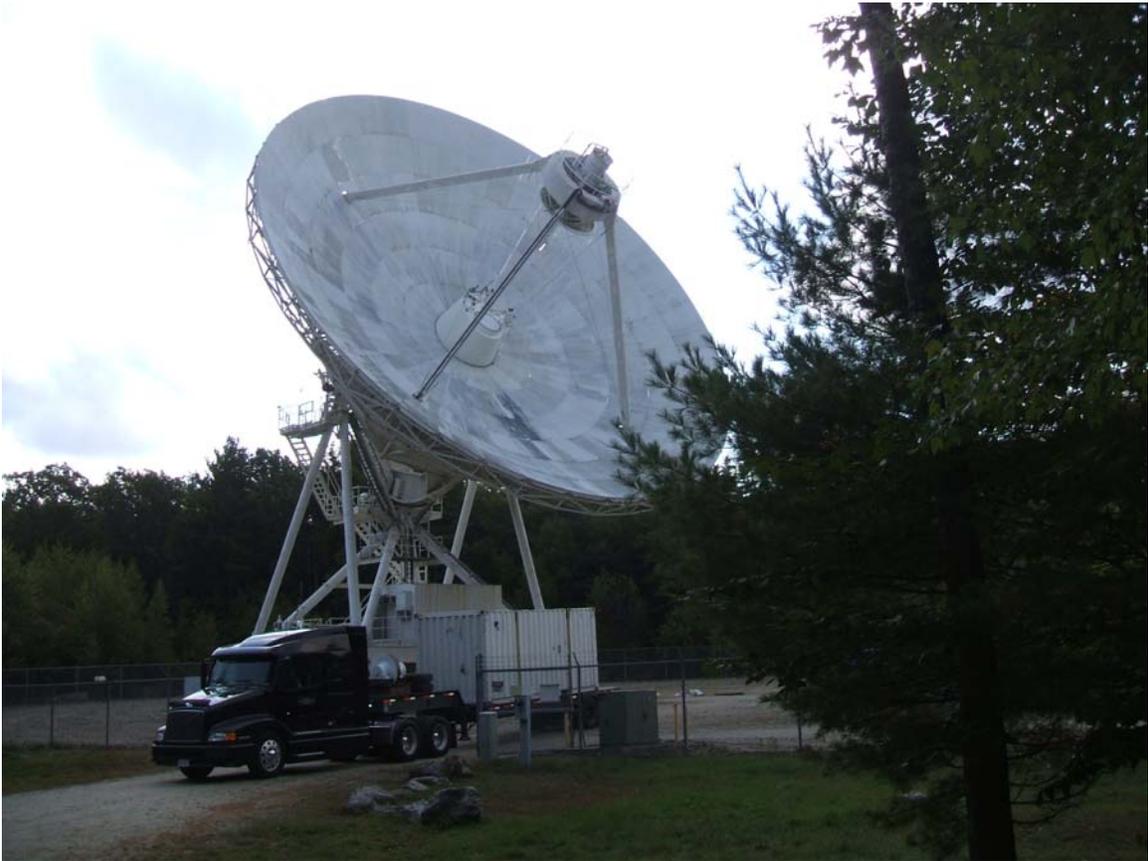
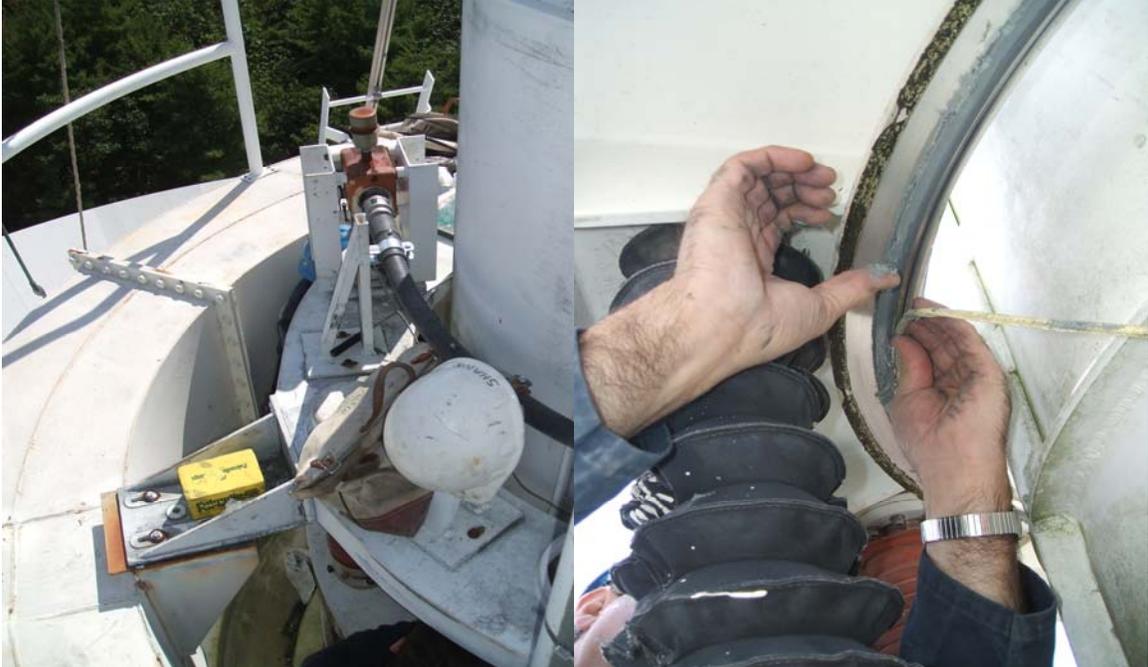
The FRM was given a thorough inspection. The focus flex shaft was replaced along with the INA bearing seal.

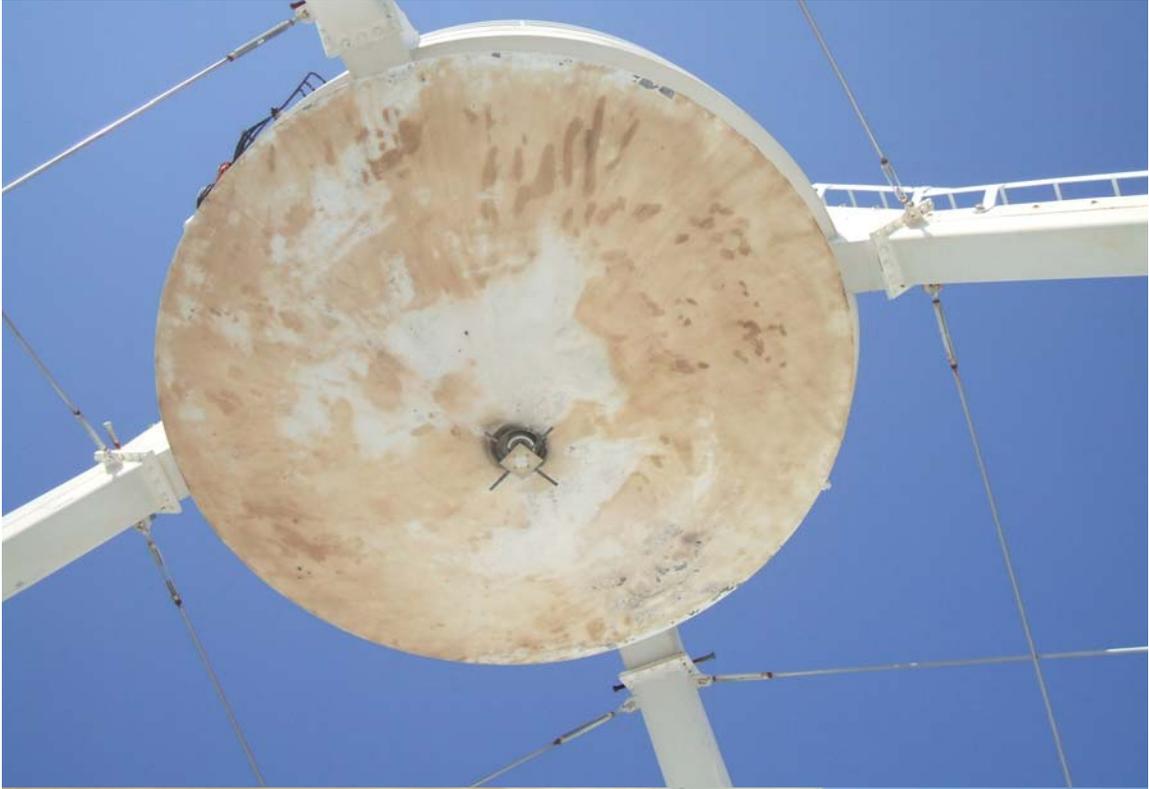
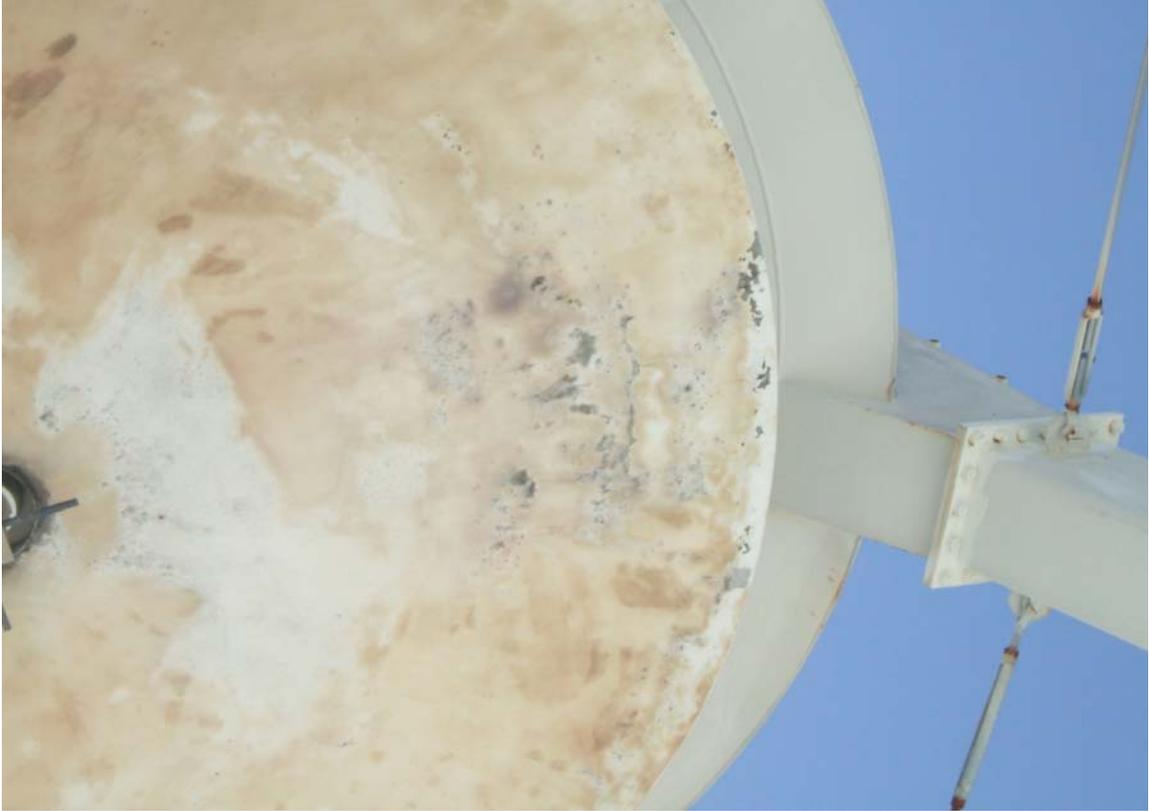
Hancock's sub reflector paint is degrading.

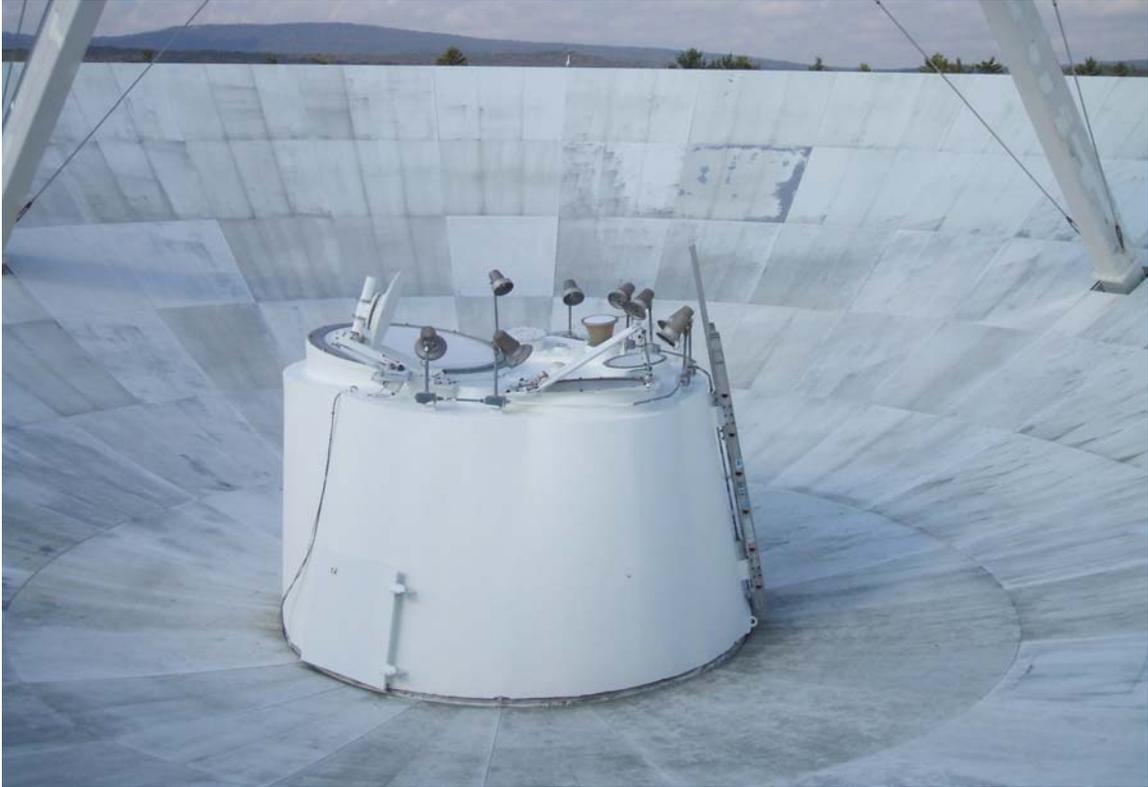
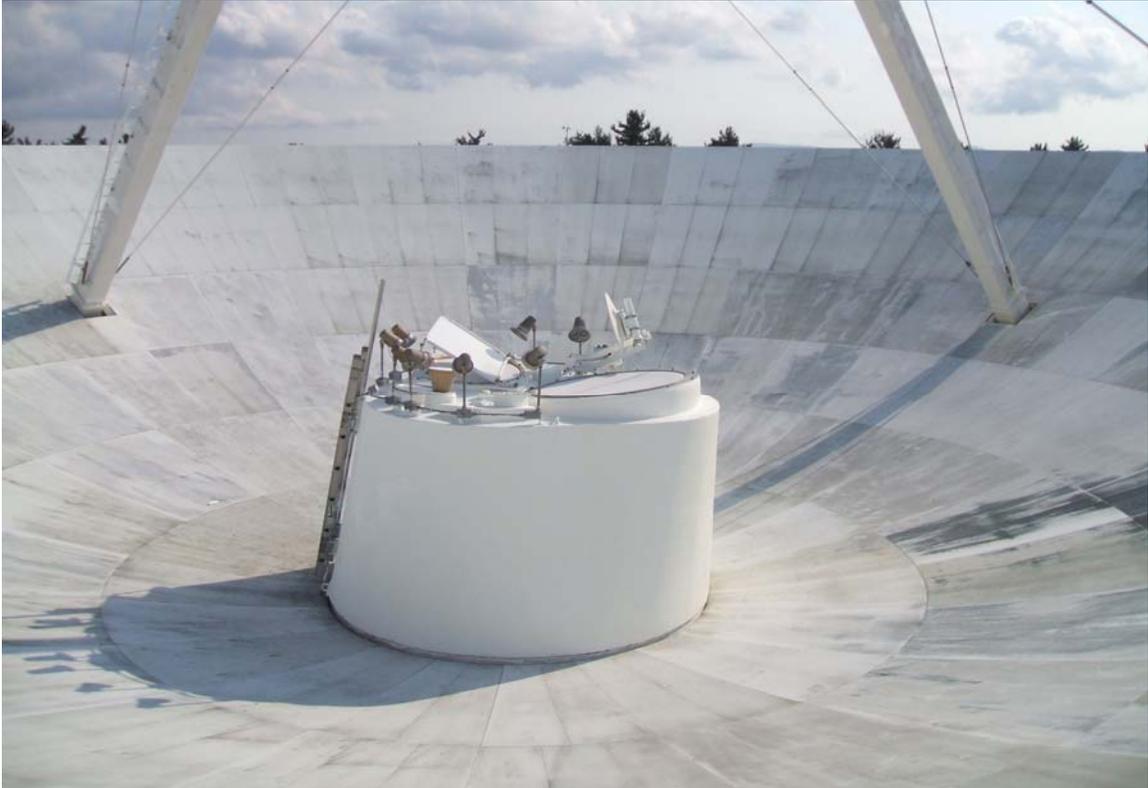
Dish panels are in good condition with no dents. The feed cone was sealed and painted with elastomeric.

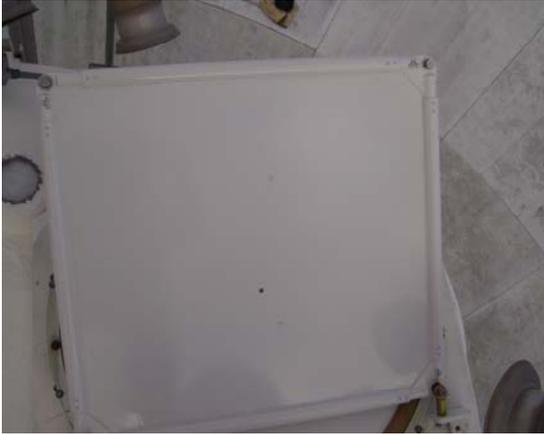
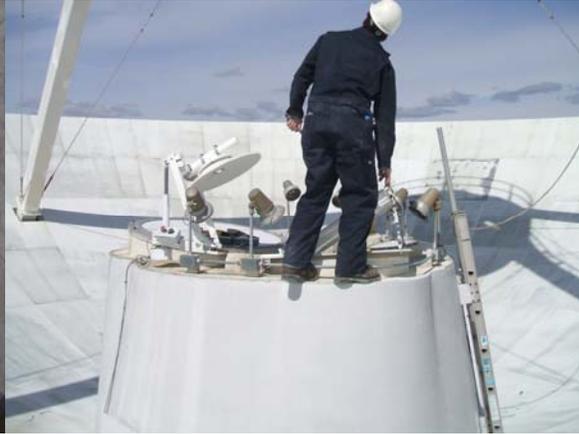
A new dichroic reflector was installed and aligned. The ellipsoid reflector was realigned and is in good operating condition.

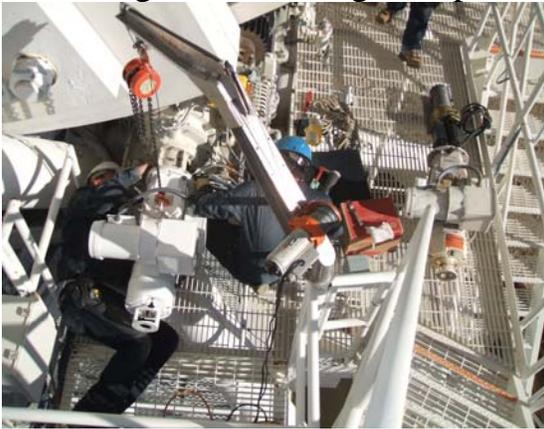
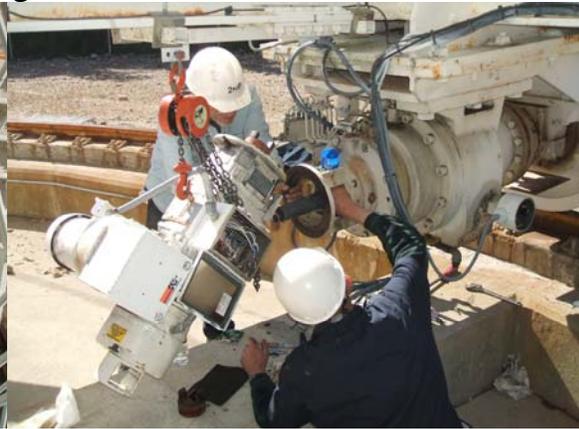
Elevation motors #1 and #2 were replaced. AZ #1 motor needed a new brake assembly. A new blower motor and air box was installed on AZ #2. AZ#2 gear box seal was also replaced.

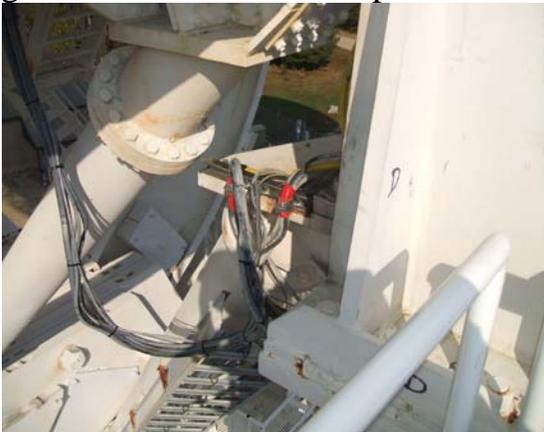
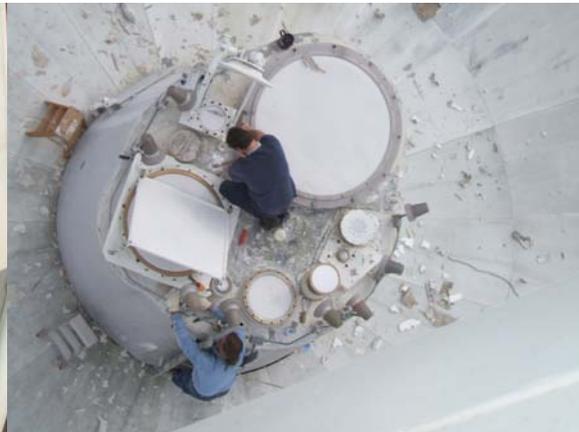
The Elevation synchro side cable wrap was repaired. Vulchem was retaining water on top of the feed cone. The vulchem had to be scrapped off and the feed cone sealed and painted.

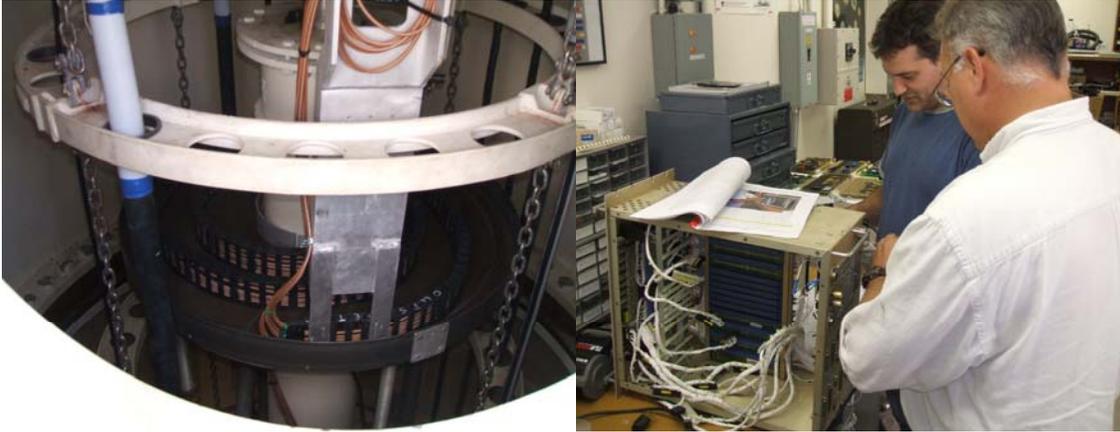
The new IF cable wrap was installed and tested. Four pieces of teflon were added to chaffing power SO cables. The ACU power supply and backplane modification was completed and tested.

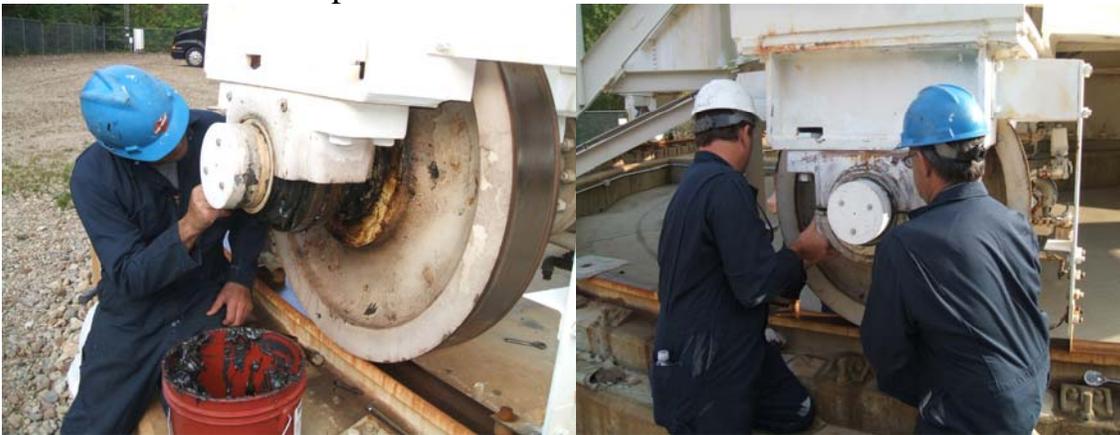
Azimuth wheel bearings were inspected. No AZ bearings were replaced.

INNER BEARING	OUTER BEARING
D1	Few minute flakes.	Few minute flakes.
D2	Few minute flakes.	Few minute flakes.
I1	Good, no metal.	Good, no metal.
I2	Good, no metal.	Good, no metal.

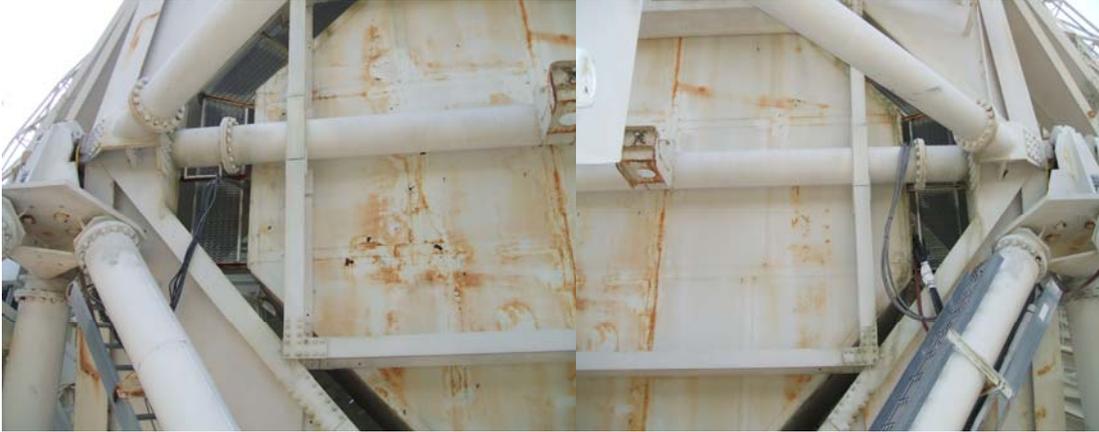
Elevation axle has no visible signs of cracks. Both elevation axle ground cables were replaced. Paint is in poor condition.

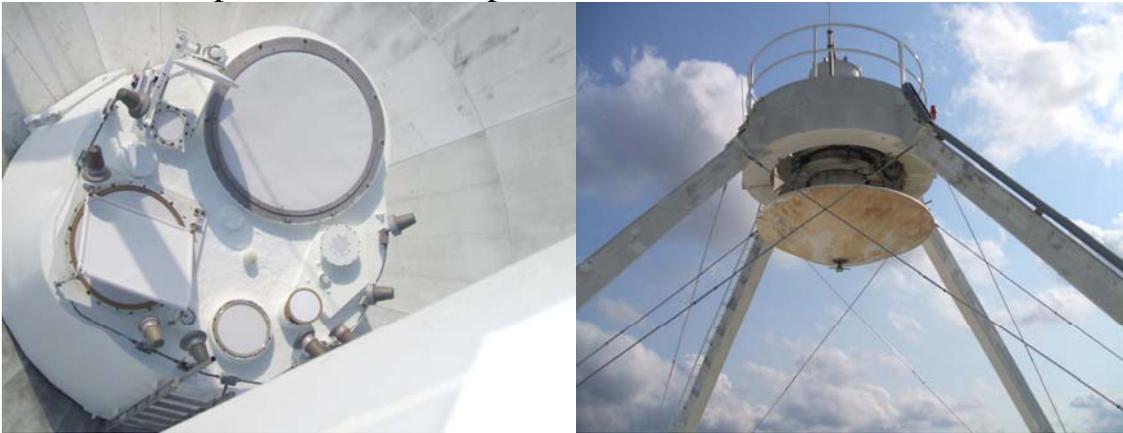
Feed heaters and FE windows are in good condition. Feed heaters operated correctly, 1 feed heater needed replaced. Apex paint is in fair/poor condition.

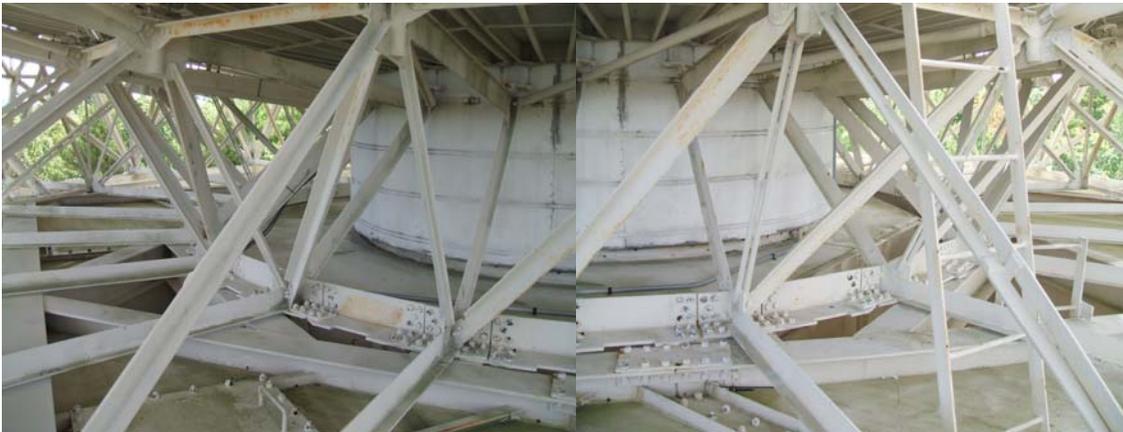
Antenna backup structure is in good condition. Paint is in fair condition.

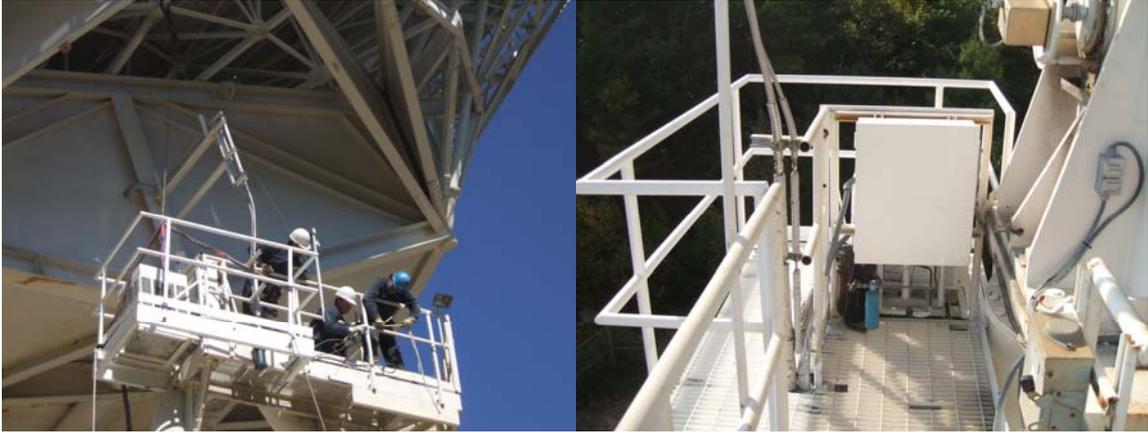
A new Elevation HVAC platform extension was installed.

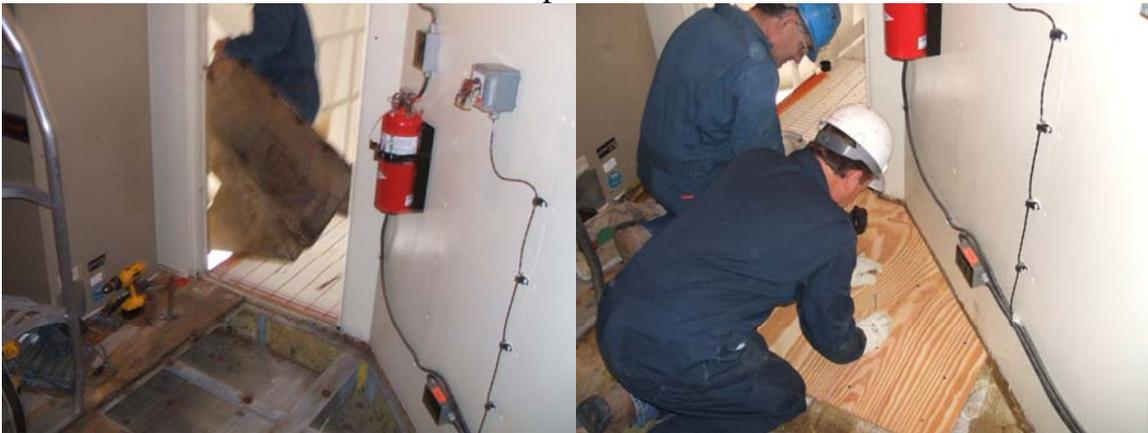
One section of the Vertex room floor was severely damaged by water. This section was cut out and replaced. Vertex room floor tiles were removed for the site techs to seal and paint the floor.

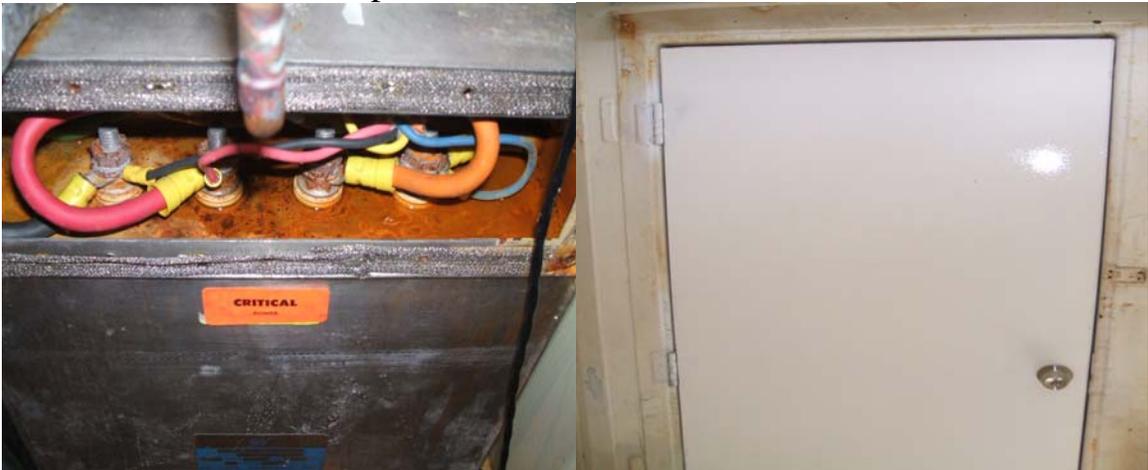
The Vertex room RFI critical power filter was full of water. Vertex room power was shut off. The filter was dried out and connections cleaned. RFI filter leak was located and sealed. The vertex room door was also replaced.

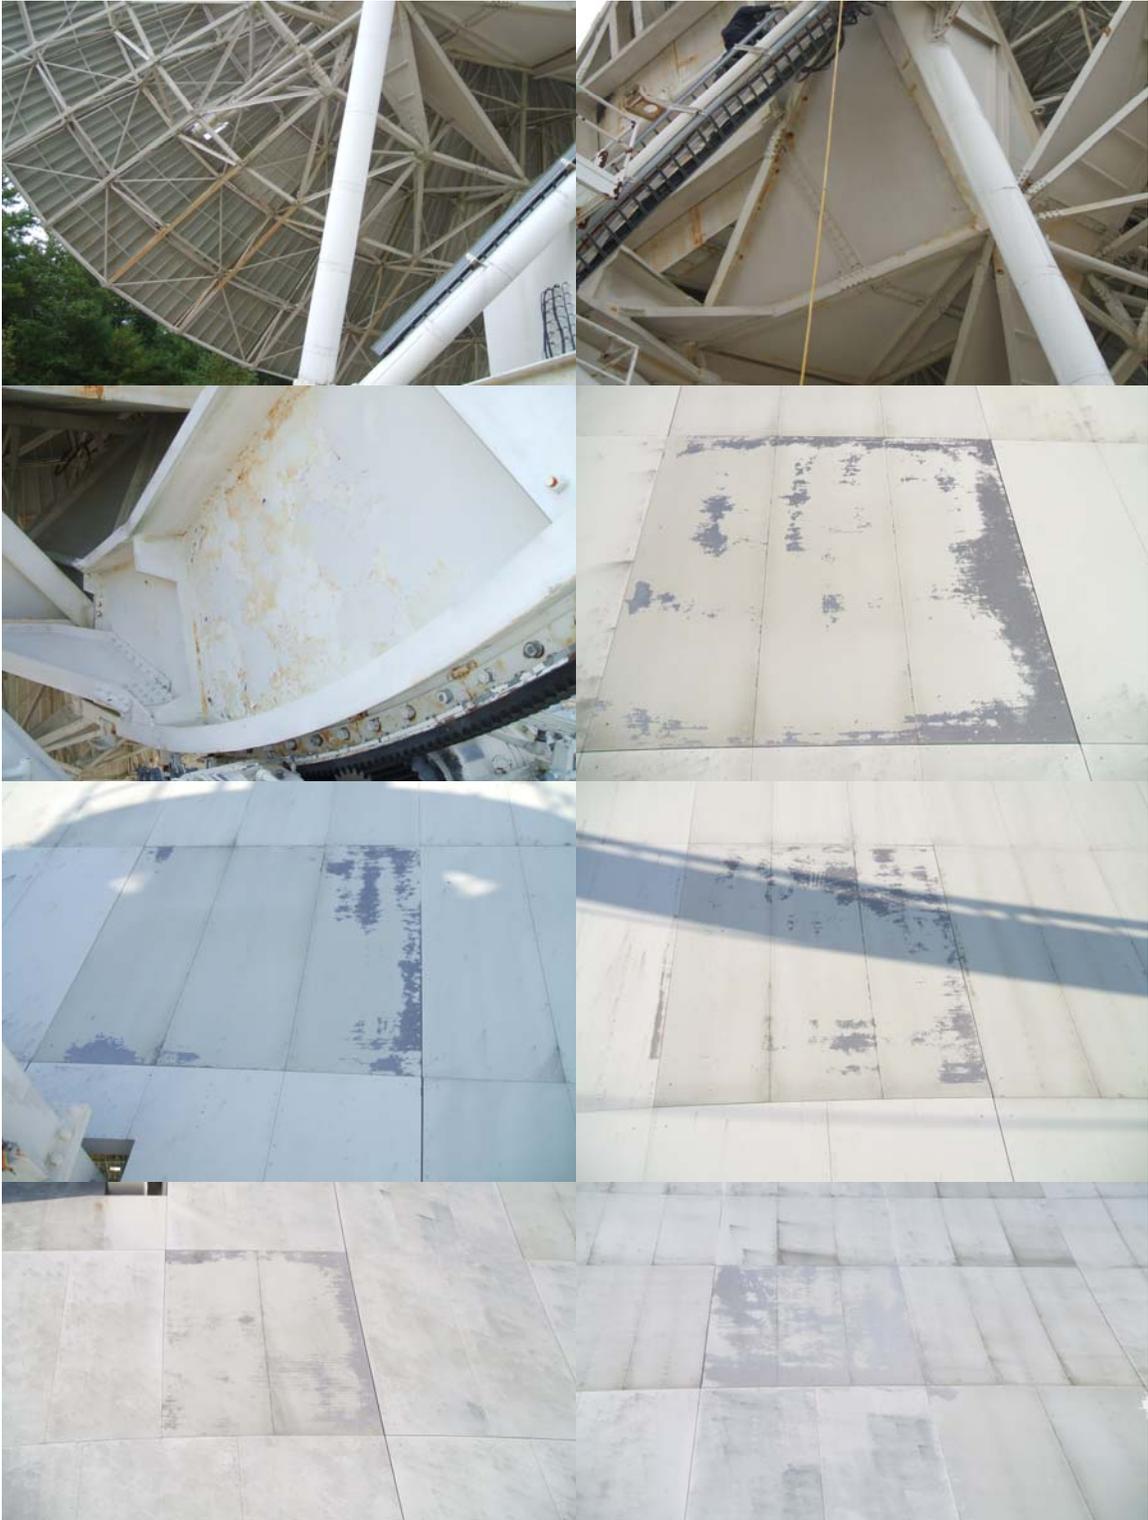
Overall the antenna paint is in poor to fair condition. With mainly lots of surface rust found every where on the structure. The paint on several dish panels is deteriorating.

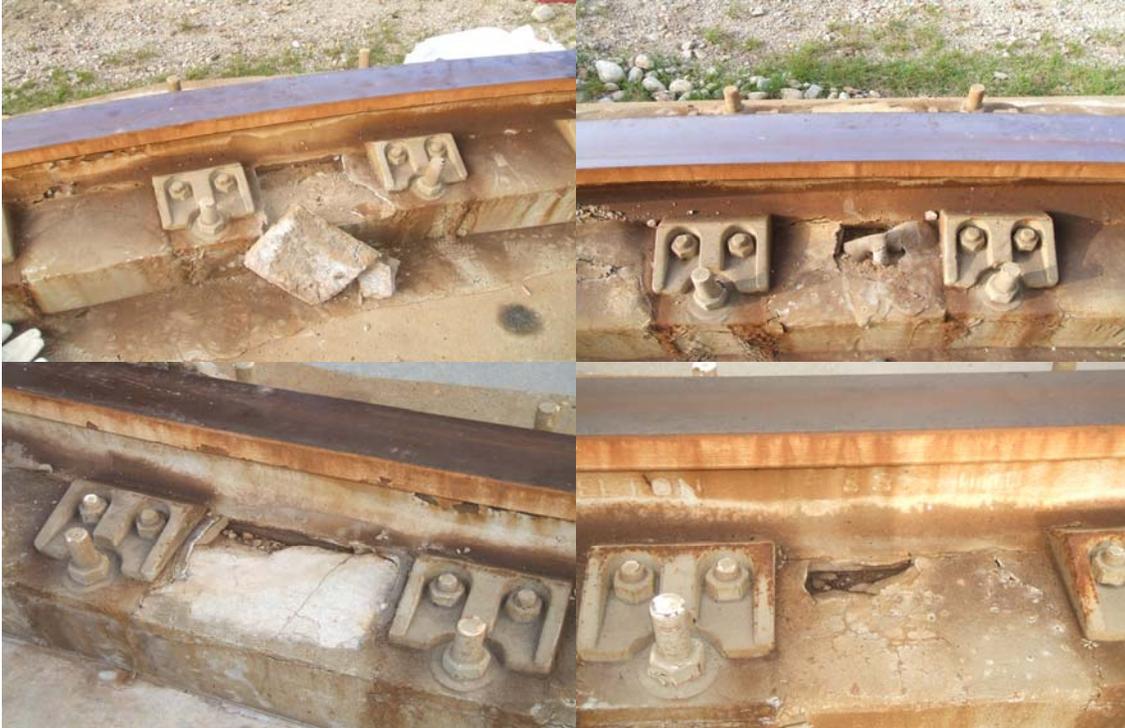
Hancock's rail grout needs to be replaced.

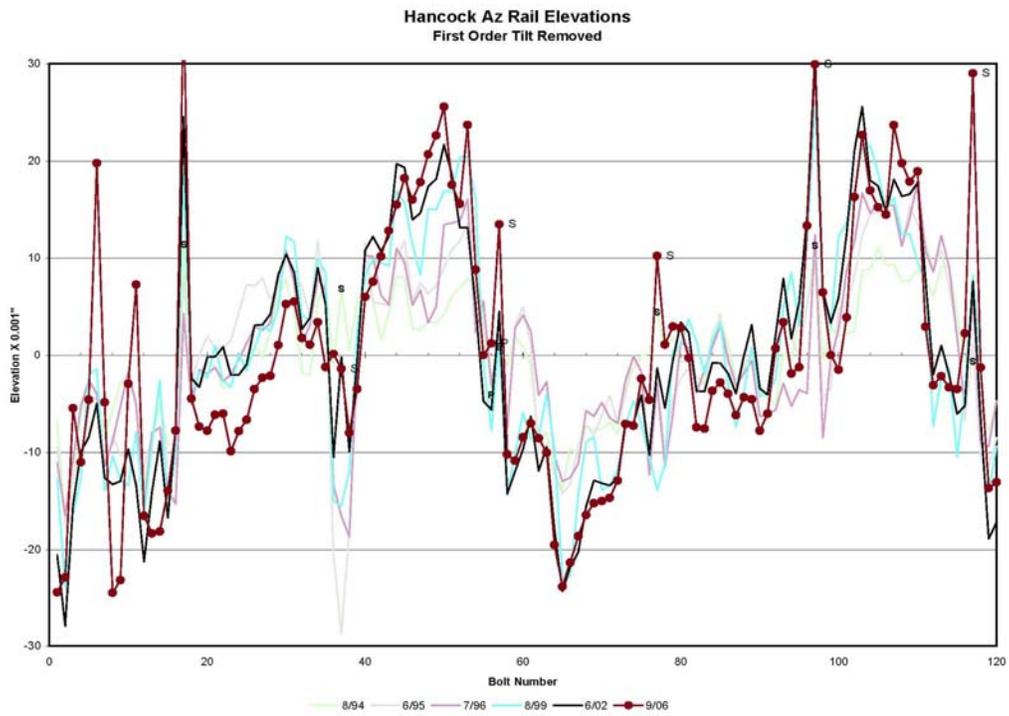
Splices at bolt numbers, 17, 97 and 117 are failing.
