National Radio Astronomy Observatory
Socorro, New Mexico
VLBA Antenna Memo #74

Owens Valley, California VLBA Maintenance Visit August 18-25, 2008. Team members consisted of Steve Aragon, Mike Burgert, Eric Carlowe, Ray McFarlin and Phillip Sanchez. VLBA Site Technicians Jim Brown and Bill Robbins assisted in all areas of antenna maintenance.

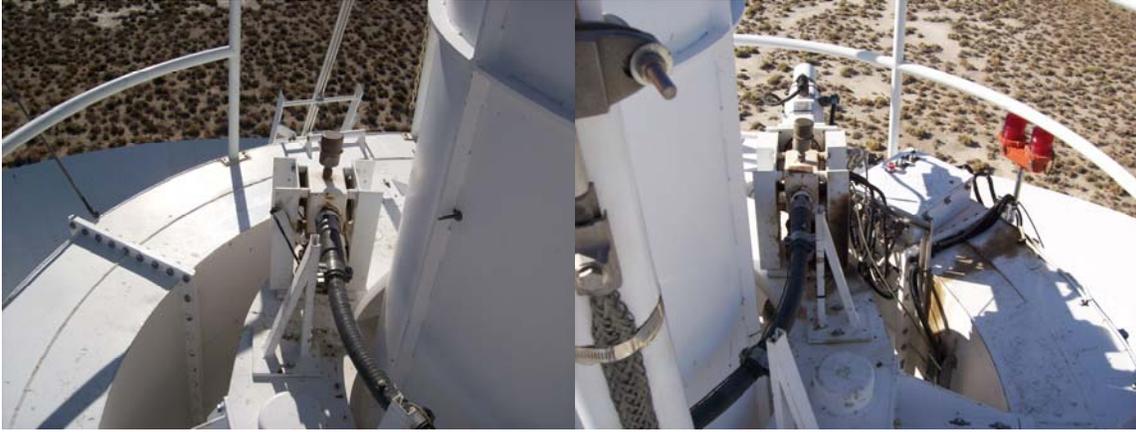
FRM was given a thorough inspection and the focus flex shaft was replaced. Three 1 inch drain holes were drilled in the center of the sub reflector for extra drainage.

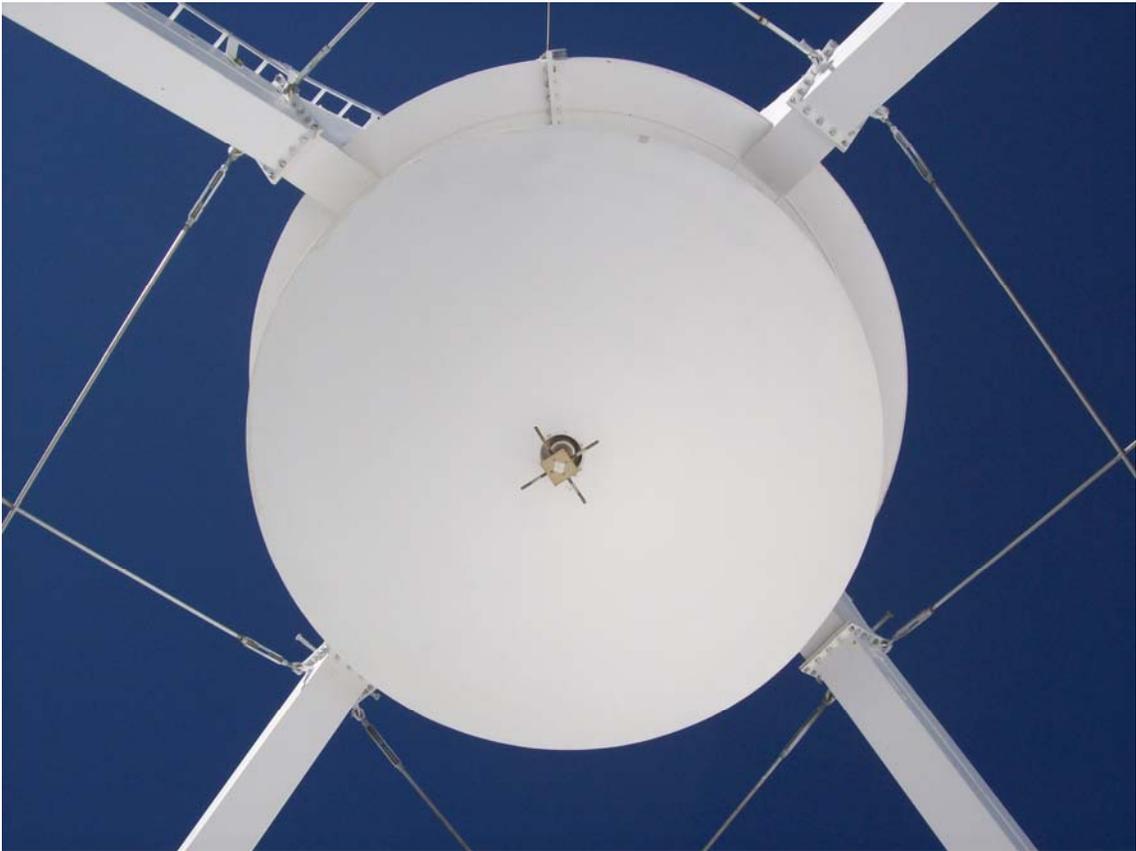
Sub reflector is in good condition.

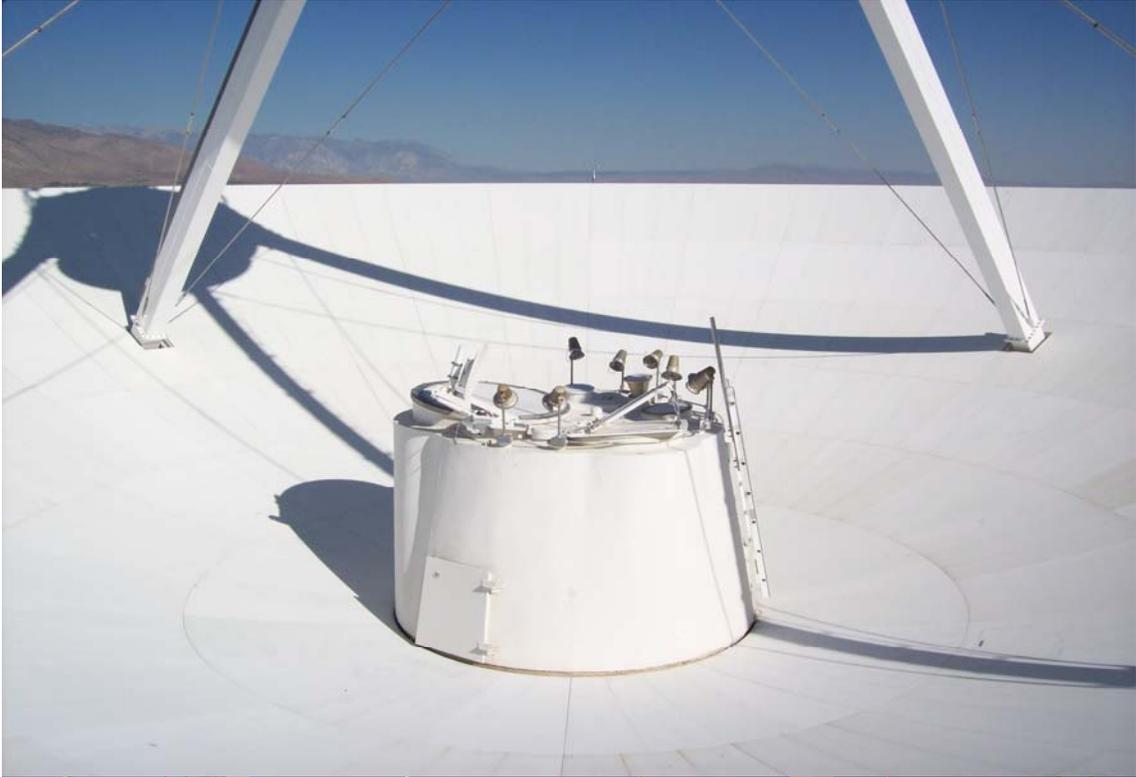
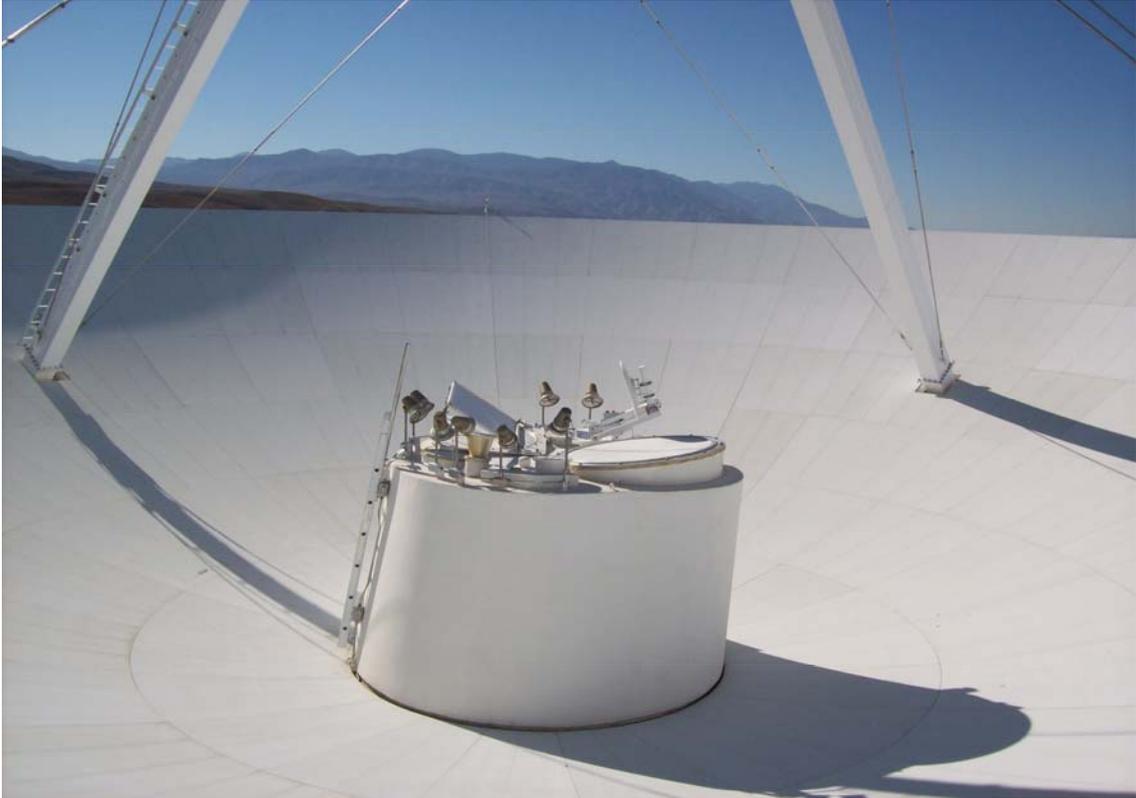
Dish panels are in good condition. The feed cone's elastomeric paint job is holding up well. The feed cone was sealed and painted during the last maintenance trip in 2004.

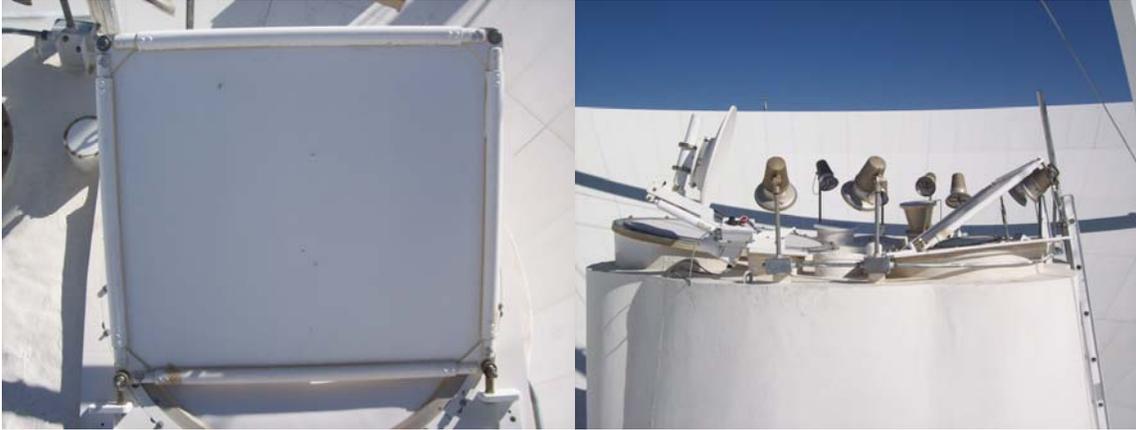
The Dichroic reflector is in excellent condition. The Ellipsoid reflector is in good condition. Ellipsoid actuator operates correctly.

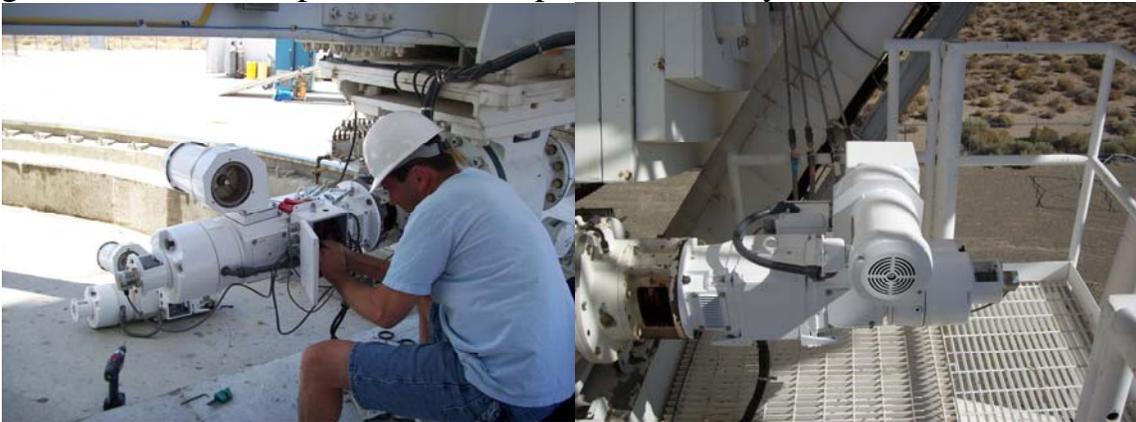
Azimuth #1 and Elevation #2 motors were both replaced.

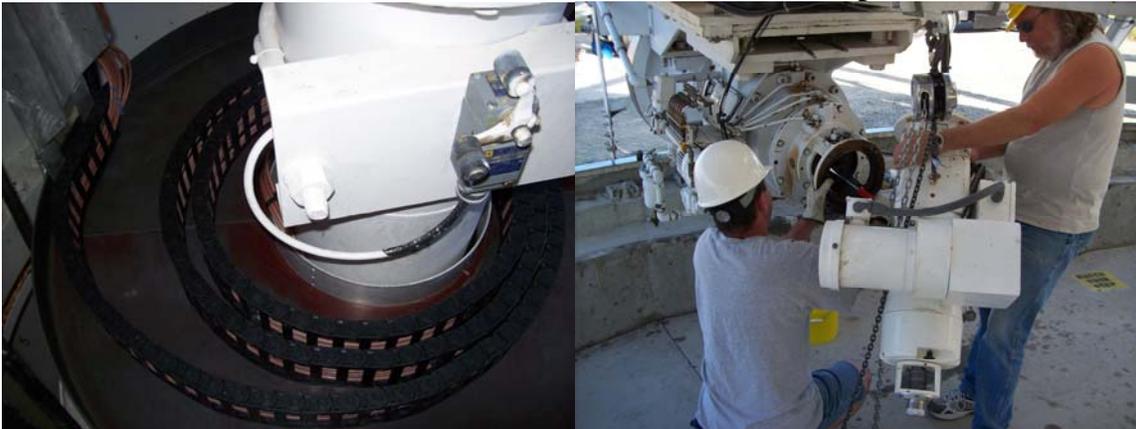
The new IF cable wrap was installed and tested. Azimuth #1 and Azimuth #2 gear box seals were leaking. Both seals were replaced.

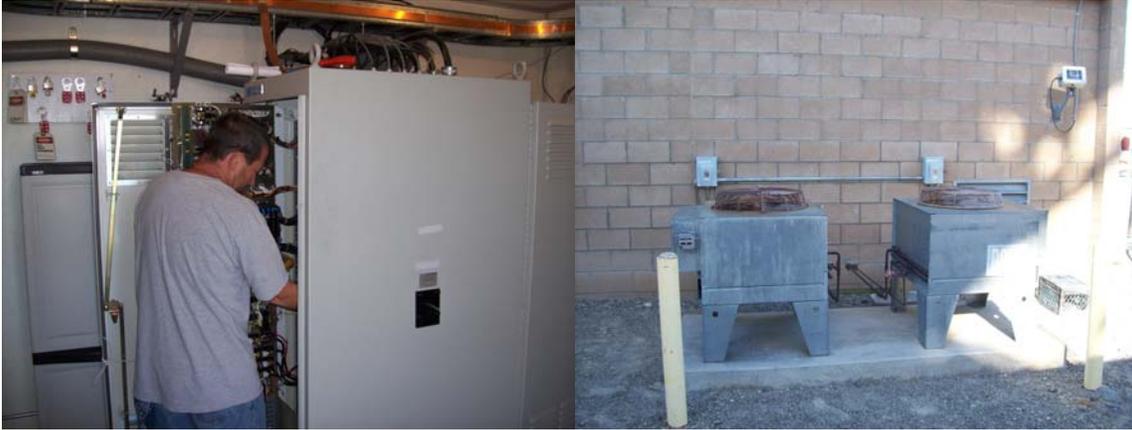
The servo drive cabinet power supply upgrade was completed. The lock out tag out switch tested bad and was replaced. Both Contempo condenser variable speed controllers were replaced after Contempo #2 tested bad.

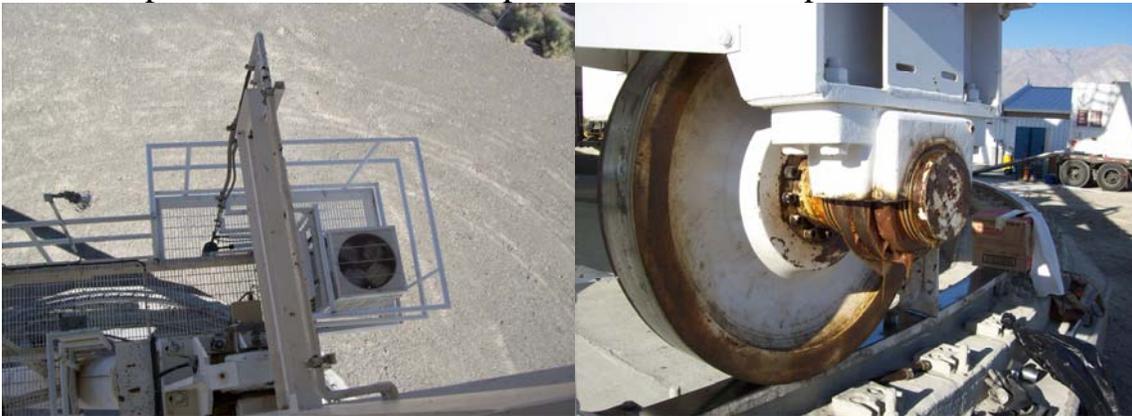
A new Elevation HVAC extension platform was installed. All antenna bearing were inspected.

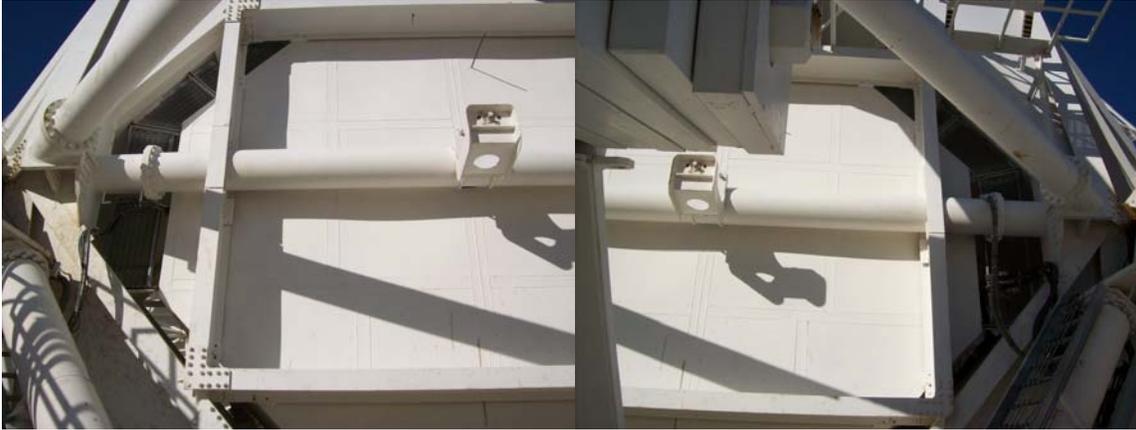
Elevation axle has no visible signs of cracks. Paint is in good condition.

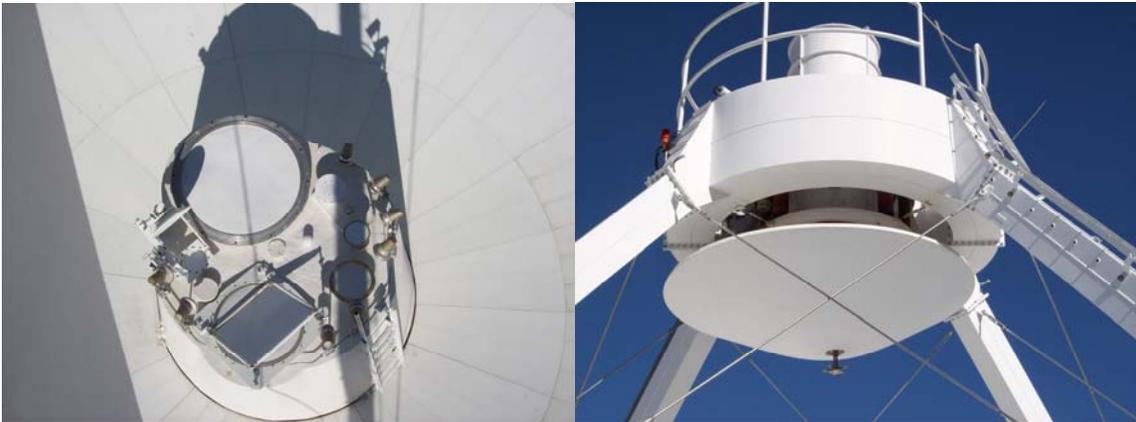
The feed heaters and FE windows are in good condition. Apex paint is in good condition.

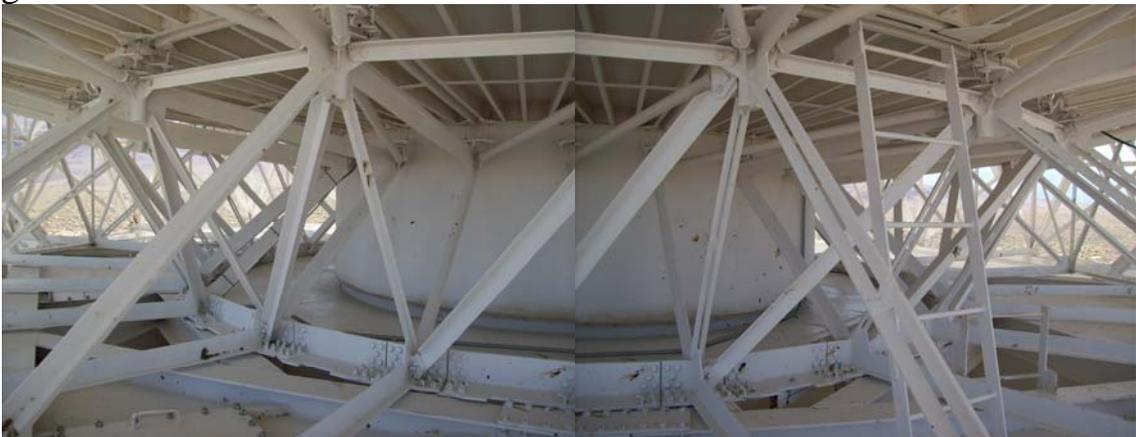
Antenna backup structure is in good condition. Paint is in good condition.

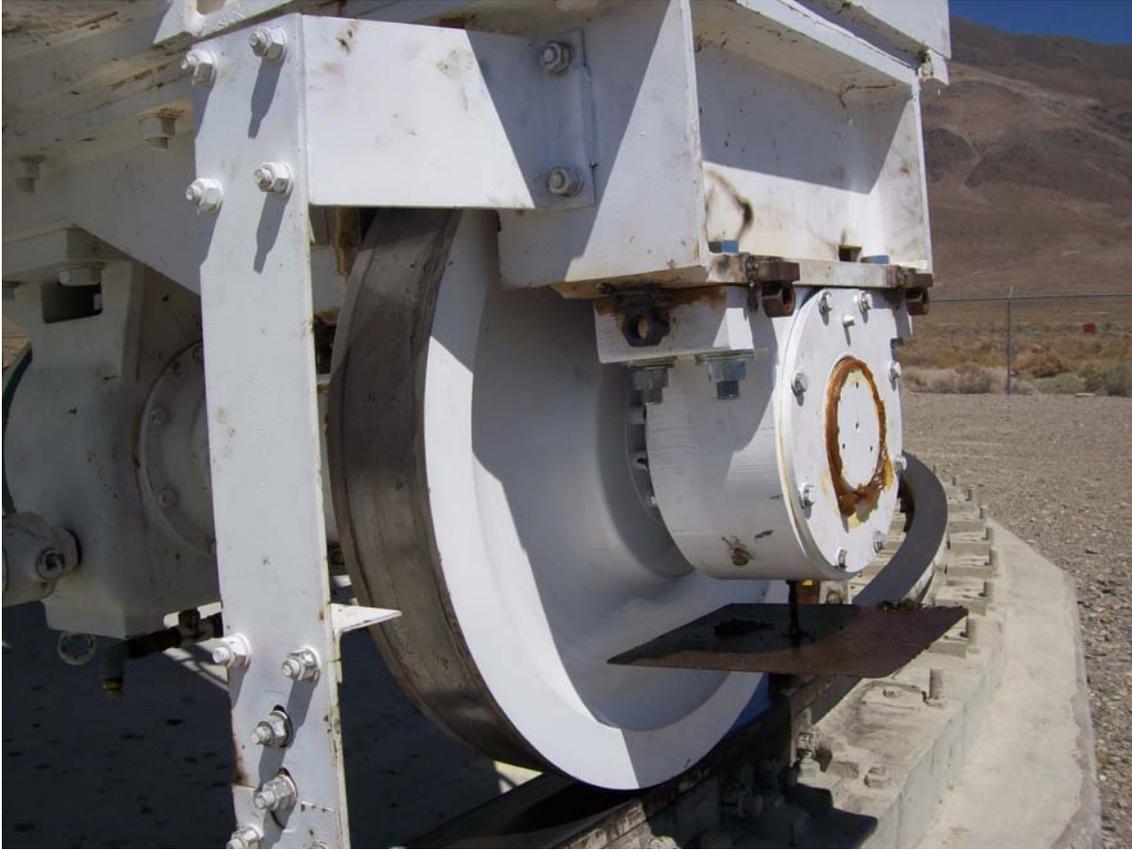
Azimuth #1 Wheel assembly was replaced. The new drive wheel assembly rotated smoothly without any popping or grinding noises.

MEASURED	SPECIFIED
Conic Radius	300.201	300.00 +/- .25
Coupling Runout	.003	<.005
Vertical	93.447	93.440 +/- .023
Horizontal	.006	<.023

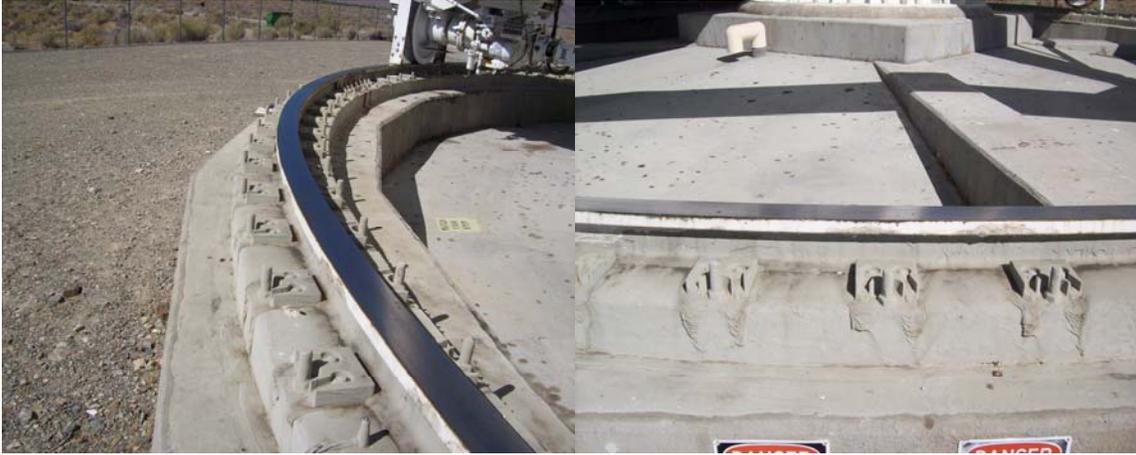
The Owens Valley rail is in good condition. The vulchem still looks as though it has been recently applied.
