VLBA Antenna Memo Series No. 75

**St Croix Maintenance Trip Report**  
**October 27 - November 14, 2008**

J. E. Thunborg  
December 18, 2008

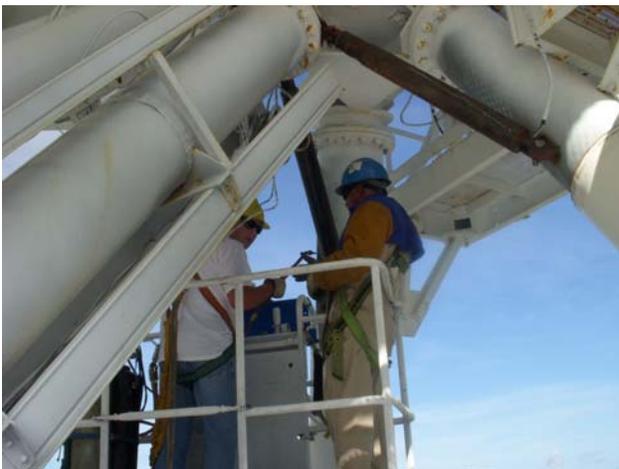
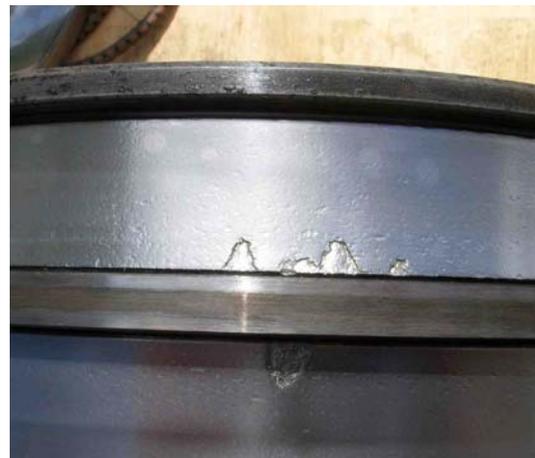
Metal particles were found in the grease on the encoder side elevation bearing. Steel beams, struts and stiffeners were bolted or welded to the antenna to support the lifting jacks and reinforce the structure. The bearing was changed using the method used on the Fort Davis antenna described in “VLBA Antenna Memo Series No. 70”, with the exception of 10 ton jacks located between the dish structure and the elevation bearing that were used to push the bearing from the housing. This method proved cleaner than torching out rollers so that the bearing could be pulled with the 100 ton jack as was done in Fort Davis.

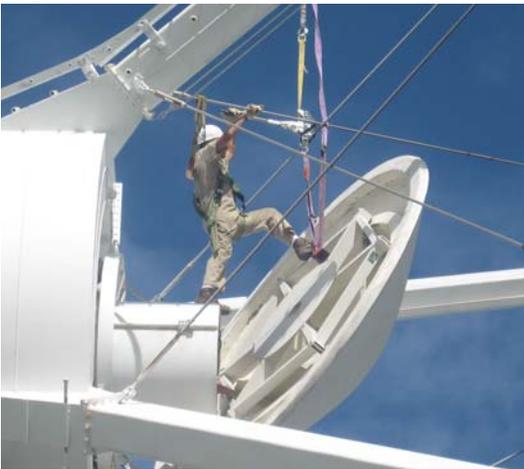
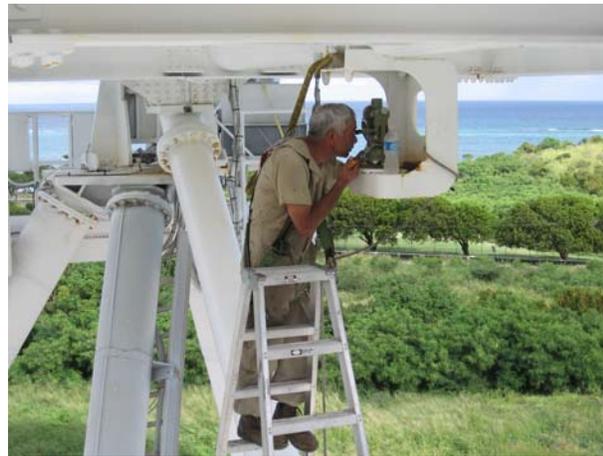
After the new bearing was installed, an improved design encoder mount and a refurbished encoder were mounted and aligned with the elevation axle.

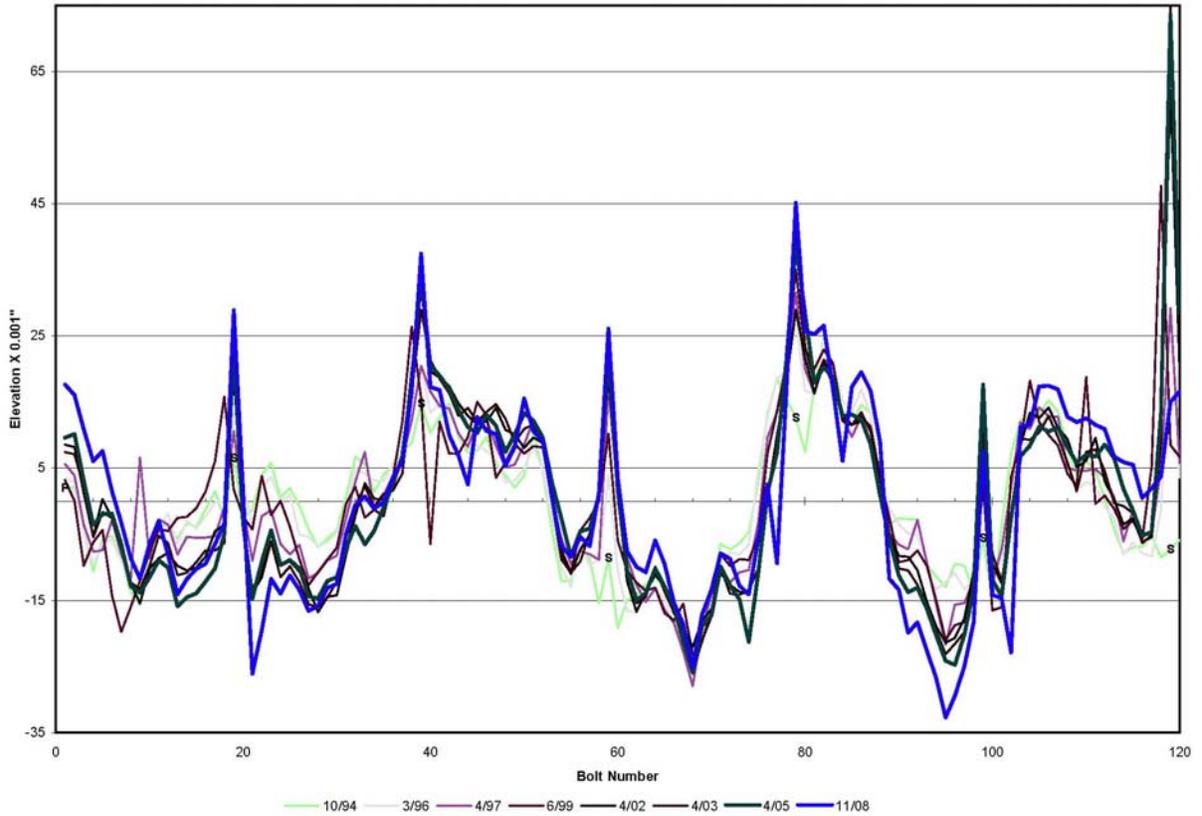
St Croix Az Rail Elevations  
First Order Tilt Removed

The azimuth rail was measured. As can be seen in the chart above, a low spot was developing at bolt number 119. This spot was repaired by installing shims between the rail and the splice plate. These shims should be monitored on subsequent maintenance visits to ensure that they do not initiate corrosion under the rail. A 0.080\"/>

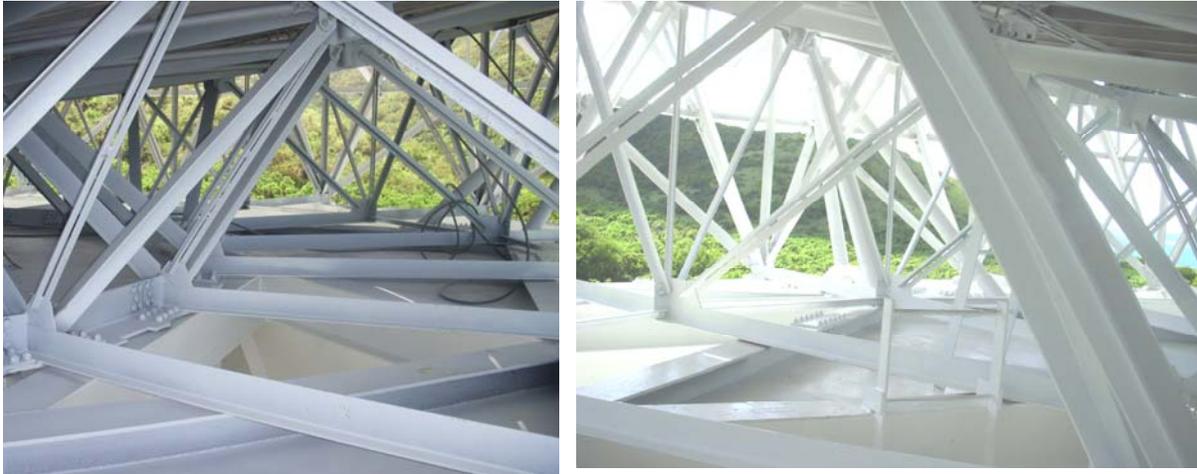
The inside portion of the truss structure under the dish was left unfinished during the 2007 painting due to time constraints. This part of the structure was primed with organic zinc epoxy and then coated with aluminum filled epoxy in 2007. During this visit, all of the bolts and places which showed signs of corrosion were stripe painted by brush with aluminum filled epoxy (Amerlock 400AL) before the final topcoat of Acylic Polysiloxane (PSX 1001) was applied. A small section of this structure was topcoated with aliphatic acrylic polyurethane gloss (Benjamin Moore P-74) in order to compare the performance of the two topcoats.

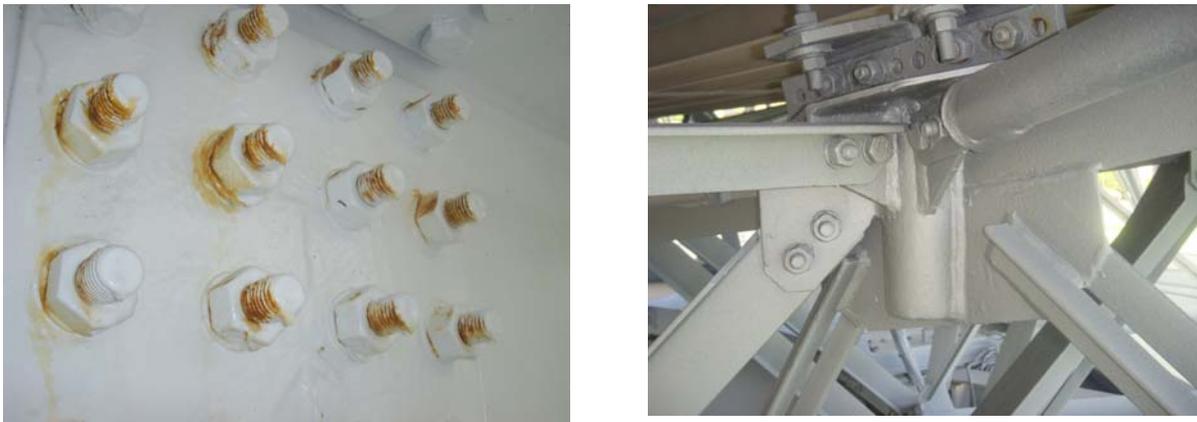
There is some rust staining on the bolt heads and nuts on the lower portions of the structure. However, this staining is not nearly as prevalent in the upper backup structure. The reason for this is that the backup structure had significantly more surface preparation and a more robust paint job than the remainder of the antenna. Since the corrosion was most prevalent and destructive on the upper backup structure, we focused our efforts on this part of the structure in 2007. This included more thorough surface preparation, the application of an organic zinc primer and additional paint application by brush at the connections. Another VLBA Antenna Memo focused entirely on the painting and paint system performance will be issued in the near future.

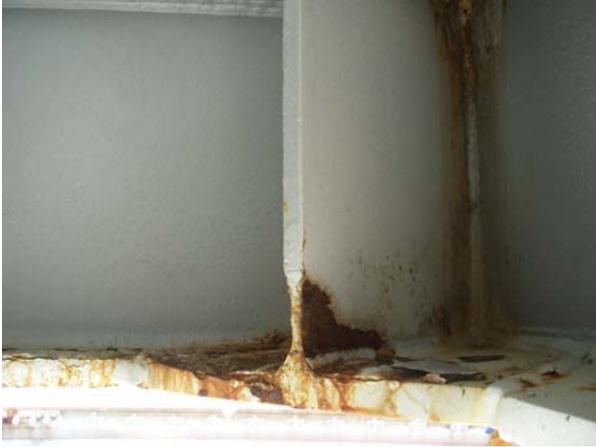
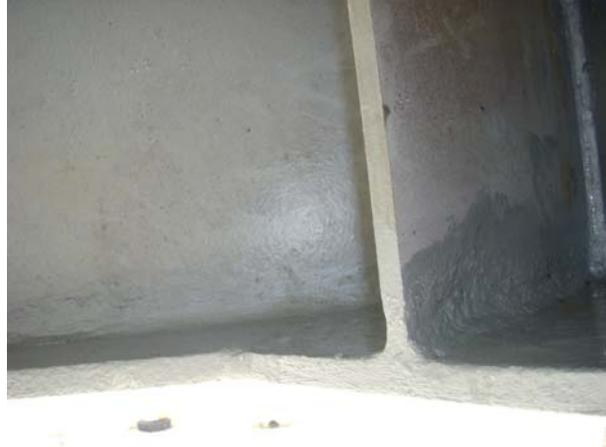
Shown above is the area where water gets trapped below the pintle bearing pocket.

Locations that showed significant corrosion were repaired by needle scaling the existing rust and then applying aluminum filled epoxy by brush. The pictures below show some of these repair locations.

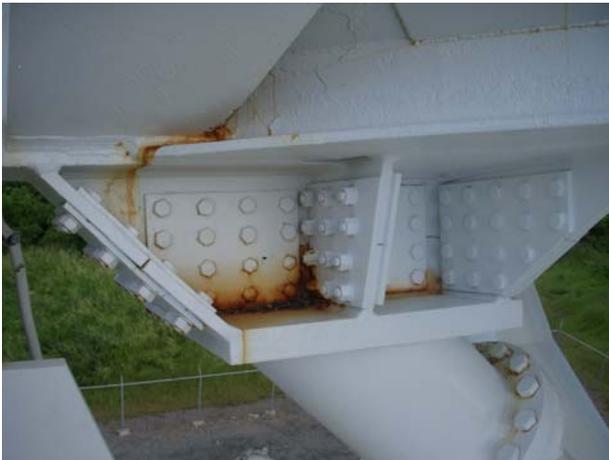
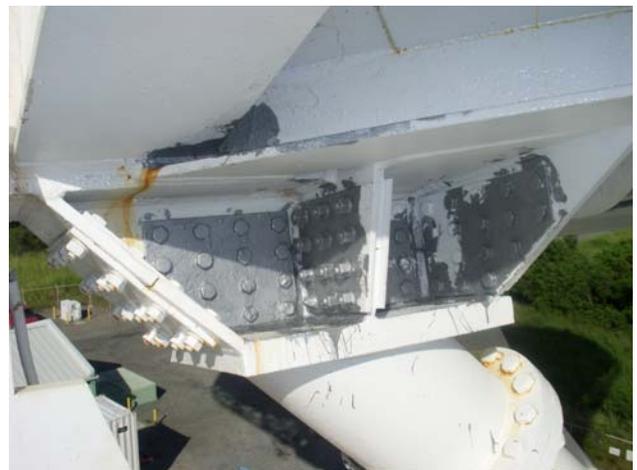
Shown above is the structure where the dish structure is attached to the counterweight tubes.

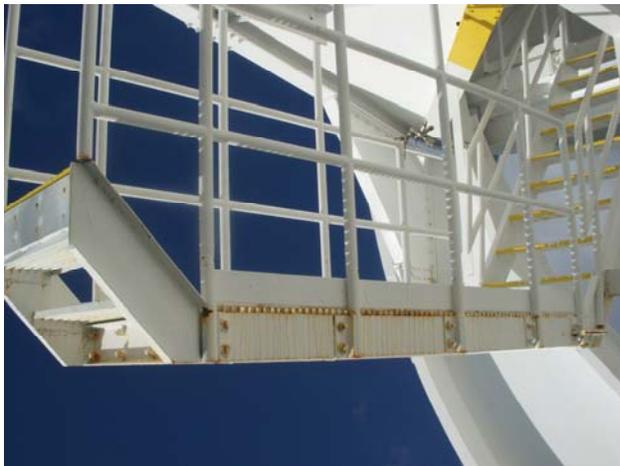
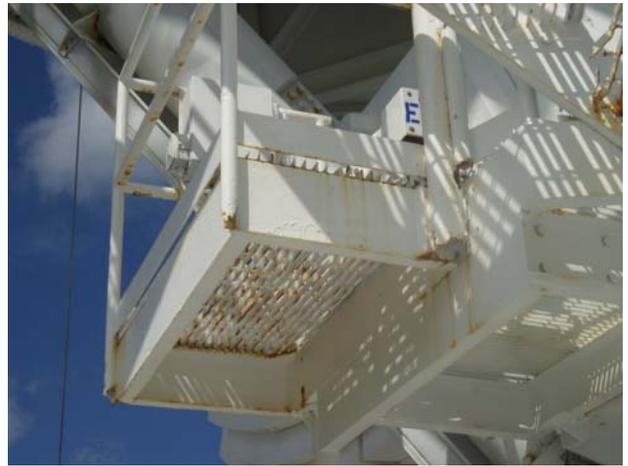
The elevation platform extensions and swinging platform have significant corrosion and will need to be replaced during a future maintenance visit. The hand rails on these parts of the structure are corroding from the inside out. A crane with at least 70 feet of stick will be needed to replace the swinging platform.
