National Radio Astronomy Observatory
Socorro, New Mexico
VLBA Antenna Memo #80

Hancock NH, VLBA Maintenance Visit February 8-20 2010. Team members consisted of Eric Carlowe, Ramon Gutierrez, Martin Lopez, Ken Lakies, Ray McFarlin and Tommy Montoya. VLBA Site Technicians Tom Baldwin and Don Haenichen assisted in all areas of antenna maintenance throughout the visit.

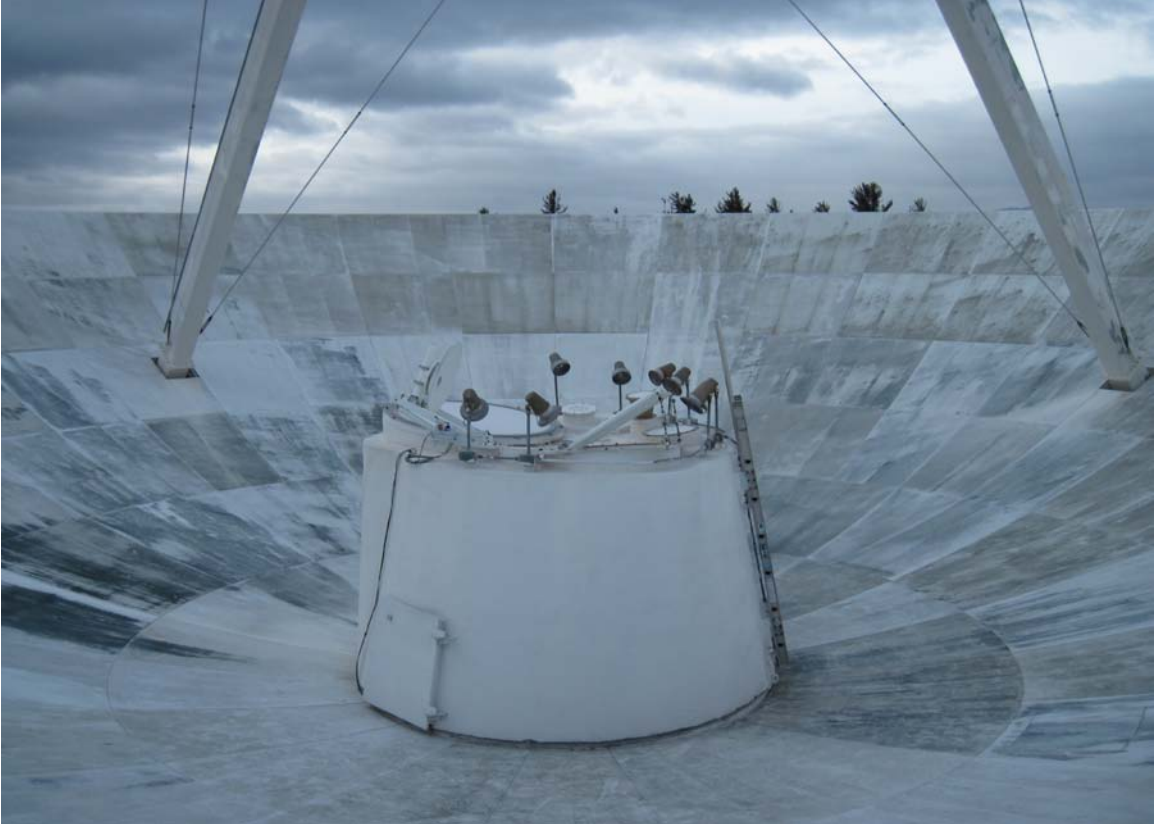
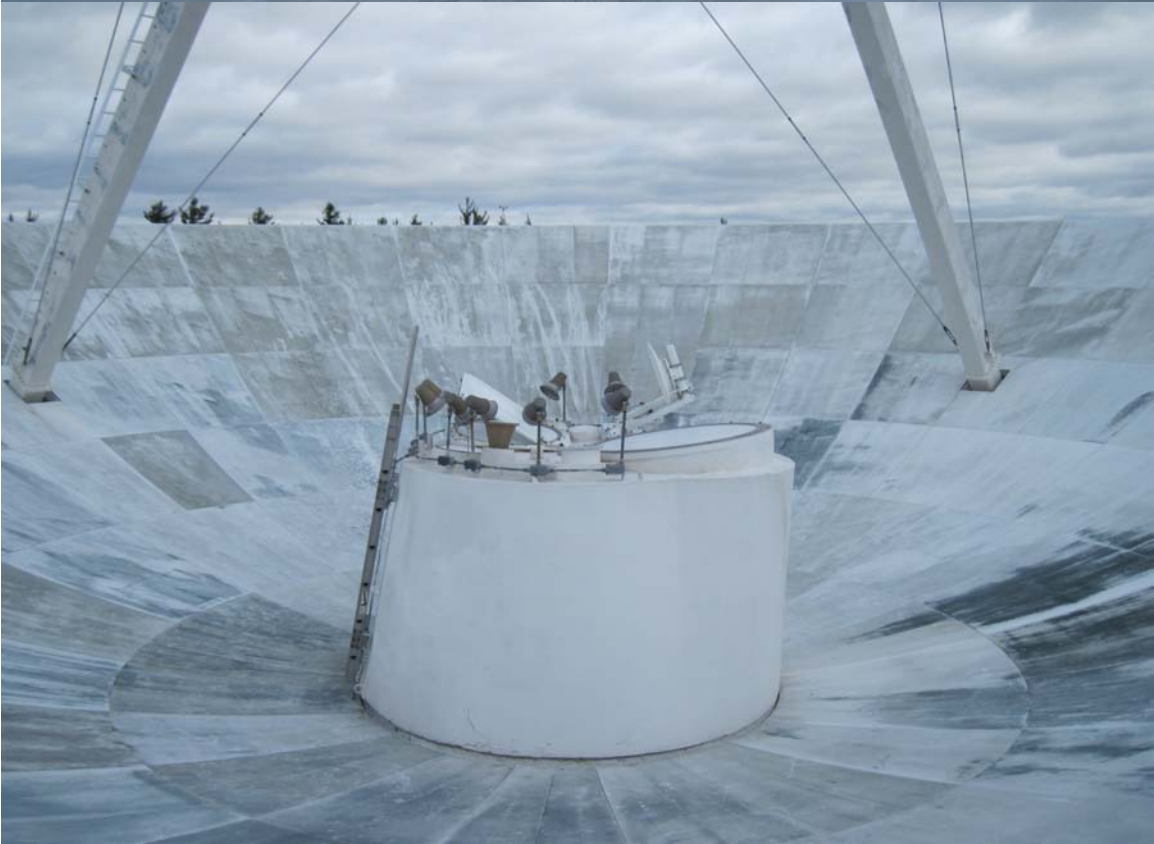
The Sub Reflector is in good condition.

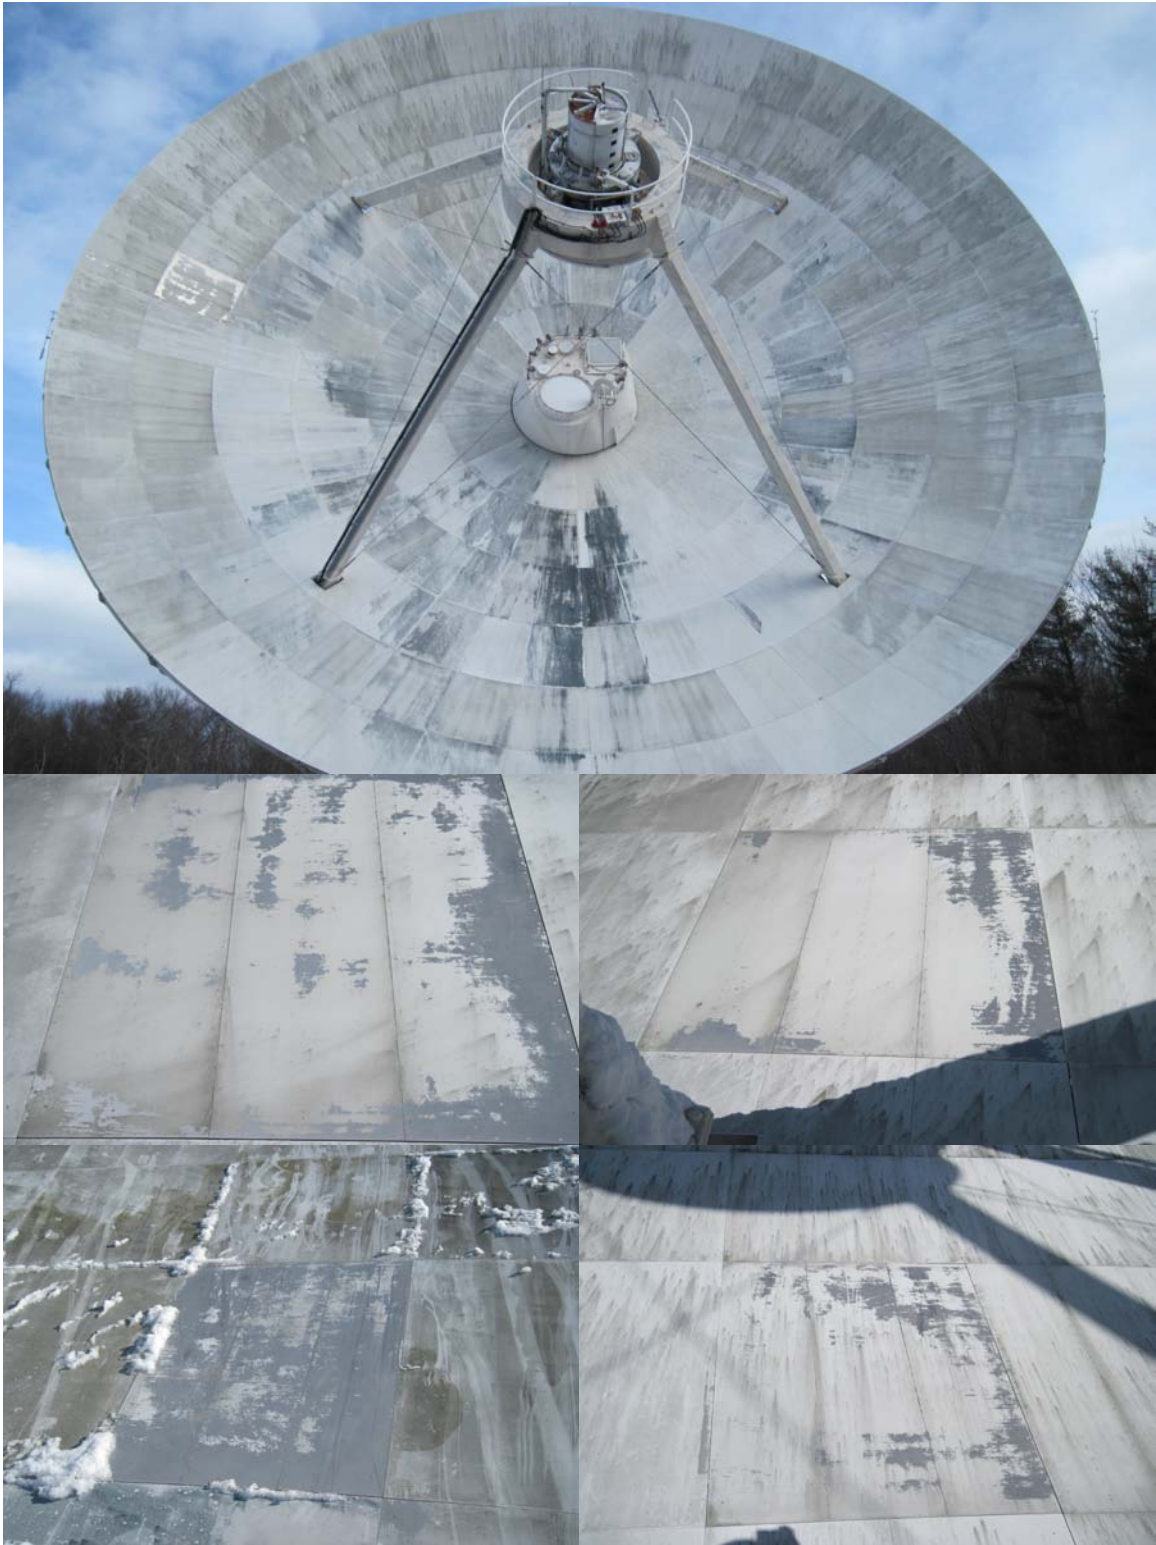
Paint is deteriorating on a few dish panels. All dish panels are stained with mold.

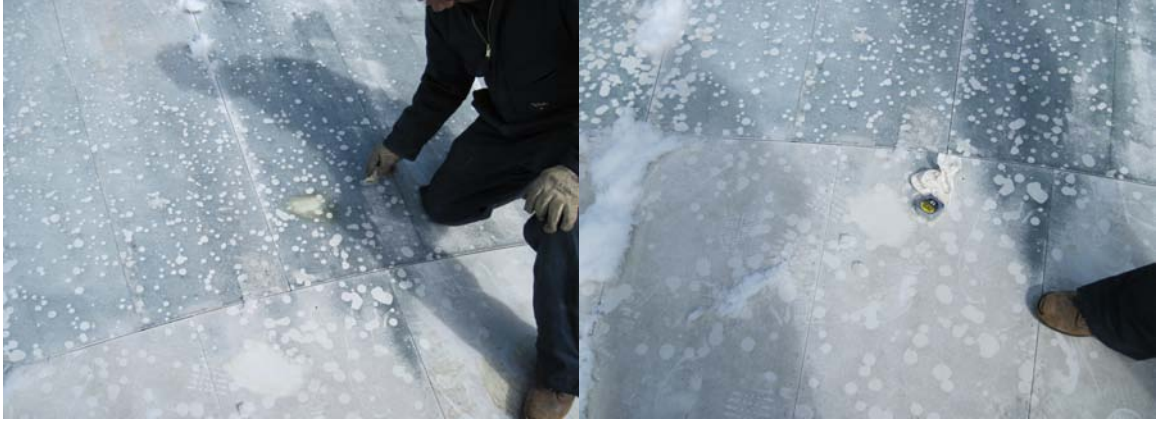
Simple Green cleaner is very effective removing mold off the dish panels.

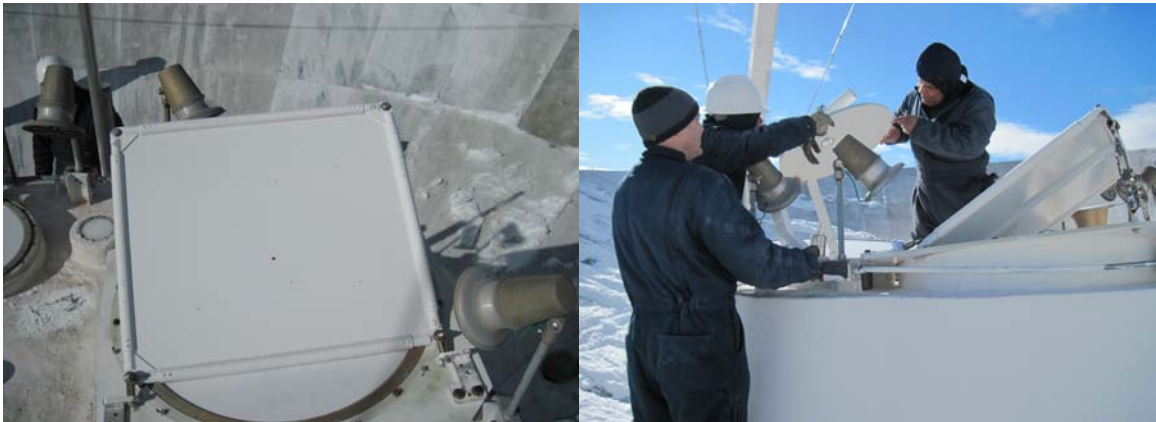
The Dichroic reflector was replaced. The Ellipsoid reflector needed realignment. Ellipsoid actuator operates correctly and is good condition.

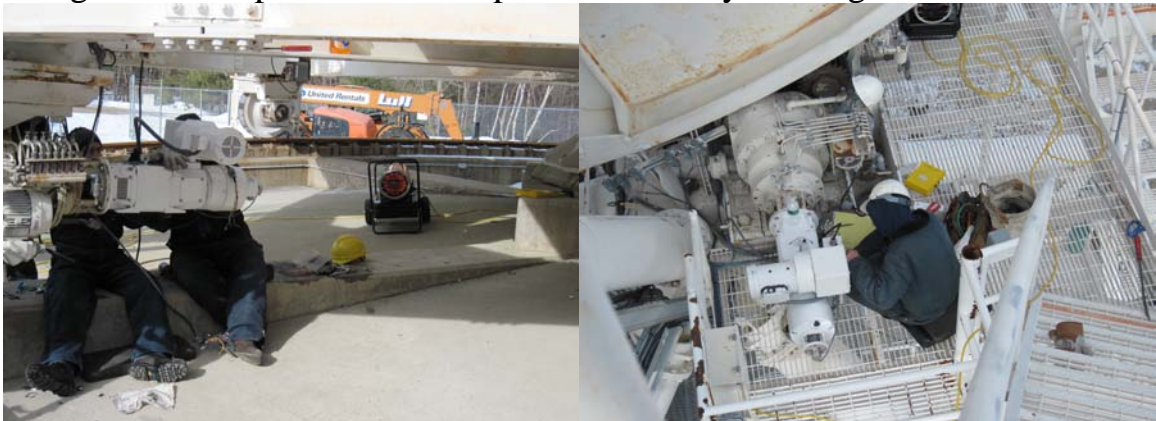
Azimuth #2 motor and Elevation # 1 motor were replaced.

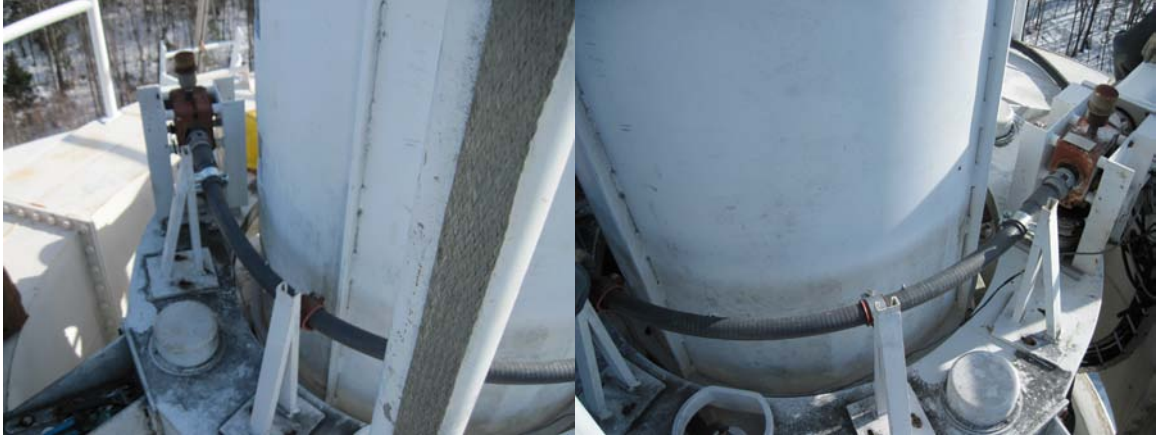
The FRM was given thorough inspection and the focus flex shaft was replaced. FRM is very well lubricated.

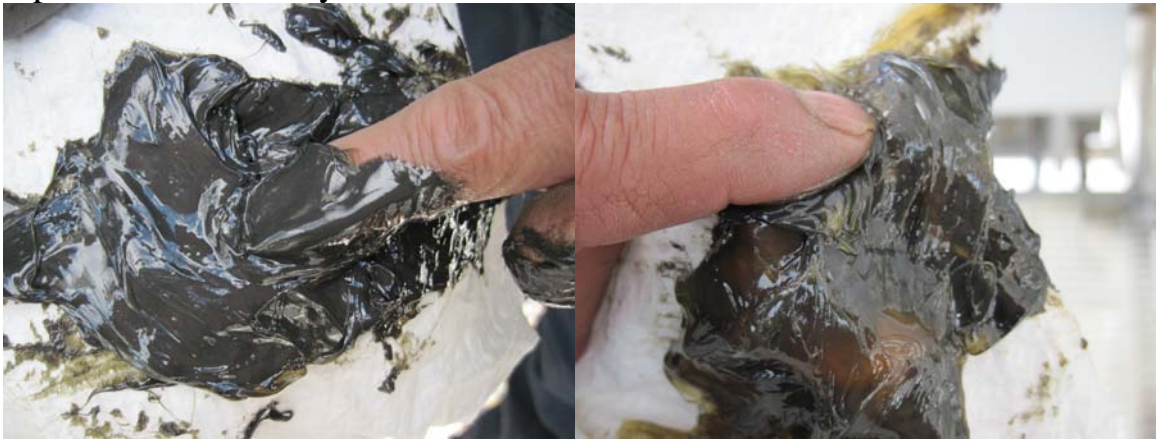
A grease inspection of the synchro and encoder elevation bearings revealed small brass and steel particles in both bearings

Encoder	Good grease with a few metal flakes.
Synchro	Good grease with a few metal flakes.
All bearings are very well lubricated.	
Pintle is very well lubricated. Grease revealed no signs of metal.

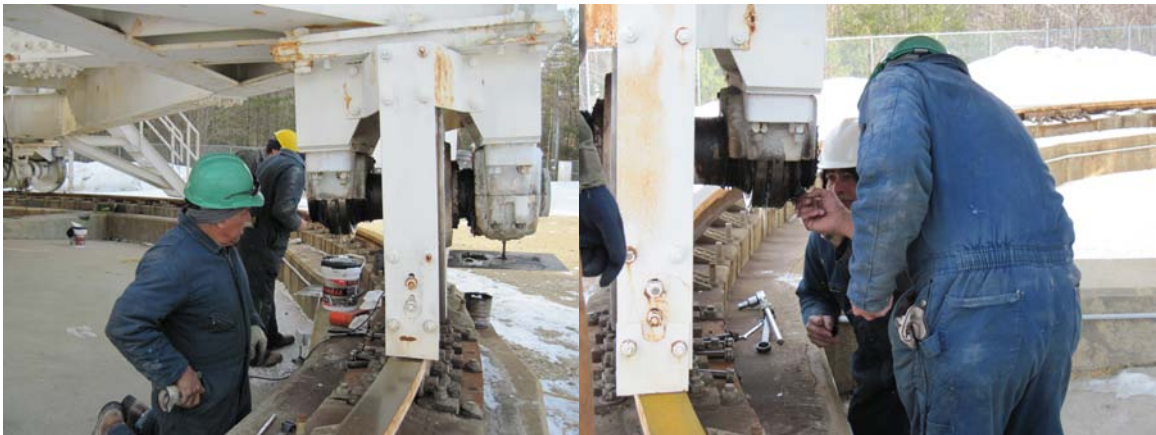
No Azimuth idler wheel bearings needed replacement.

INNER BEARING	OUTER BEARING
D1	New Wheel.	New Wheel.
D2	New Wheel.	New Wheel.
I1	Good, no metal.	Good, no metal.
I2	Good, no metal.	Good, no metal
All bearings are very well lubricated.

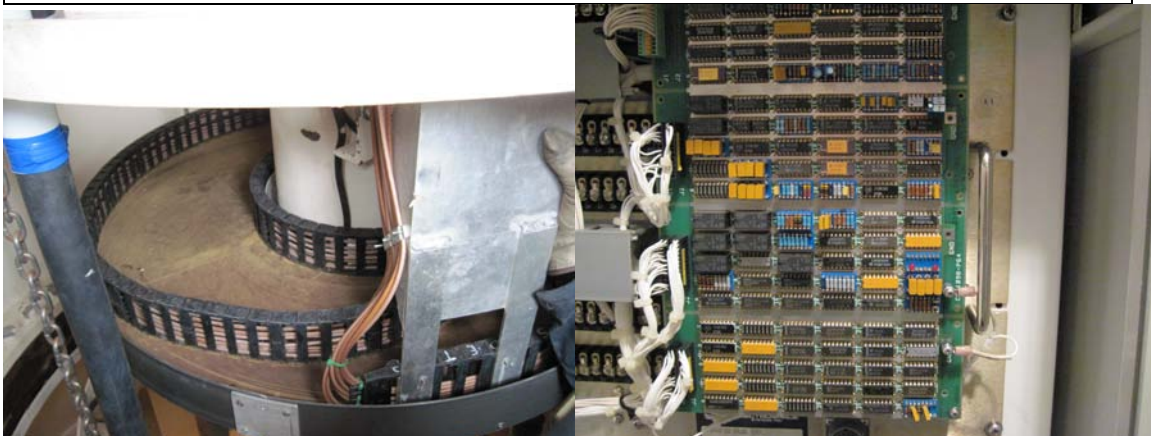
Cable wrap is in good condition. Reverse preload modification was installed.

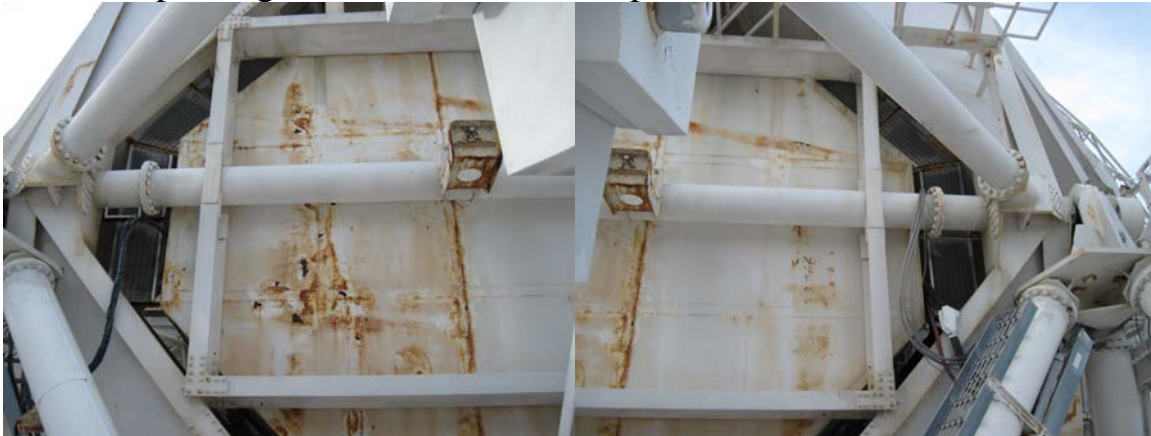
Elevation axle has no visible signs of cracks. Paint is in poor condition with lots of surface rust eating through it.

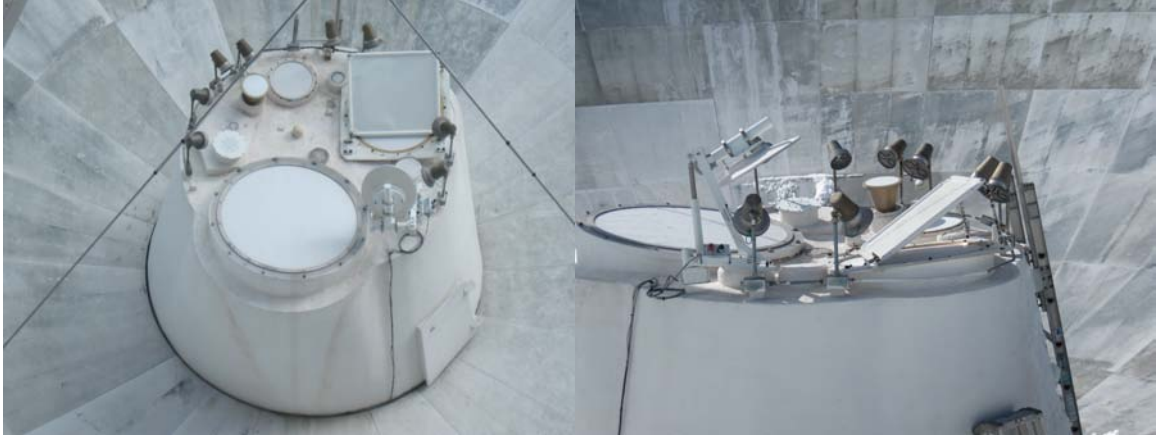
Feed cone feed heaters and FE windows are in good condition.

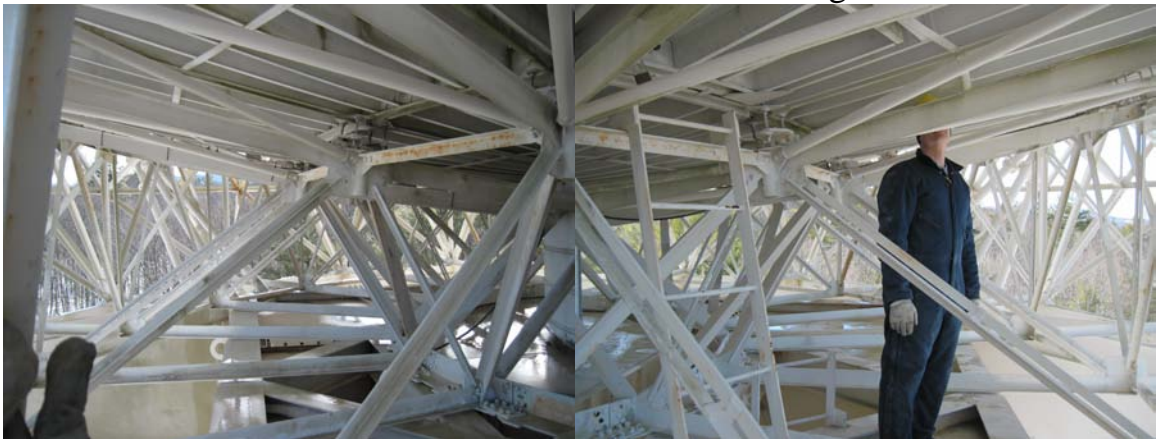
Antenna backup structure is in good condition. Paint is in fair condition with lots of surface rust.

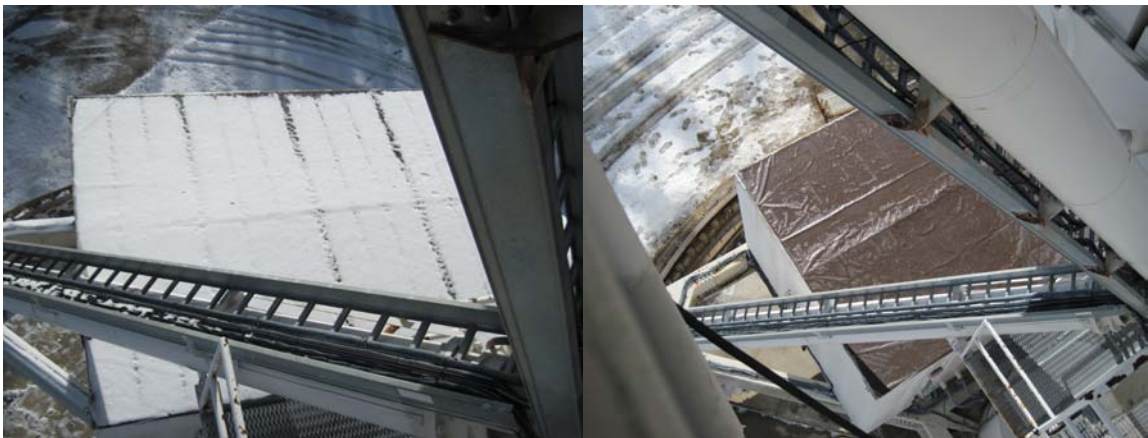
The antenna pedestal room roof has deteriorated so much that the site technicians attached a tarp to keep moisture from leaking into the Servo and FRM electronics. This roof needs replaced ASAP.

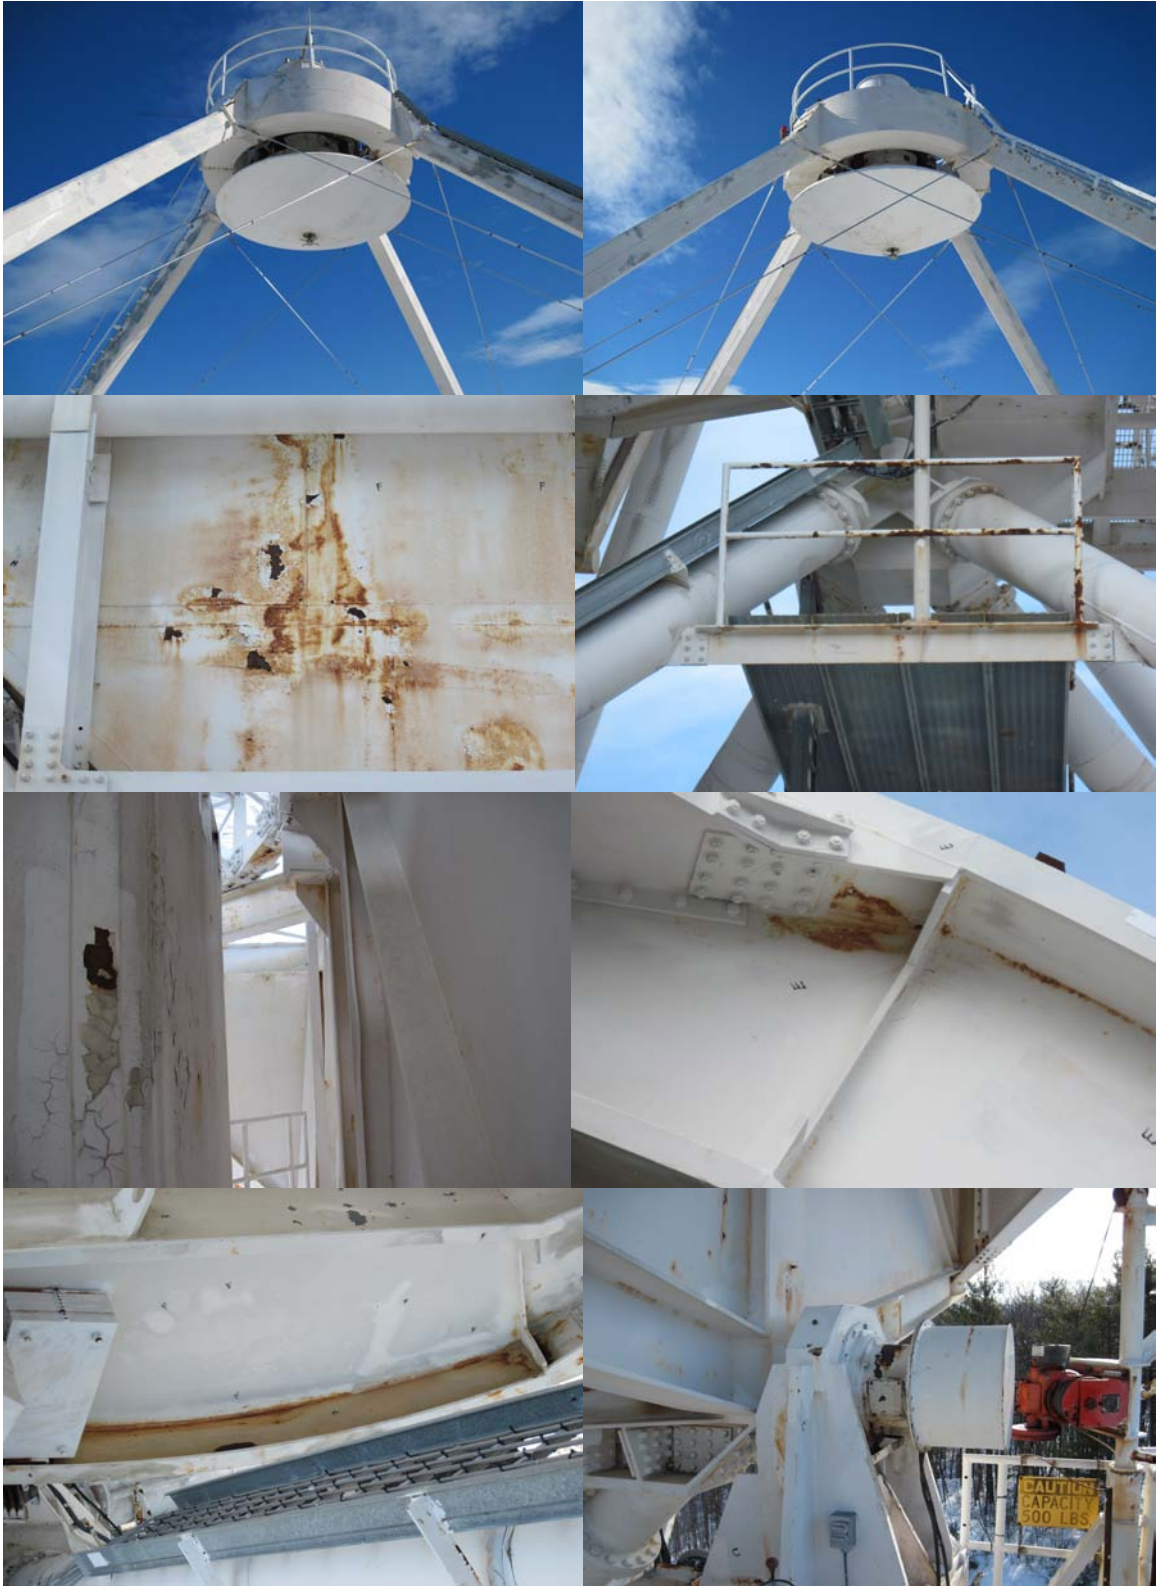
Antenna paint condition is fair to poor, with allot of surface rust.

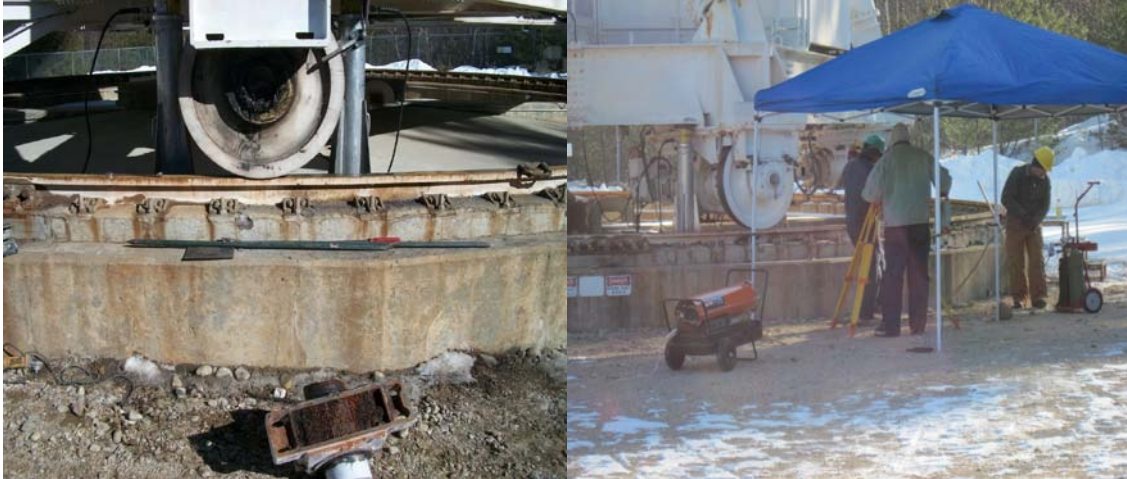
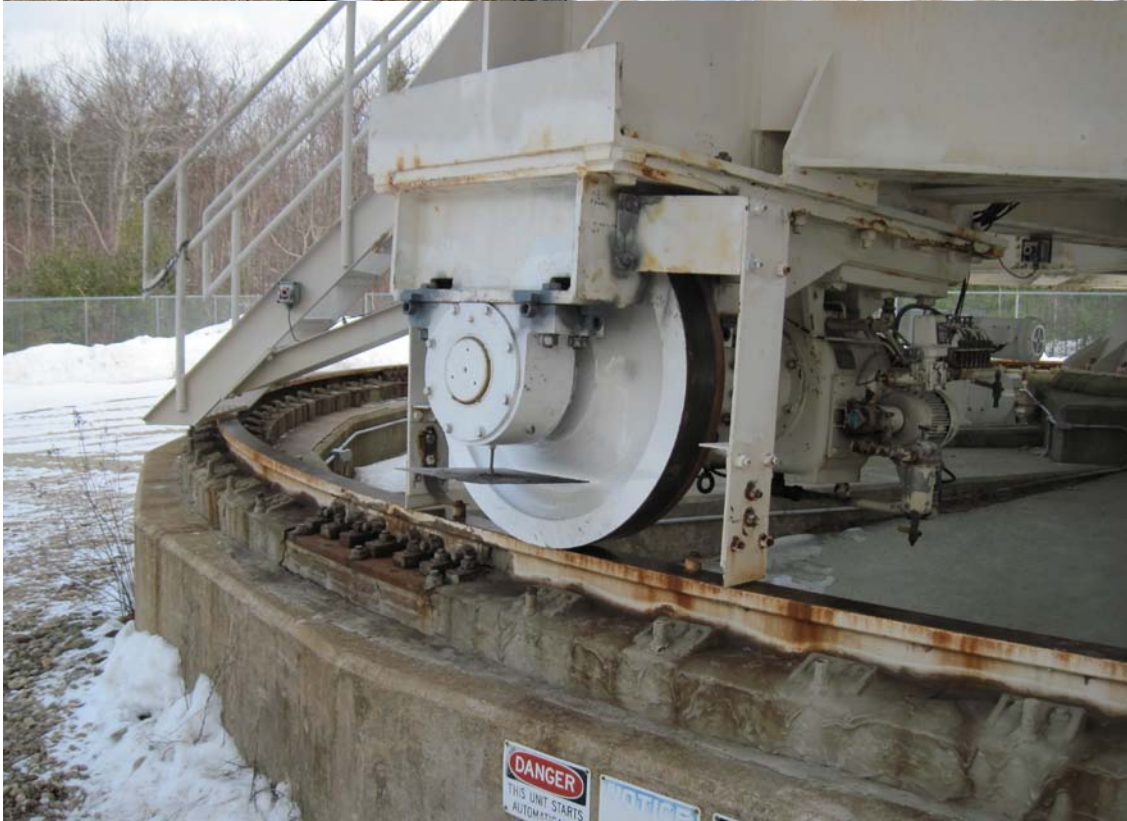
Azimuth #2 Drive Wheel assembly was replaced. The new drive wheel assembly rotated smoothly without any popping or grinding noises.

MEASURED	SPECIFIED
Conic Radius	300.260	300.00 +/- .25
Coupling Runout	.001	<.005
Vertical	93.458	93.440 +/- .023
Horizontal	.020	<.023

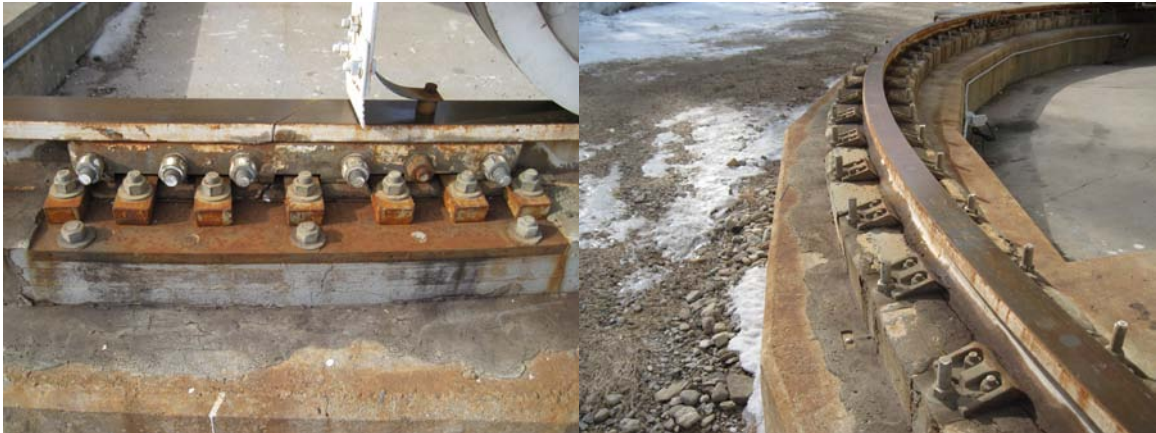
The last 180 degrees of rail is scheduled to be repaired in July 2010.
