National Radio Astronomy Observatory
Socorro, New Mexico
VLBA Antenna Memo #81

Fort Davis, Texas VLBA Maintenance Visit April 19- April 27, 2010.
Team members consisted of Eric Carlowe, Ramon Gutierrez, Ken Lakies,
Ray McFarlin, Tommy Montoya and Adrian Zamora. VLBA Site
Technicians John Smith and John Jordan assisted in all areas of antenna
maintenance.

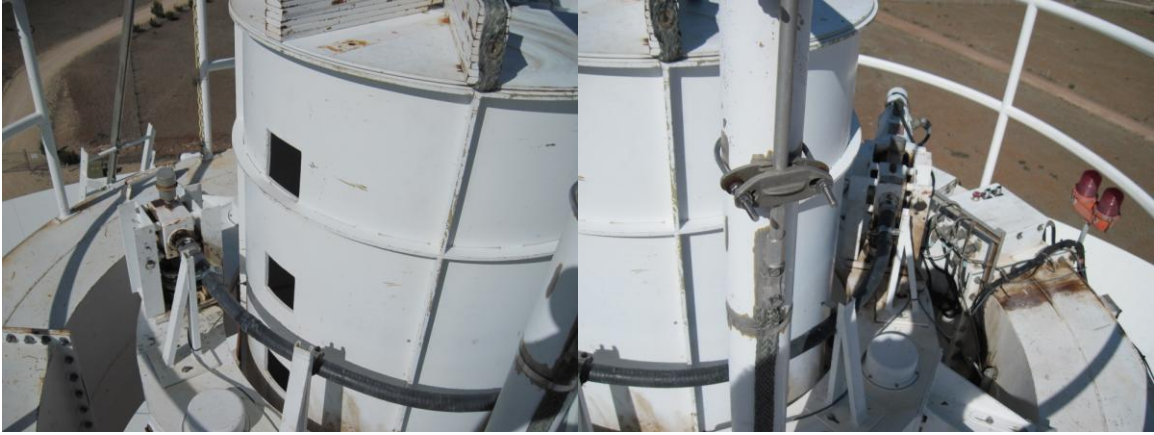
FRM was given a thorough inspection and the focus flex shaft was replaced.

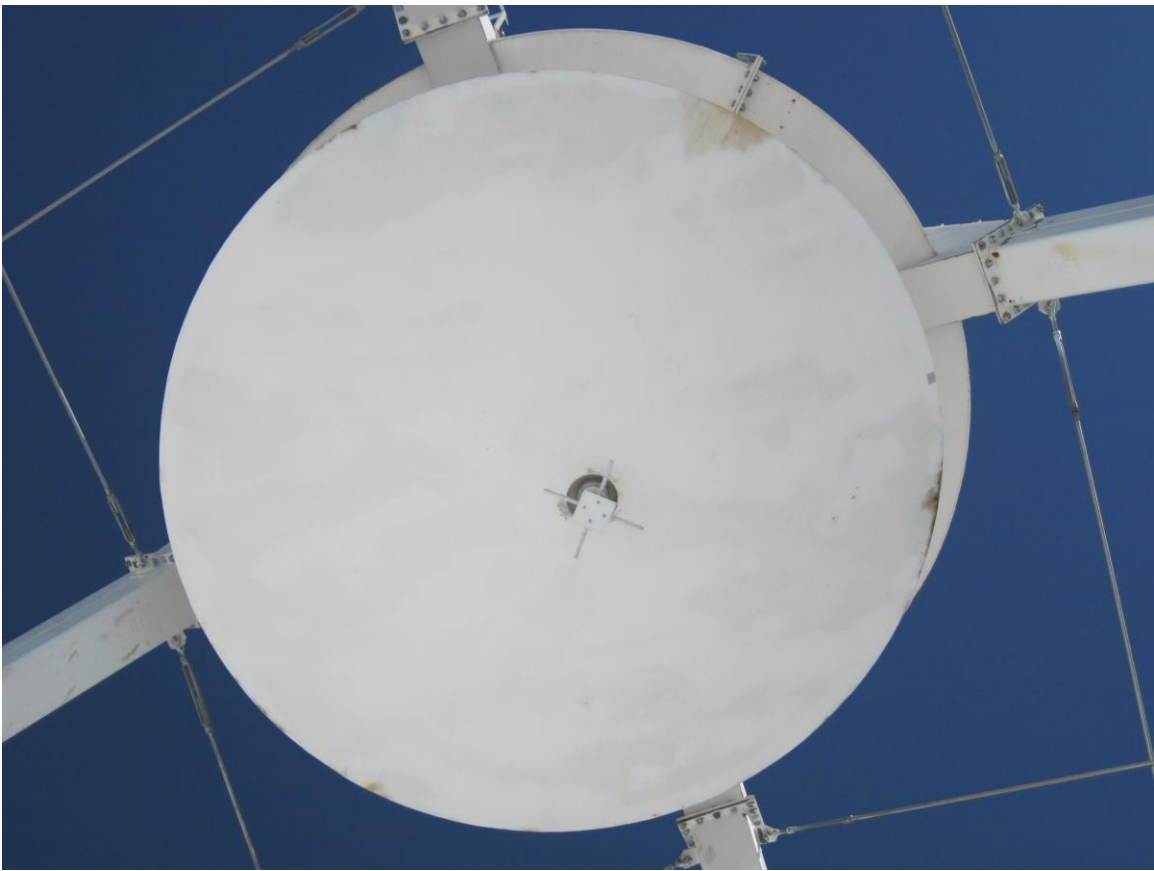
Sub reflector is in good condition.

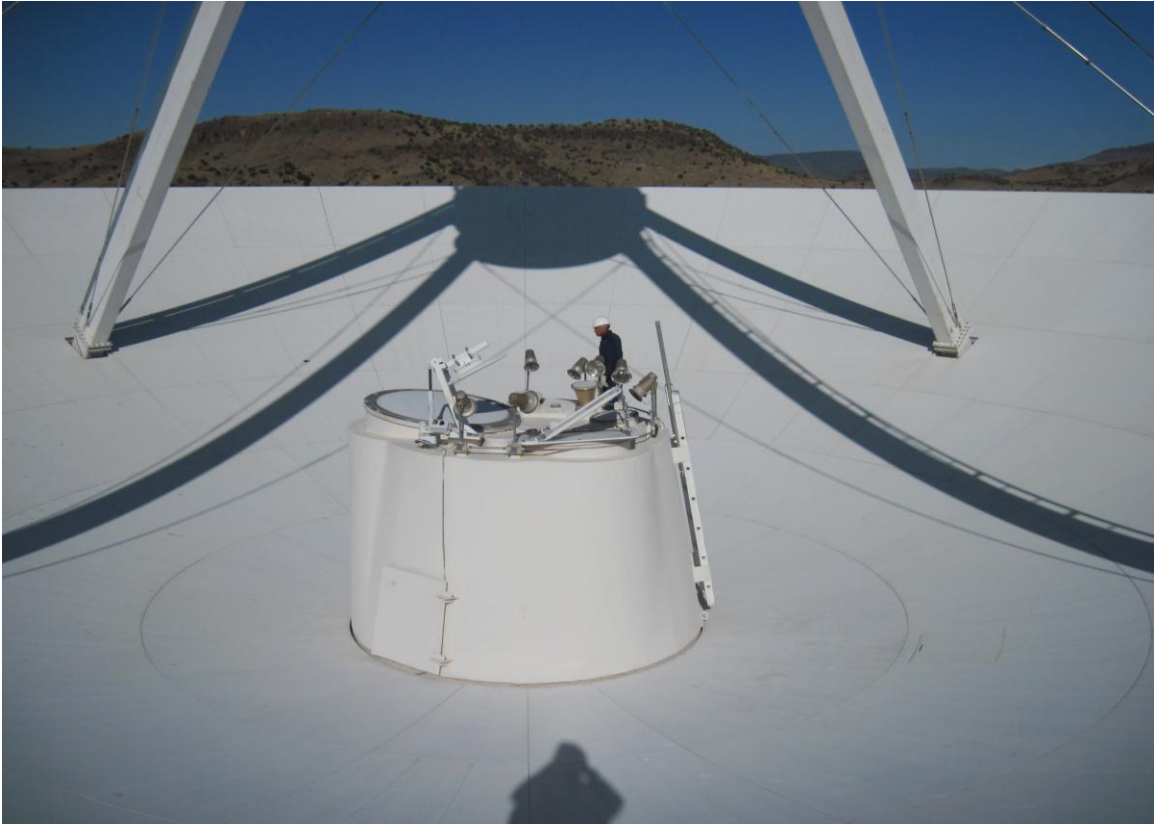
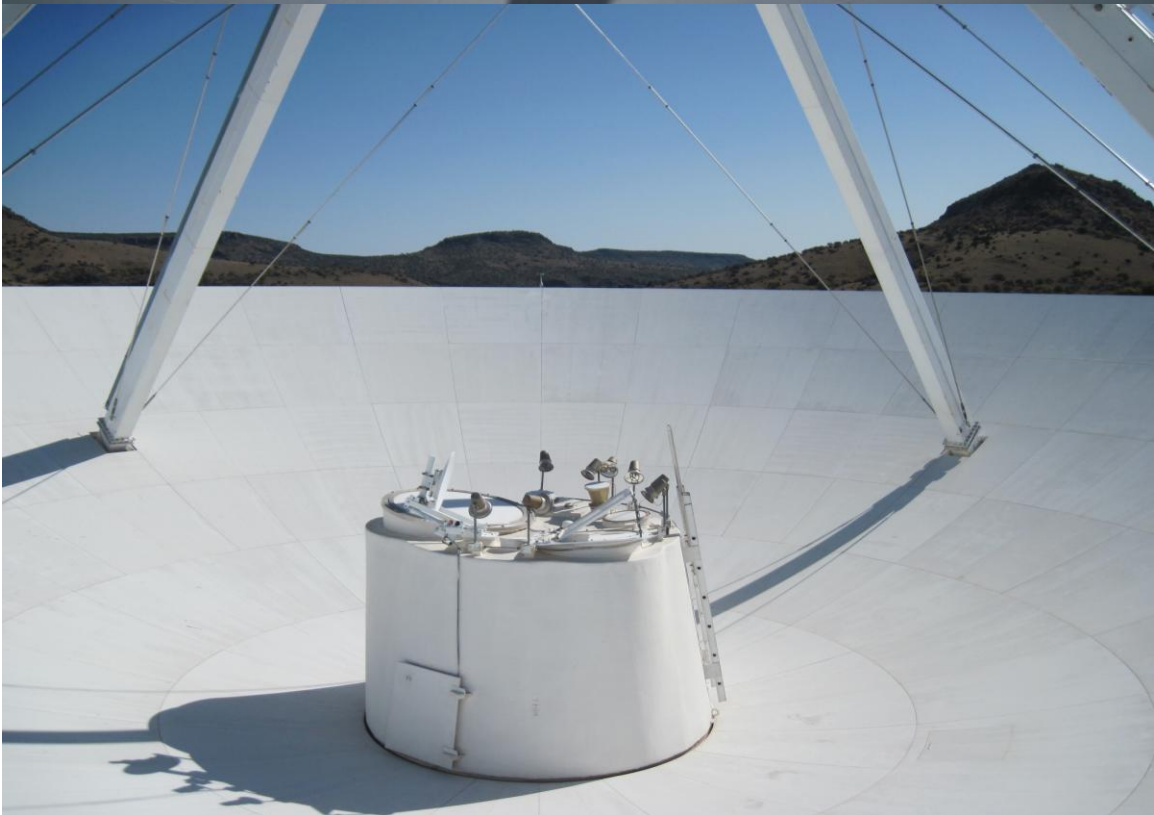
Dish panels are in good condition. The feed cone's elastomeric paint job is holding up well.

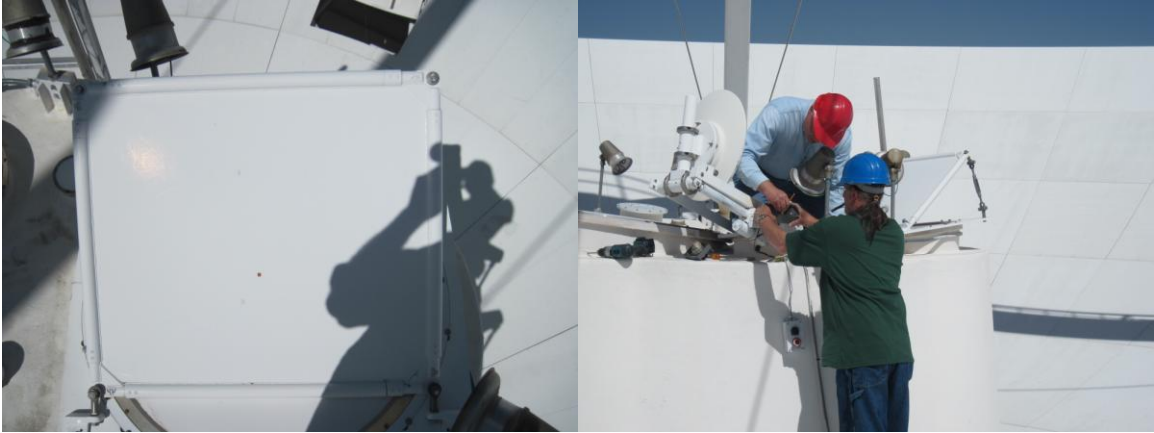
The Dichroic reflector is in good condition. The Ellipsoid reflector is in good condition. Ellipsoid actuator manual/e-stop switch was replaced.

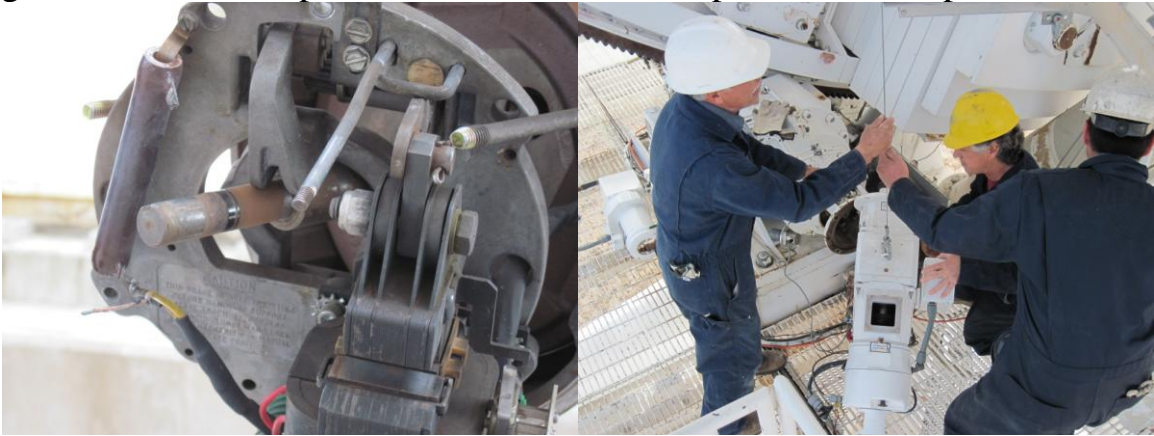
Azimuth #1 motor brake heater was repaired. Elevation # 2 motor was replaced.

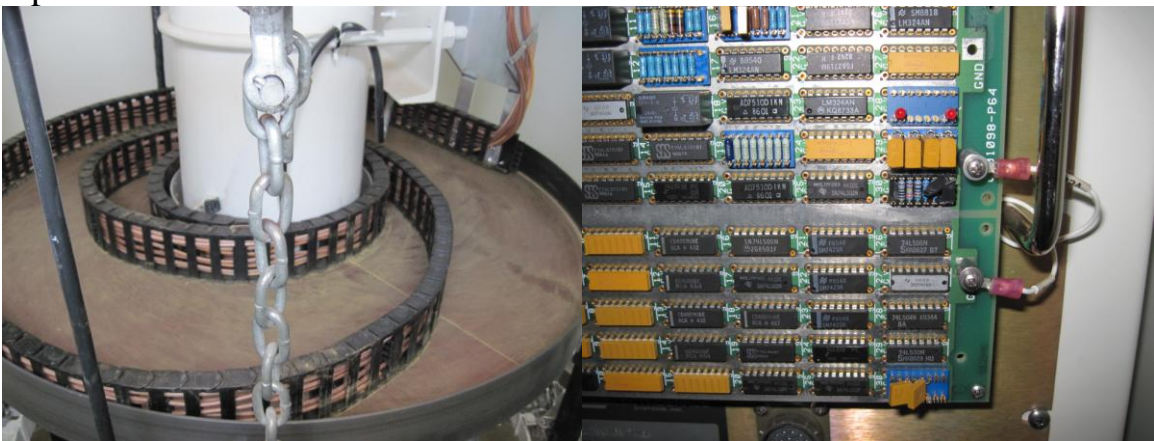
The new IF cable wrap is holding up very well. The reverse pre-load mod was installed and tested for AZ and EL.

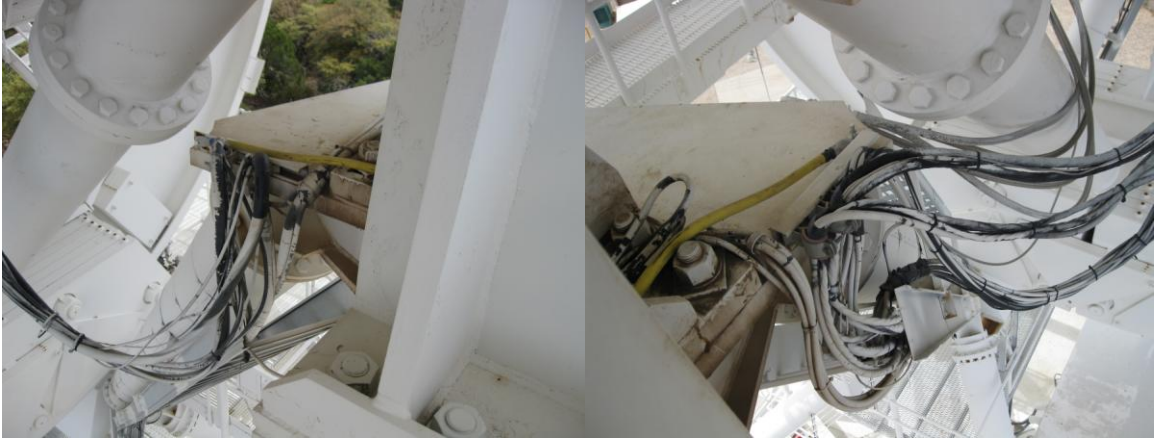
Both Elevation cable wraps are in good condition.

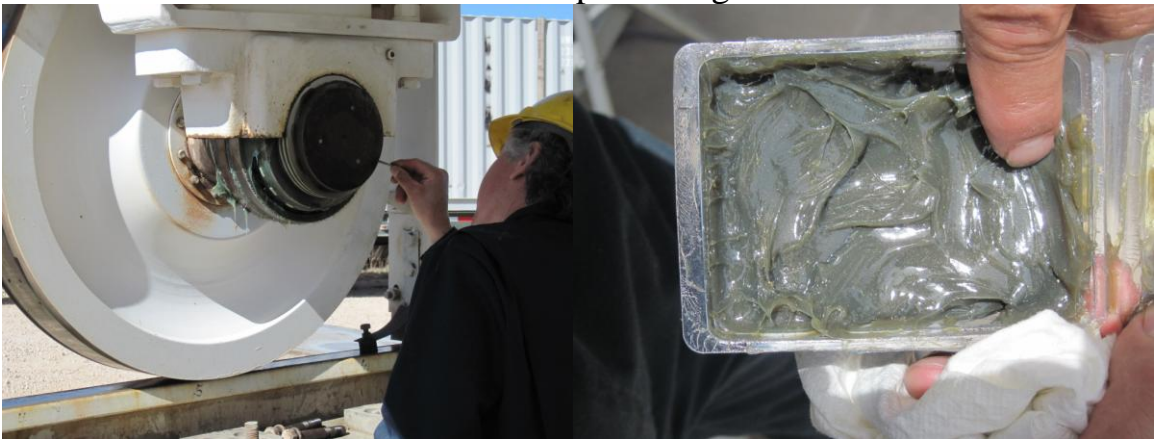
No azimuth idler wheel bearing needed replacing. The new (2/2008) Elevation encoder side bearing grease inspection revealed a lot of metal particles. Site techs will send the NRAO monthly grease samples to monitor.

Encoder	Lots of metal flakes found.
Synchro	Good grease with no metal flakes.
Both bearings are very well lubricated.	
Pintle bearing is well lubricated with no metal flakes.

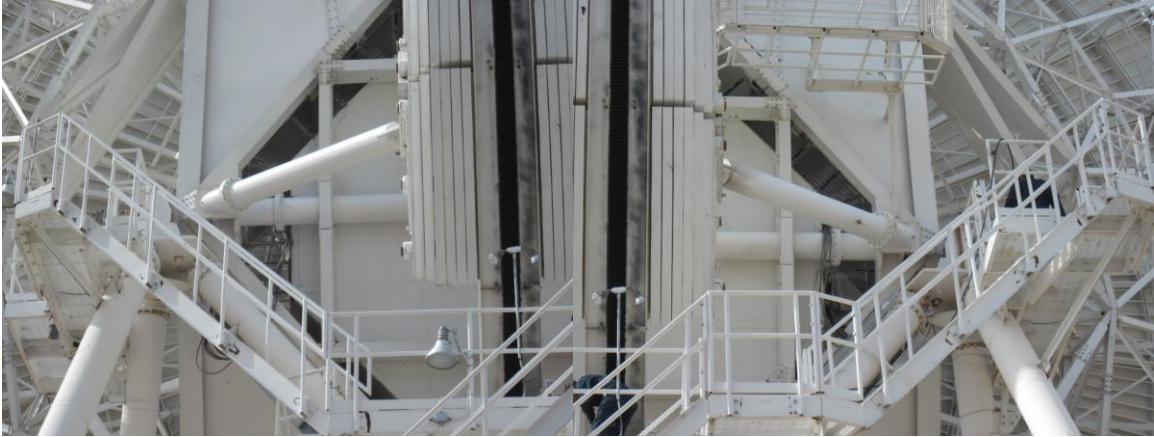
Elevation axle has no visible signs of cracks. Paint is in good condition.

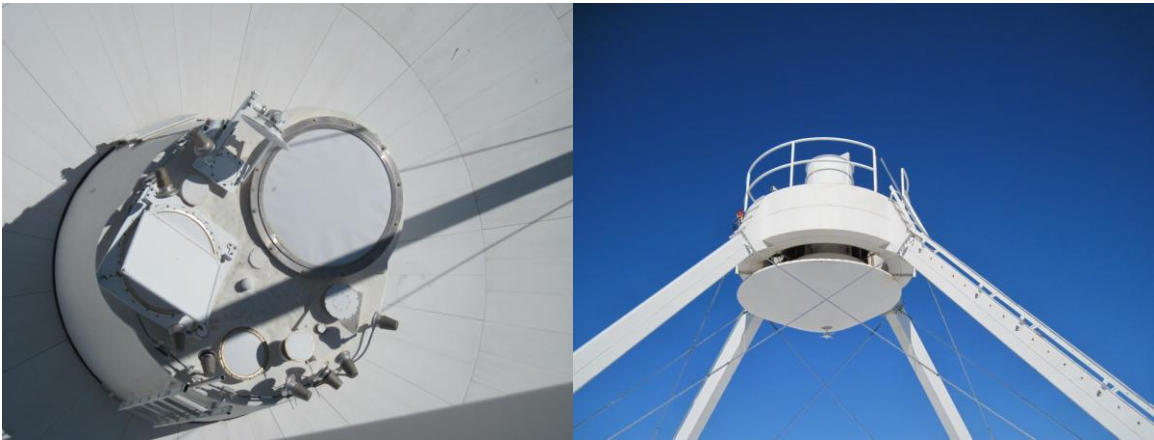
The feed heaters and FE windows are in good condition. Apex paint is in good condition.

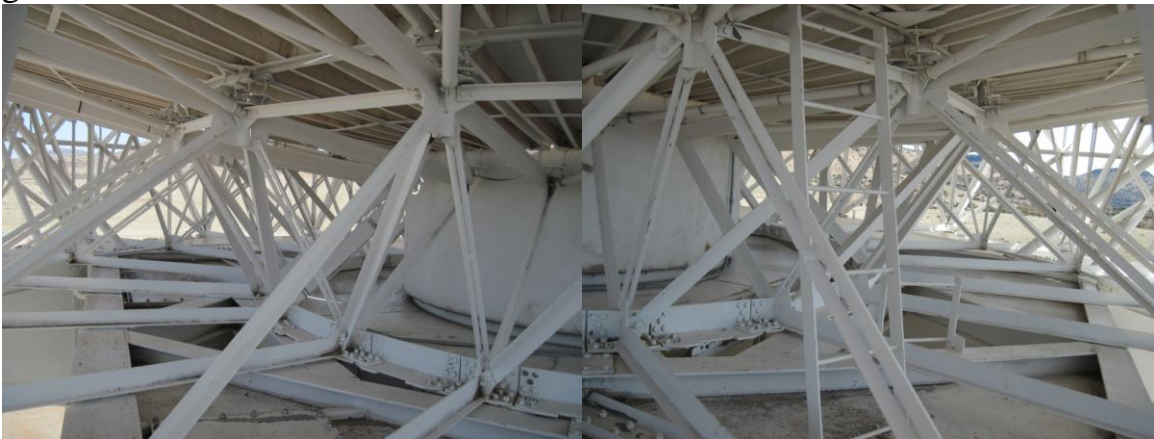
Antenna backup structure is in good condition. Paint is in good condition.

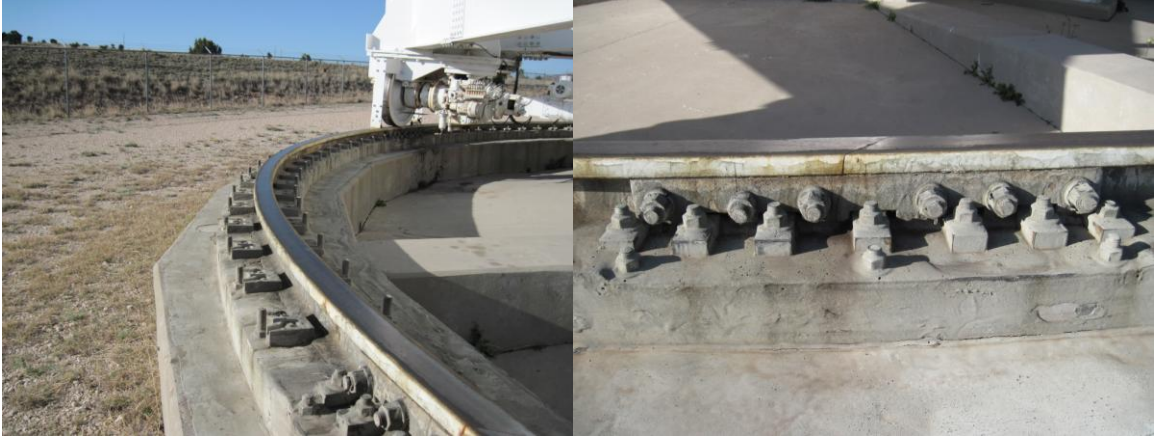
The Fort Davis rail is in good condition.
