National Radio Astronomy Observatory  
Socorro, New Mexico  
VLBA Antenna Memo #85

Owens Valley, California VLBA Maintenance Visit June 9-15, 2011.  
Team members consisted of Mike Burgert, Eric Carlowe, Ramon Gutierrez,  
Ken Lakies, Ray McFarlin, Martin Lopez and Steve Tenorio. VLBA Site  
Technician Jim Brown assisted in all areas of antenna maintenance.

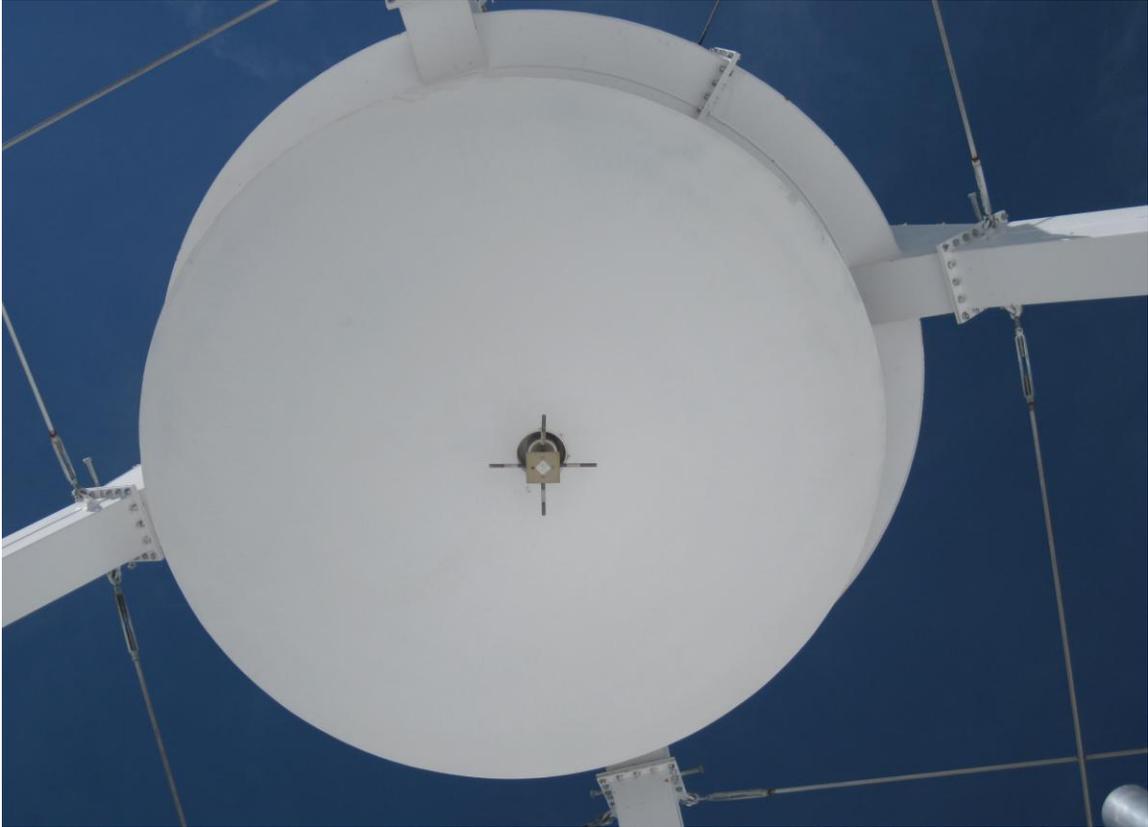
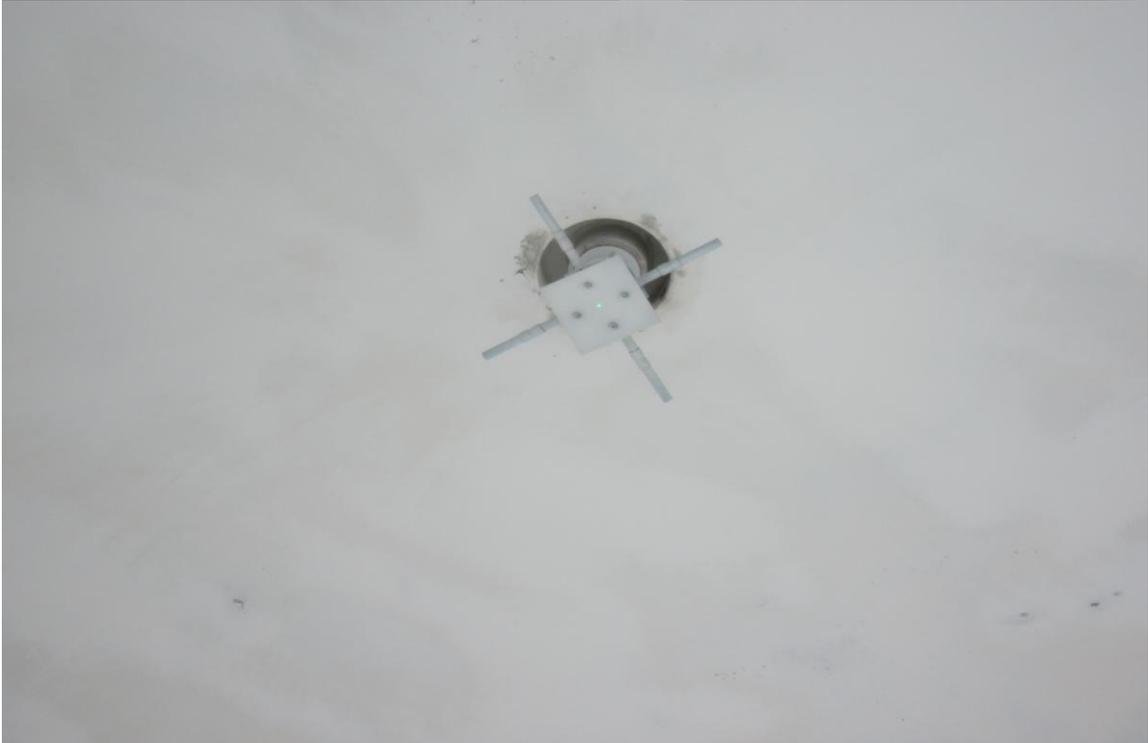
Sub reflector paint is in great condition. FRM was given a thorough inspection and the focus flex shaft was replaced. FRM is well lubricated.

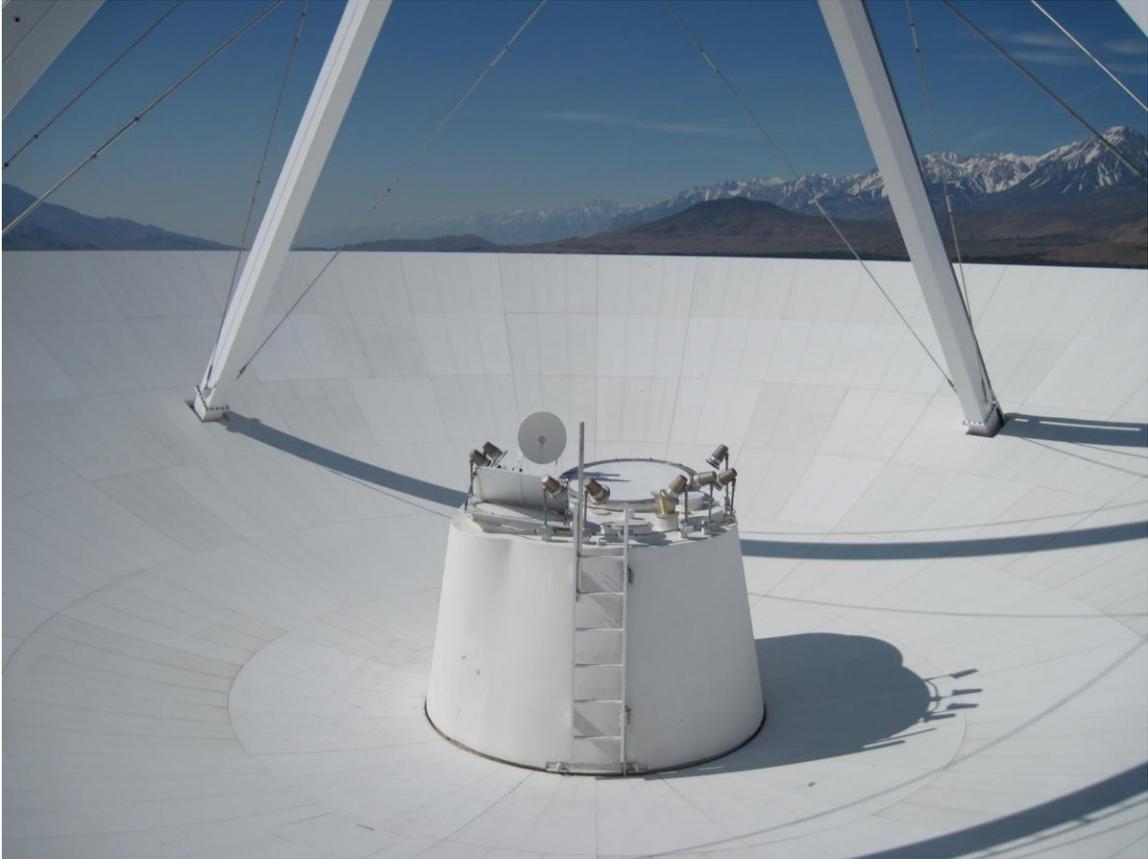
Dish panels are in good condition. The feed cone's elastomeric paint is holding up well. The feed cone was sealed and painted back in 9/2004.

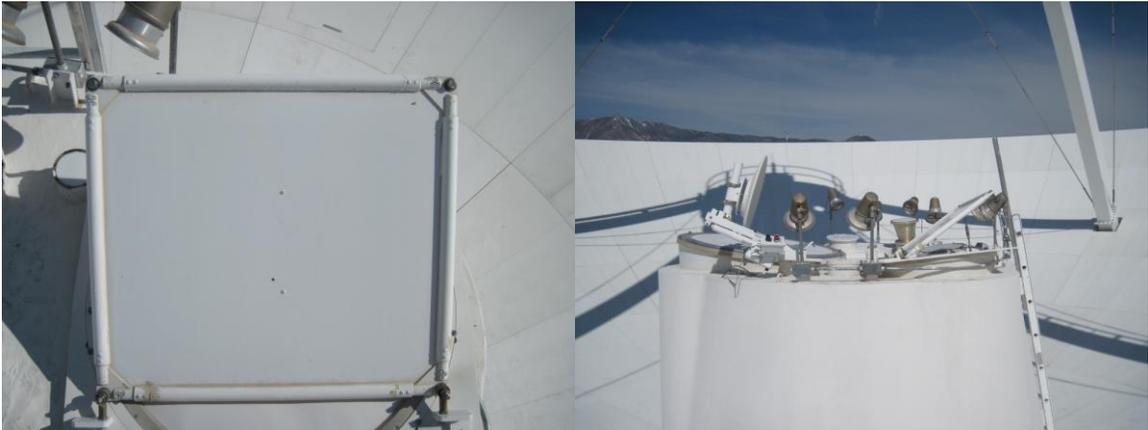
Dichroic reflector is in good condition. Ellipsoid reflector is in great condition and the actuator operates correctly.

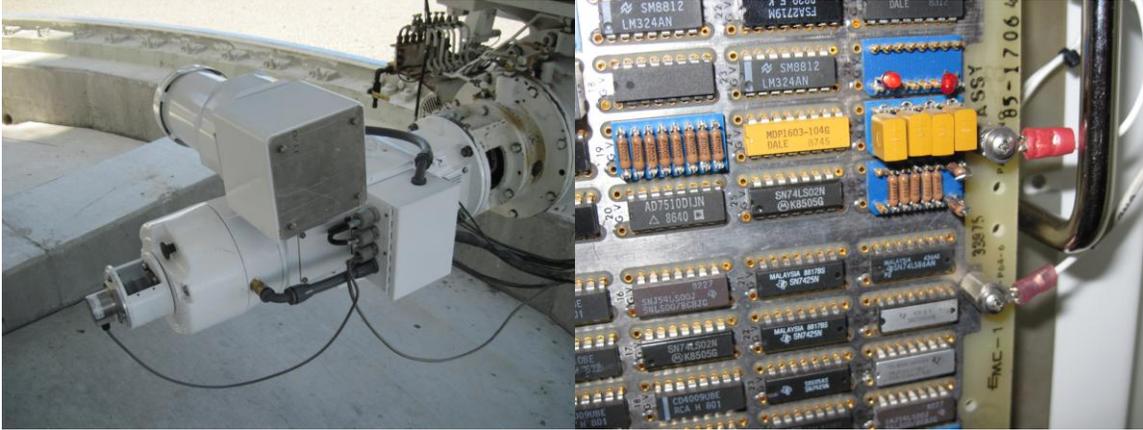
Azimuth motor #2 was replaced. AZ and EL gearbox preload were reversed.

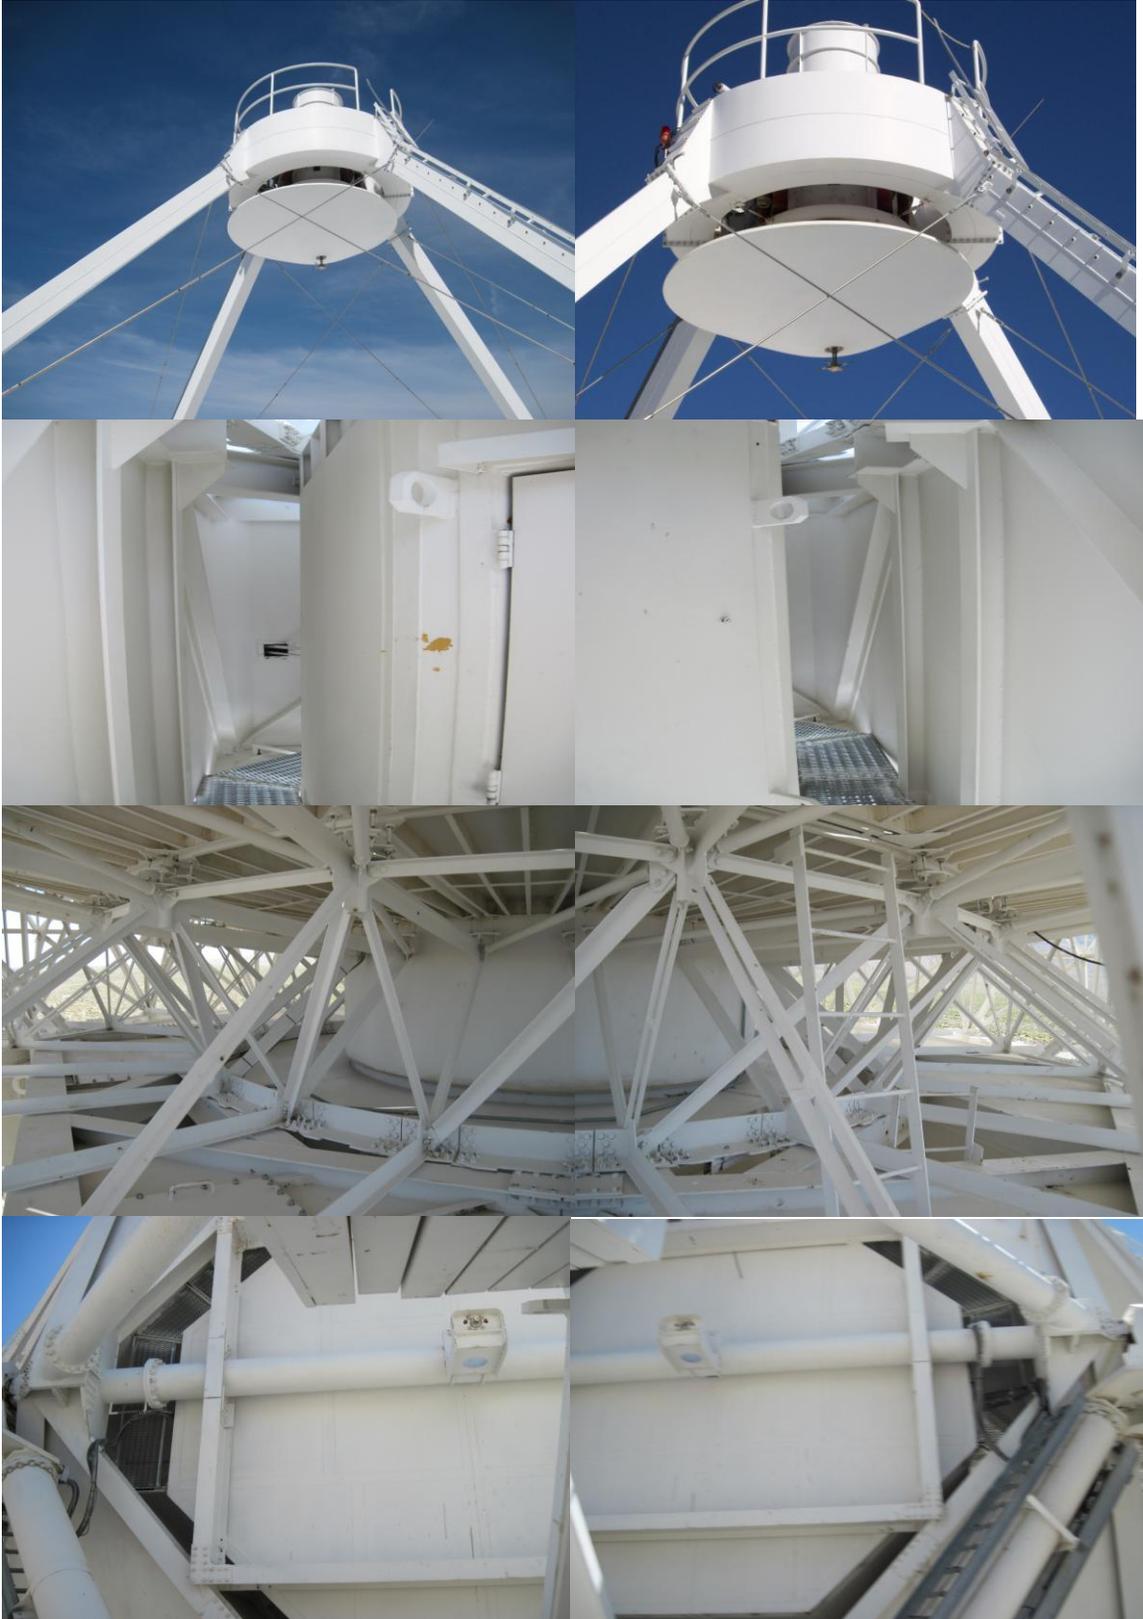
Site techs regularly pressure wash the antenna. Paint condition is excellent.

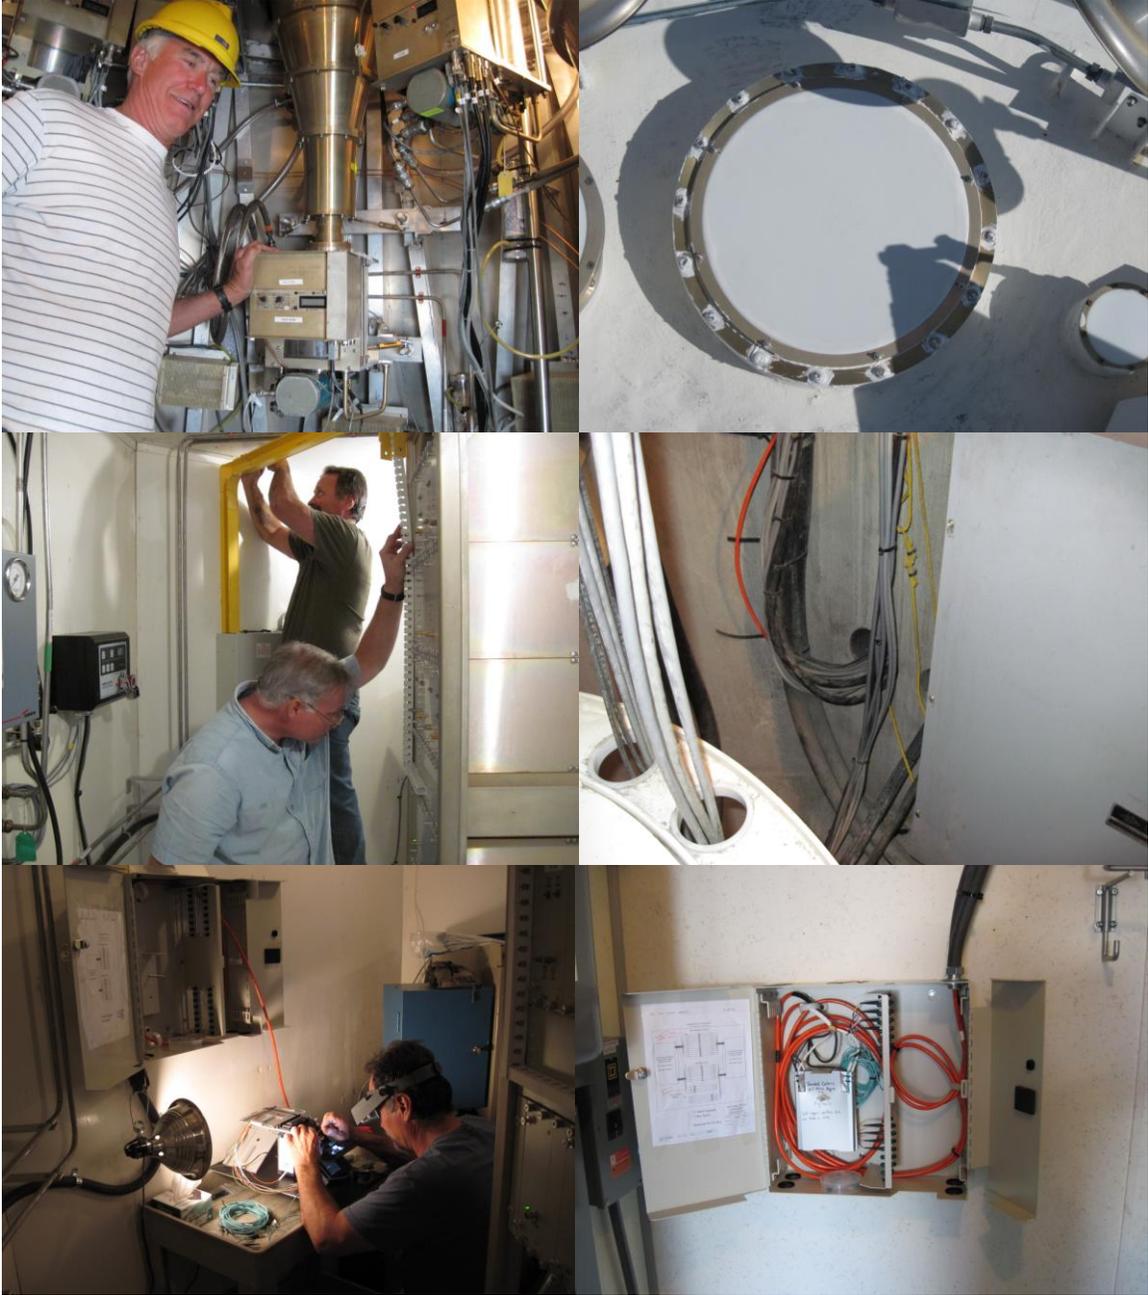
The C-Band Feed and Fiber installation was completed.

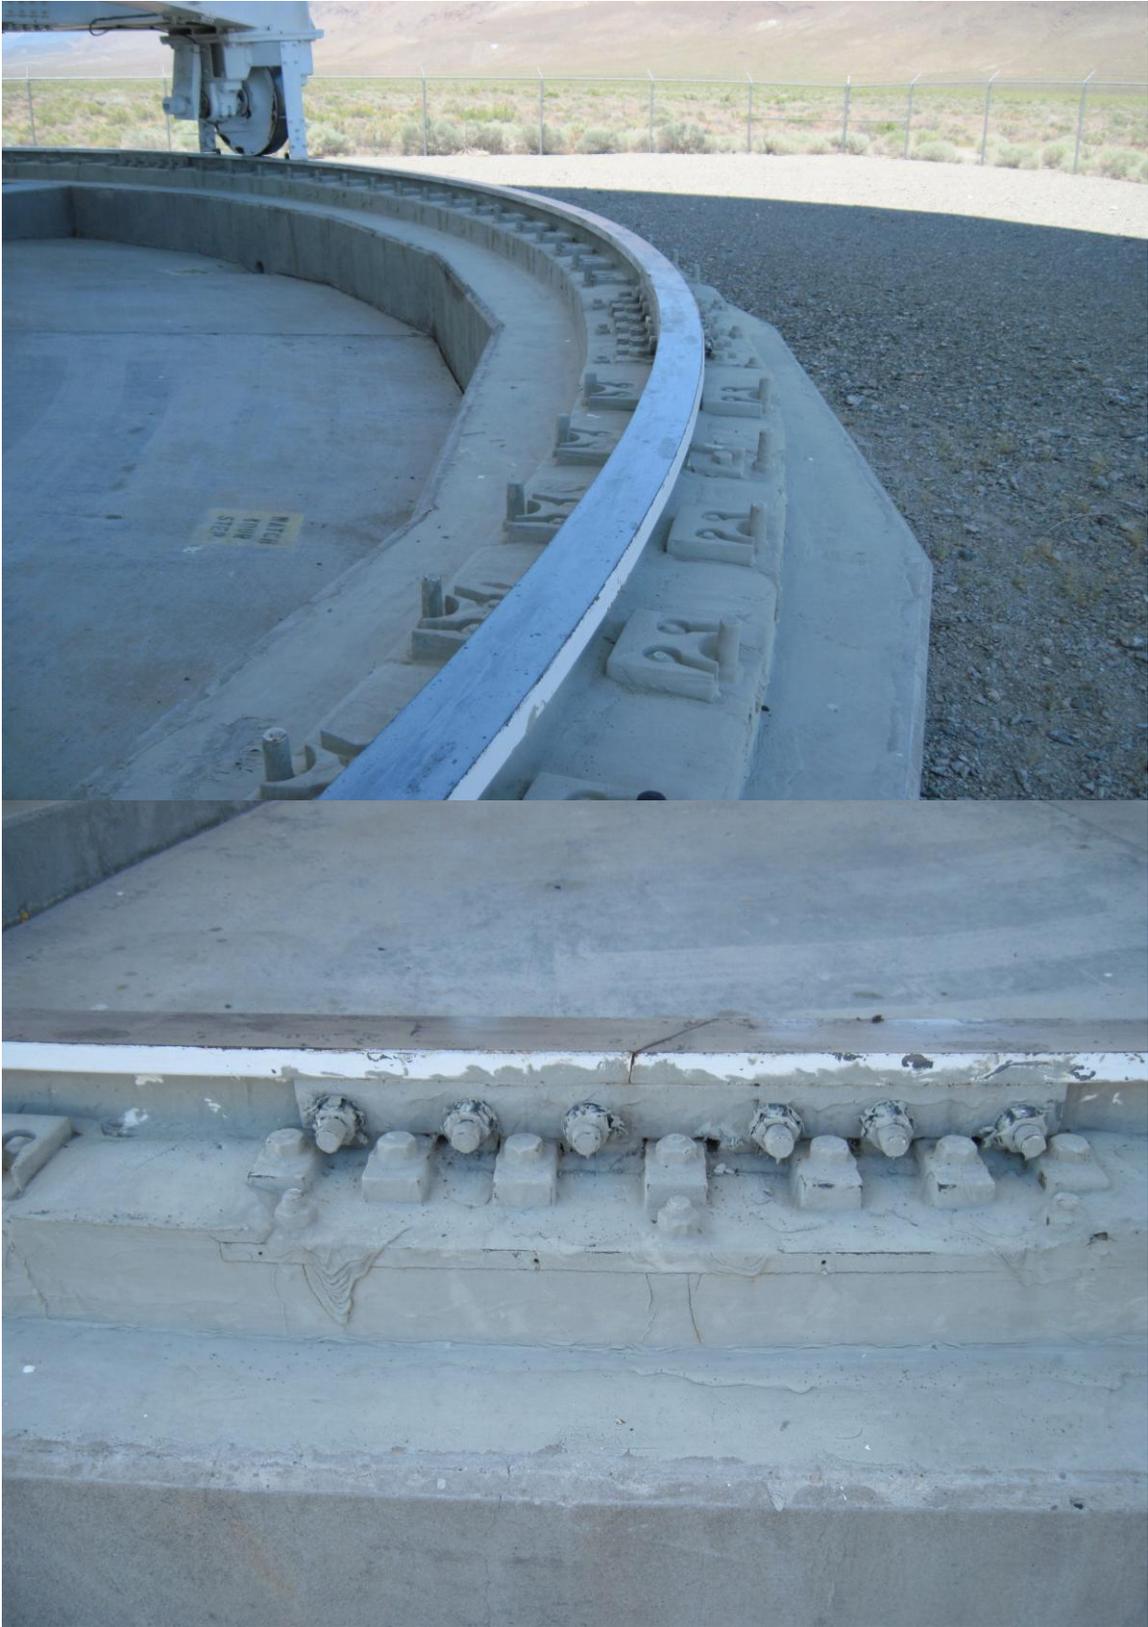
The antenna's rail and grout is in great condition.
