NATIONAL RADIO ASTRONOMY OBSERVATORY
Socorro, New Mexico

VLBA Antenna Memo Series No.90

2015 - St Croix Corrosion Report

J. E. Thunborg
August 12, 2015

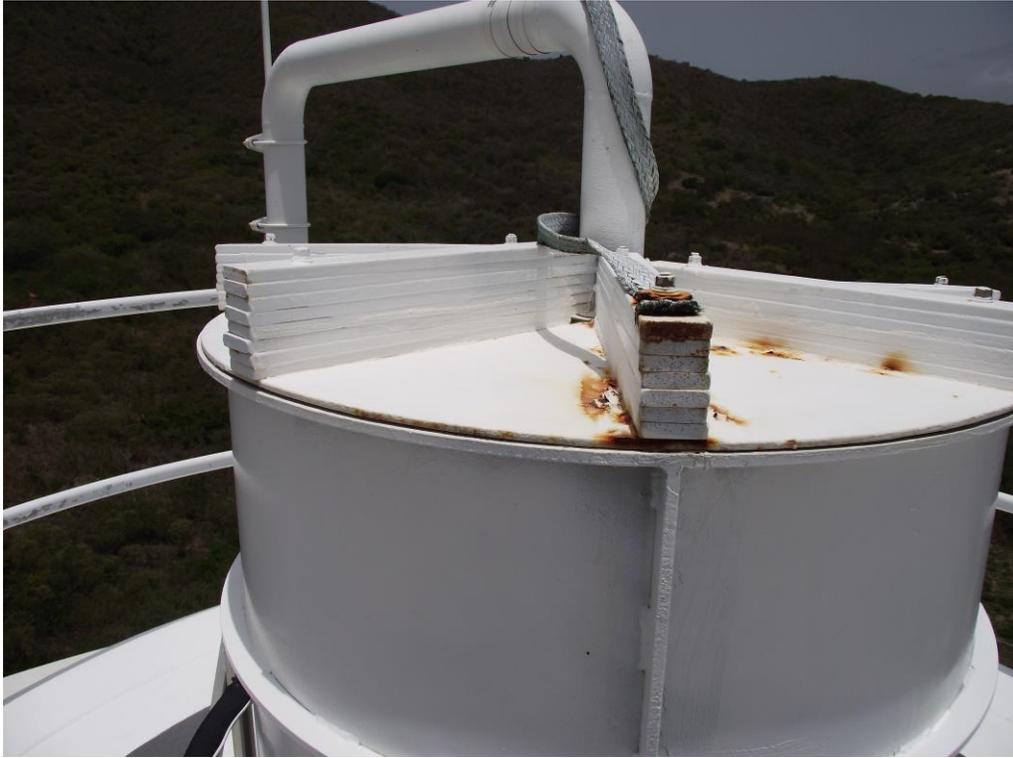
The corrosion on the upper part of the quad legs and donut structure is minimal. The bolted connections where the Quad legs attach to the donut shaped structure are showing rust staining due to corrosion of the fasteners. There is also superficial corrosion on the FRM counterweights and other locations (Figure 1).

Figure 1, Superficial corrosion at FRM barrel counterweights.

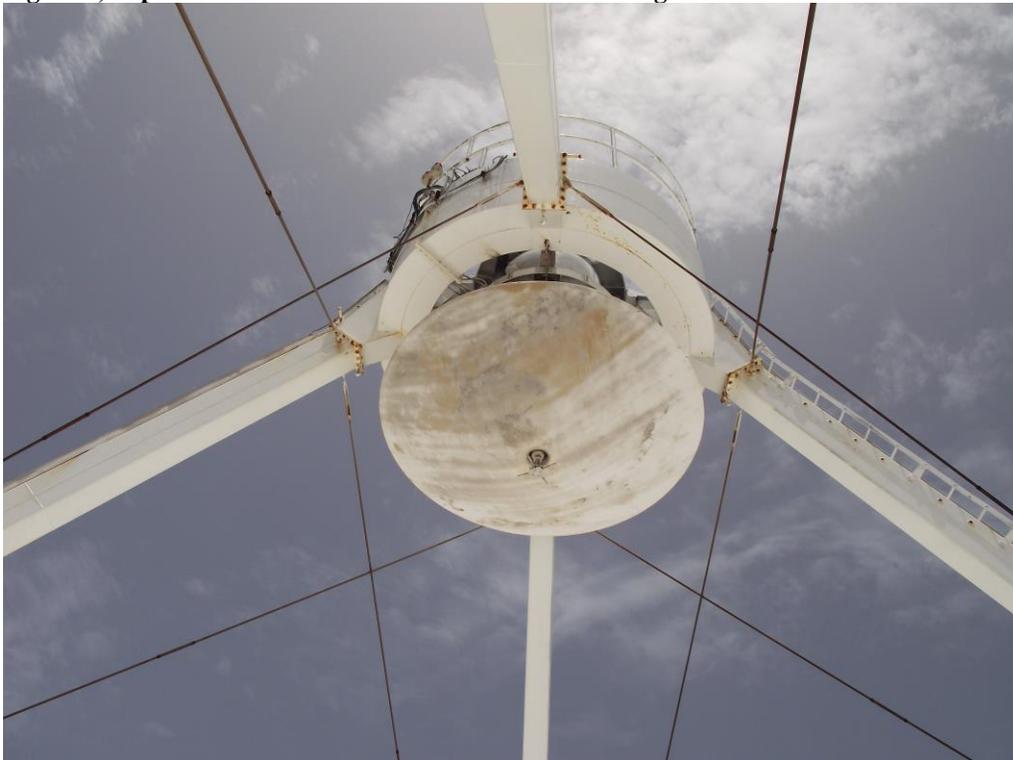
Subreflector – The white overcoat paint on the subreflector has eroded to the point where it looks bad cosmetically but the silver layer below is still intact and functional. There is a small area on one side of the subreflector where it appears that a fiberglass patch is beginning to delaminate (Figure 2).

Figure 2, Rust staining on bolted connections at apex. Subreflector paint condition

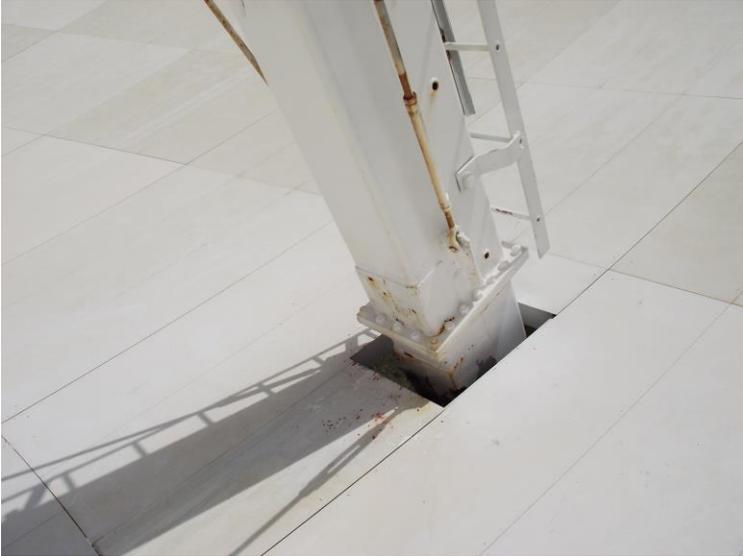
Quad Leg – Although the upper sections of the quad legs only show minimal corrosion (Figure 3), the lower part of one of the quad legs is corroded all the way through (Figure 4). The other quad legs have not corroded all the way through but they have sections that have corroded to the extent where they will need repair.

Figure 1, Quad leg corrosion above the dish.

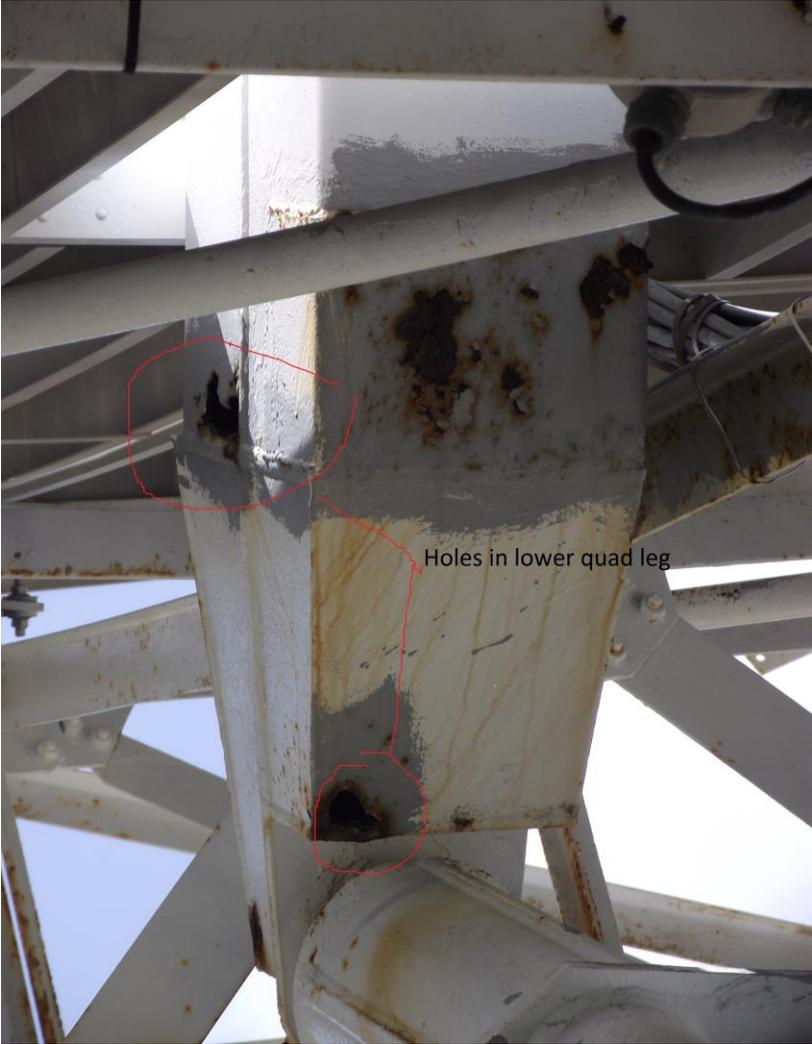
Figure 2, Quad leg corrosion below dish

7. Replace lightweight grating around vertex house. Use galvanized material and paint per specification.
8. Repair corroded quad legs.
9. Repair holes in tank sections
10. Replace HVAC condenser platform.

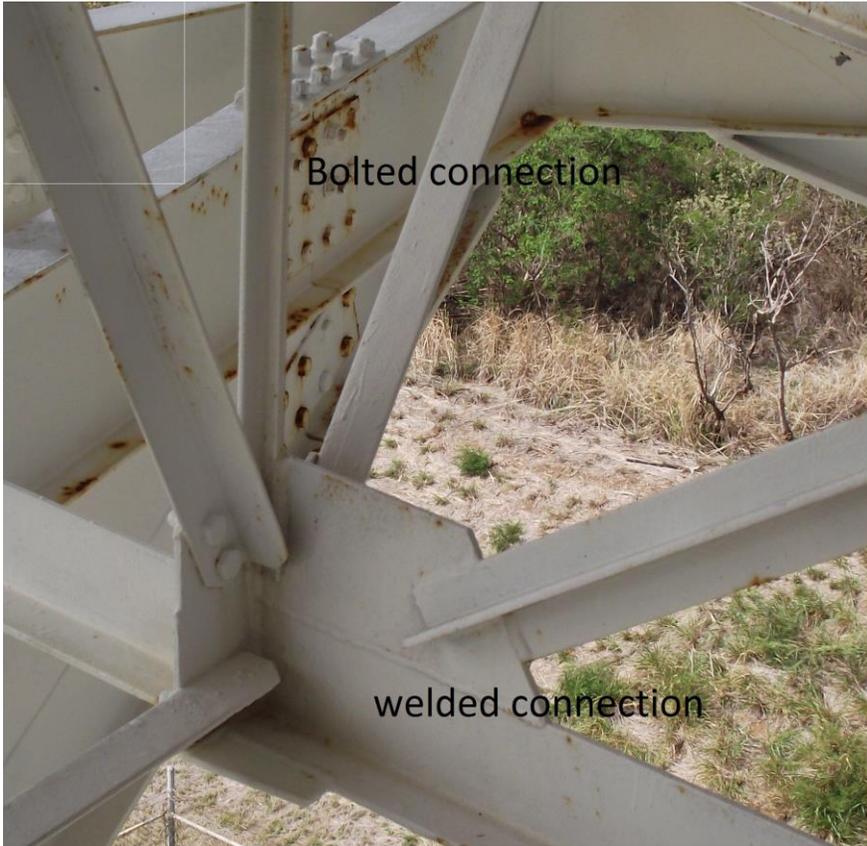
The antenna backup structure located just below the dish was designed using bolted connections instead of welded connections which are preferred for marine environments (Figure 5). A large percentage of these bolts are showing rust staining or corrosion. The bolts have not corroded to the extent where they need to be immediately replaced but they will need to be repainted. The corrosion is worse on the windward side of the antenna.

Figure 3, Welded connections vs. bolted connections in marine environment.

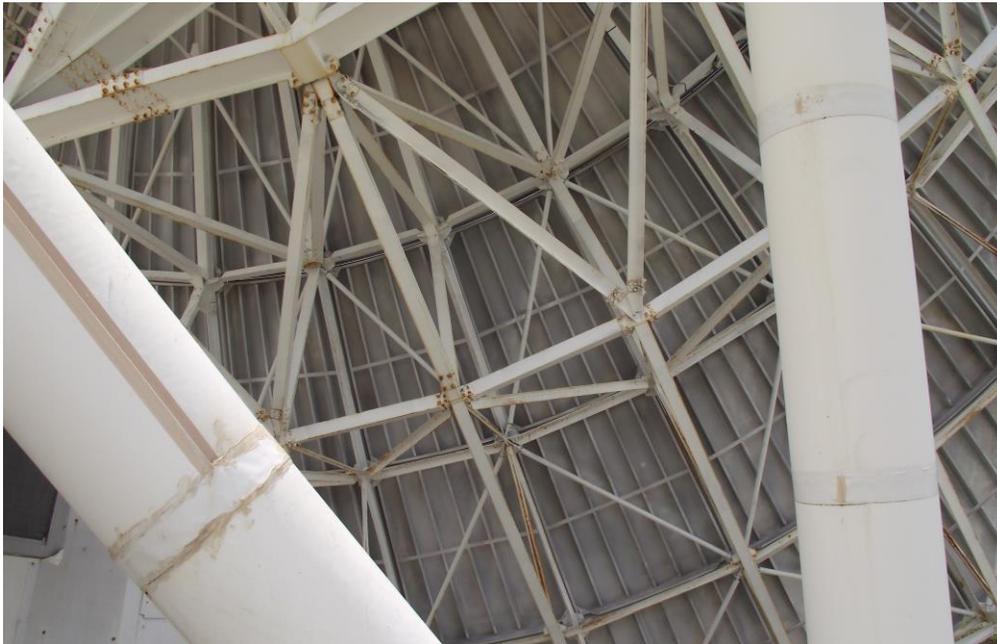
Figure 4, Extent of rust stained bolts.

At this point the most economical remedy would be to send a crew of painters on the next tiger team to repair the paint system. In areas where there is heavy rust scale, the surface will need to be surface prepped and then repainted. Areas where there is light rust staining or tightly adhered rust can be cleaned and overcoated. Overcoating rust is not a permanent solution but the barrier can eliminate the available oxygen and electrolyte and extend the surface life. This overcoat will need to be continuously maintained and will require frequent repainting. If the site technicians cannot keep up with the painting, then other resources will need to be employed.

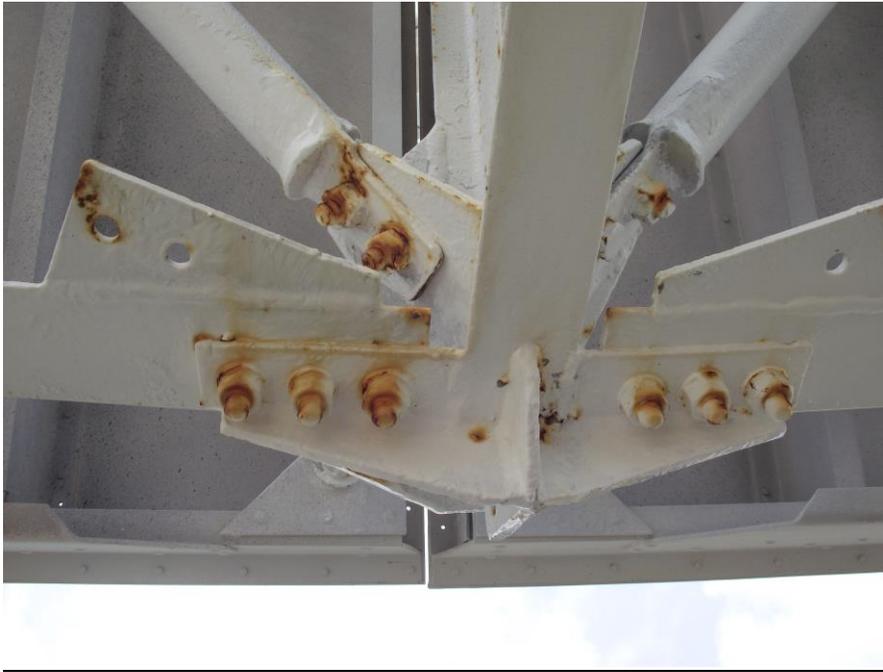
Figure 5, Close up of typical bolted connection.

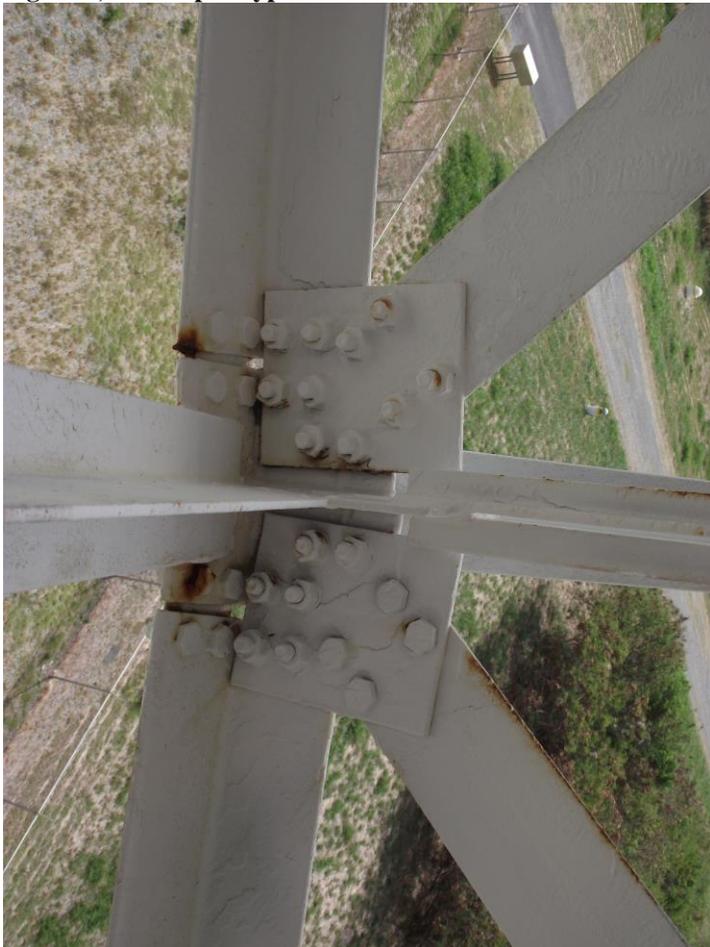
Figure 6., Minor corrosion due to paint thinning on edges.

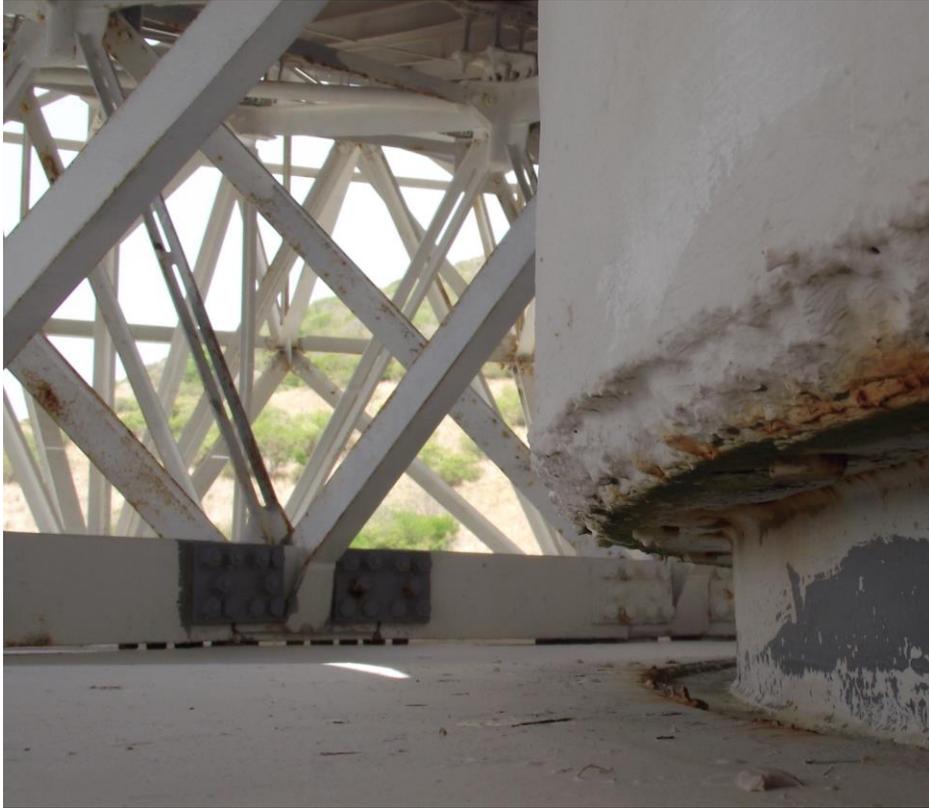
Vertex Room – Prior to the antenna painting in 2007, the bolts and nuts that attach the vertex room feed house to the structure were severely corroded. These bolts were replaced and put in from the opposite direction and were carefully painted in 2007. The new bolts are holding up quite well as evinced in figure 9.

Figure 7, Vertex room bolt corrosion.

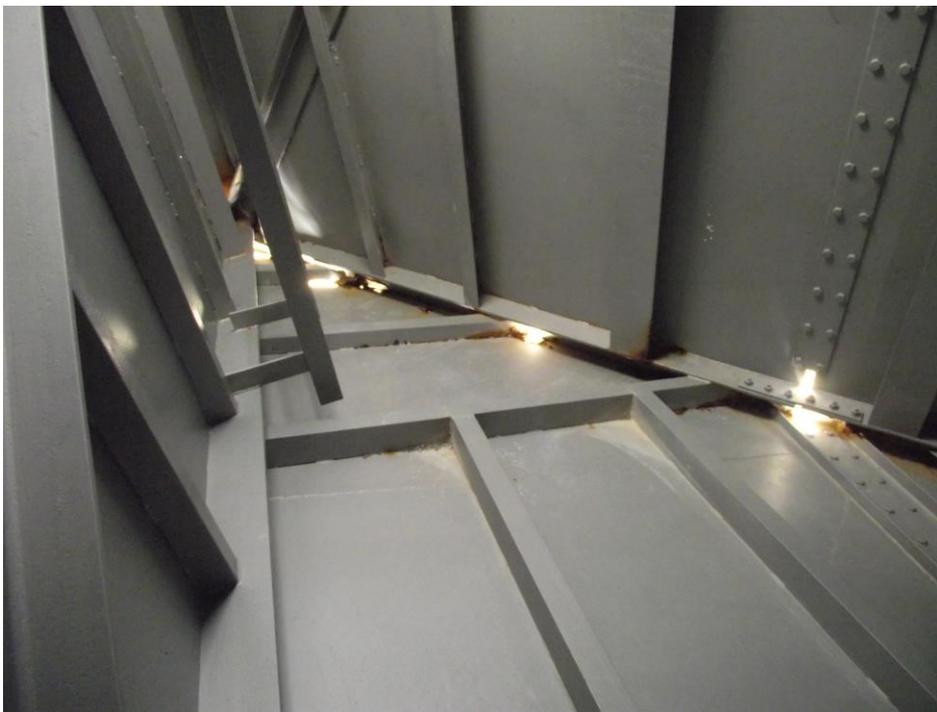
Tanks – The access doors on the large enclosed box sections of the backup structure were opened so that the box sections could be inspected from the inside (Figure 10). In 2007, the inside of the box sections were severely corroded. This part of the structure was a pleasant surprise as the box sections only showed minimal corrosion where the drain holes (Figure 11) were previously cut and slight staining where water pools in the structure. These drain holes should be repaired by cutting out the corroded sections and then welding in patches. These patches will then need to be painted.

Figure 8, Photograph of the inside of the box structure. This part of the antenna is not subject to UV radiation so it was not painted with the white topcoat.

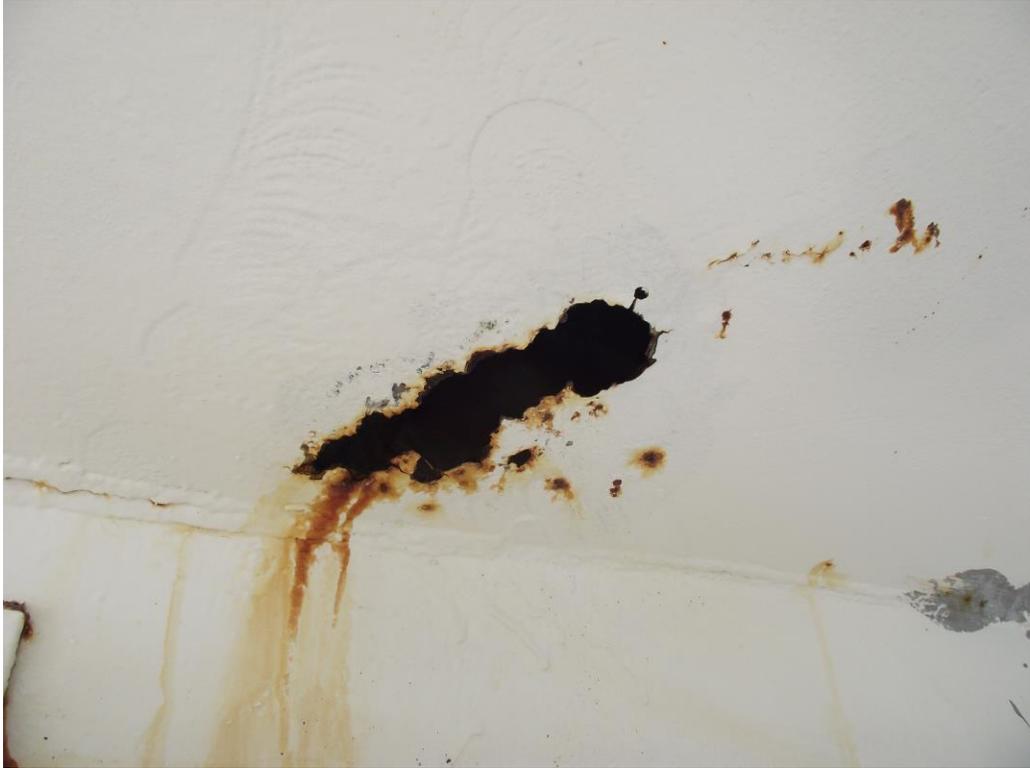
Figure 9, Corroded drain hole that will need repair.

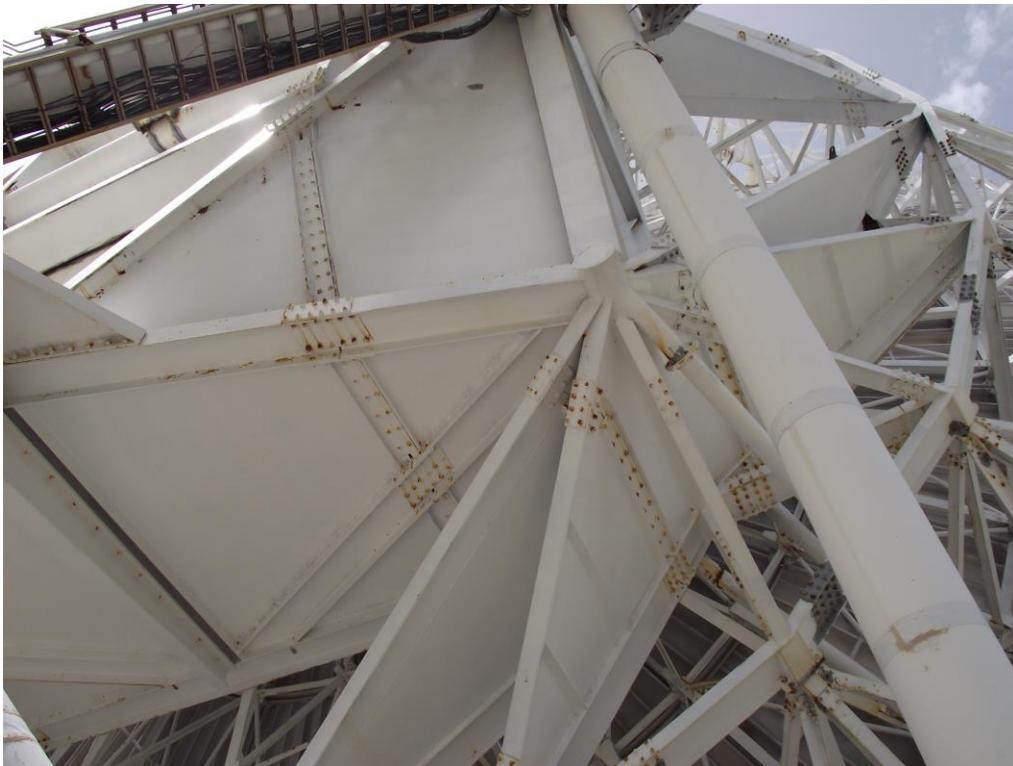
Star Structure – The paint on the large surfaces like the star structure is performing well. However, the bolts in these areas are rust stained (Figure 12).

Figure 10, Star structure bolt corrosion.

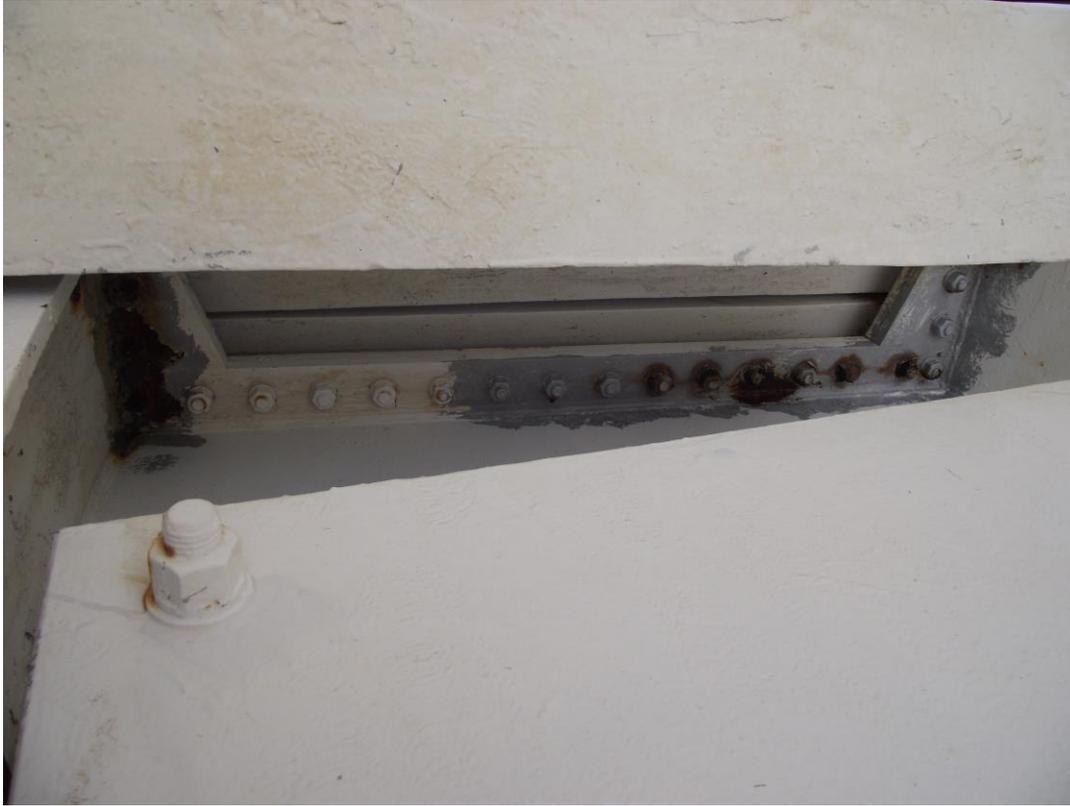
Counterweights – Some of the bolts on the counterweight and gear sector are corroded and will need attention (Figure 13).

Figure 11, Counterweight bolts. Corroded section on left is where the site techs needle scaled the corrosion and have not yet repainted.

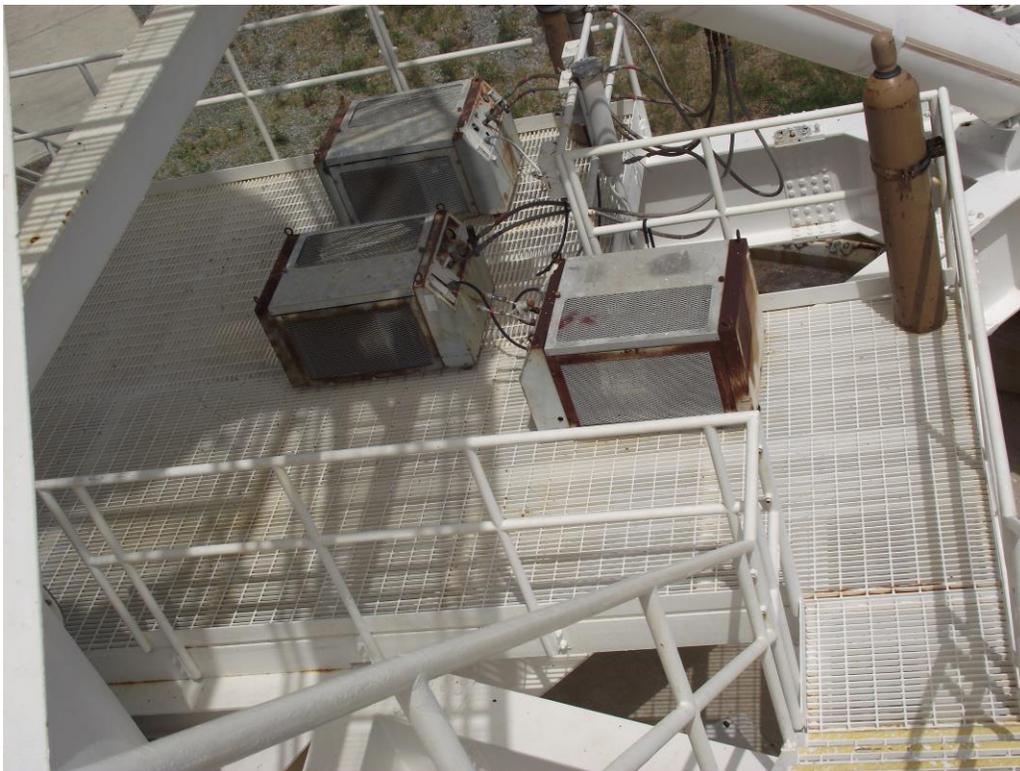
majority of this grating is still in great condition (Figure 14). However, in the places where the coating did become compromised, the bar grating has extensive corrosion and must be replaced (Figure 15). The site technicians have installed plywood decking over the failed bar grating as a temporary repair. The lightweight grating around the vertex room is also corroded to the point where it will soon need to be replaced (Figure 16)

Figure 12. Typical paint condition on bar grating and hand rails.

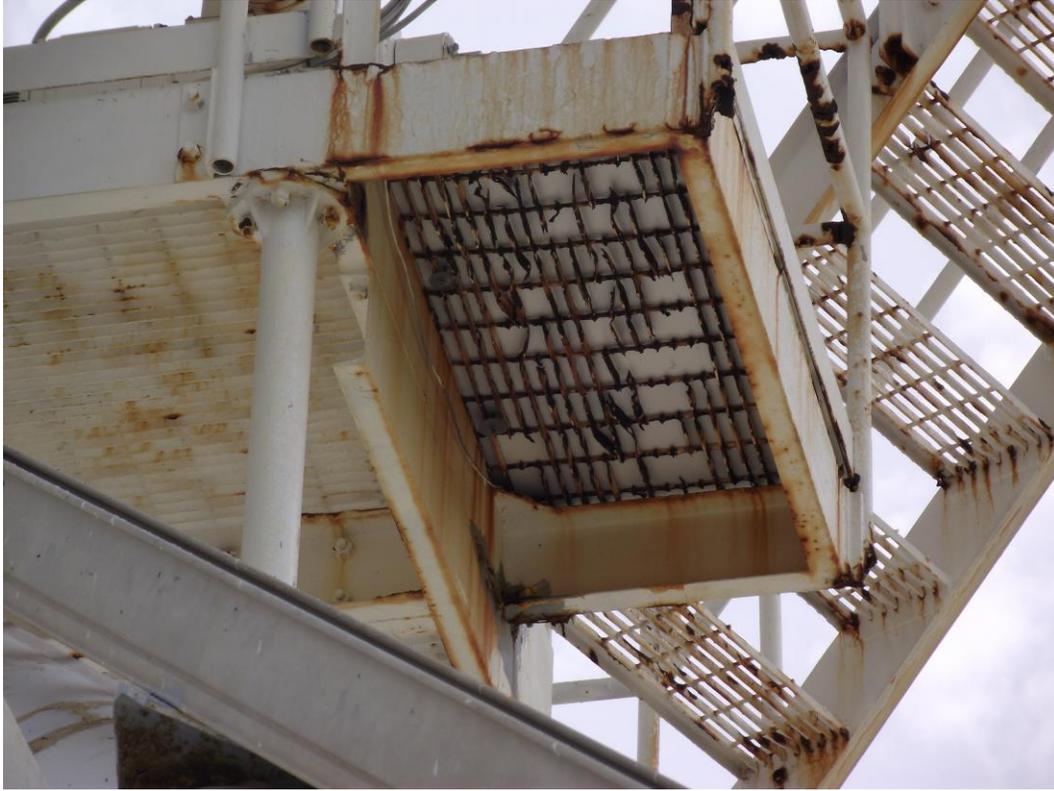
Figure 13. Example of failed bar grating.

3. Replace grating marked with blue paint. Replace with hot dipped galvanized bar grating painted per specification.
4. Repair swinging platform handrail pipes.
5. Replace swinging platform stair supports.
6. Replace elevation platform extensions.

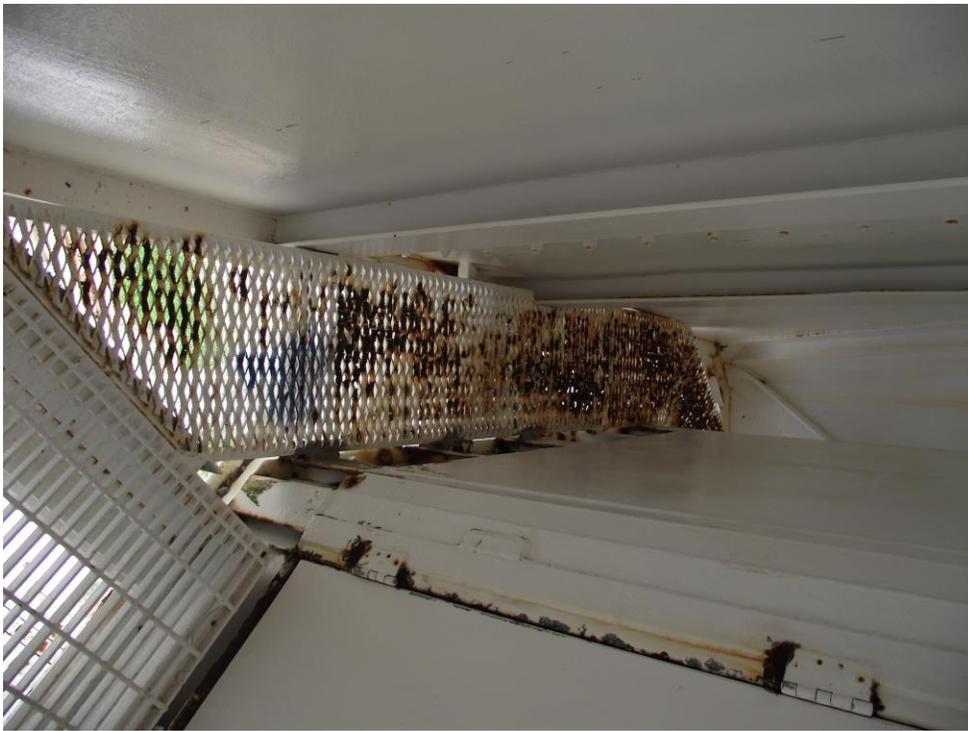
Figure 14, Lightweight walkway grating around vertex room is failing and will need to be replaced.

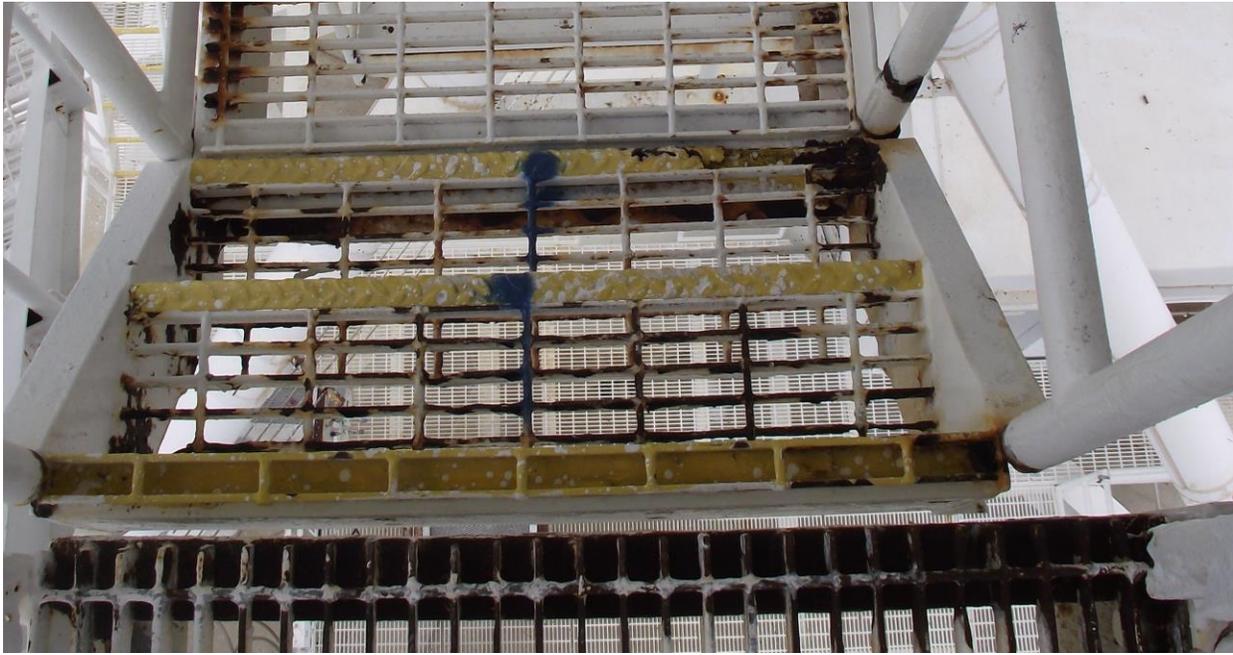
There are 9 pieces of bar grating that need to be replaced. There are also 17 stair treads and nose pieces that need to be replaced (Figure 17). There are an additional 13 steps that only need the nose piece replaced (Figure 18). These repairs should be done as soon as possible.

Figure 15, Stair treads and noses that will require replacement

1. Replace 17 stair treads and noses. Treads needing replacement marked with blue paint. Replace with hot dipped galvanized bar grating painted per specification.
2. Replace 13 additional stair noses. Marked with blue paint. Replace with hot dipped galvanized and paint per specification.

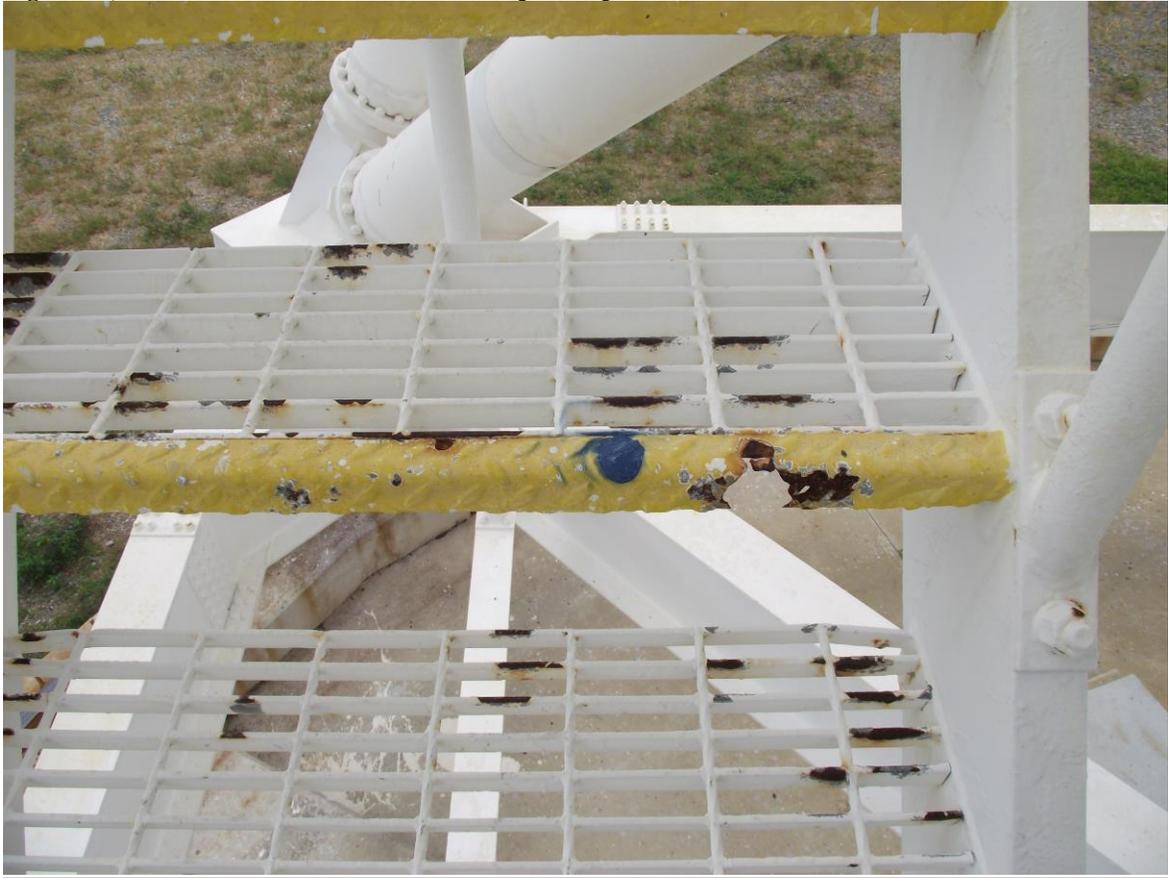
Figure 16. Stair nose that requires replacement.

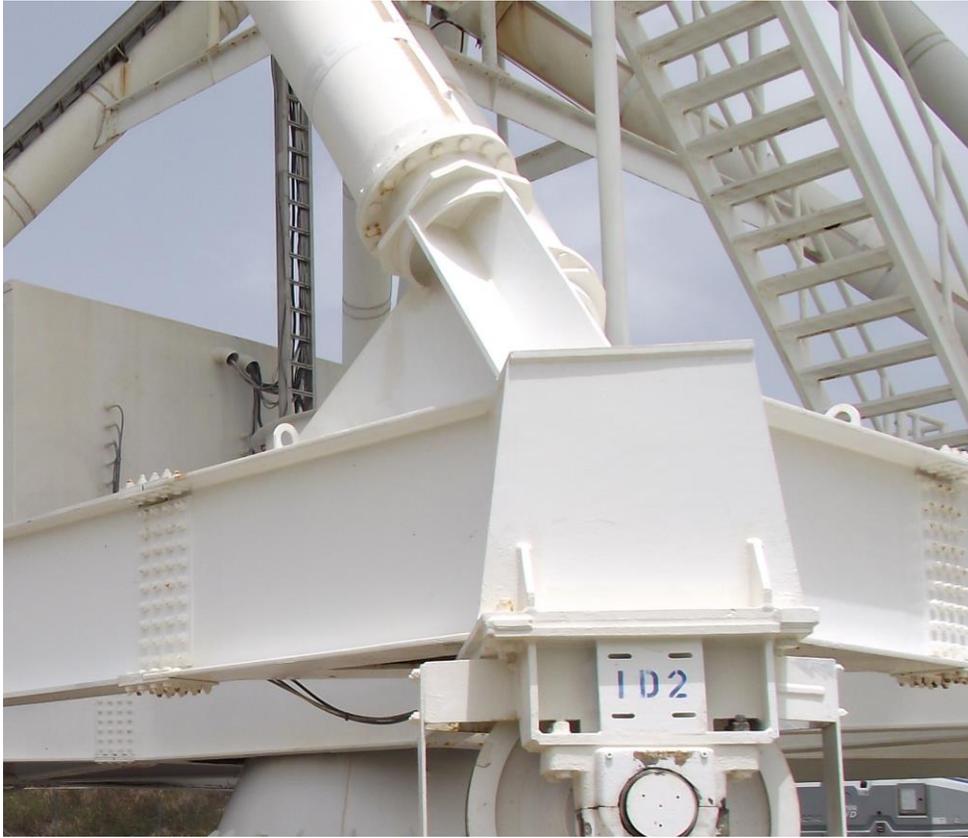
Large Tubes and I beams - The large structural tubes and I-beams supporting the antenna show only minimal corrosion on some of the flange bolts where the tubes are connected (Figure 19).

Figure 17, Support structure corrosion is minimal.

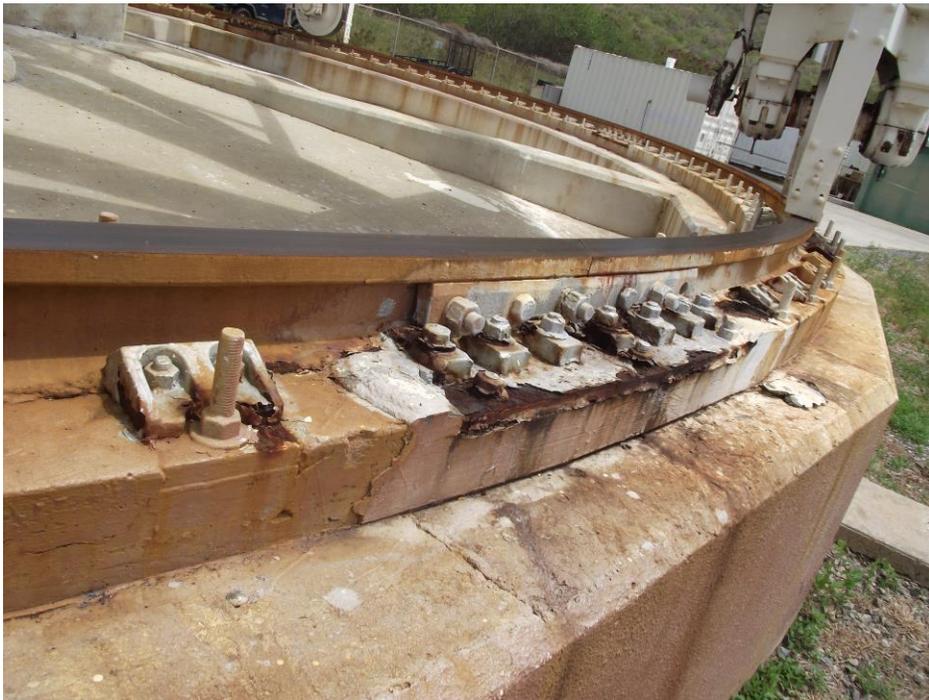
Rail – The rail was painted with latex paint and is not corroding excessively. The splice plates and rail clips are showing some signs of corrosion and will need to be scaled and repainted (Figure 20).

Figure 18, Corrosion on rail, rail clips and splice plates.

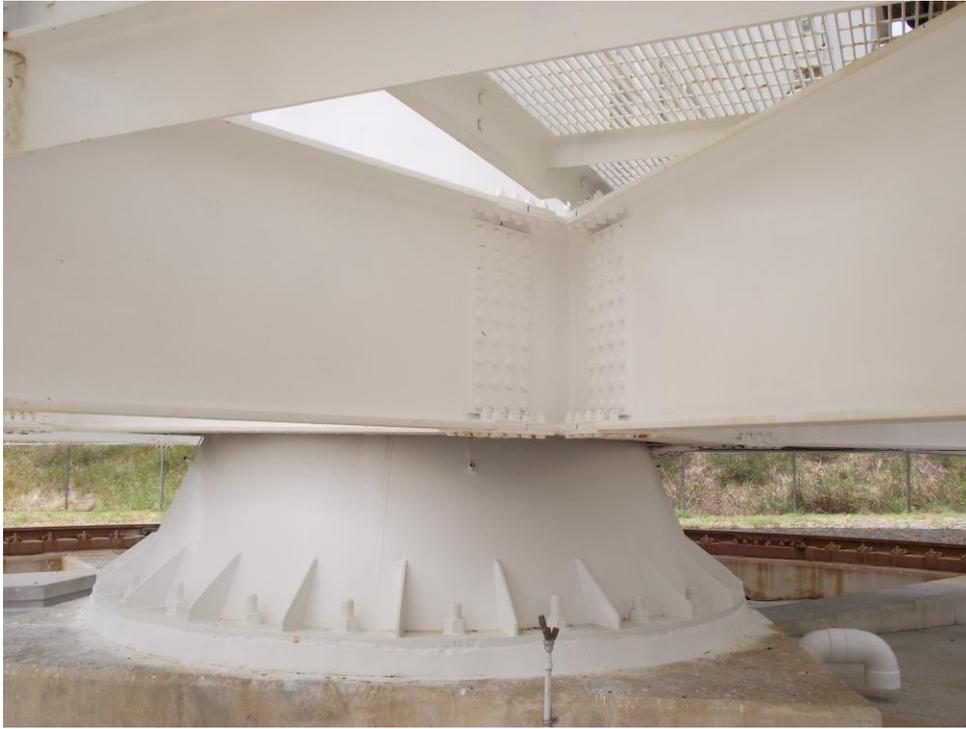
Pintle Bearing – The washers under the pintle bearing nuts were replaced with galvanized washers and repainted during the 1999 maintenance visit. The new paint has performed well and there is very little corrosion in this area (Figure 21).

Figure 19, Pintle bearing housing corrosion.

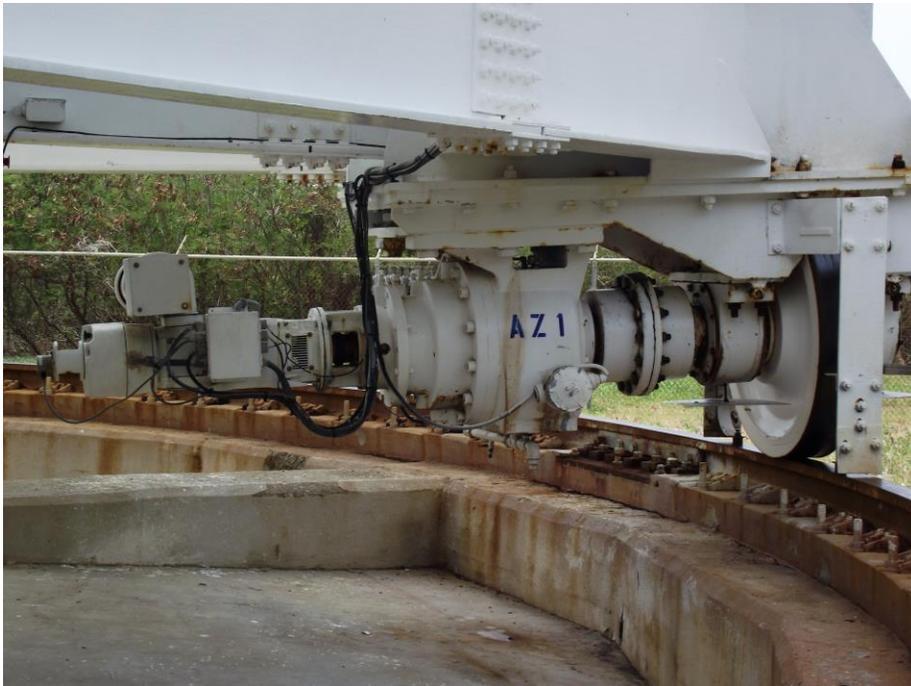
Drive Systems – The corrosion on the drive motors and gearboxes is mostly superficial (Figure 22).

Figure 20, Drive wheel and gearbox assembly corrosion.

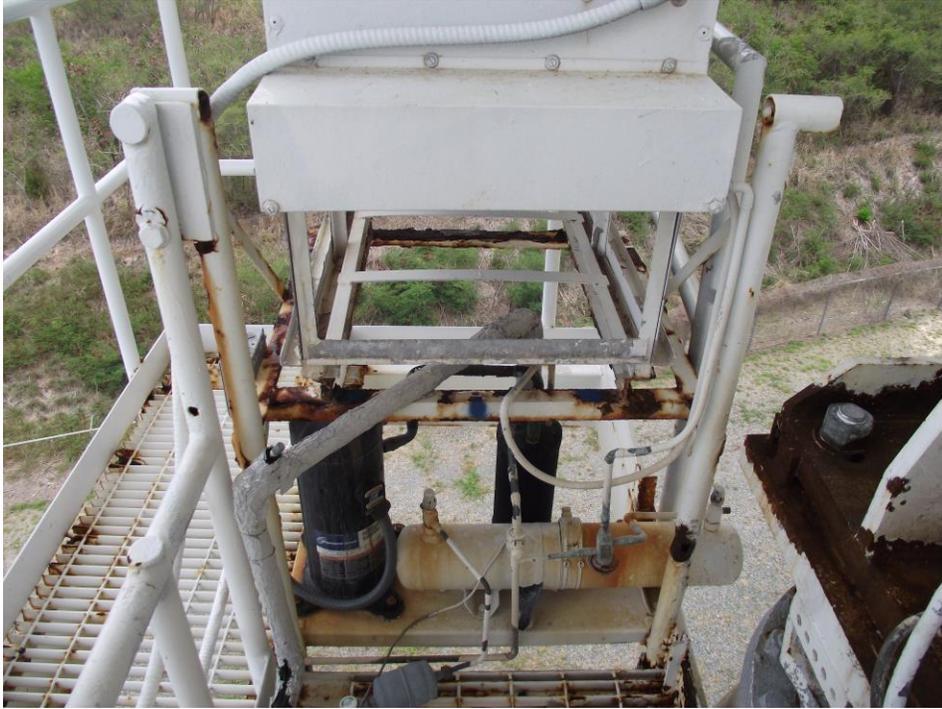
HVAC –The HVAC condenser platform is badly corroded and will need to be replaced (Figure 23).

Figure 21, HVAC condenser platform.
