National Radio Astronomy Observatory
VLBA Antenna Memo Series – No. 95
TRIP REPORT – HANCOCK, NH MAY 14-23, 2022
DUAL ELEVATION BEARING CHANGE

Trip Report – Hancock, NH VLBA Station
Dual Elevation Bearing Change and Failure Analysis

May 14-23, 2022

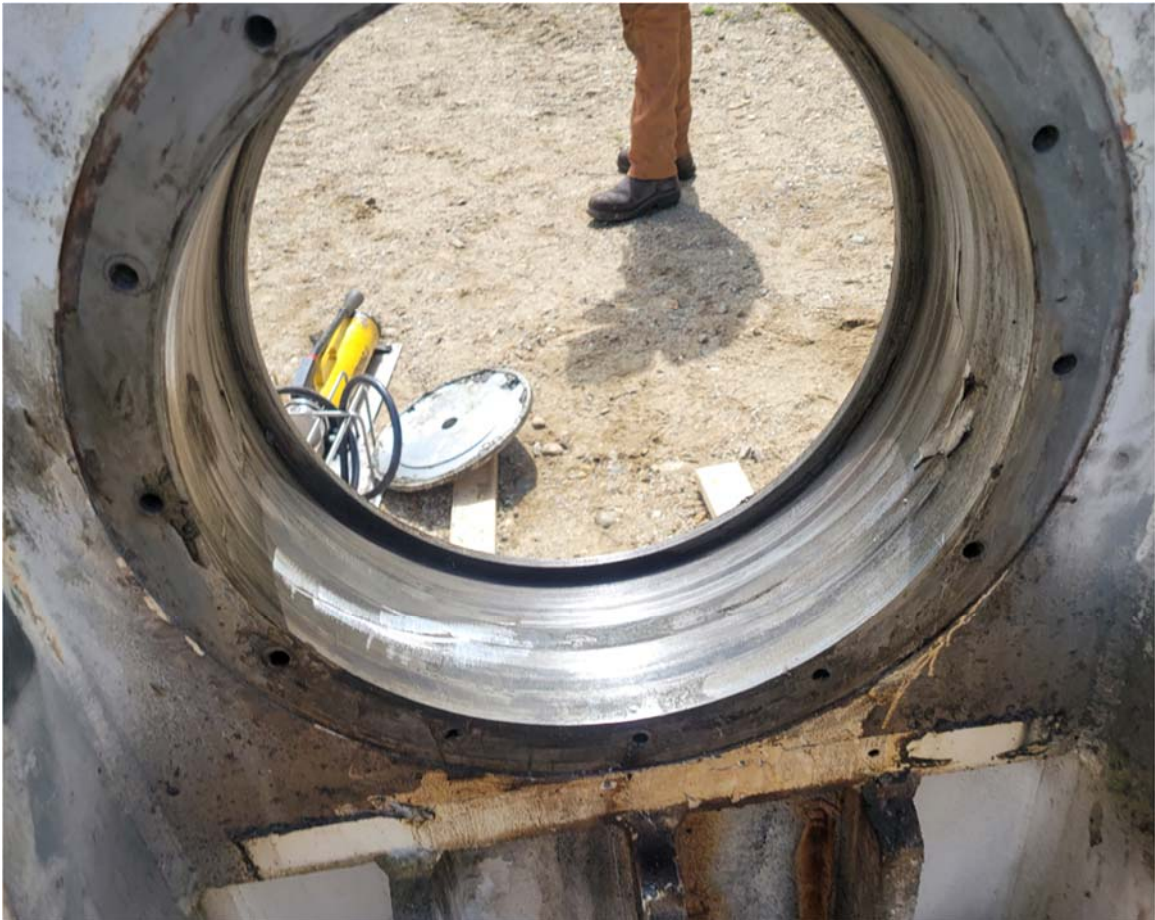
several places and hammered out of the block. The broken outer race caused significant gouging in the pillow block's bearing surface. These gouges were sanded and care was taken to not over sand the surface of the pillow block.

Figure 10: The broken outer race of the old bearing left large gouges in the bearing surface.

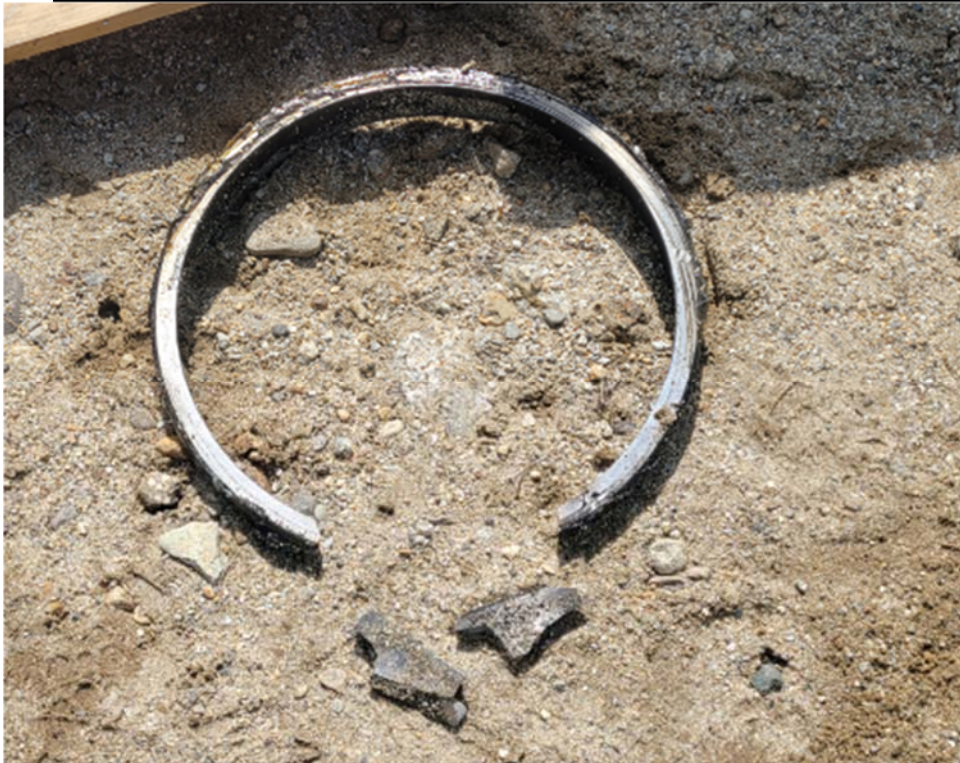
After jacking up the dish, the pillow block was lifted out of the antenna and the bearing was removed. The bearing's outer race was split in half around its perimeter and this breakage made it difficult to press the bearing out. Eventually the broken outer race had to be cut in

Figure 11: The outer race of the old bearing had to be cut and hammered out. The broken edges where it split around the perimeter caused the gouges in the pillow block.

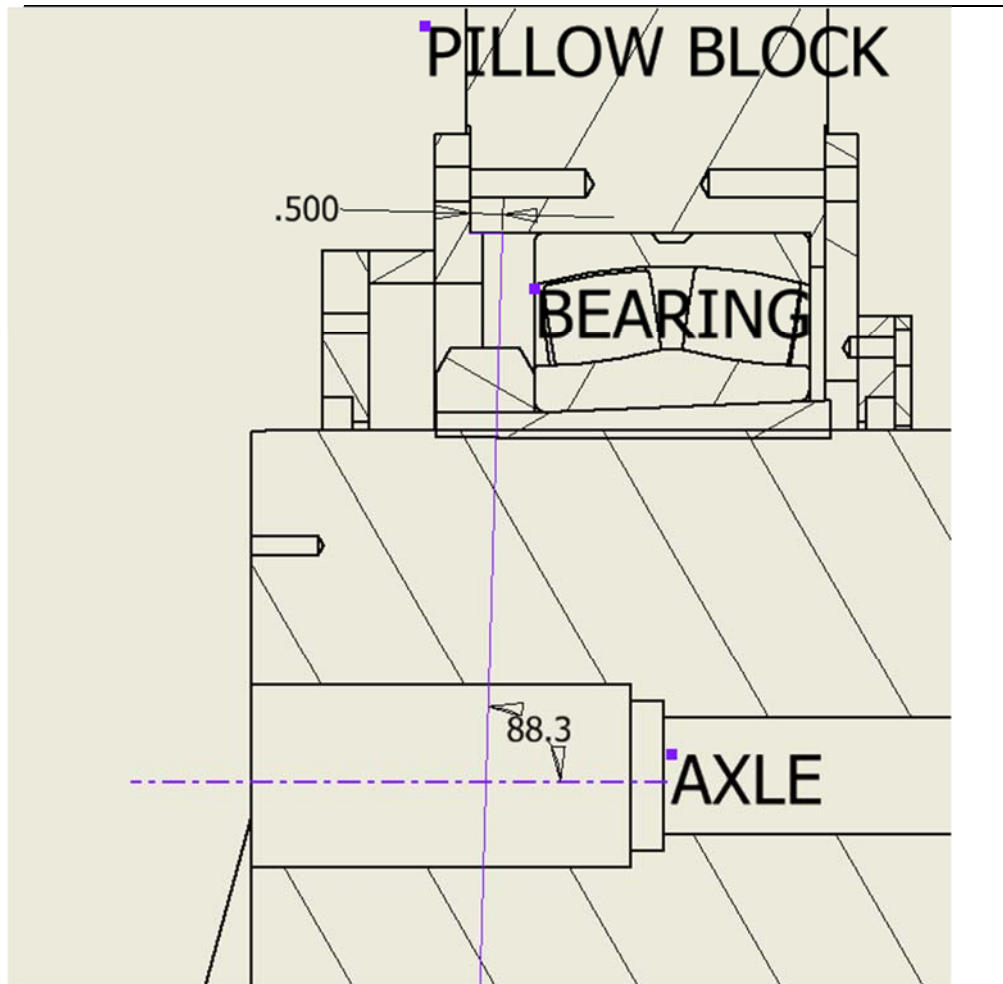
The synchro side elevation bearing was uncovered on Sunday, May 15th. The grease around the bearing contained significant amounts of large metal flakes and glitter, indicating the bearing was at least approaching failure. Further inspection while the bearing was installed revealed the outer race was split into two pieces around the perimeter. The depth of the bearing was measured relative to the face of the pillow block while it was still installed. The outer section was sitting approximately 88.3 degrees tilted upwards with respect to the axle.

Figure 15: A drawing showing the relative angle between the face of the synchro bearing and the face of the pillow block.

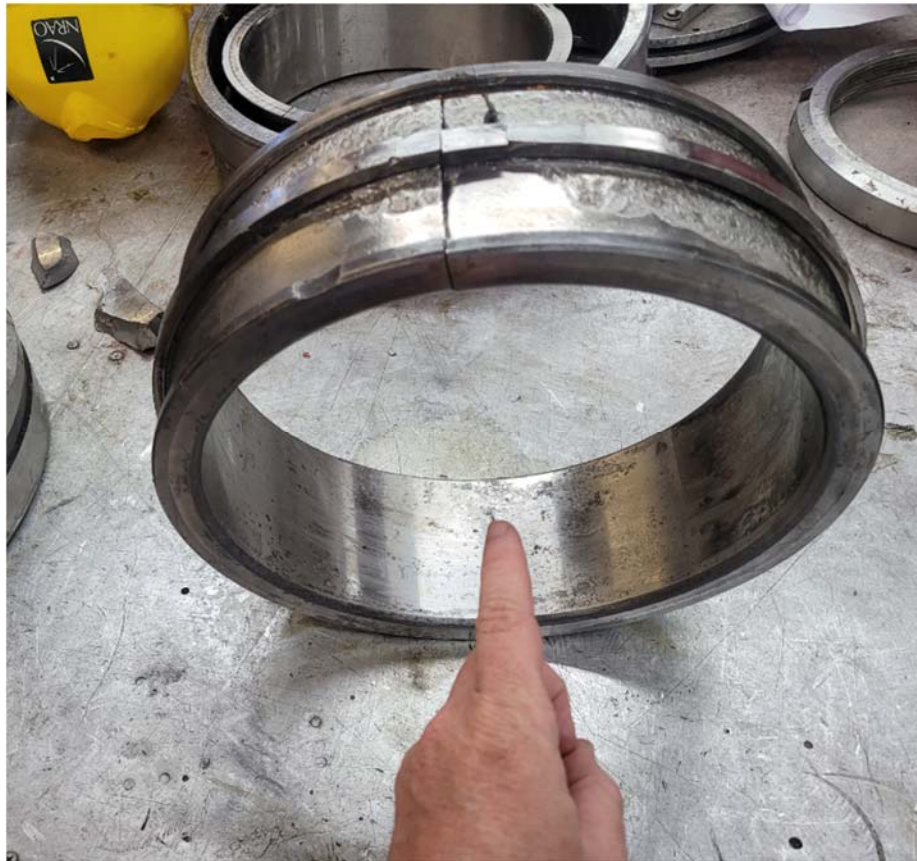
The bearing was taken to the VLA site where it was cleaned and disassembled for further inspection. The inner race showed severe spalling, fragmentation denting, and cracks, both radially and axially. A piece of the roller guide between the two roller surfaces was also broken off. All of the major damage to the inner race existed near the cracking.

Figure 16: The bearing's inner race. The finger is representative of the antenna's axle, pointing away from the center of the antenna.

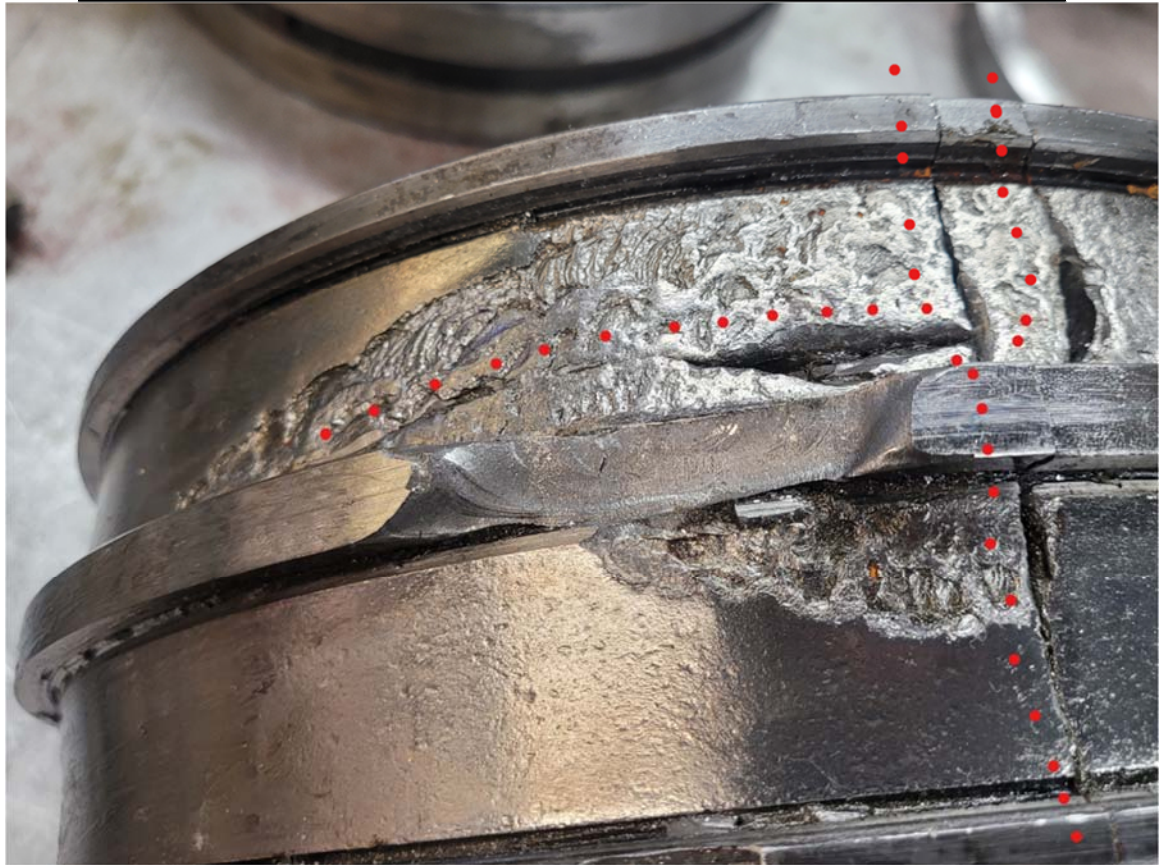
Typically, an axial crack on the inner race would form from an excessively tight interference fit, such as a taper coupling being tightened too much. There is fragmentation denting on both rolling surfaces of the race which indicates that the rollers were rolling over metal chips inside of the bearing. As the rollers pass over a metal chip, the loads are concentrated into one small area and the race material begins to fail. The failure shows up as spalling, which in turn produces more metal chips, more concentrated loads, and more spalling.

Figure 17: The inner race's roller surfaces were severely spalled and cracked in several places. The cracks are highlighted with the red dotted lines. Also, a part of the roller guide that divides the roller sections broke free.

The synchro bearing was probably damaged by a taper coupling being excessively tightened during installation. This crack may not have developed any further damage for a long time, but once it began developing it became a chain reaction that caused more and more damage.

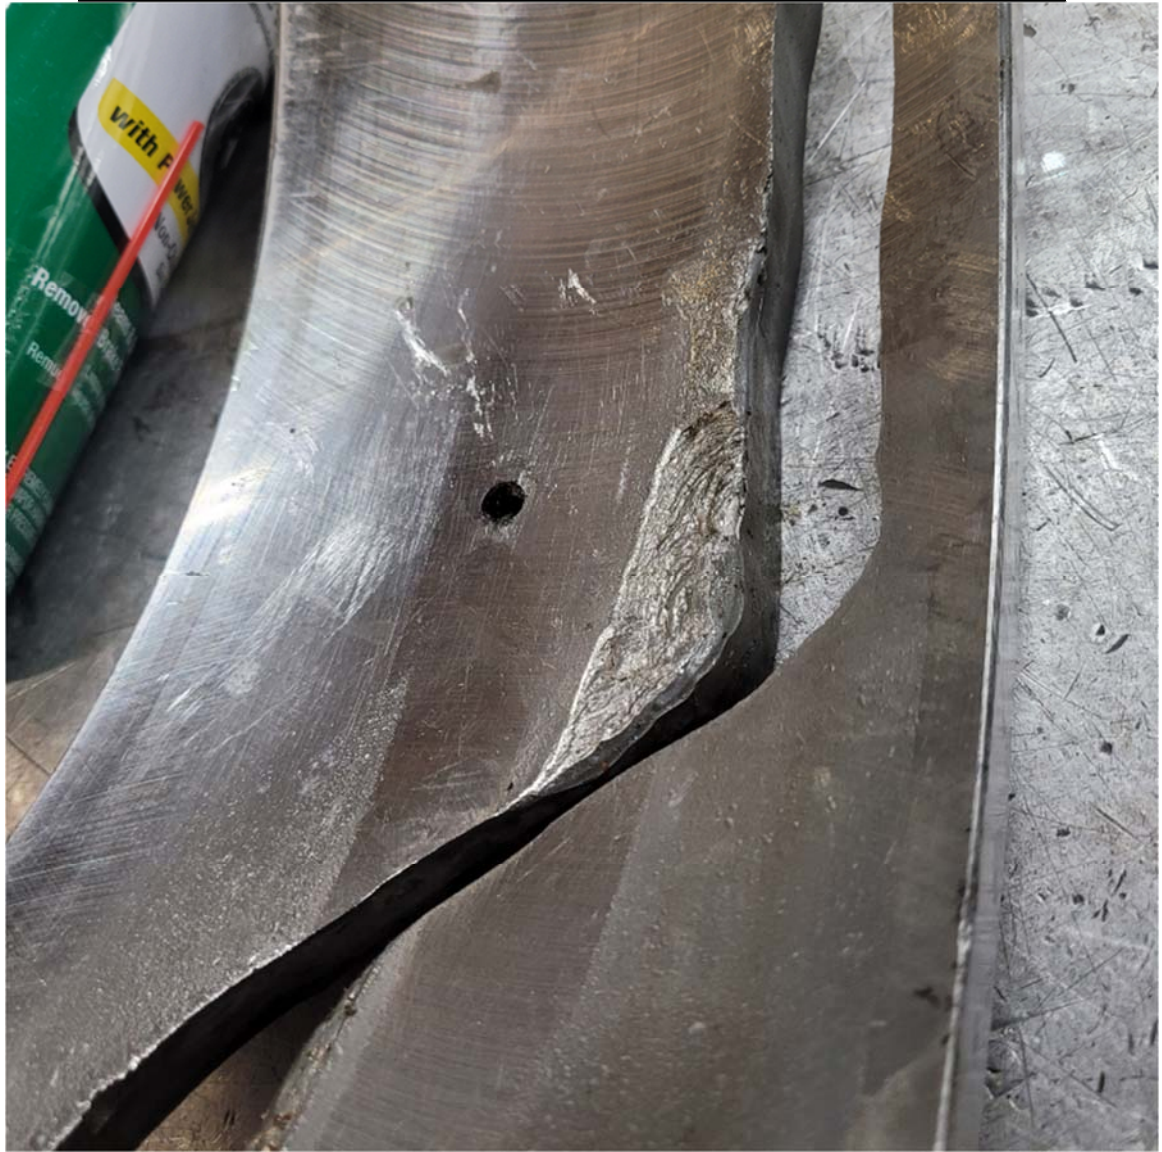
The outer race was found with a radial crack that ran around the entire perimeter. In a typical situation, this type of cracking forms from a faulty fit in the bearing housing, such as debris between the housing and race or a misshapen housing. This also could have occurred as a result of the inner race's failure. The spalling on this race was found on one side of the crack, likely because the outer part of the race moved away from the rollers and the load was concentrated on what remained in place. The area around the spalling on the broken edge was rounded off, likely from the rollers rounding the sharp broken edge as they pressed down onto it.

Figure 18: The spalling on the outer race. Note the rounded broken edge and fragmentation denting.

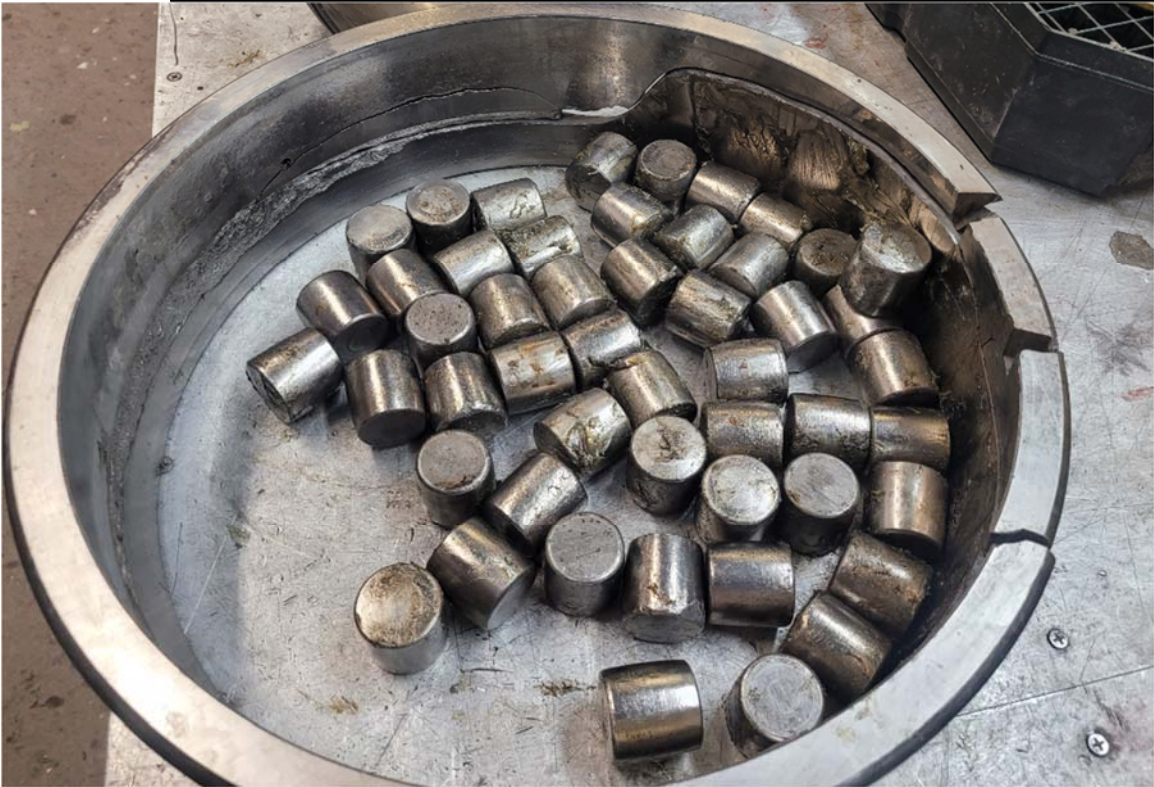
Figure 19: The outer race and rollers. The radial crack is visible and the axial cracks came from cutting the race out of the block.

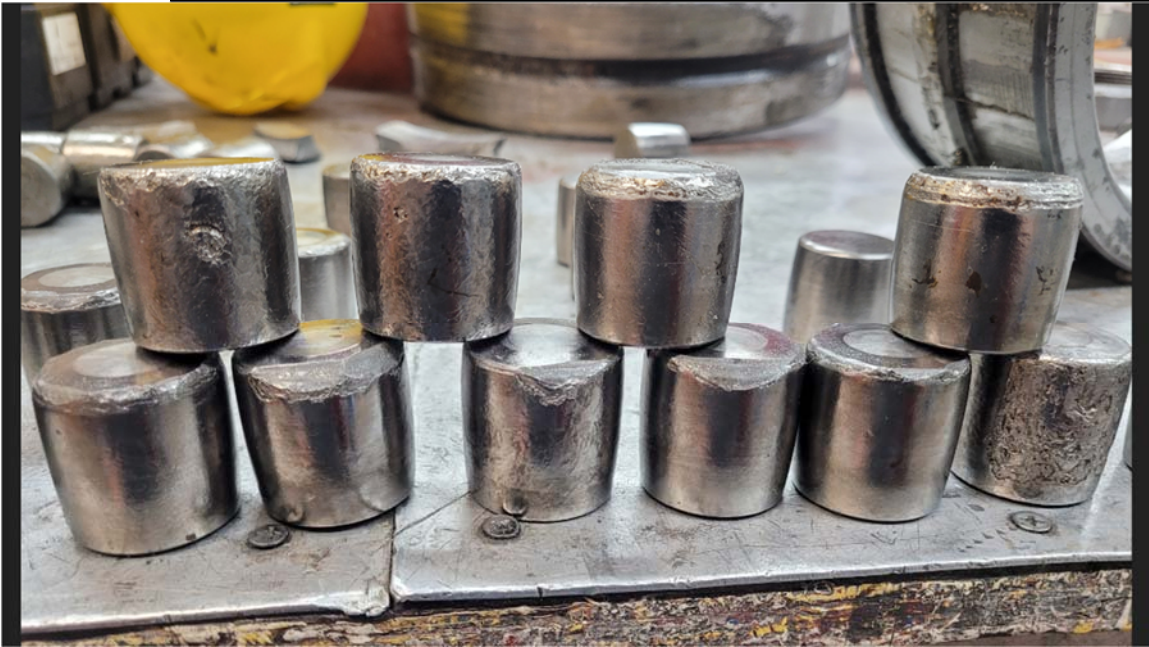
The rollers were found in equally bad condition. All of them showed fragmentation denting, spalling, or both. A few of the rollers showed that they were supporting an uneven load as evidenced by significant spalling on one side but not the other. Some of the rollers had large flat dents on the inside corners. These rollers were possibly being pushed up against the roller guide in the middle of the inner race.

Figure 20: The rollers were dented and spalled. Note the tops of the upper rollers have spalling on one side. These rollers were likely subjected to all of their load being concentrated on that side.

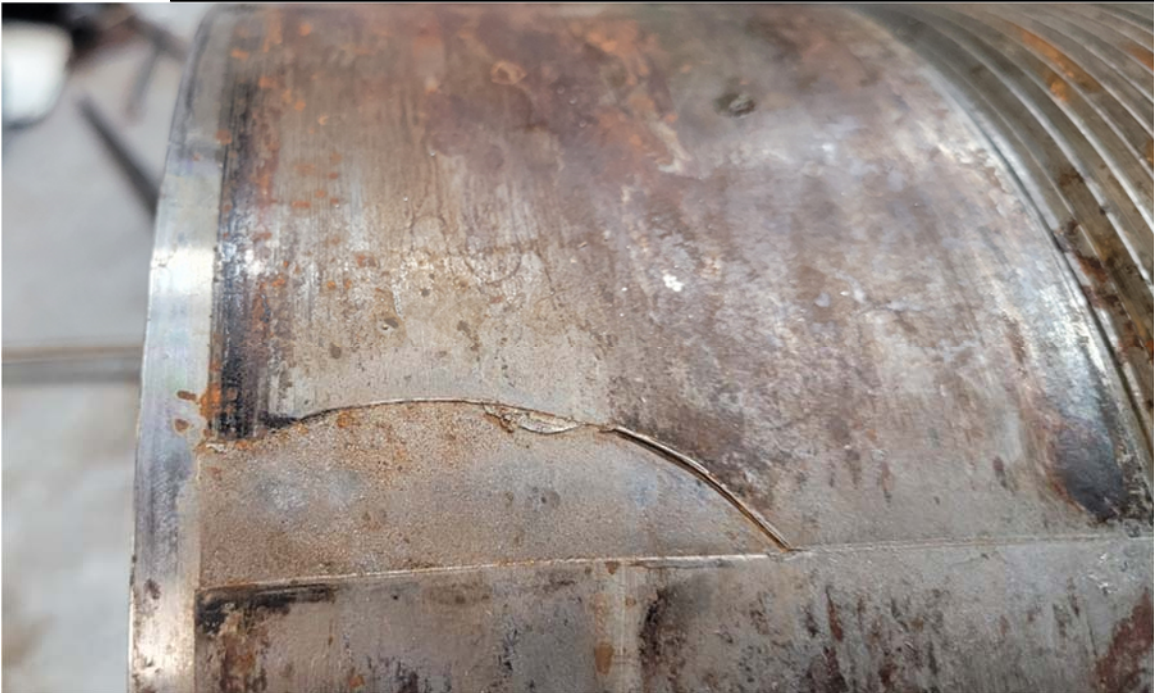
The taper coupling had some damage where the cracked pieces of the inner race were lodged. The roller cages didn't show any damage.

Figure 21: The marks on the taper coupling match up with the axial cracks on the inner race.

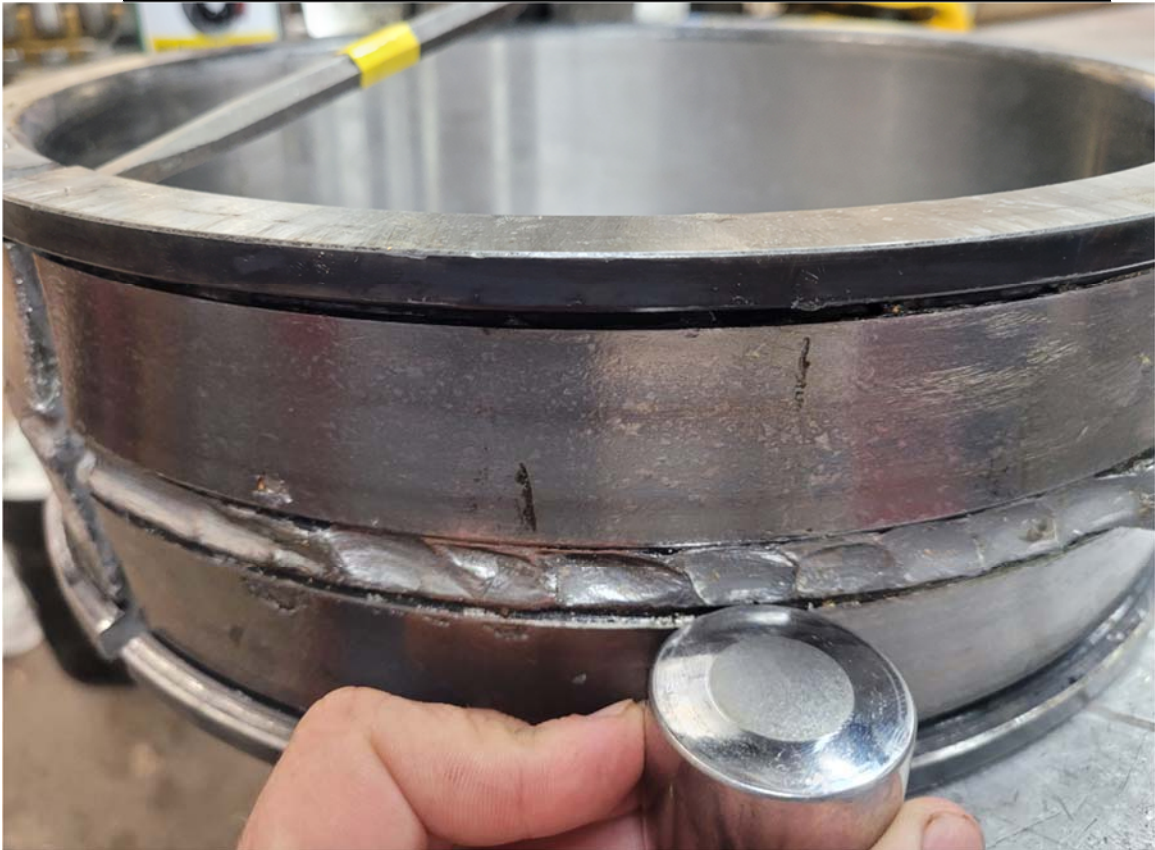
The Encoder bearing was not as damaged as the synchro bearing. The inner race of the bearing had a similar axial crack. The inside faces of the crack showed signs of fretting, where the two faces were rubbing against each other. The rolling surfaces had fragmentation denting but was not spalled yet. The major damage to the inner race was the roller guide, which had a pattern of approximately 1" chunks that were broken off. These chunks appear to have broken off one after the other in series.

Figure 22: The rolling surface of the inner race. The broken chunks of the roller guide were found inside of the bearing.

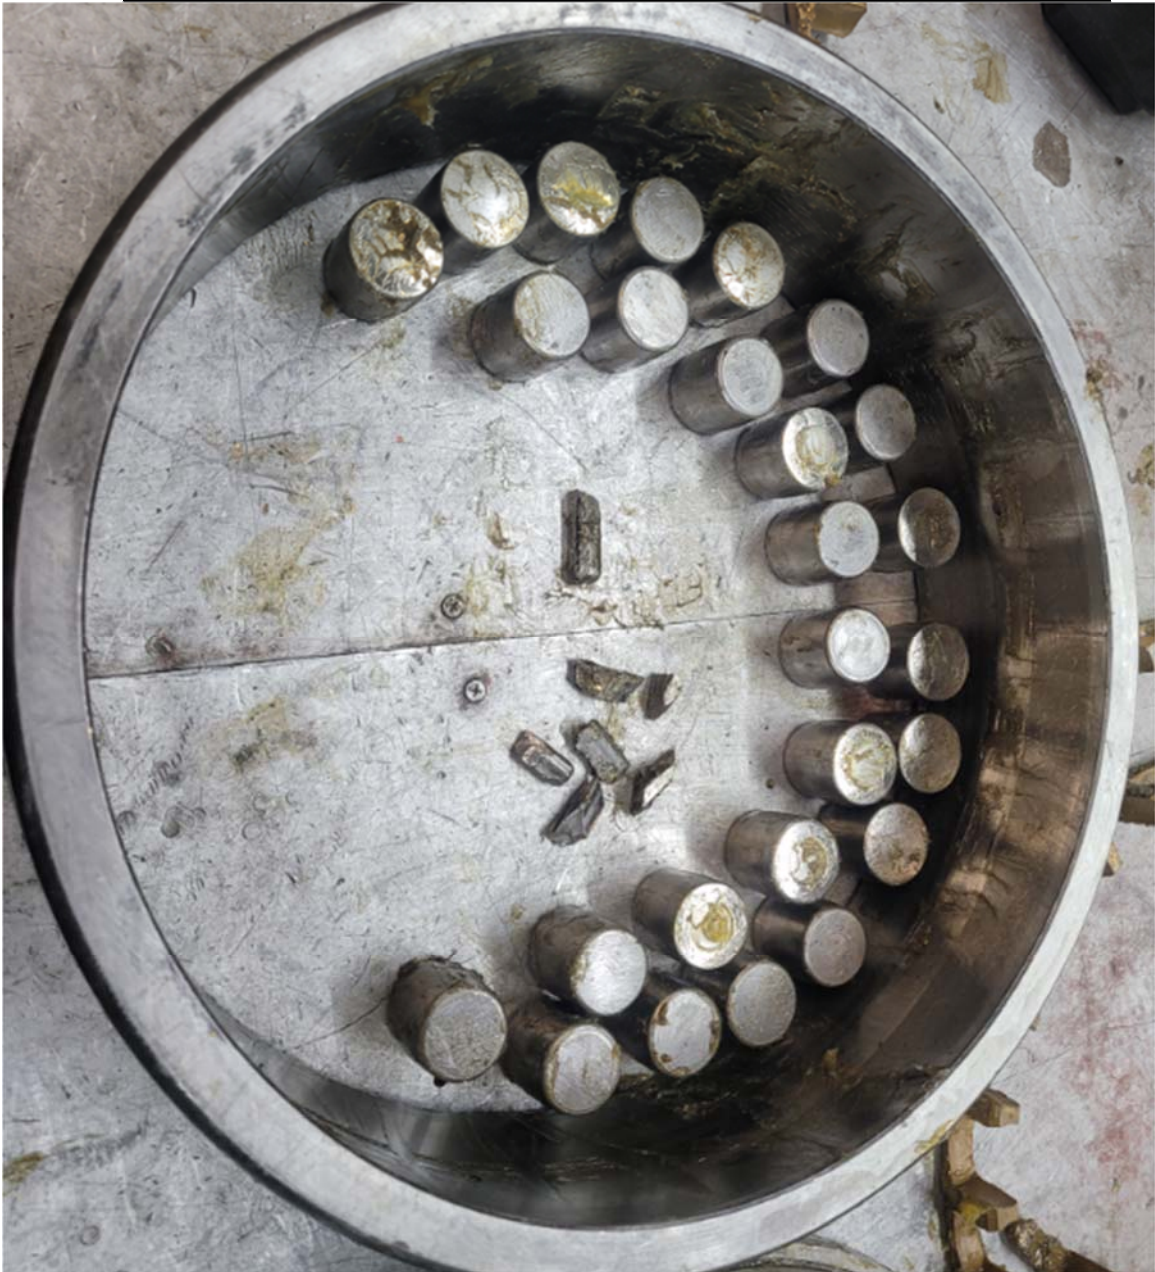
The outer race was found in decent condition. It had some minor fragmentation denting where the rollers contacted the surface. The rollers were in similar condition, with minor fragmentation dents but nothing otherwise notable.

Figure 23: The outer race and rollers. Neither of these components showed any major damage. Also pictures are the fragments of the roller guide that broke free from the inner race.

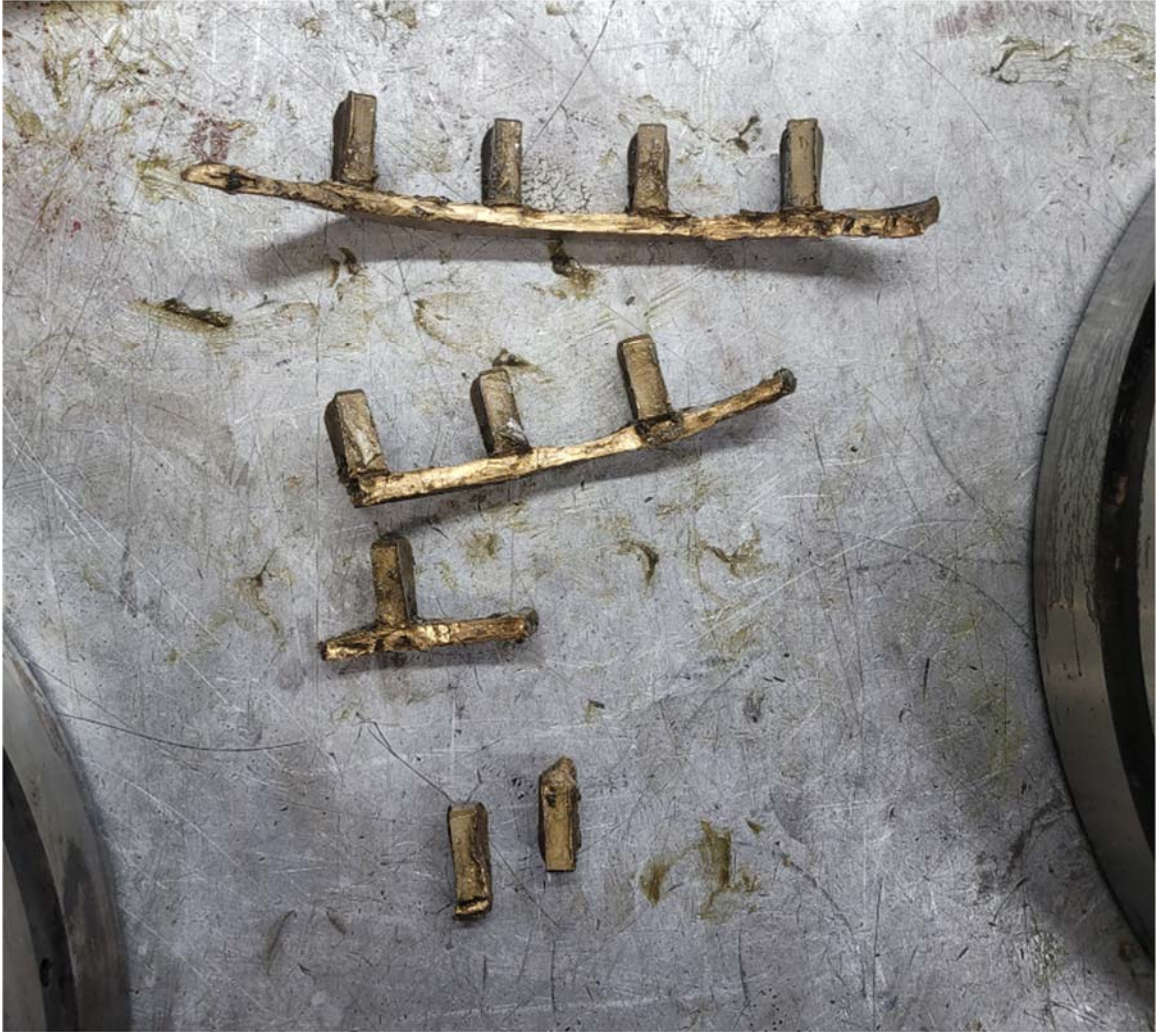
The roller cages both had similarly sized sections broken free. One broken section broke into smaller pieces. These broken sections allowed one roller to rotate sideways so it was no longer rolling along the rolling surface. Besides being dragged along, the roller didn't seem to do any major damage.

Figure 24: The fragments of the broken roller cages.

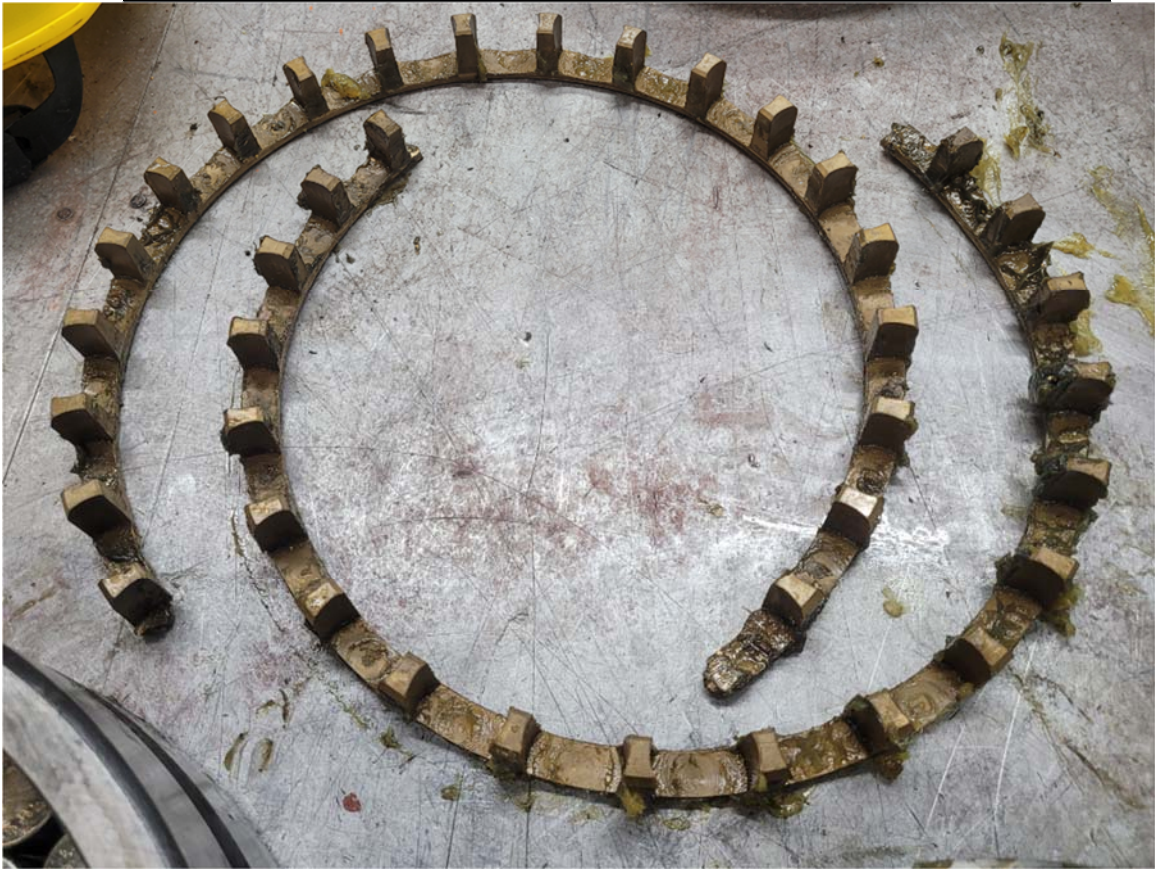
Figure 25: The roller cages with their missing sections removed. Both roller cages were missing similarly sized sections.

The fragments of the inner race roller guide and the roller cages were likely causing more chips which would have eventually lead to spalling on the roller surfaces like what was seen in the synchro bearing. The damage was likely a chain reaction stemming from the axial crack in the inner race. The axial crack could have formed from the taper coupling being excessively tightened during installation.
