VLBA Antenna Memo Series #33

Owens Valley Maintenance Visit
June 11th through 17th, 2001

Jim Ruff
7/10/01

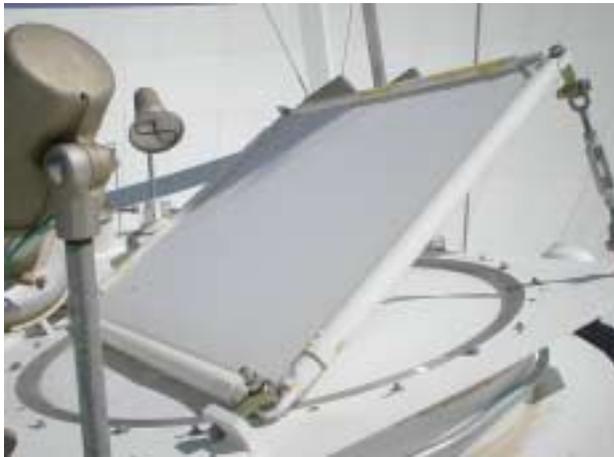
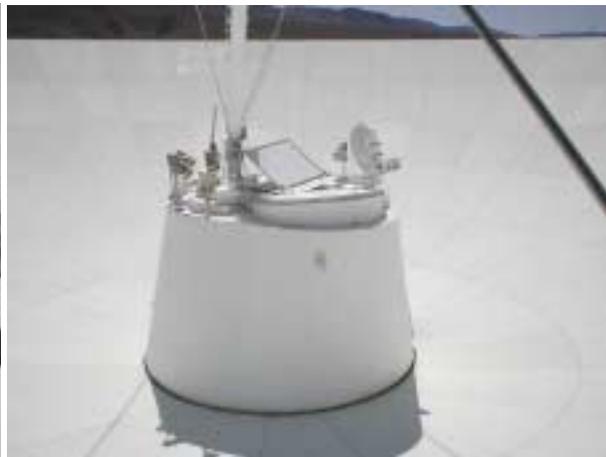
The dichroic panel is in good condition, but the paint on the frame needed touch-up.

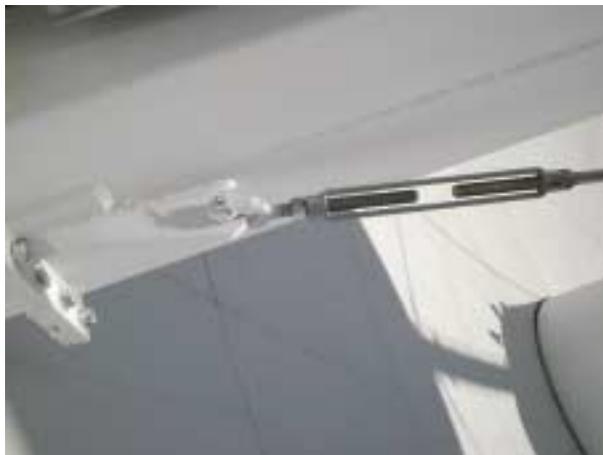
One quad leg t-buckle jam nut needed tightening.

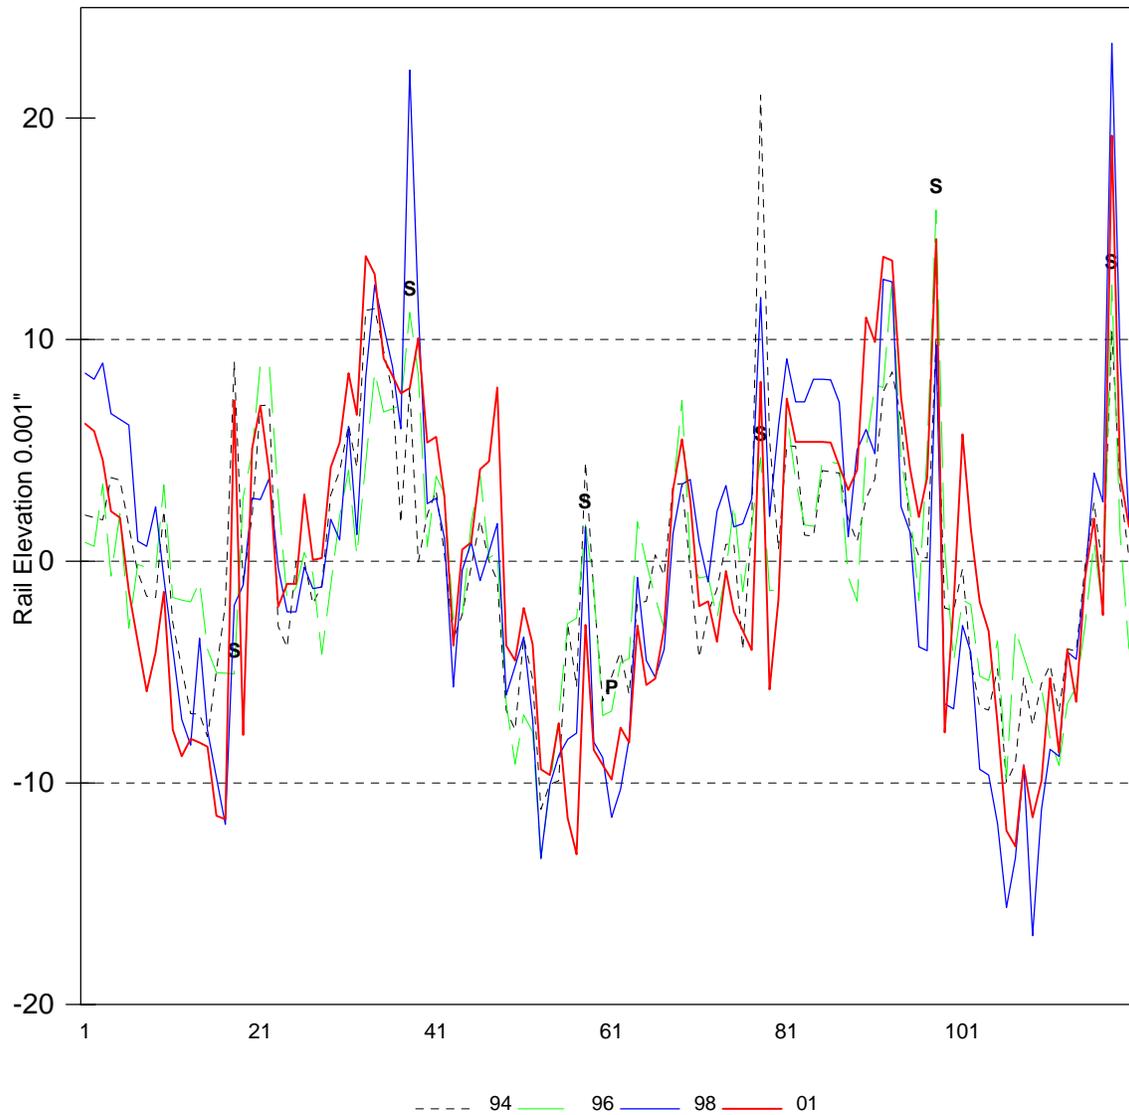
OV Azimuth Rail

The azimuth rail grout and Vulkem are in excellent condition.

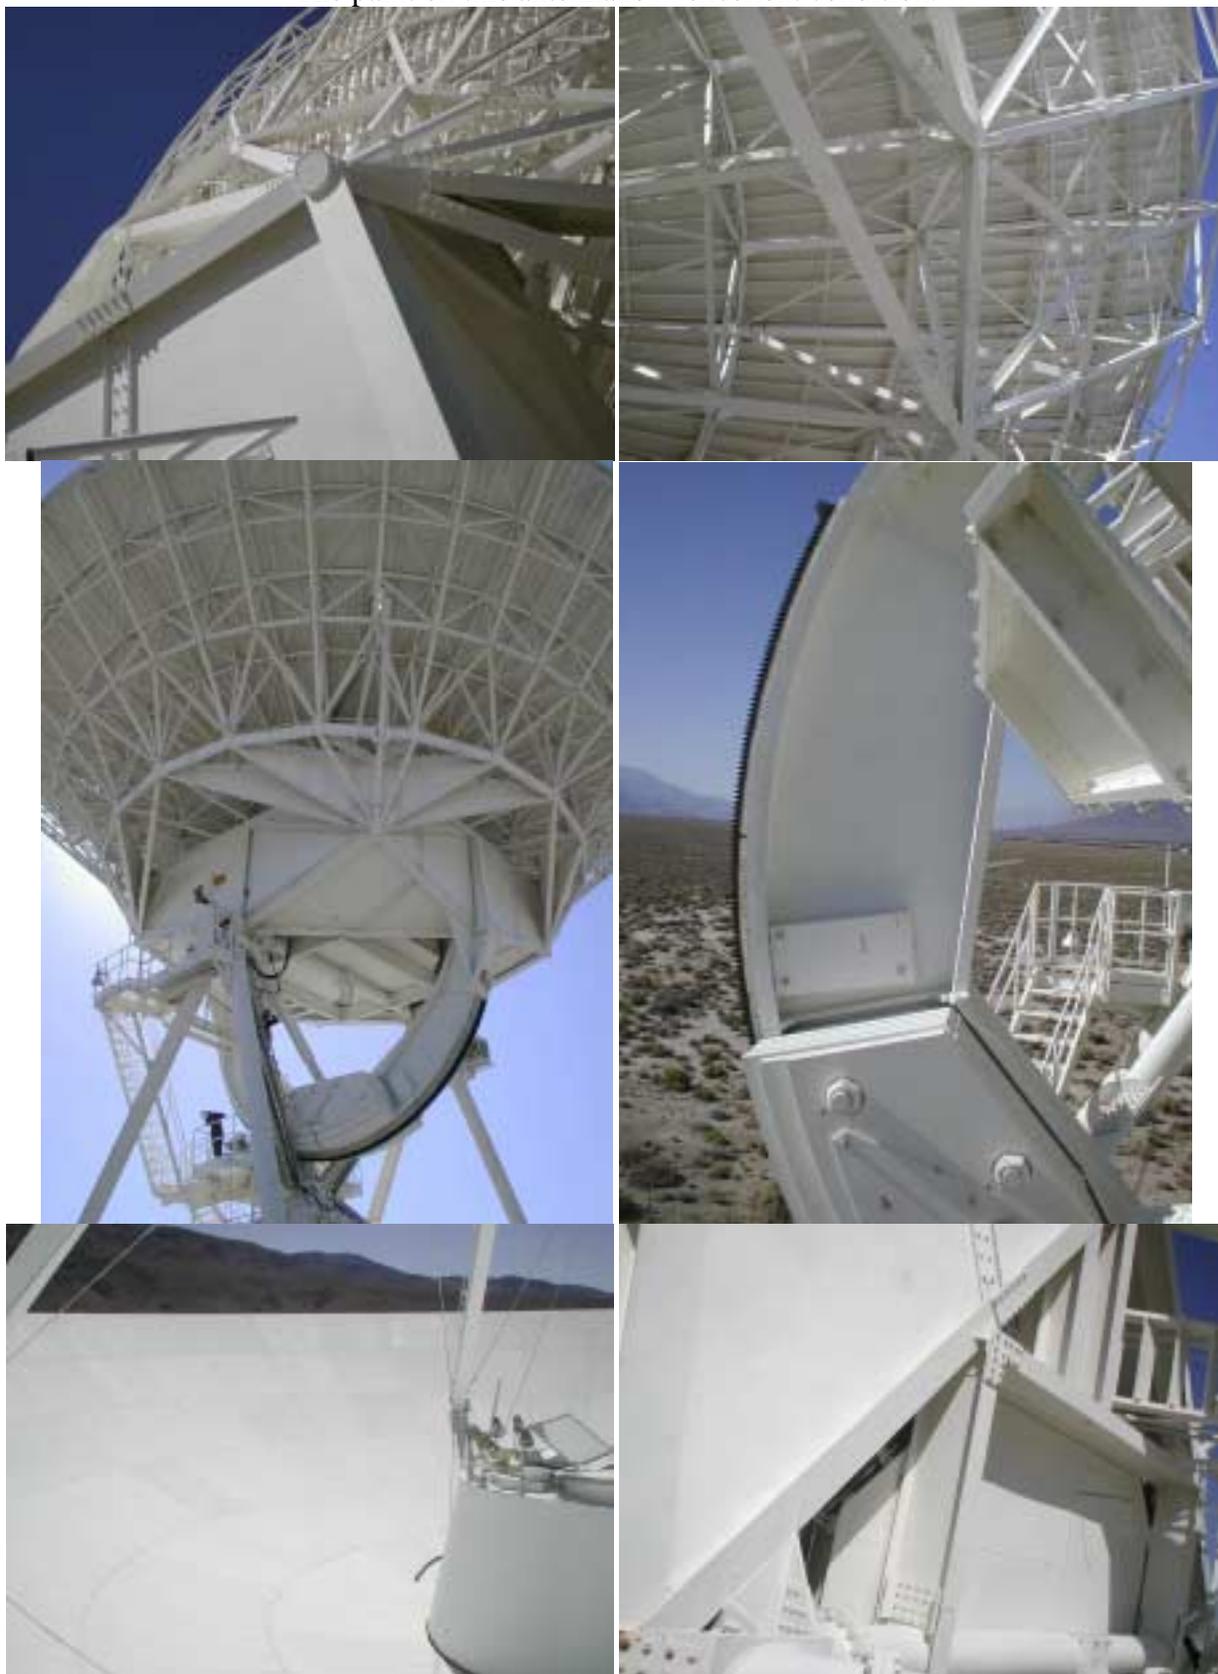
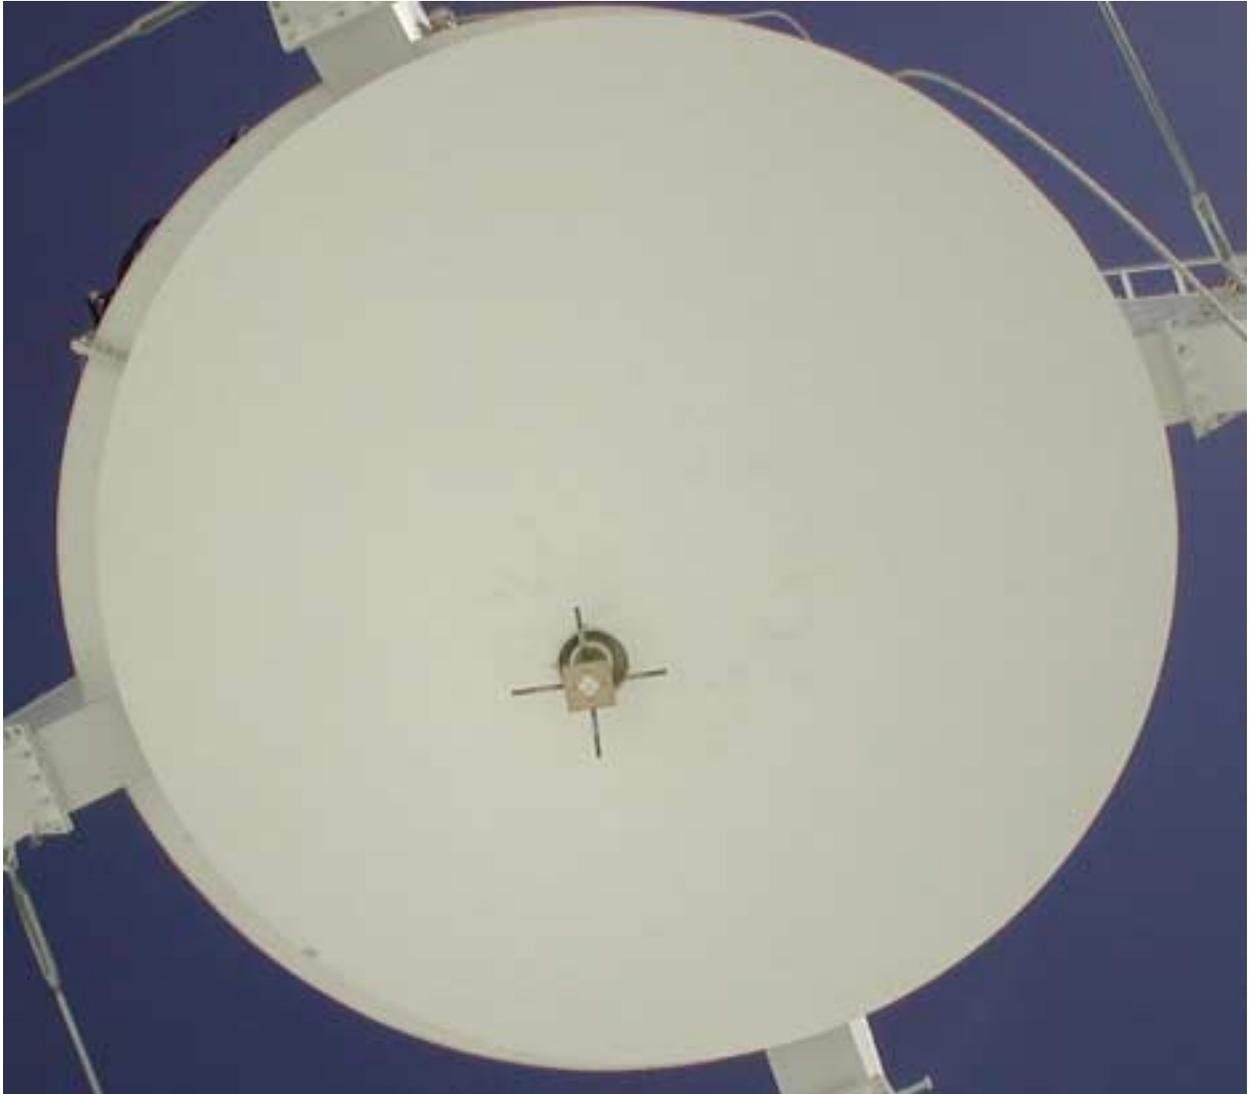
The paint on this antenna is in excellent condition.
