**National Radio Astronomy Observatory**  
Socorro, NM

VLBA Antenna Memo Series #36

**Pie Town Maintenance Visit**  
2001

Jim Ruff  
1/04/02

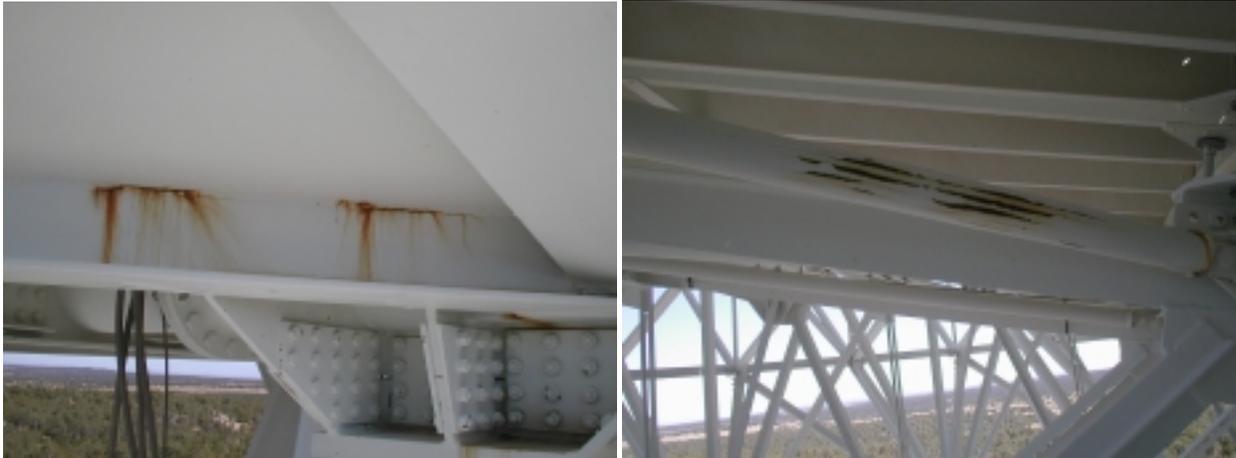
Structural cracks found previously had not progressed. A backup structure tube with freeze cracking was found.

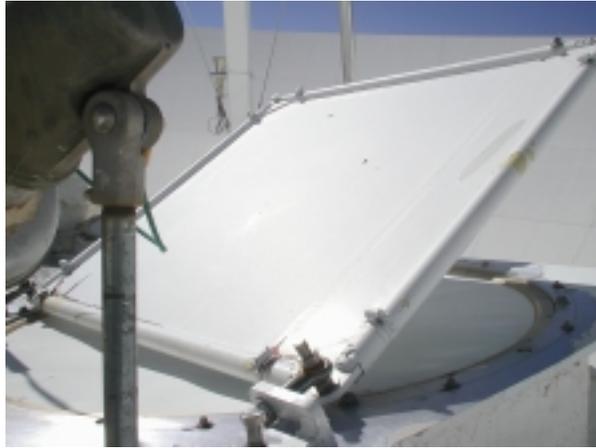
The dichroic panel is in good condition.

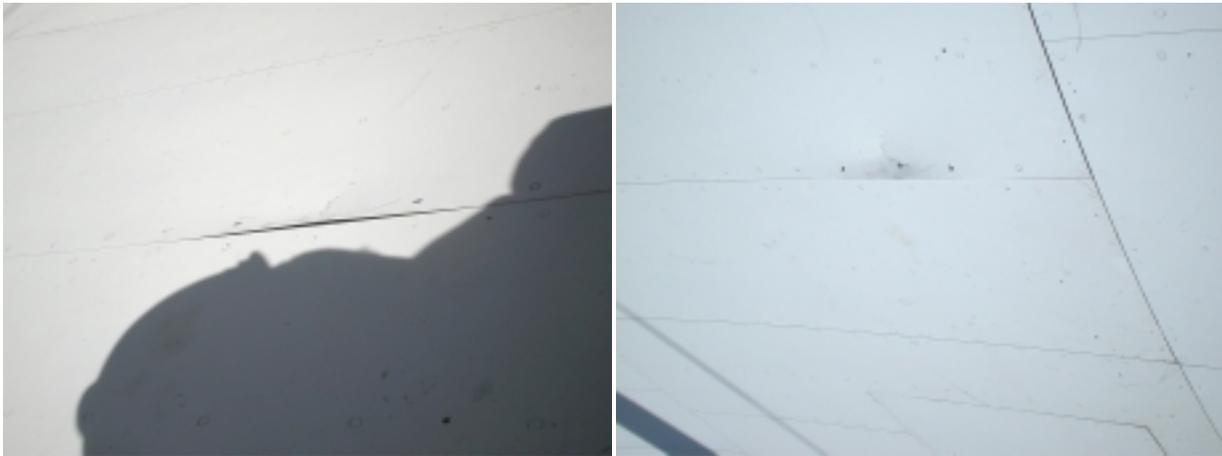
There is a dented panel near the main dish access hatch.

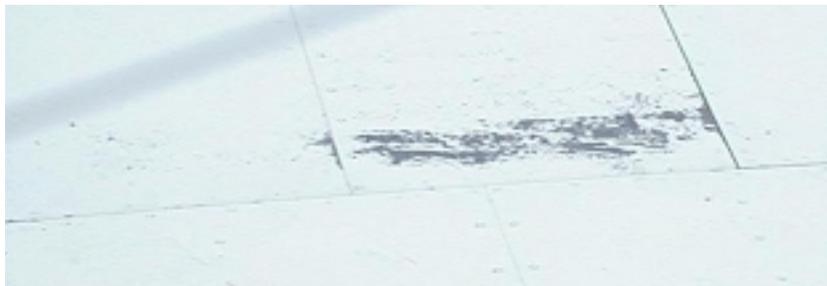
There are areas of eroded paint on some of the panels.

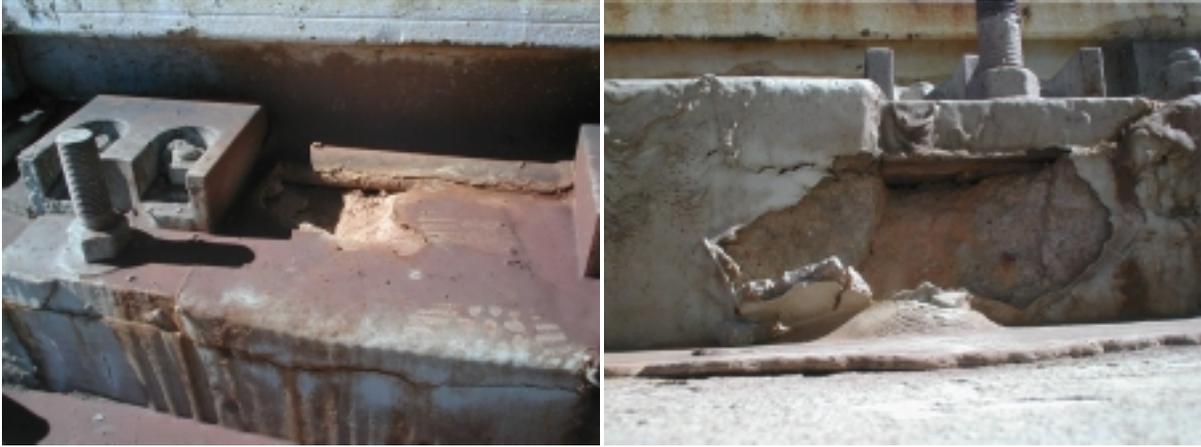
The azimuth rail grout is in need of spot patching. There are damp spots under the Vulkem that may promote further degradation.

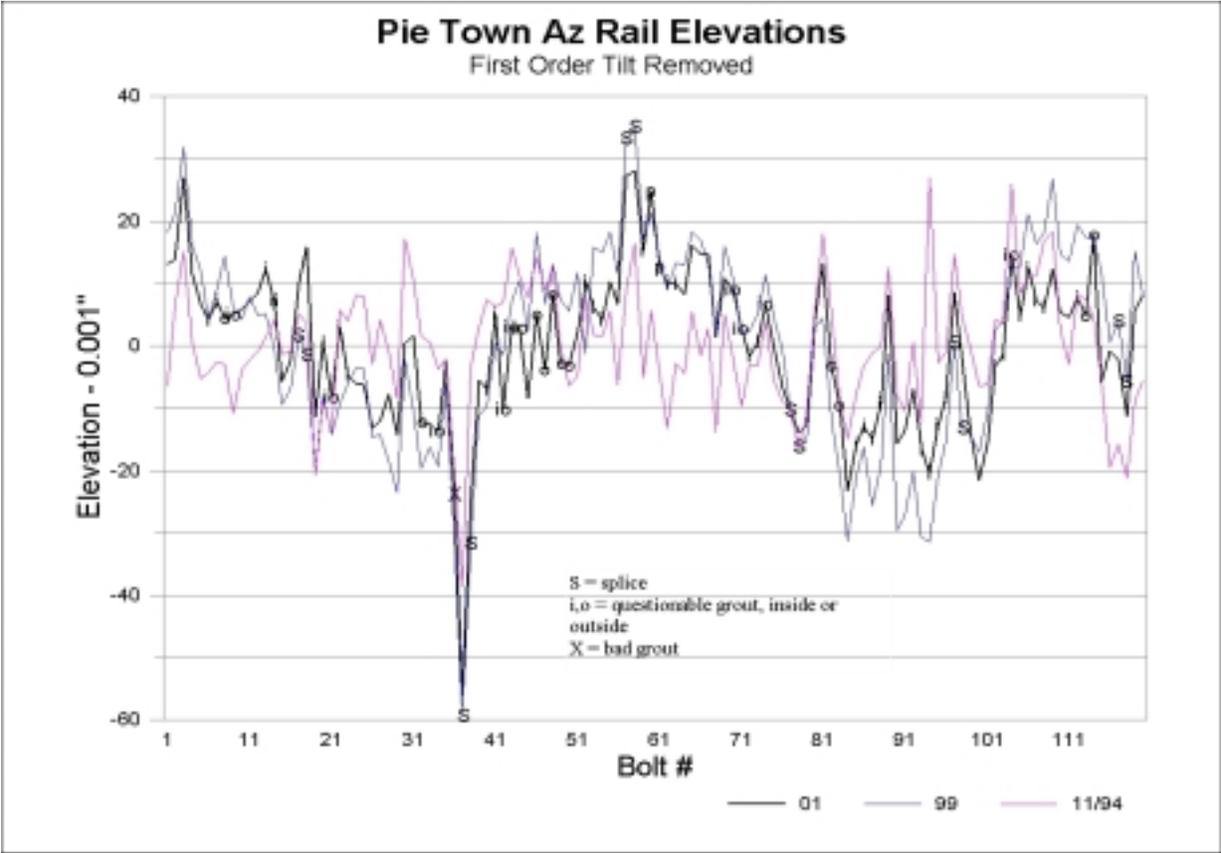
First order tilt is 0.31 inch (3' 32").

The paint on this antenna is in need of touch-up.
