**NATIONAL RADIO ASTRONOMY OBSERVATORY**

VLBA Antenna Memo Series No.37

**Owens Valley Gearbox Repair**

J. E. Thunborg  
April 26, 2002

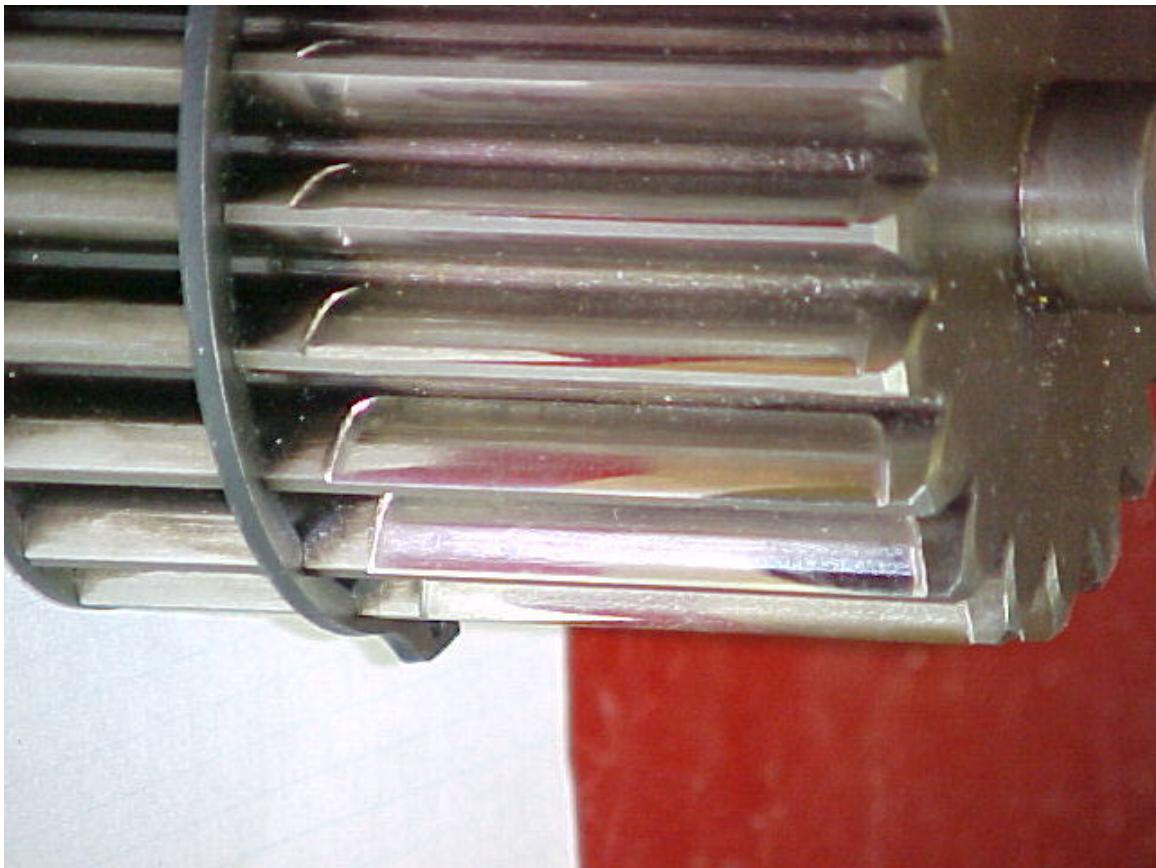
A groove matching the profile of the planetary gears was worn into one side of the sun gears. A typical groove is shown in the photograph below. The depth of the grooves was between 0.010 and 0.015 inches. The deeper grooves were on the latter or slower moving stages of the gearboxes. The surfaces of the grooves were very shiny, almost a lapped appearance. There were no scratches in the gear teeth that would indicate foreign particles in the oil. The fact that the slower running, higher loaded, later stage gears showed more wear than the faster running, lighter loaded, early stage gears may indicate that we should use a higher viscosity oil.

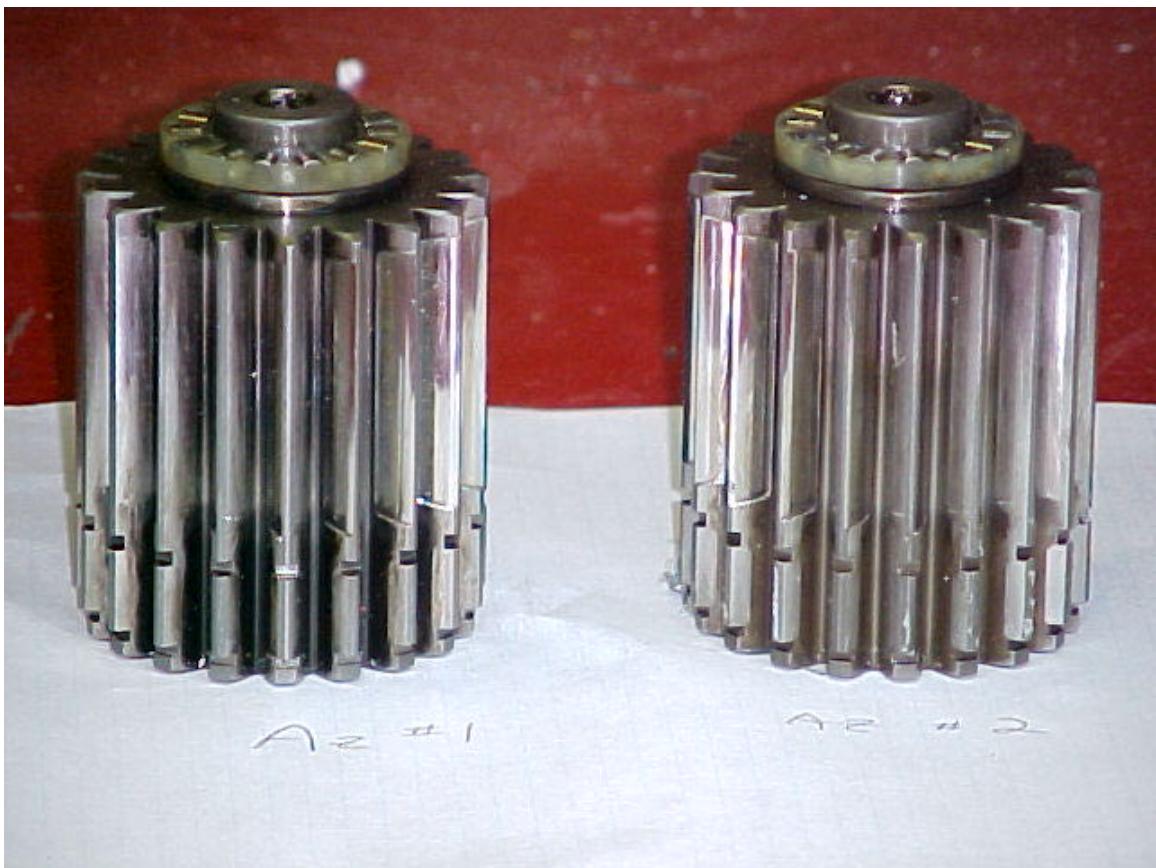
The photograph below shows that the sun gears in Az#1 gearbox are worn on the counter clockwise rotation side while the sun Gears in Az#2 gearbox are worn on the clockwise side. The sun gears show very little wear on the opposite side. This uneven wear is probably due to the 30% servo preload used to reduce backlash. If this is the case, we should be able to extend the life of the gears by reversing the direction of the preload or swapping the gears from one gearbox to another.

During maintenance visits to other sites, we will open up the gearboxes and inspect them. If these gearboxes show identical wear patterns, then we should immediately reverse the preload or the exchange the gears in the gearboxes.
