NATIONAL RADIO ASTRONOMY OBSERVATORY

VLBA Antenna Memo Series No.38

North Liberty Rail Repair

J. E. Thunborg June 14, 2002

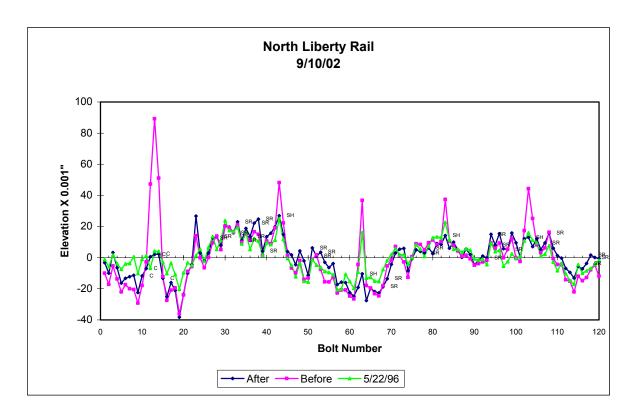
SH – Marks places where shim was added between rail and splice plates.

SR – Marks places where spot repairs were done.

C -- Marks place where complete gout repair was done.
