NATIONAL RADIO ASTRONOMY OBSERVATORY
Socorro, New Mexico

VLBA Antenna Memo Series No.39

Los Alamos – Drive #1 Axle Repair
June 18-19, 2002 - Trip Report

J. E. Thunborg

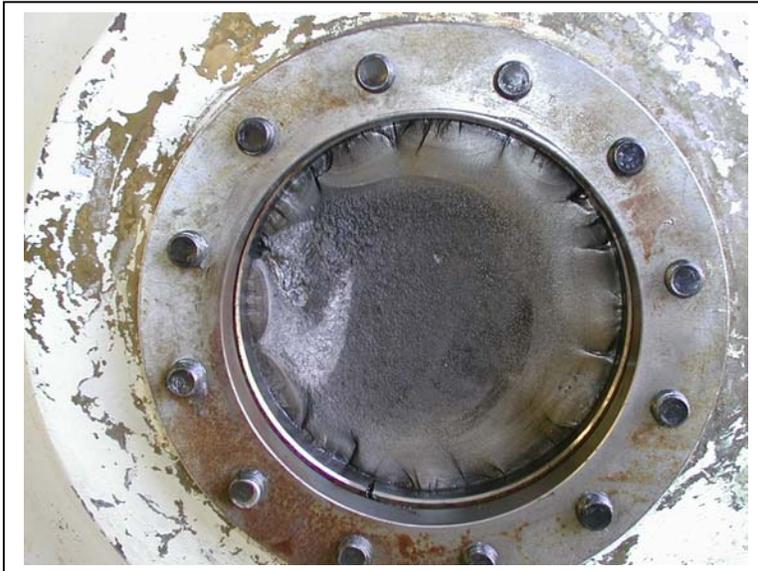
The azimuth drive #1 wheel in Los Alamos started making popping noises. The 7" diameter axle subsequently broke a few days later. The axle broke about 1 inch inside the edge of the taper coupling between the wheel and the outside bearing. The break and place of the break were very similar to the previous axle failure on Drive #2 of the Los Alamos antenna (VLBA antenna Memo's #28 and #30).

The paint on the gearbox drive shaft revealed that the coupling on the shaft had moved out approximately 1/4". This most likely occurred when the axle broke, as it was not detected when the wheel started making popping noises.

During the maintenance visit in April 2001, Jim Ruff and company found that the angular alignment of this drive wheel was off by 0° 4' vertical and 0° 1.5' horizontal. It is unknown whether this misalignment contributed to the failure.

Gene Dunn, Ramon Gutierrez, Paul Johnson, Jim Ruff and John Wall replaced the wheel/bearing assembly on June 18. The author of this report showed up on June 19 after the bulk of the work was done.

On June 19 the following alignment parameters were recorded for the new axle/wheel assembly. The antenna rotated smoothly without popping sounds.
