National Radio Astronomy Observatory
Socorro, NM

VLBA Antenna Memo Series #40

St Croix Maintenance Visit
April 8th through 25th, 2002

Jim Ruff
6/24/02

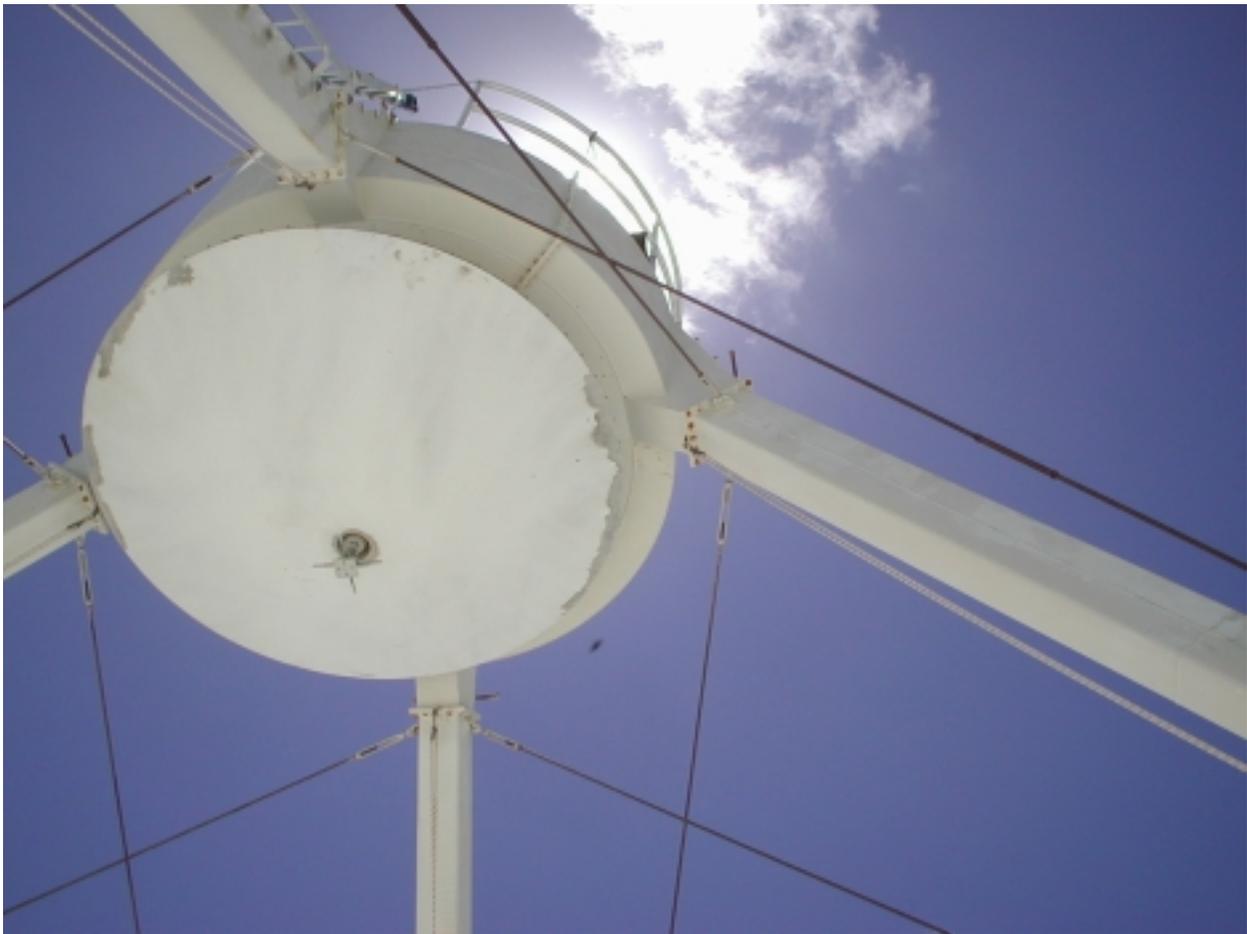
A quad leg ladder and Sellstrom fall arrest system were installed. (The handrail was installed previously.) The site techs were treated to a training session on use of the Sellstrom system and general fall protection. Note the corroded guy wires in the photo above.

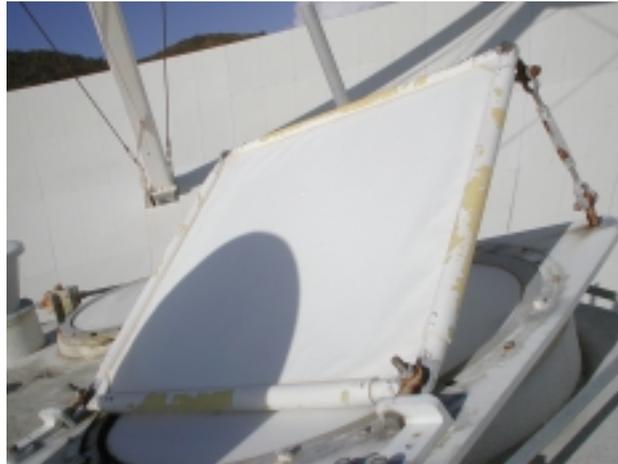
The dichroic panel is delaminating. (The frame was repainted after this picture was taken.)

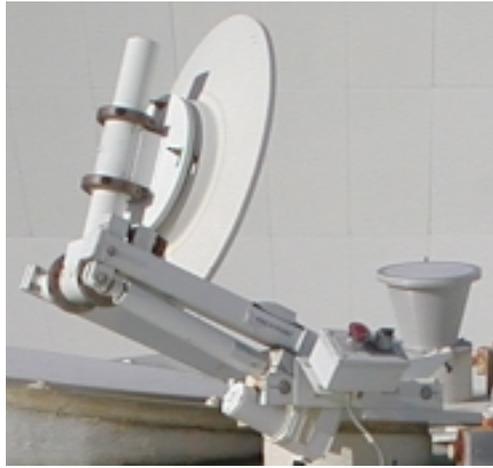
The dish tipper looked fine.

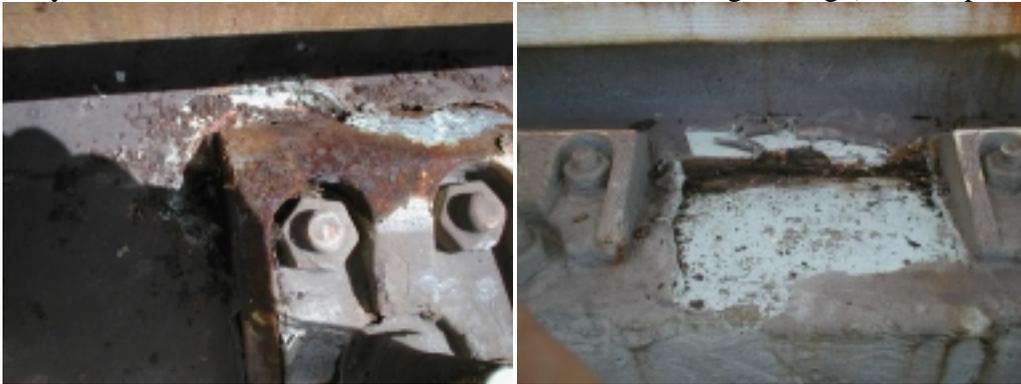
The rails and rail clips on this antenna are rusting. The Vulkem has cracked to the point where it no longer keeps water away from the metal. In fact, it holds water in, facilitating rusting (if that's possible at STX!)

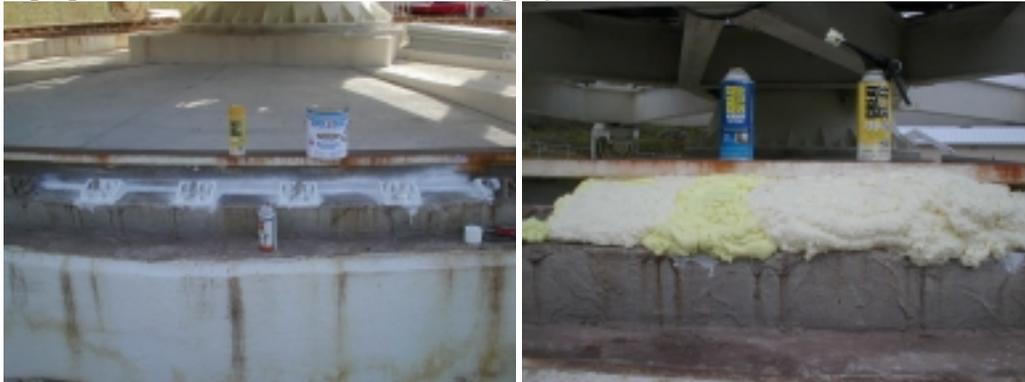
I did some experiments on ways to slow the deterioration. I scraped off the Vulkem in some bad areas and applied "Rust Cap" primer to the bare metal. Then I sprayed "Great Stuff" foam over half of the primed areas.

We need to monitor these patches, consider other alternatives, and decide how to proceed. I think we can wait a while before doing something, but the longer we wait, the more rust we'll have to deal with. In the mean time, the site techs are removing vulkem in their spare time.

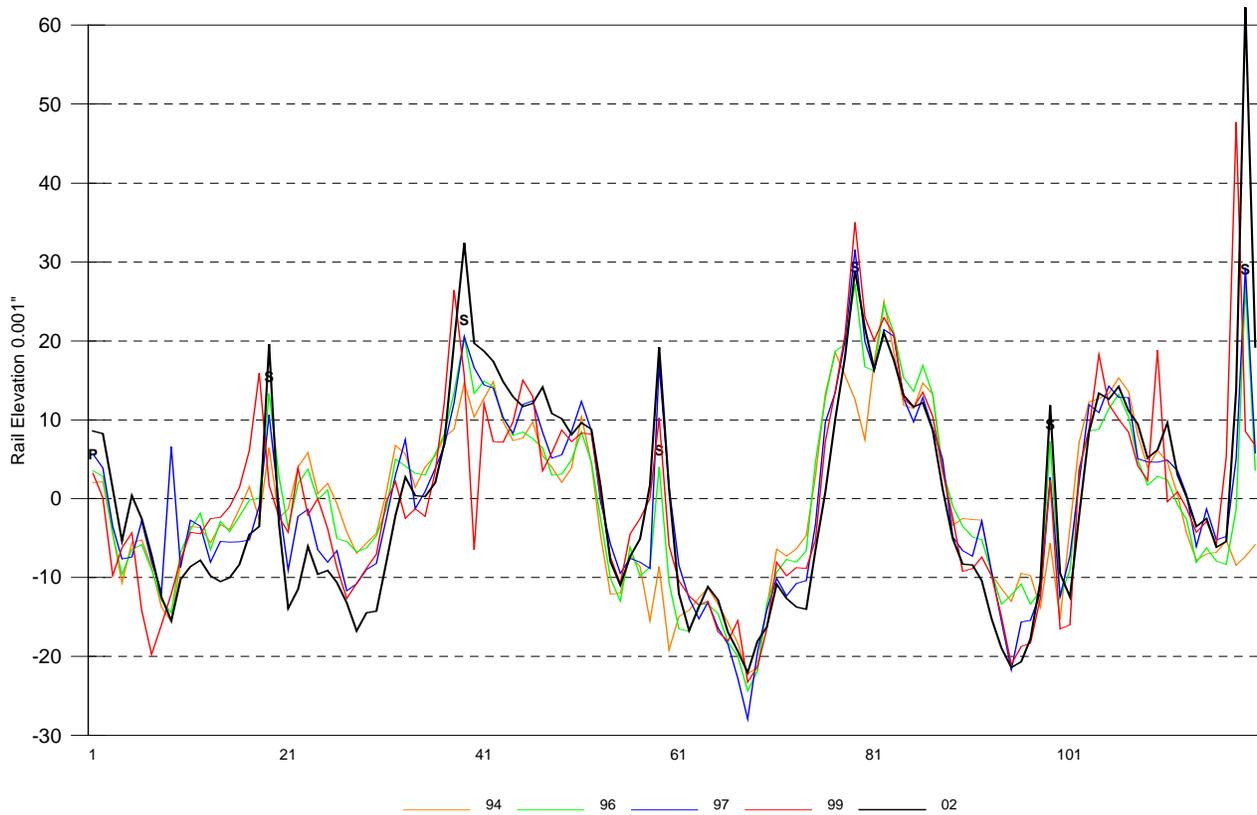
SC Azimuth Rail

The SC rail has a first order tilt of nearly 0.3" peak-to-peak.

The splice at bolt #119 appears to be sinking over time. Similar behavior was seen at NL by the rail grout repair crew this year. It appears the rail is being slightly, slowly squashed at the splices. This should be repairable by shimming.

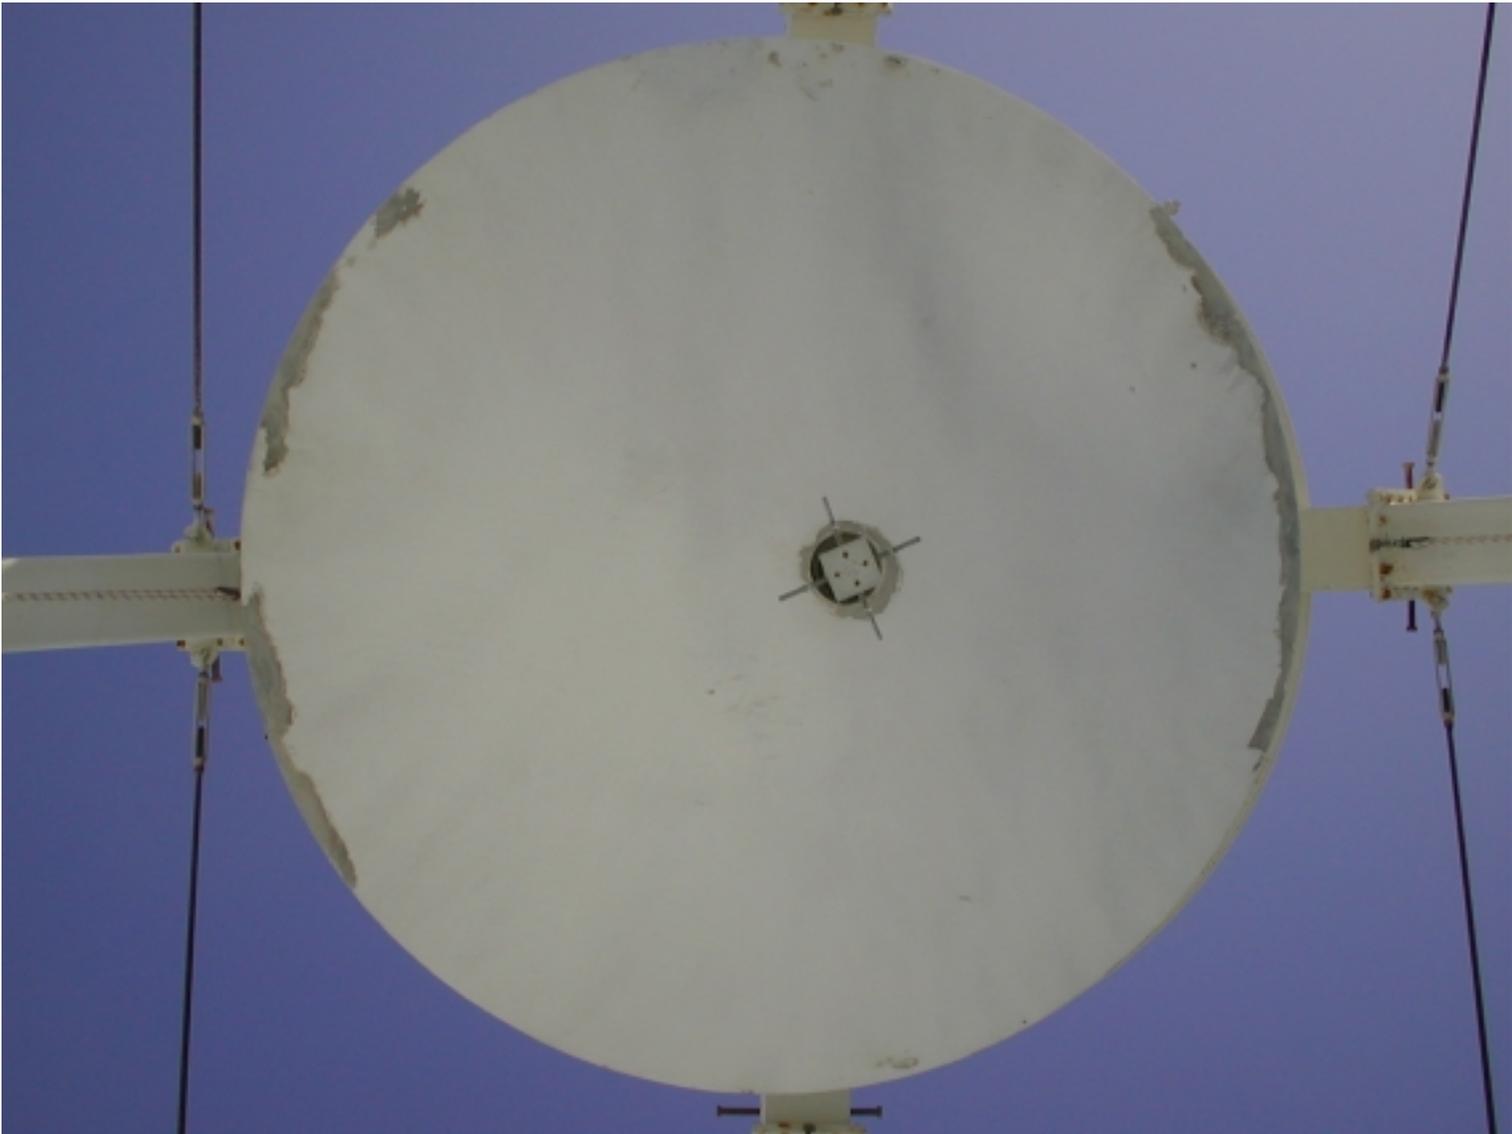
Some of the paint on the subreflector is peeling.
