National Radio Astronomy Observatory
Socorro, New Mexico

VLBA Antenna Memo # 46

Saint Croix, Virgin Islands Maintenance Visit March 15-25.

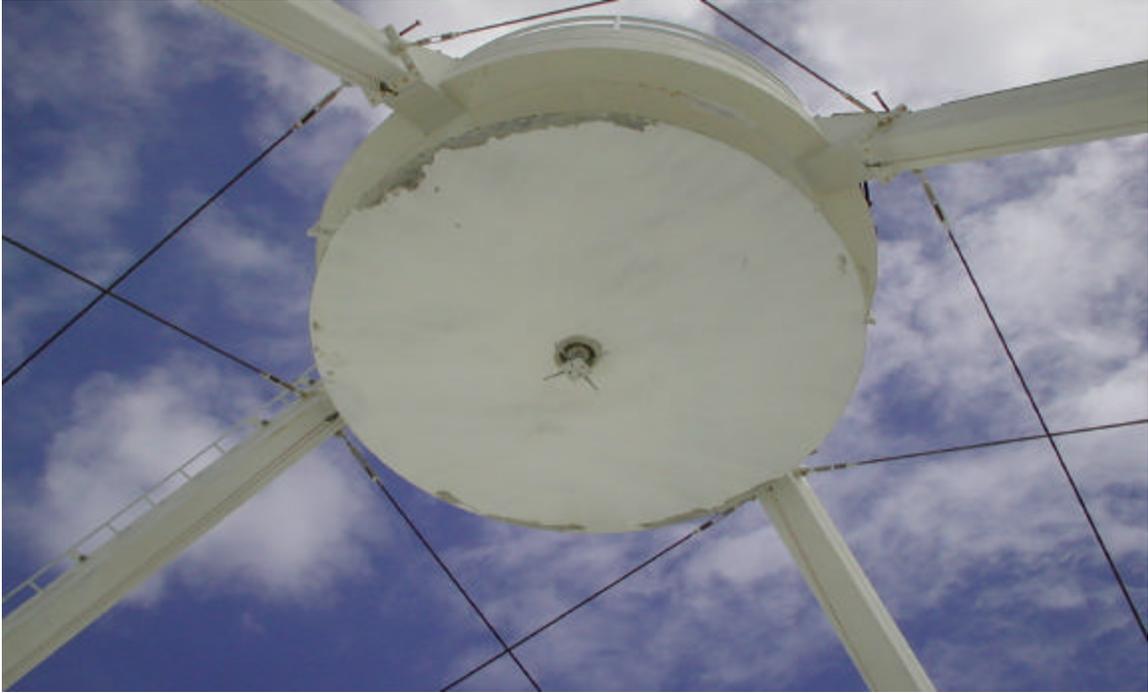
Subreflector has some peeling paint on the outside perimeter, ~ 3" strip.

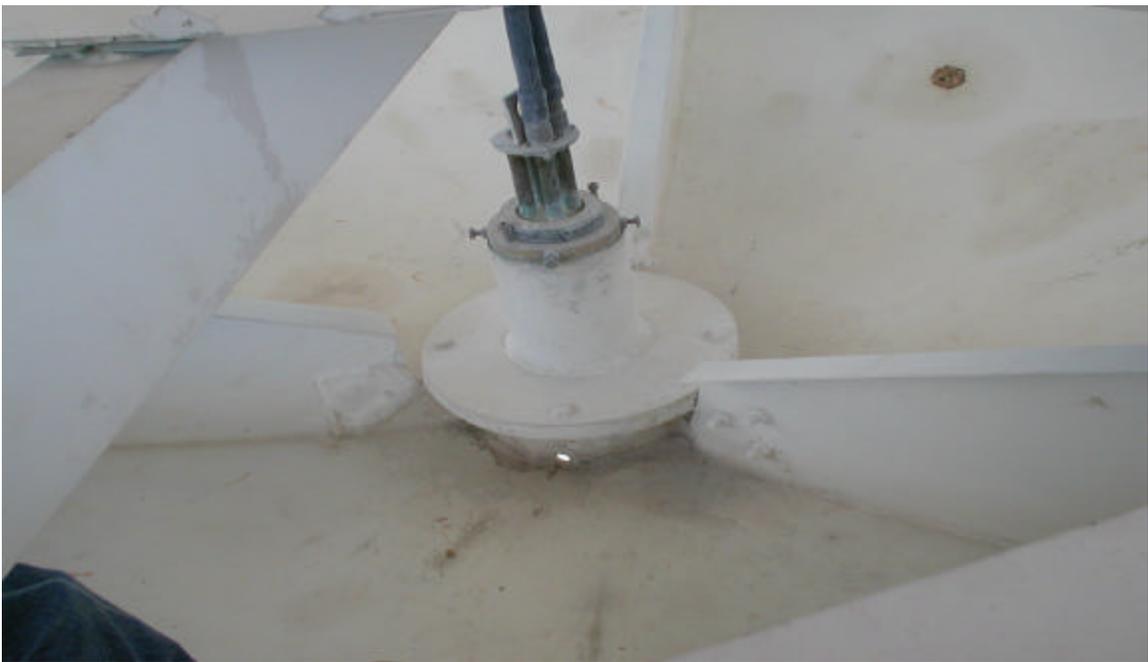
Subreflector drain holes are clear. The di-pole is in good condition but slightly corroded. 90/50cm FE cables are in good condition.

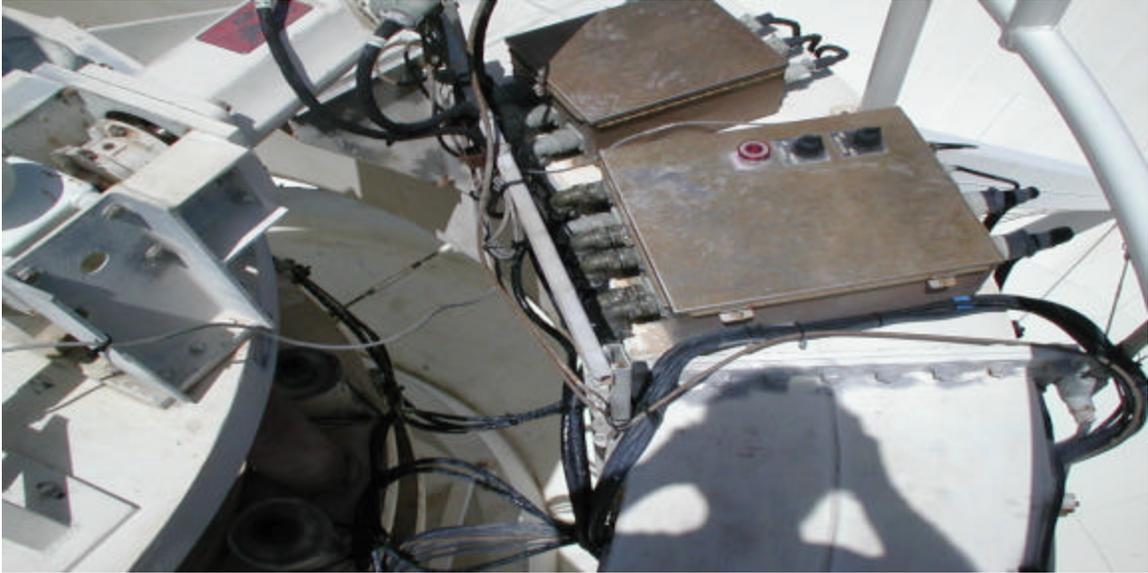
FRM INA BEARING CHECK 50 LBS PULL ON PRIMARY SIDE

Primary Travel: +.001"	Secondary Side: -.001"
--------------------------	--------------------------

FRM INA BEARING CHECK 50 LBS PULL ON SECONDARY SIDE

Primary Travel: -.001"	Secondary Side: +.00015"
--------------------------	----------------------------

FRM motors to j-box cable connectors were replaced. As were the j-box to j-box connectors. The focus flex shaft and a bellows were also replaced.

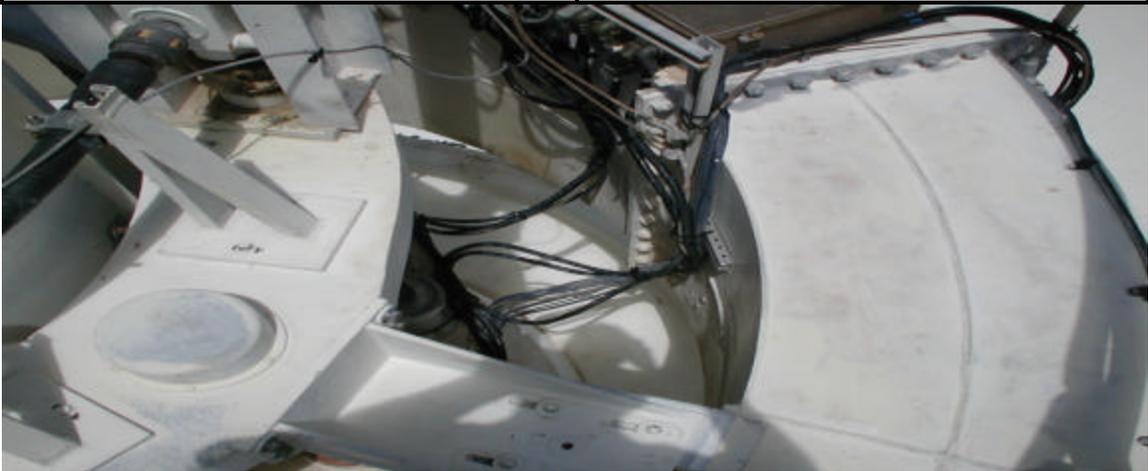
FRM cable strain reliefs were badly rusted and the cable trays were broken. Strain reliefs were replaced with aluminum brackets Ramon made. Cables are lashed to these brackets with ss ty-wraps. The broken cable trays were removed. FRM cables are bundled and looped together with ss ty-wraps.

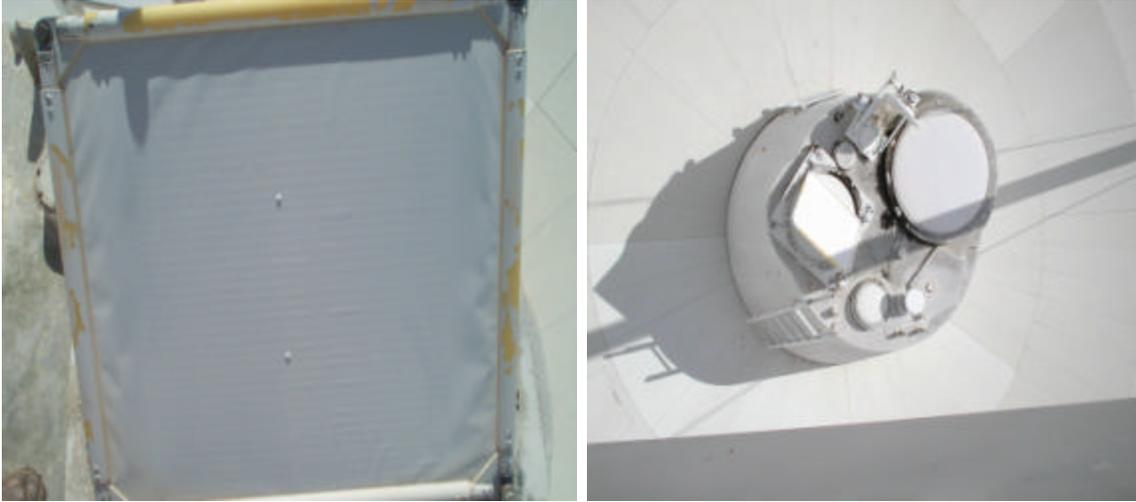
The dichroic reflector is delaminating. View of feed cone and dish panels.

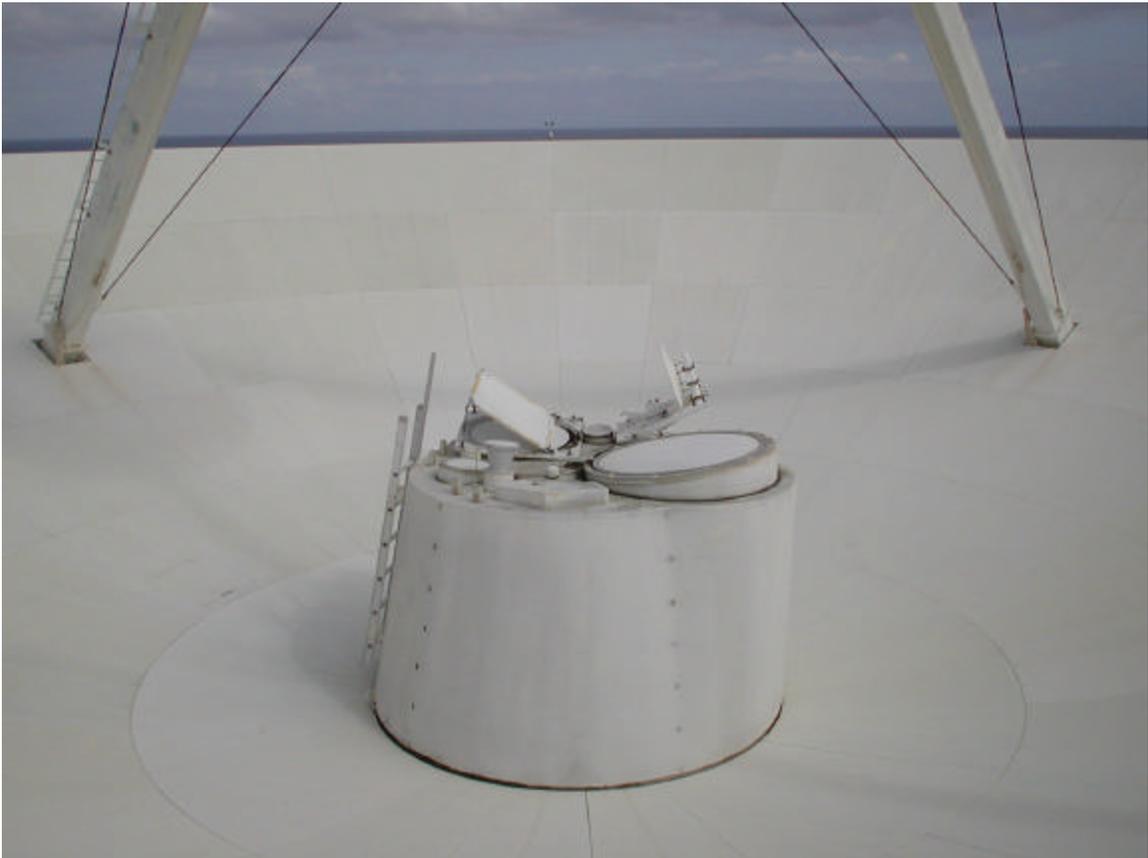
Feed cone insulation, ellipsoid reflector and dish panels are in good condition. Quad legs and guy wires have a little surface rust.

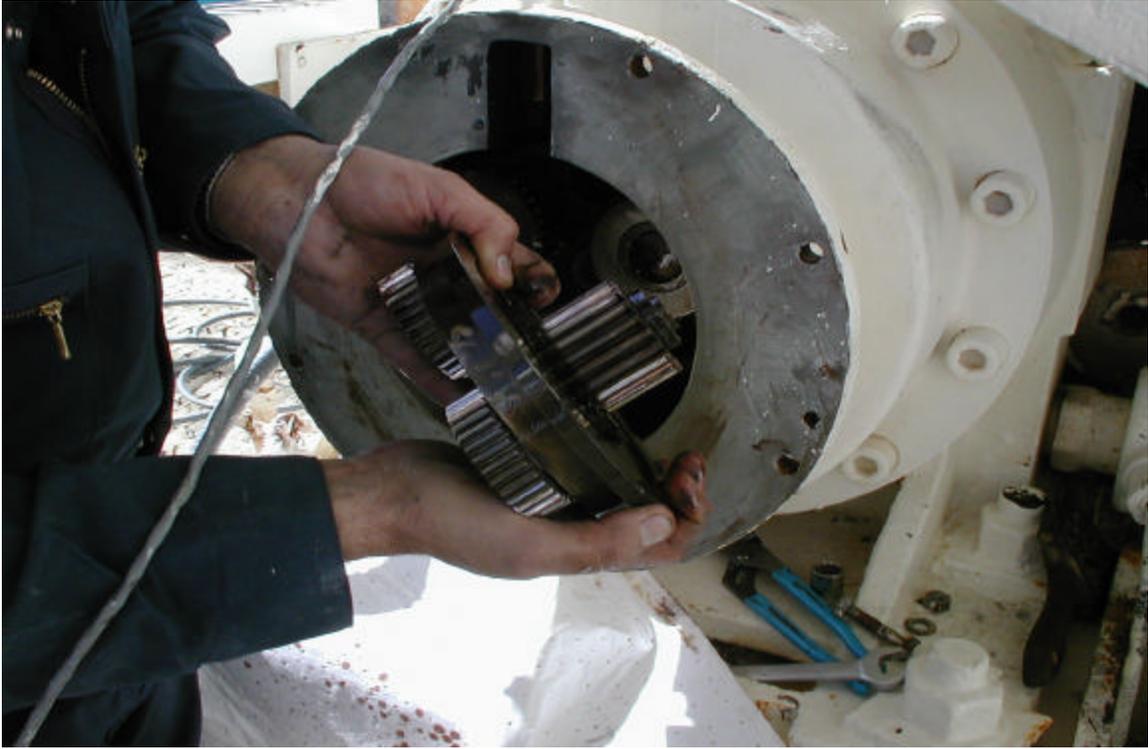
Elevation gearbox #1 pre-load inspection showed very little signs of wear. Both gearboxes oil was changed and several flow gauges were replaced.

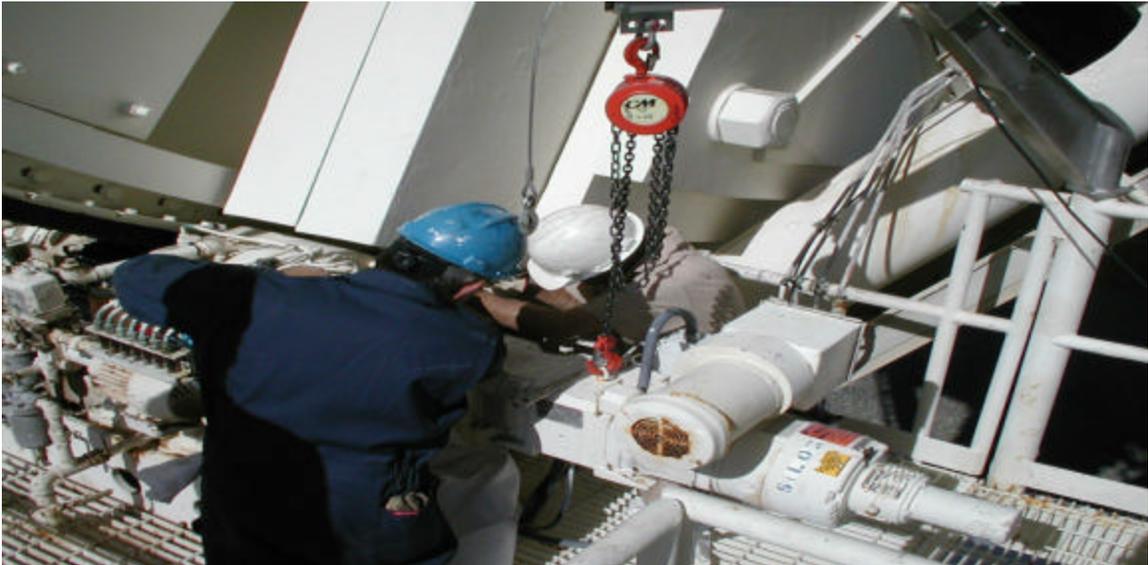
Elevation motor # 1 was replaced. The elevation bull gear is well lubricated.

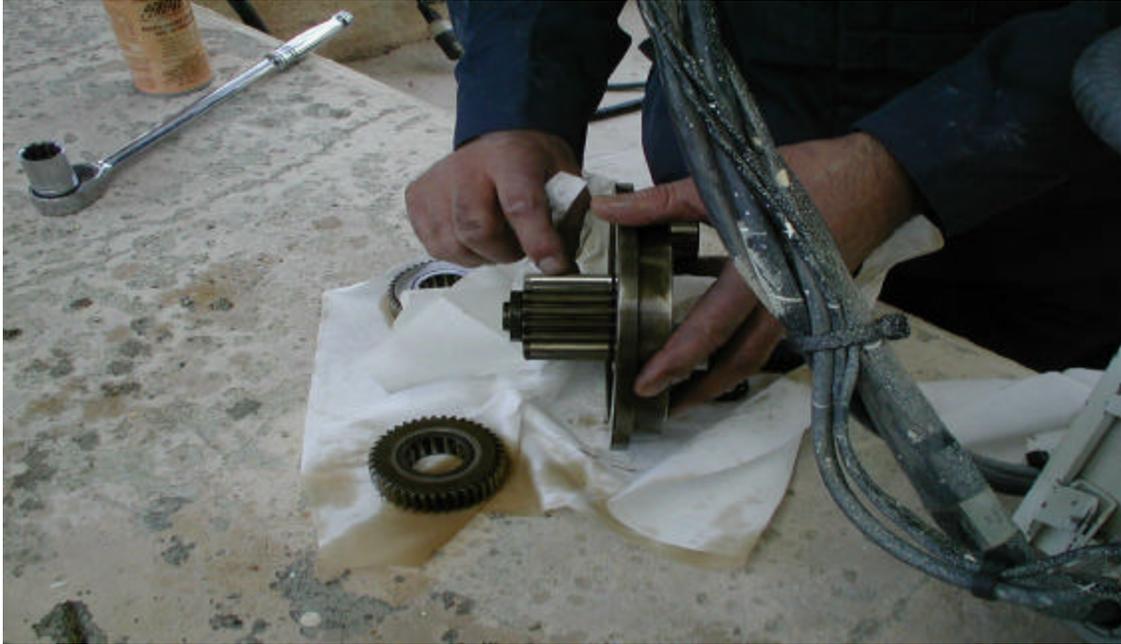
Azimuth #1 gearbox pre-load inspection.

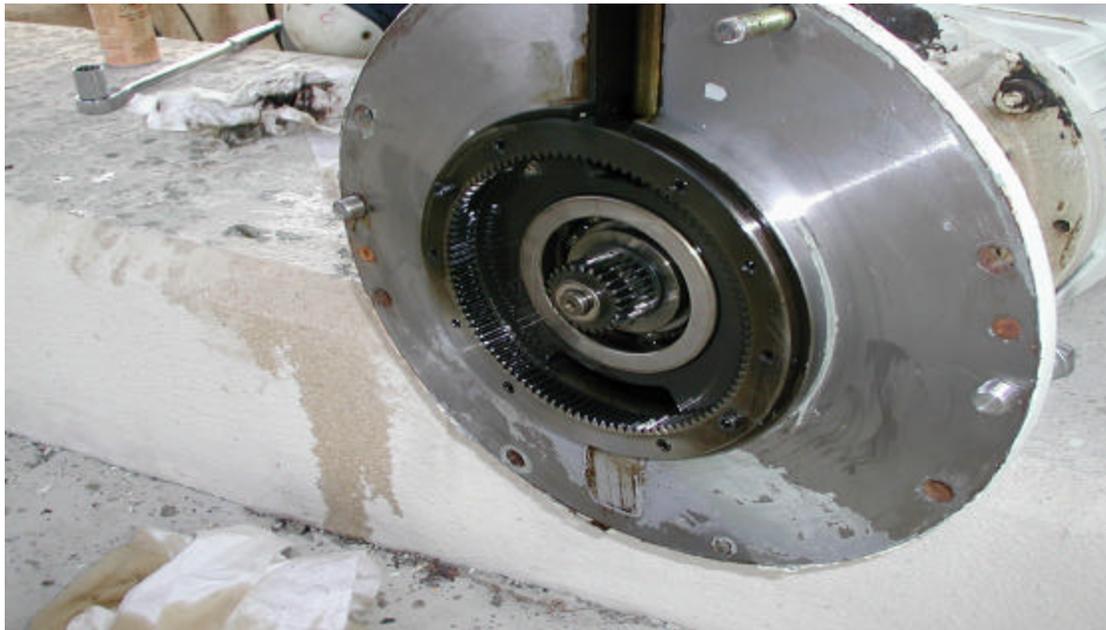
Azimuth #2 gearbox pre-load inspection. Both gearboxes showed very little signs of wear. Both gearboxes oil was changed and several flow gauges were replaced. A gearbox oil seal was replaced on AZ #1.

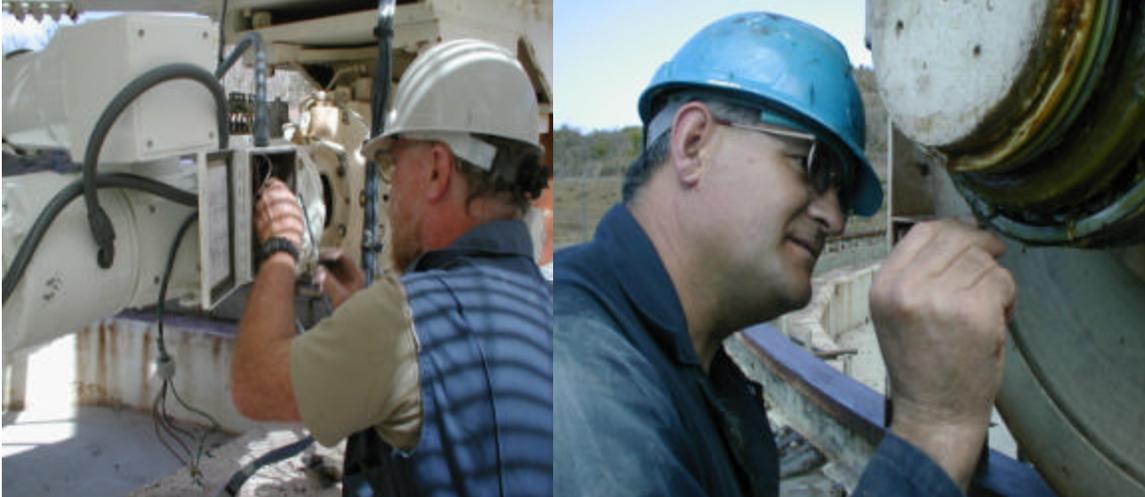
Azimuth motor #2 was replaced.

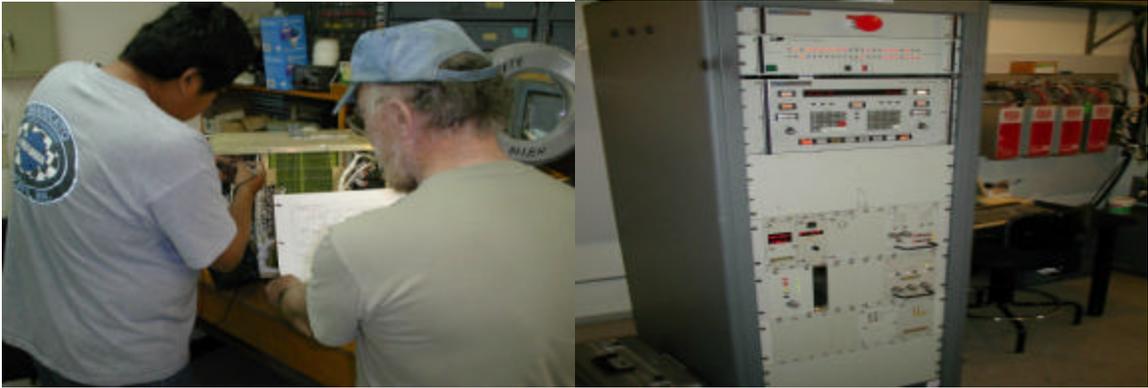
The ACU power supply upgrade was completed. During the ACU retrofit 6 bad TB2 crimps were found and repaired. The AZ synchro was repaired.

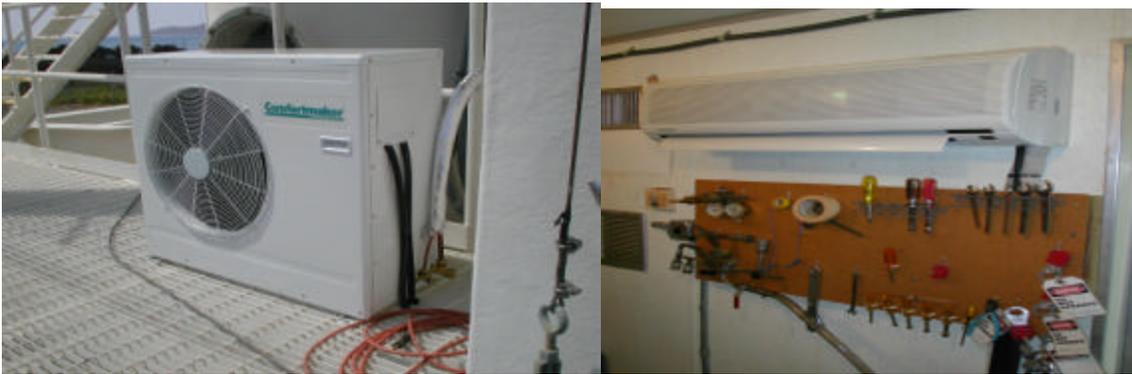
A new back up AC was installed in the pedestal room.

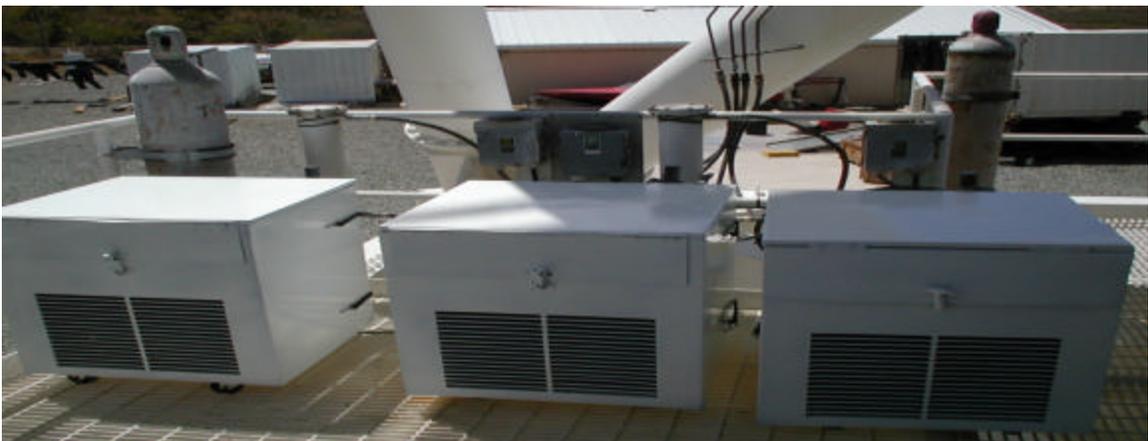
The cryo compressors are in good condition. Shown here with fresh paint.

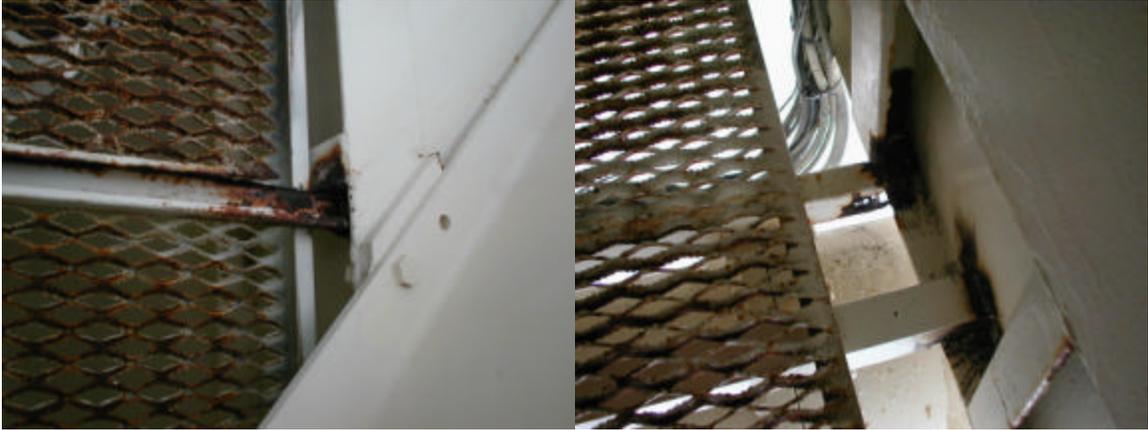
The vertex room catwalk was nearly rusted away and had to be rebuilt.

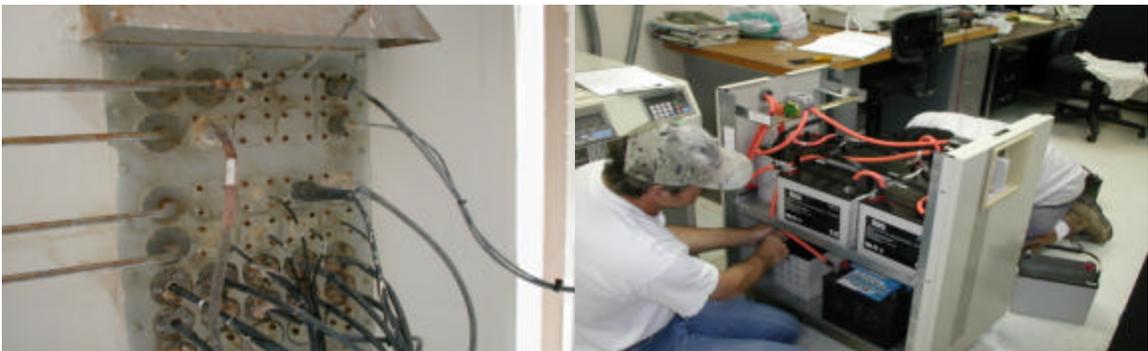
The ellipsoid reflector signal/power cable connectors on the vertex room baulk head were replaced. The station 12.5kva UPS batteries were replaced.

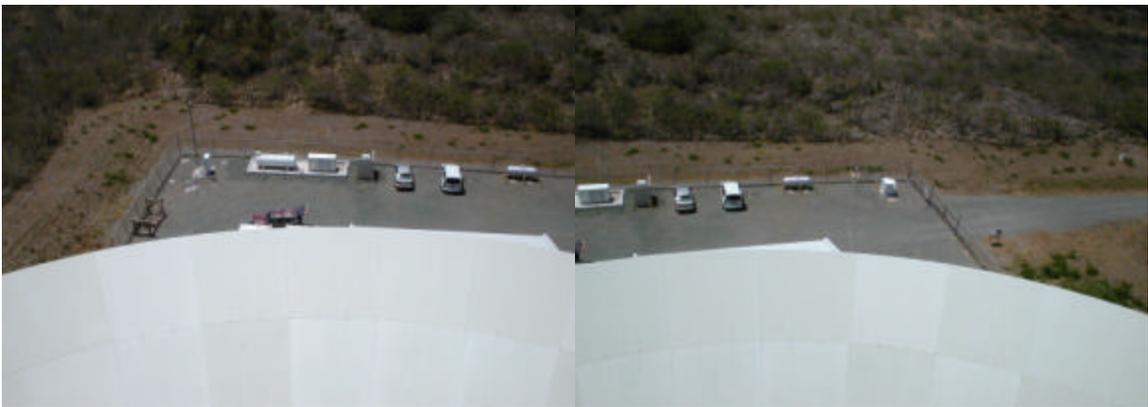
Brush is cut back ~30 feet around perimeter of the VLBA site. The area inside the fence is weed free and orderly.

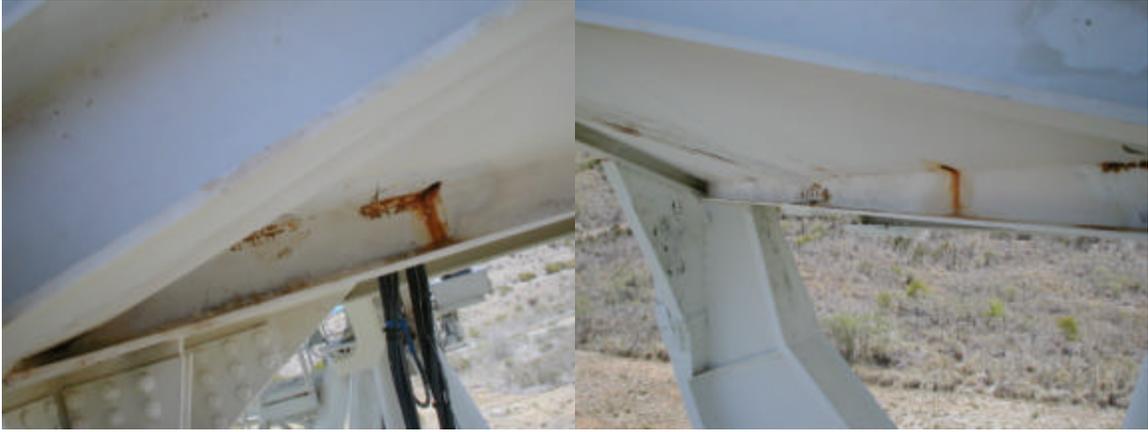
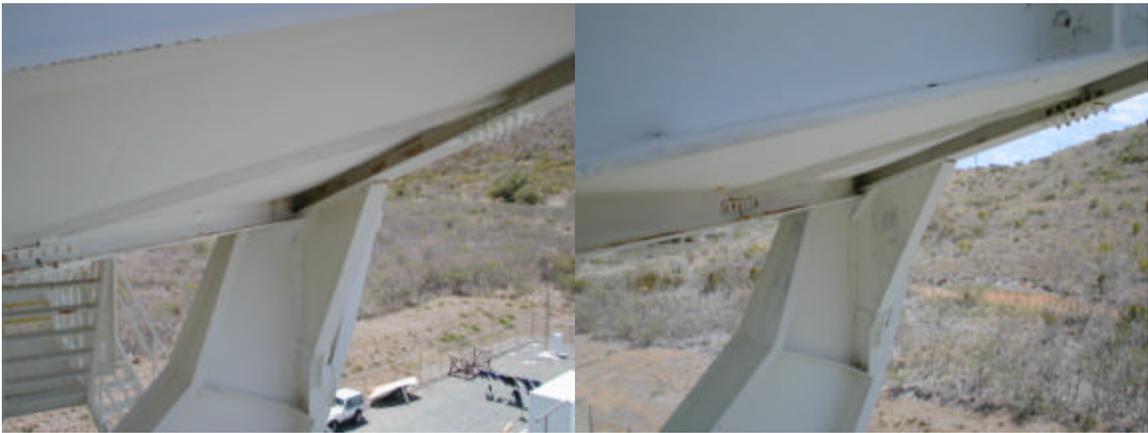
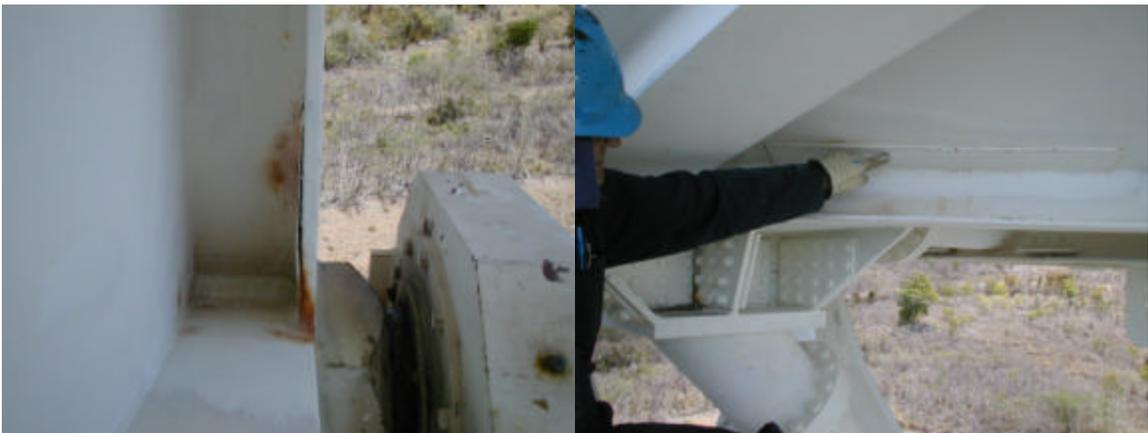
These photos show the worst areas of rust on the antenna. Painters and site techs are doing an effective job keeping up. Steve points to a repair completed during our last maintenance visit in April 2002.

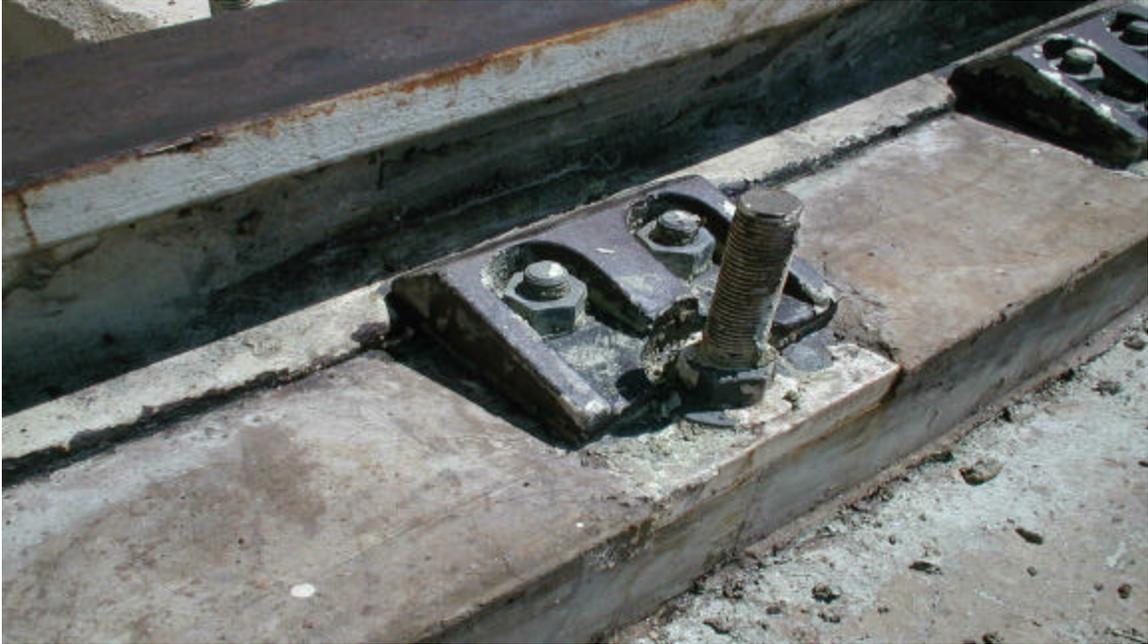
A typical rail clip with vulkem scraped off. Grout is in good condition. Site techs will follow up with chem prime paint on clips and splices as needed.

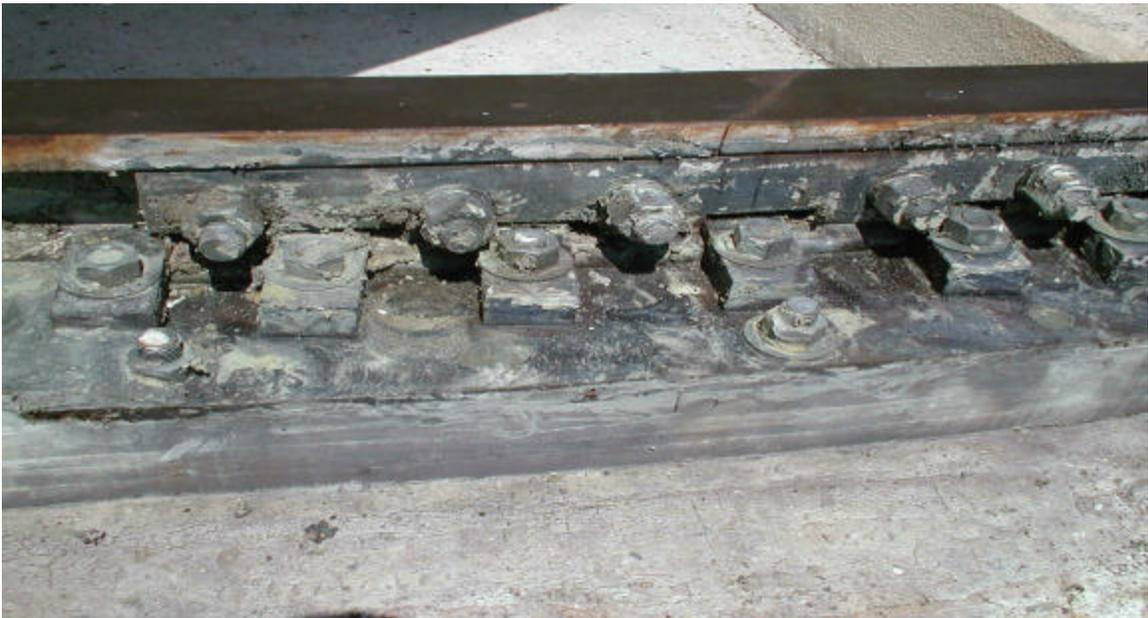
Rail splice with vulkem scraped off. The maintenance team and site techs were able to remove most of the vulkem from the rail during the visit. The rail, clips, and splices are in good condition.

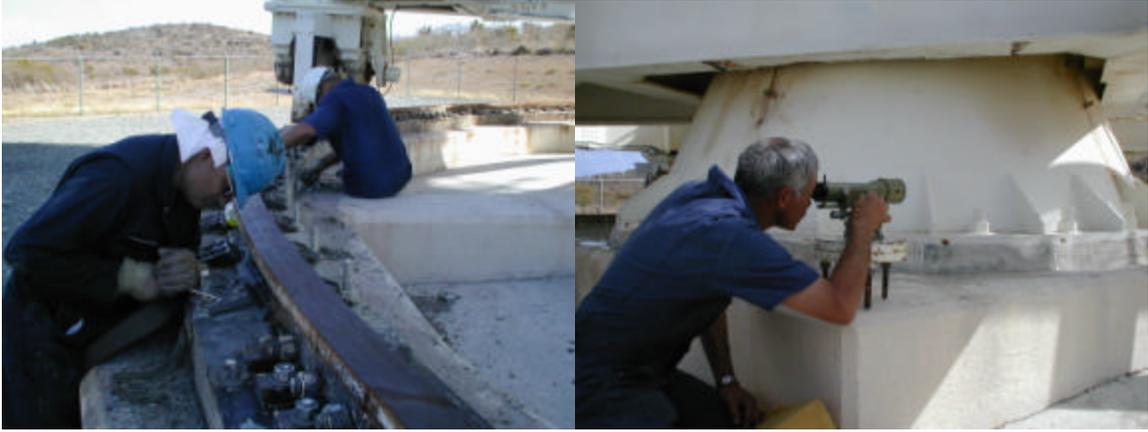
Removing vulkem from the rail.

Ramon measuring the rail.
