National Radio Astronomy Observatory  
Socorro, New Mexico

VLBA Antenna Memo #47

Kitt Peak, Arizona VLBA Maintenance Visit June 5-12/03

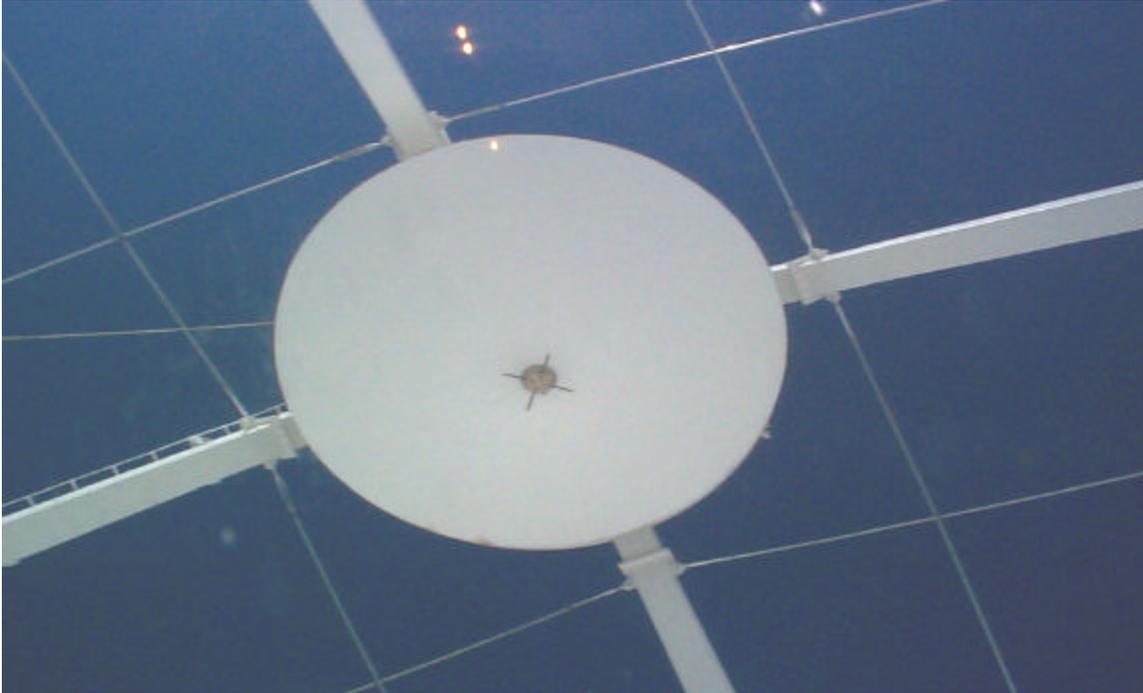
Subreflector is in good condition.

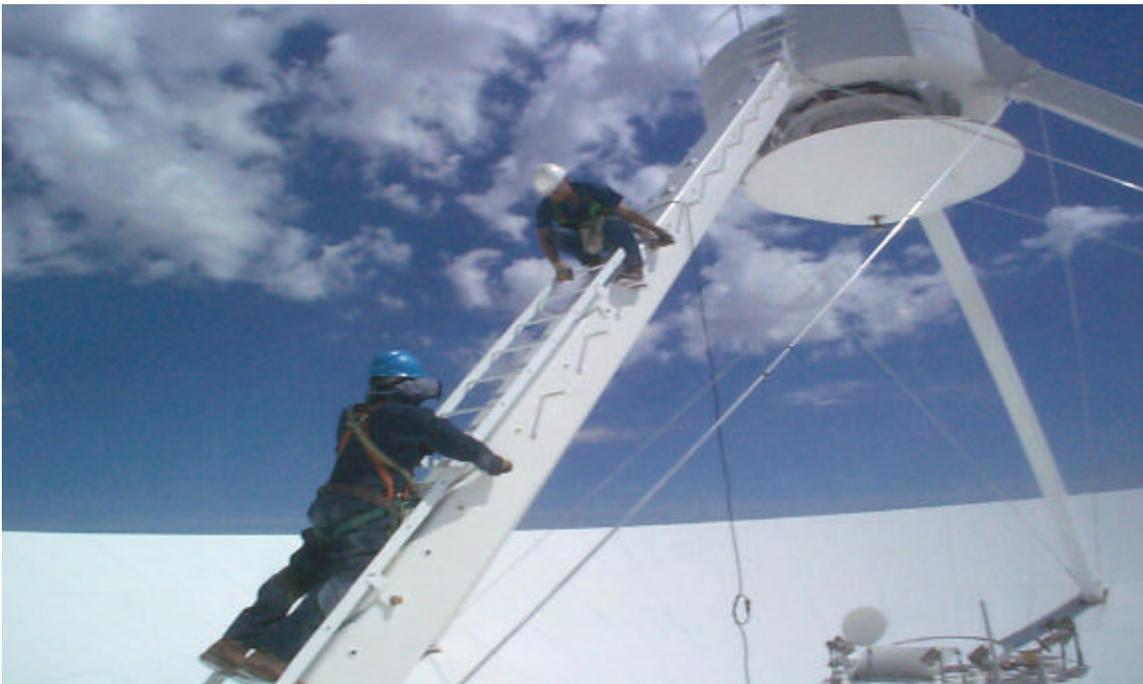
Ramon and Steve installing a new ladder and fall arrest on the quad leg. The site techs were trained on using the new Sellstrom fall arrest.

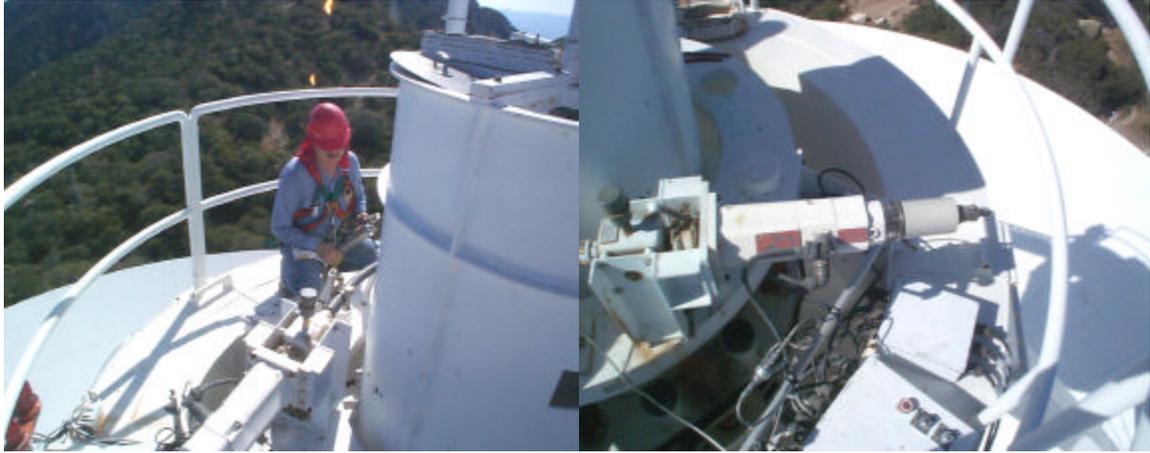
Duane greases the focus flex shaft. FRM is well lubricated and all j-boxes, cables, and connectors are in good condition. During the FRM PM a bellows was replaced. The focus flex shaft was replaced 2 months earlier by the site techs and not replaced by the maintenance team. The focus motor encoder coupling modification had been previously installed by the site techs.

**FRM INA BEARING CHECK 50LBS PULL ON PRIMARY SIDE**

Primary Travel:	+0.0015	Secondary Side:	-0.0005
-----------------	---------	-----------------	---------

**FRM INA BEARING CHECK 50 LBS PULL ON SECONDARY SIDE**

Primary Travel:	-0.001	Secondary Side:	+0.001
-----------------	--------	-----------------	--------

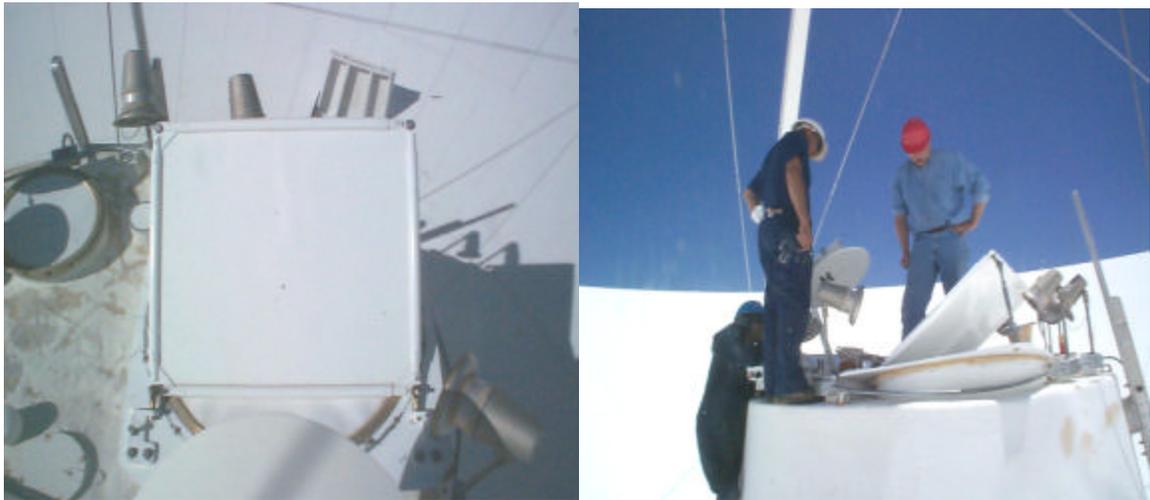
Dichroic reflector is in good condition except for a small delaminating blister in the center running vertically. The dichroic panel and ellipsoid reflectors were both realigned. Notice the feed cone is need of painting.

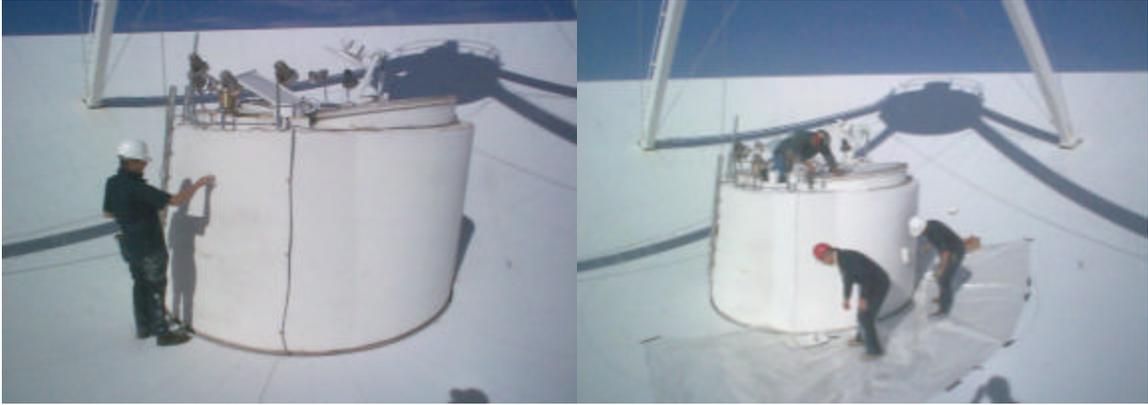
Bob preps the feed cone for painting. Ray, Bob and Steve then applied 3 coats of Elastomeric paint to the feed cone.

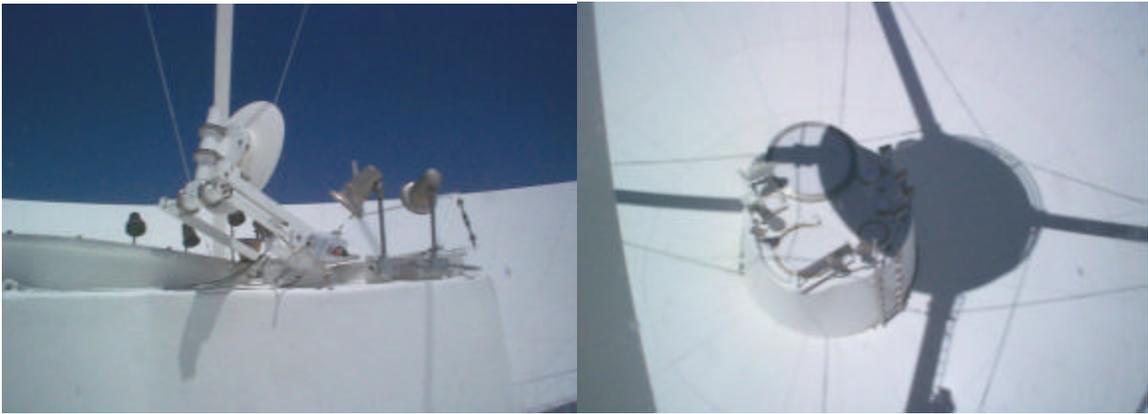
A spring was replaced in the ellipsoid actuator during alignment. Ellipsoid is in good condition. Feed cone FE windows and heaters are in good condition.

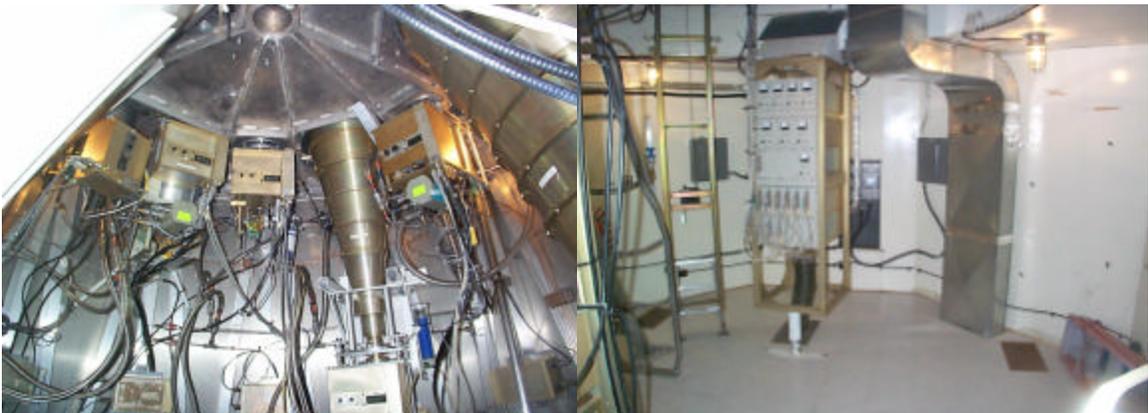
Feed cone & Vertex room. FE and rack cables are neat, orderly and secure.

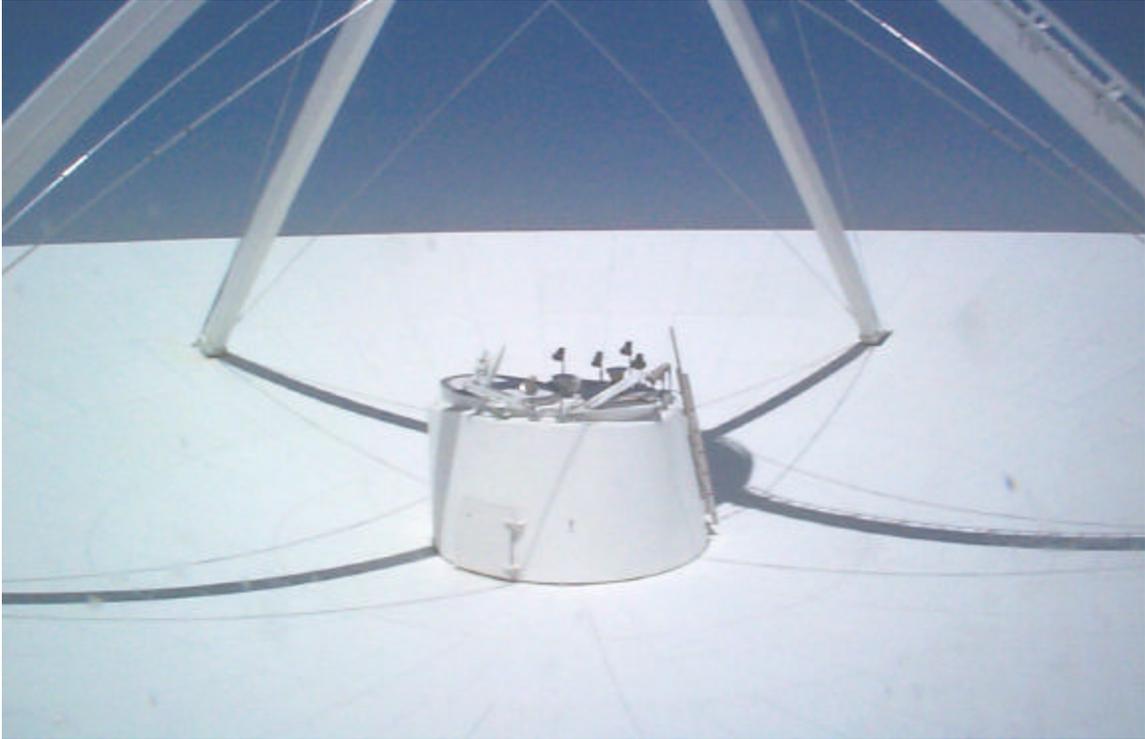
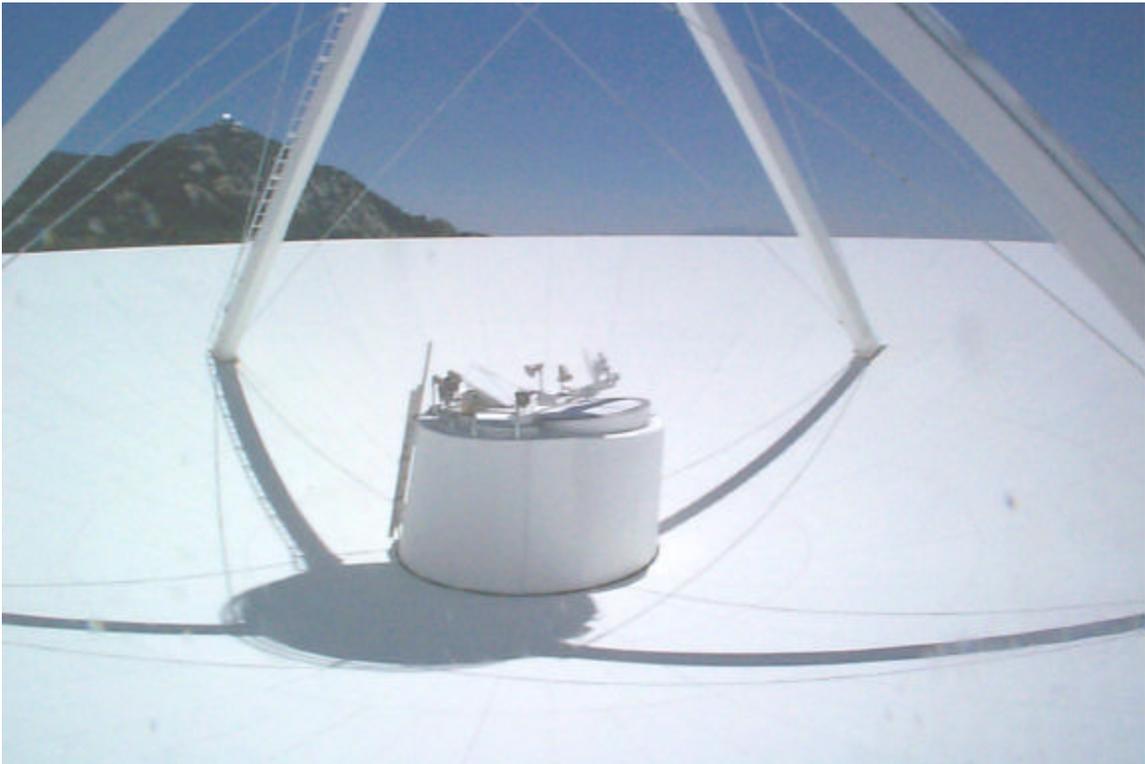
Feed cone insulation is in good condition. Dish panels, and the dish panel's paint are in good condition. Quad legs and guy wires are in good condition.

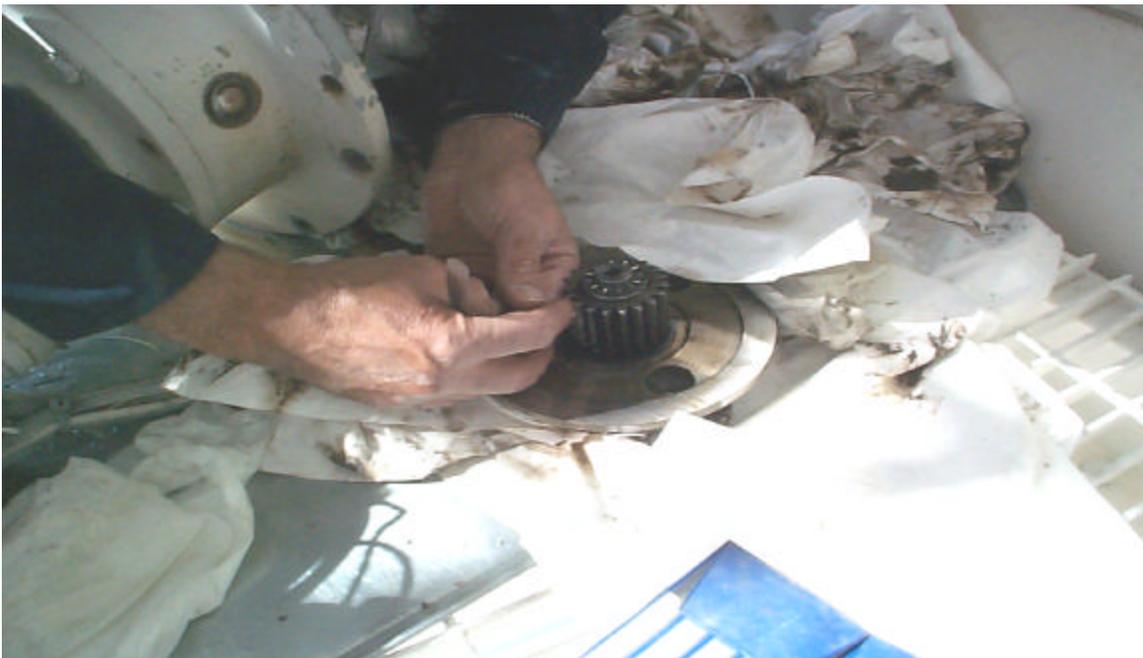
Steve measures  $\sim .002$  of wear with a feeler gauge showing EL #2 gearbox is in good condition. Both EL gearboxes oil was changed. Fish eyes and flow gauges were also cleaned. EL #1 gearbox was not opened for inspection.

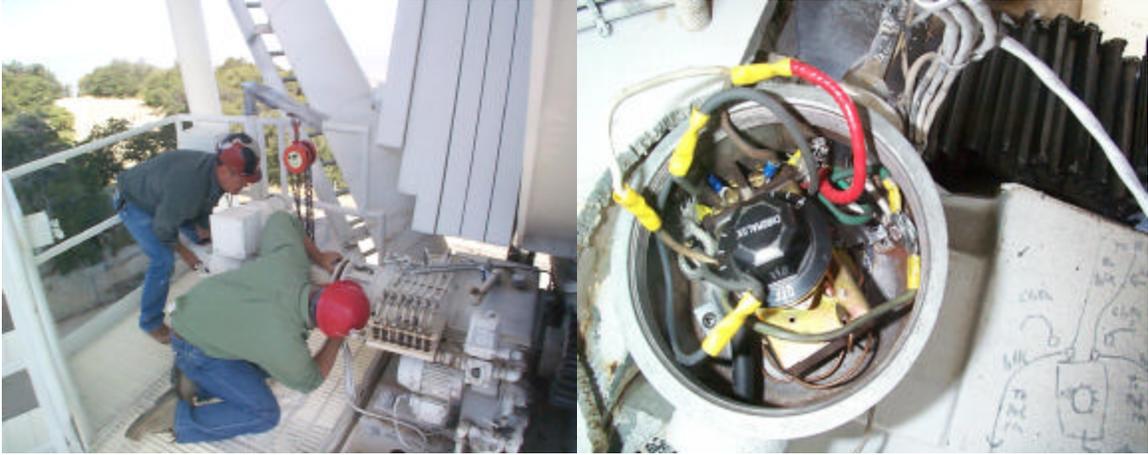
Elevation #1 and #2 motor gearbox rubber couplings (spiders) were replaced. The elevation gearbox heaters were wired in series. This was corrected to parallel and tested. The elevation bull gear is well lubricated and in good condition. Paint in the elevation platform area is in good condition.

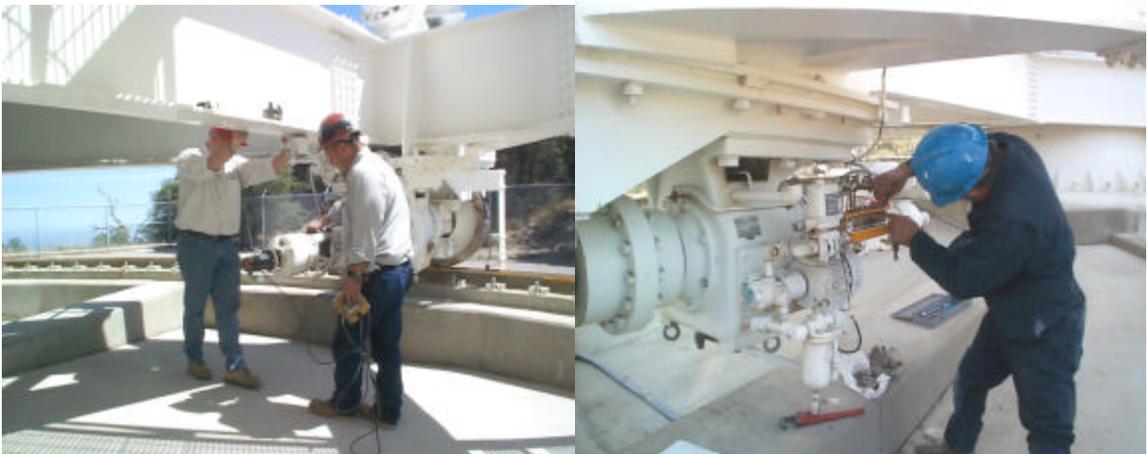
Azimuth #2 motor brushes were replaced and seated. Azimuth #2 tach and blower were also replaced. Azimuth #2 motor has a wobbling tail shaft and a rear motor bearing seal that is leaking into the brake assembly. Azimuth #2 motor was replaced on July 23<sup>rd</sup> during the writing of this report. Azimuth #1 flow gauge manifold was replaced. Azimuth #1 tach was well within spec. and wasn't replaced. Azimuth #1 motor spider was replaced. The antenna paint in the azimuth area is in good condition.

1. REPLACE AZIMUTH MOTOR #2.---REPLACED ON JULY 23<sup>RD</sup>.
2. REPLACE VERTEX ROOM DOOR (TEMPERALLY PATCHED).
3. REPLACE FRM LOGIC POWER CONTROL CABLE.
4. ADD STEEL TO PED ROOM GRATING WALK WAY (A TRIP HAZZERD).
5. REPLACE ELEVATION #1 LUBE MANIFOLD WHEN SPARE IS AVAILABLE.
6. PED ROOM PVC POWER FEED THROUGH NEEDS REPLACED.

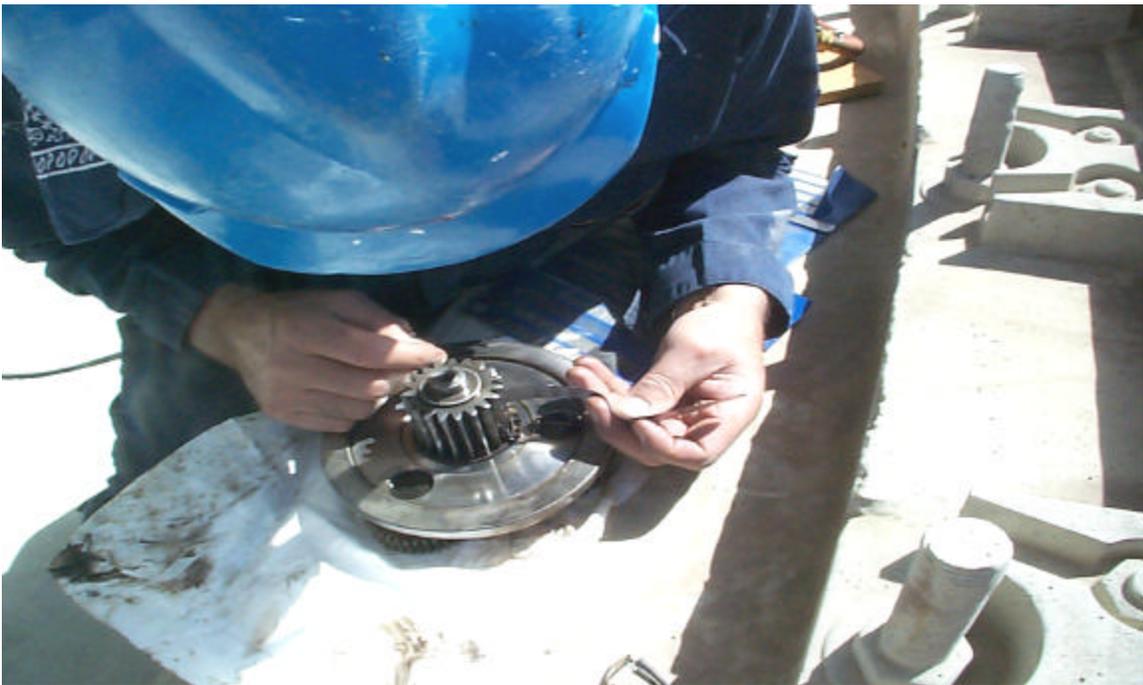
Steve measures  $\sim .002$  of wear with a feeler gauge showing AZ #1 gearbox is in good condition. Both AZ gearboxes oil was changed. Fish eyes and flow gauges were also cleaned. AZ #2 gearbox was not opened for inspection.

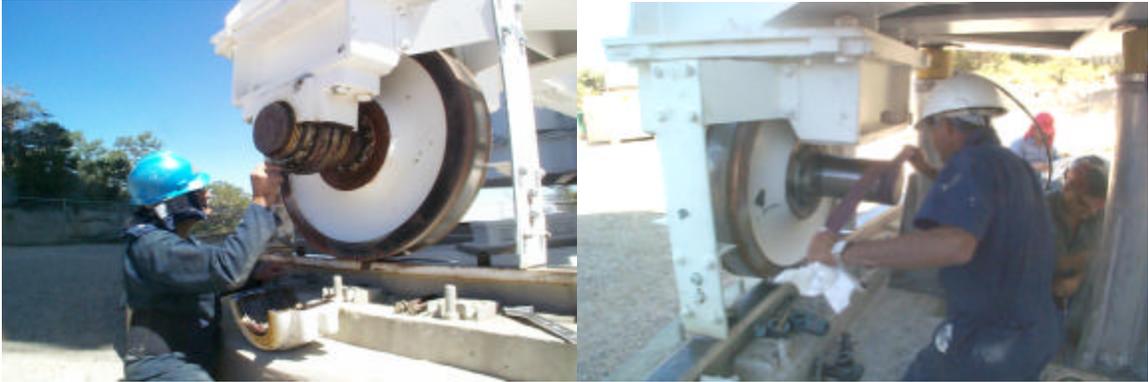
AZ wheel bearings were inspected. AZ #2 idler bearing was replaced. No popping or grinding noises were heard from the AZ bearings or gearboxes.

#### AZIMUTH BEARING GREASE INSPECTION

INNER	OUTER
D1	Very few small flakes of metal.	No metal, smooth races.
D2	Little flakes, slight scratches.	No metal, very smooth races.
I1	Good, small linear scratches.	Small scratches on races.
I2	Changed bearing.	Little flakes, slight scratches.

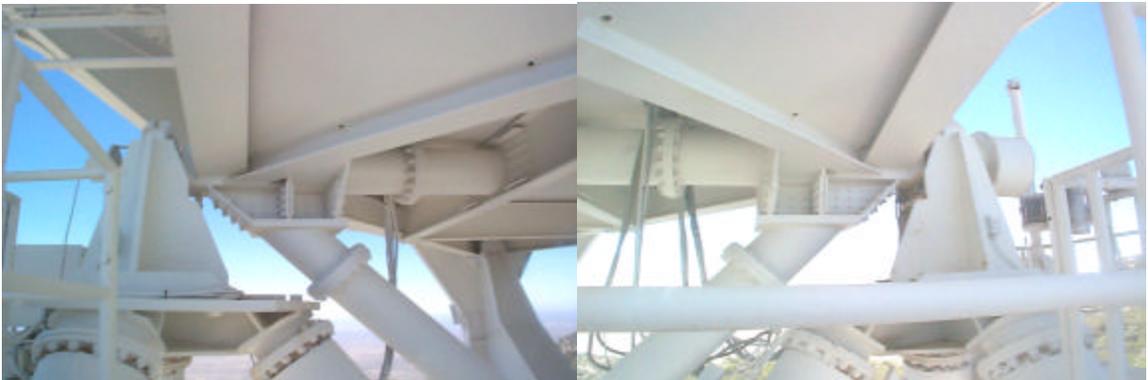
#### ELEVATION BEARING GREASE INSPECTION

EL. Encoder side	Good with no metal flakes.
EL. Synchro side	Good with no metal flakes.

Elevation bearings are well lubricated. Elevation axle has no visible signs of cracks. Antenna paint in the EL axle area is in good condition. There are no popping and grinding noises heard from the elevation bearings or gearboxes. No metal flakes were found in the pintle bearing grease.

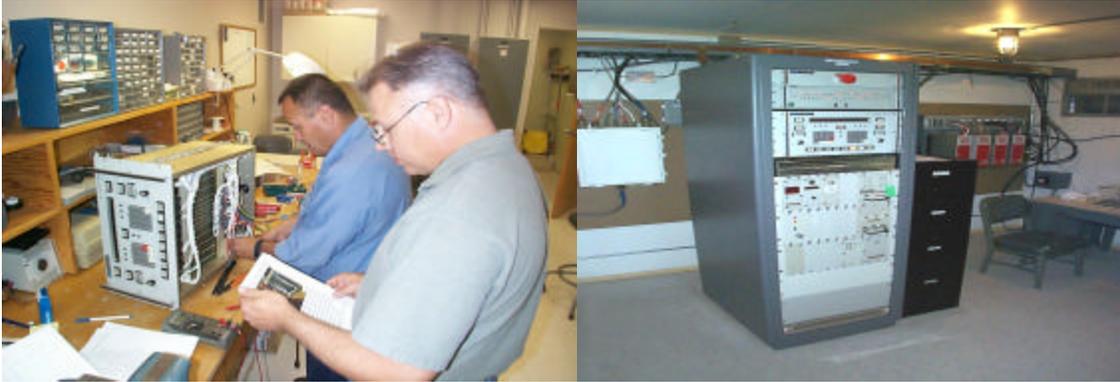
Steve and Ray retrofit the ACU with the new power supply upgrade.

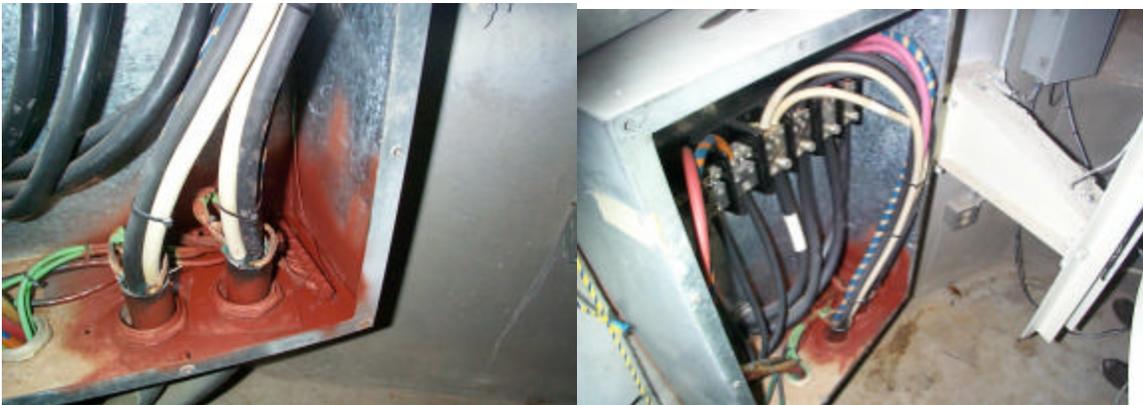
Inside the pintle bearing room power panel Bob found a ground terminal block severely corroded. The terminal block was cleaned and then sealed with primer. The antenna cable wrap and cables are in good condition.

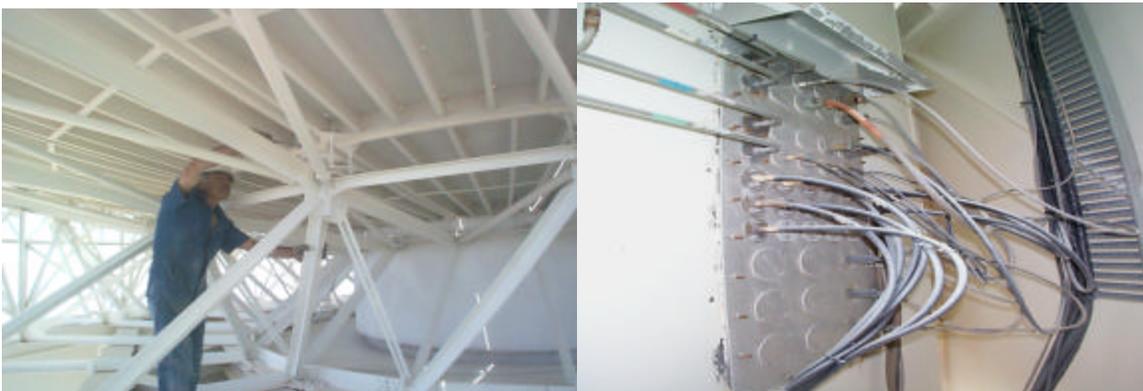
Dish panel bolts were checked. VTX baulk head is in good condition.

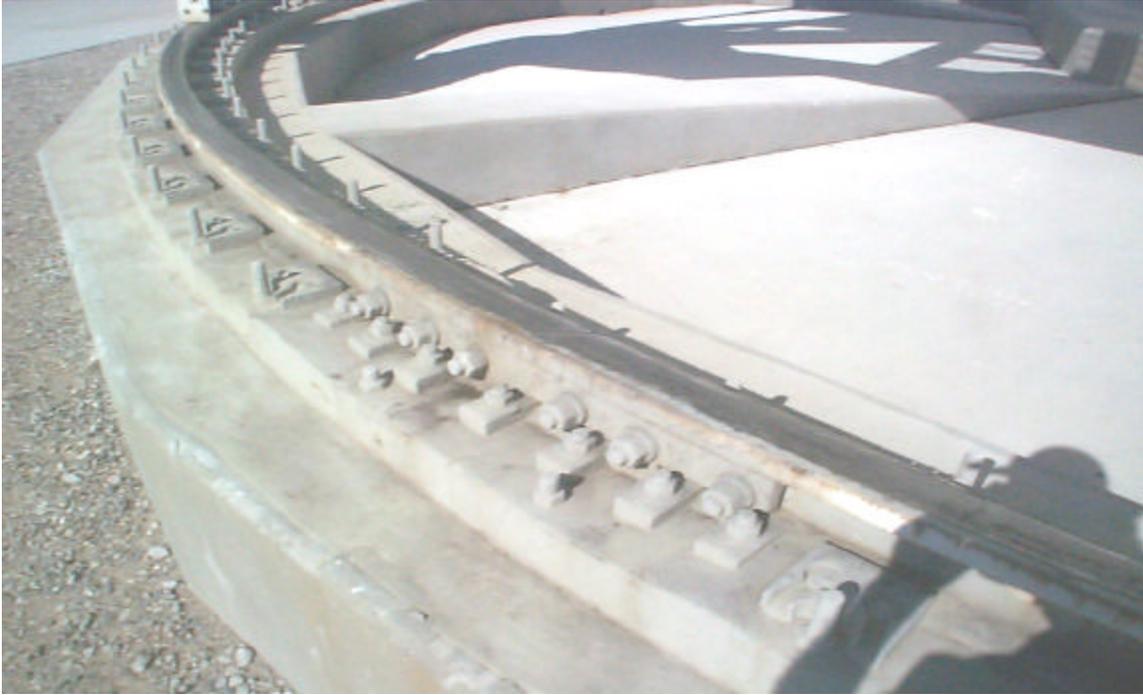
A typical rail splice. Rail splices and vulchem are in good condition.

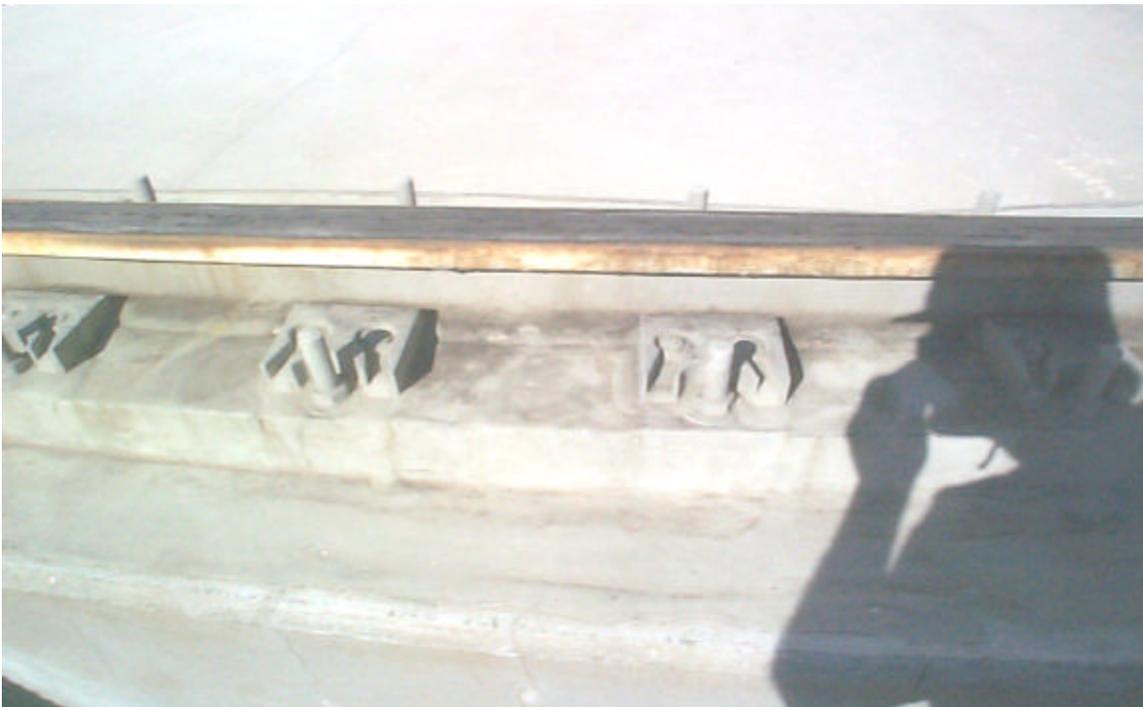
Rail clips and vulchem are in good condition.

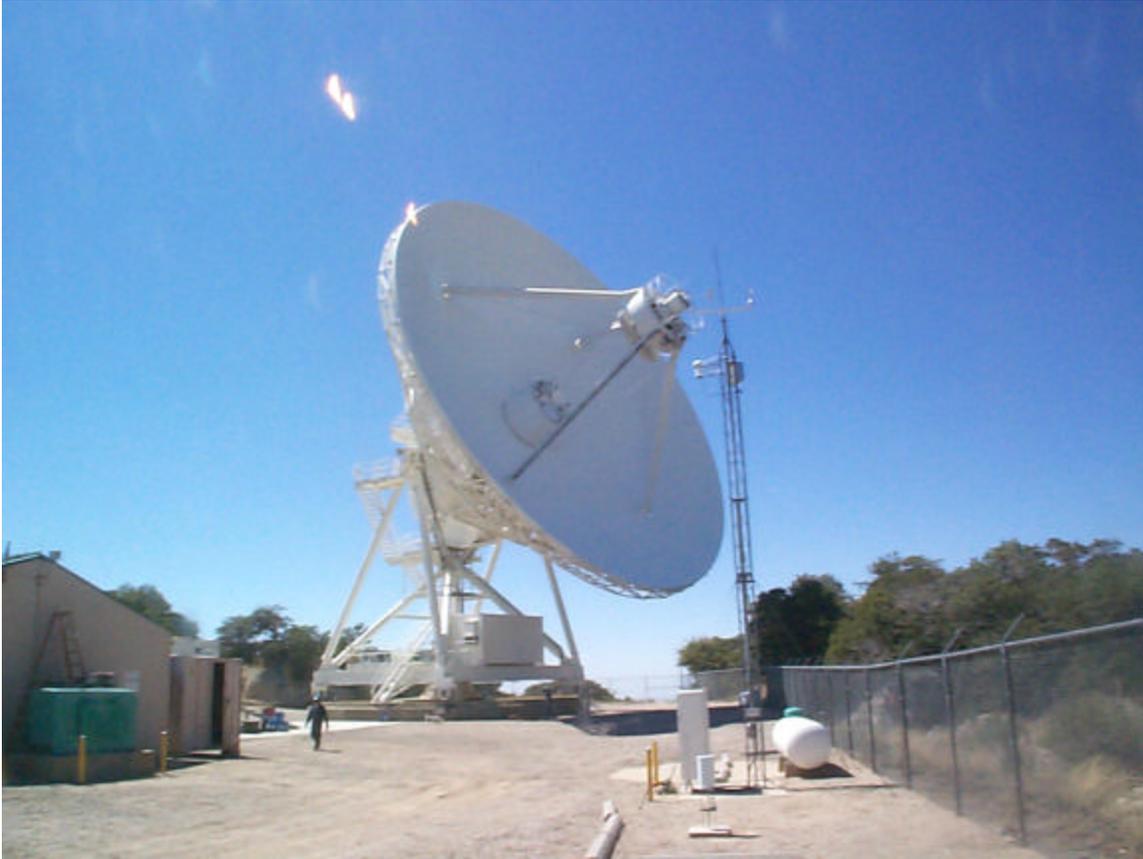
The weather station PM was done. Weather station and generator enclosures are in good condition and rust free. Generator inspection and PM was done.

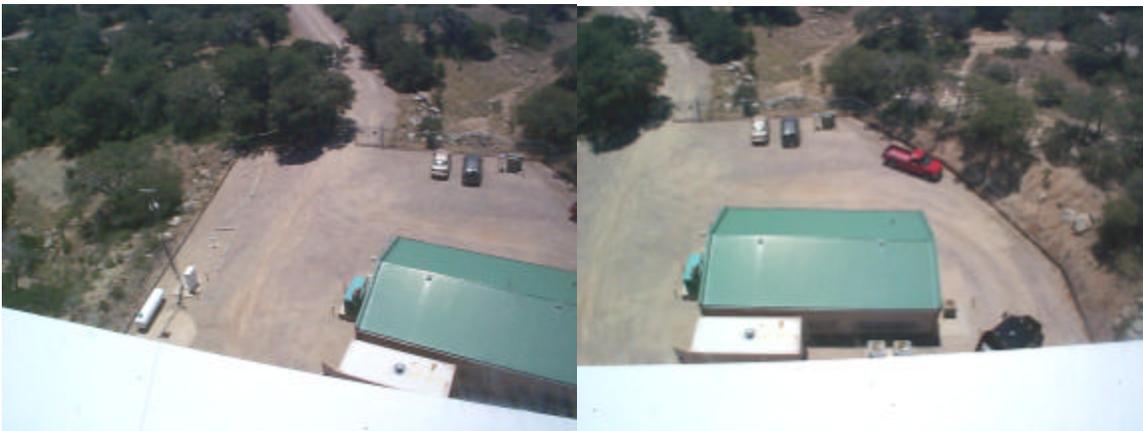
The area inside the fence is weed free and orderly.

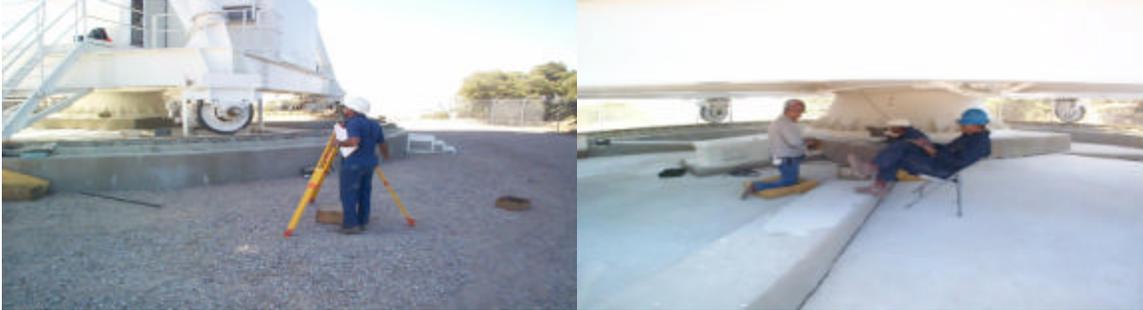
Ramon measures AZ #1&2 drive wheel alignment. The rail was measured.

### AZIMUTH DRIVE WHEEL ALIGNMENT

D1	D2
Horizontal error	0d 00'18"	0d 00'57"
Vertical error	0d 01'02"	0d 01'47"
Radius error	.317"	.135"
