NATIONAL RADIO ASTRONOMY OBSERVATORY

VLBA Antenna Memo Series No. 50

North Liberty – Drive #2 wheel/bearing replacement

October 20 – 23, 2003 - Trip Report

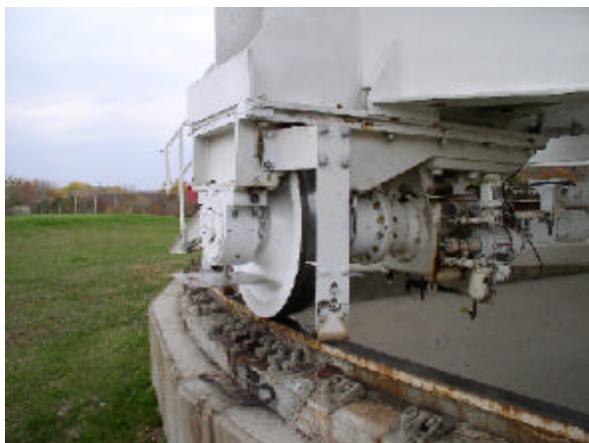
Metal particles were found in the grease on the inside drive #2 azimuth bearing during the North Liberty maintenance visit. The drive assembly was then scheduled for replacement. A team consisting of Steve Aragon, Eric Carlowe, Ramon Gutierrez and Jon Thunborg traveled to North Liberty on October 20 –23, 2003 to replace the wheel assembly.

<u>BEFORE</u>	
	Measured	Specified
Conic radius	300.024"	300" \pm ¼
Coupling runout	N/A	Not Specified
Axle Vertical Slope	93° 23' 14"	93° 26' 23" \pm 1.4'
Axle Horizontal error	3' 08"	< 1.4'

The new wheel/axle assembly was installed and aligned. After two days of operation, the following alignment parameters were recorded for the new axle/wheel assembly. The antenna rotated smoothly without popping sounds.

<u>AFTER</u>	
	Measured	Specified
Conic radius	299.894"	300" \pm ¼
Coupling runout	0.001 TIR	Not Specified
Axle Vertical Slope	93° 25' 35"	93° 26' 23" \pm 1.4'

Axle Horizontal error 43” < 1.4’
