National Radio Astronomy Observatory
Socorro, New Mexico

VLBA Antenna Memo #51

North Liberty, Iowa VLBA Maintenance Visit September 10th thru 16/03.

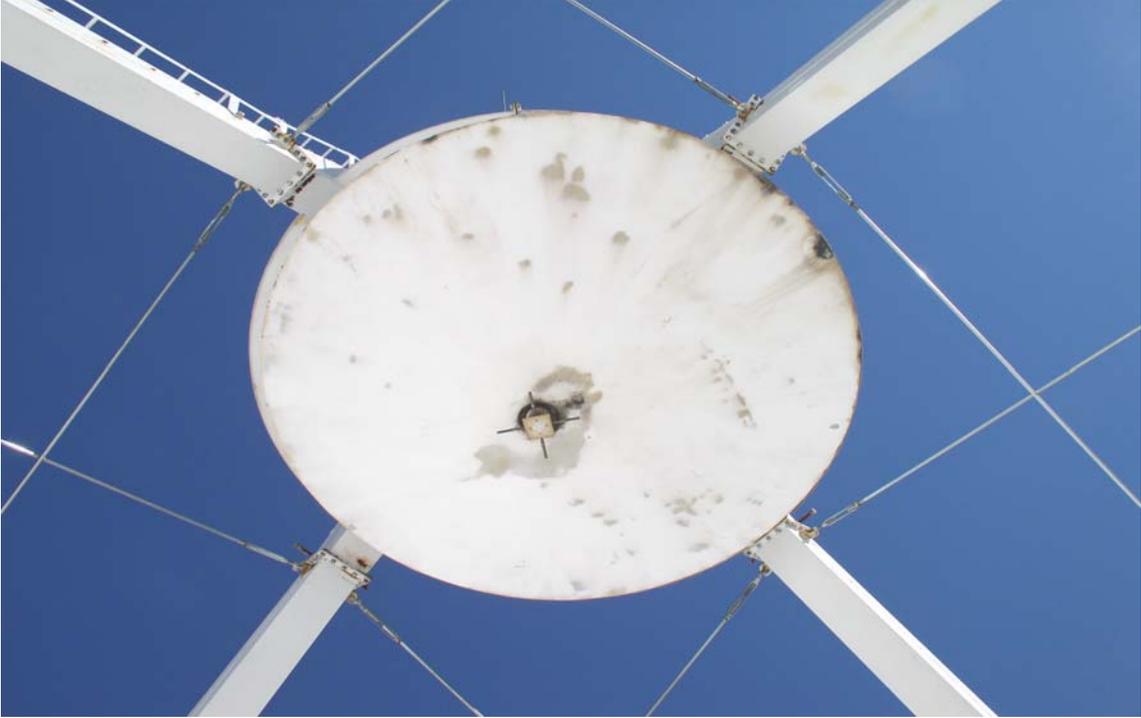
Subreflector paint is stained but otherwise in good condition.

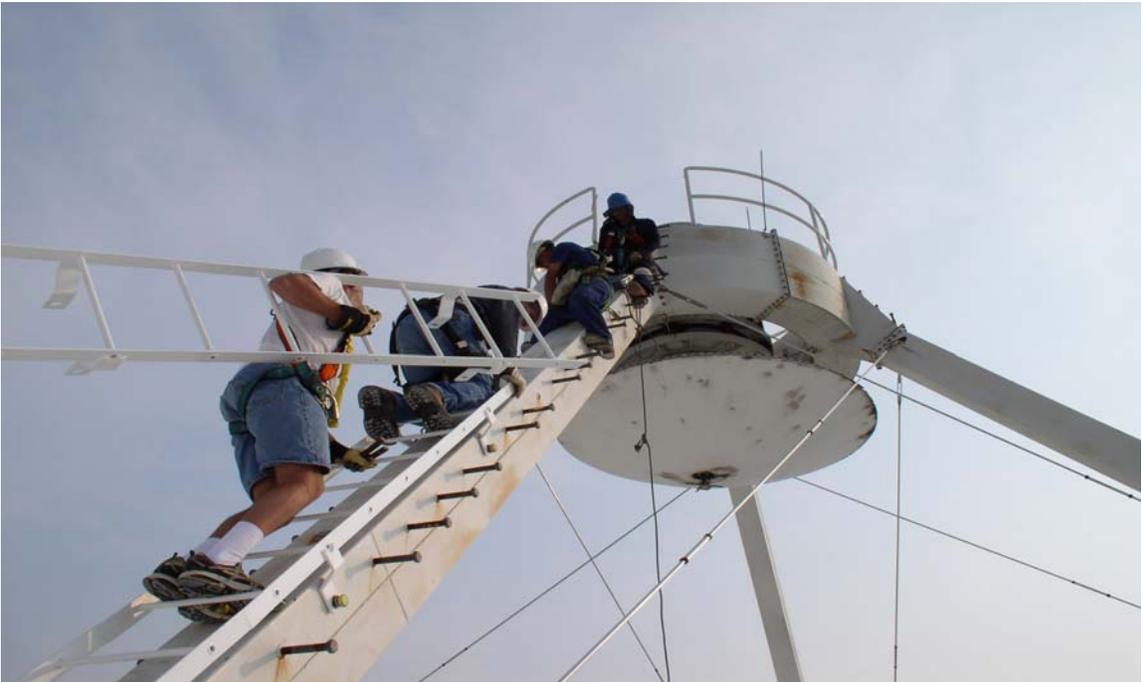
A new ladder and fall arrest was installed. Techs were trained on using the new fall arrest. Quad legs have a lot of surface rust.

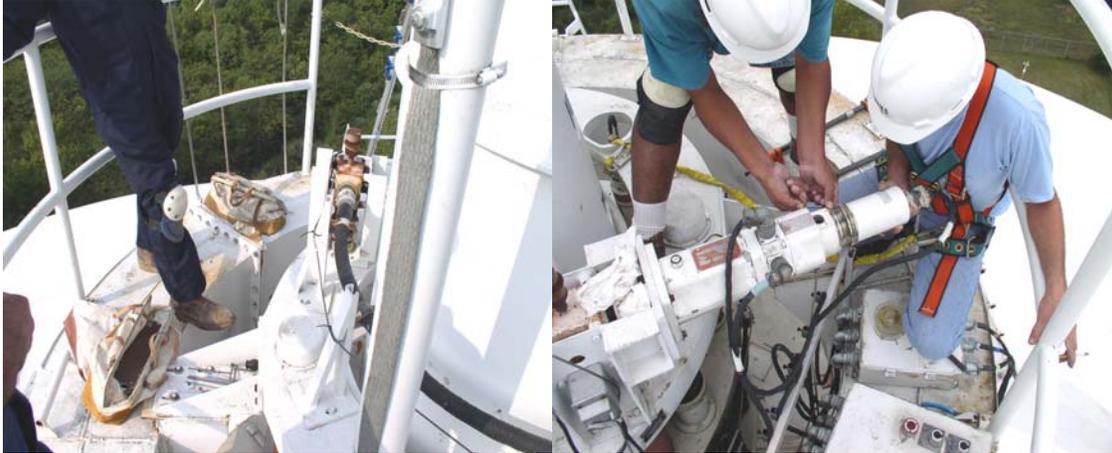
The FRM INA bearing zirks were installed. A 2nd screw and guide rod bellows were replaced during the FRM PM. Both focus motor encoder couplings were broken. These were replaced with the new encoder coupling modification. Apex j-boxes and cables are in good condition.

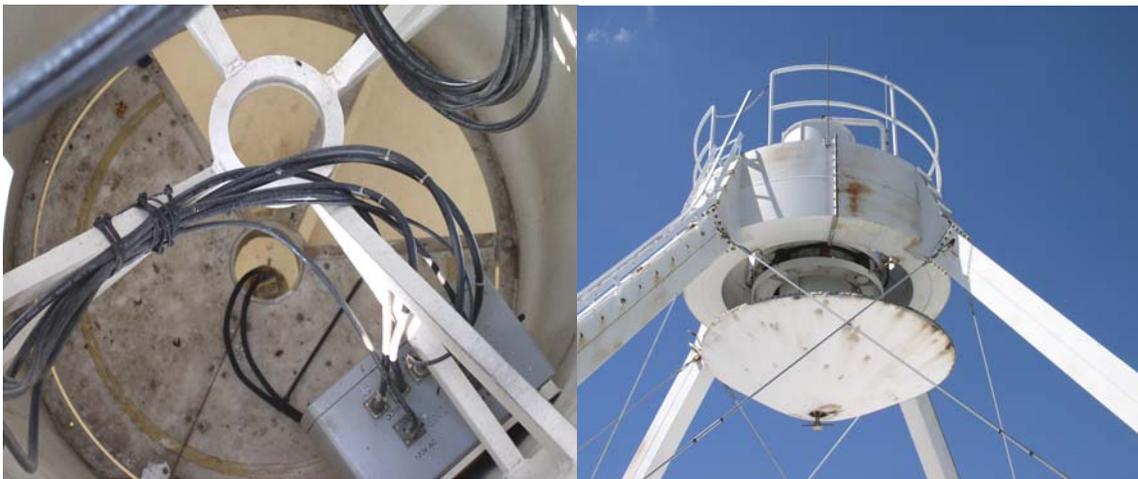
90/50 FE cables and connectors are in good condition. Subreflector drain holes are clear. Dipole is in good condition. Apex has lots of surface rust.

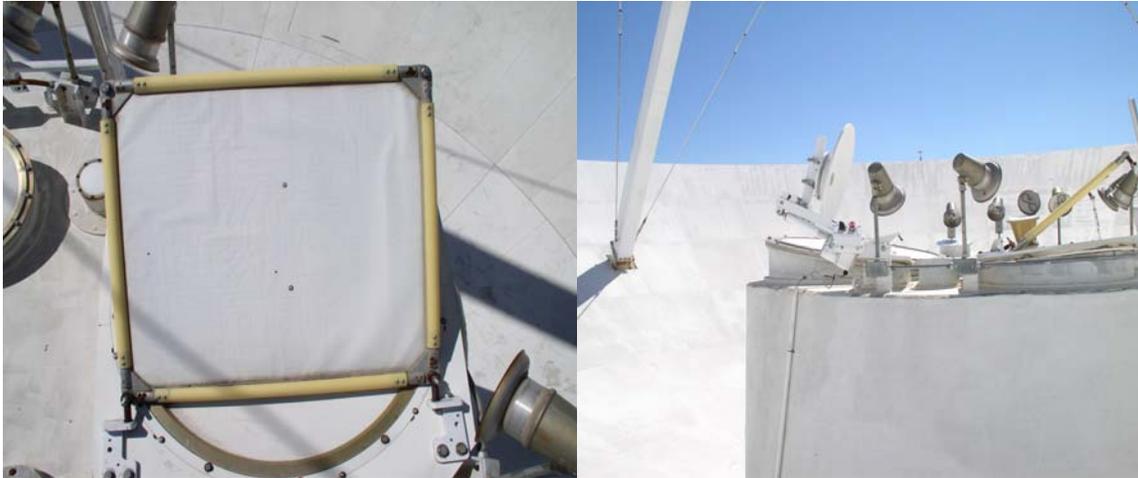
Dichroic reflector needs to be replaced. Elipsoid is in good condition.

1. REPLACE FRM X/FORMER CONTROL CABLE.
2. REPLACE AZIMUTH #2 DRIVE WHEEL ASSEMBLY.
3. REPLACE ELEVATION MOTOR #2.
4. REPLACE AZIMUTH MOTOR #1.
5. REPLACE AND ALIGN DICHROIC REFLECTOR.
6. SEAL AND PAINT FEED CONE WITH ELASTOMERIC.
7. REPLACE VERTEX ROOM DOOR.
8. COMPLETE TT SERVO TESTS.
9. REPLACE ELIPSOID ACTUATOR POWER CABLE.

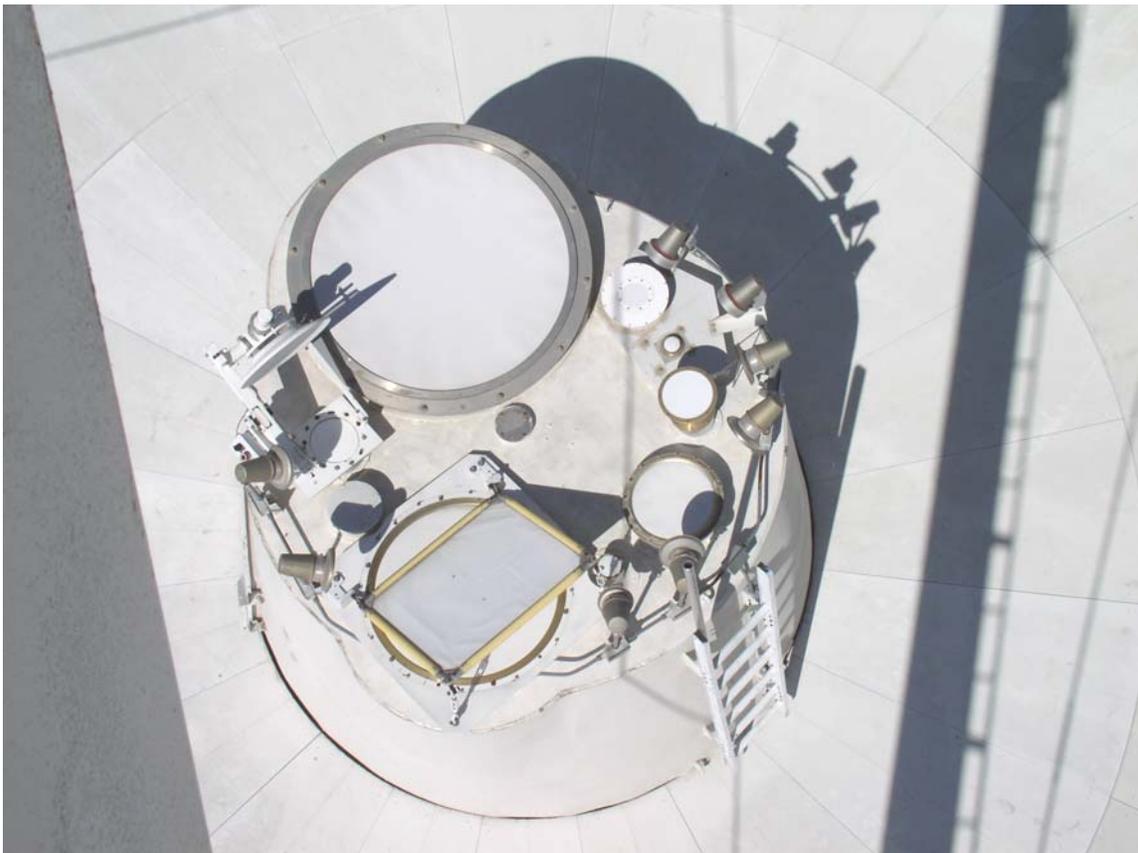
Feed cone needs spot sealed and painted. FE windows are in good condition. Insulation on top of the feed cone has been removed by the site techs. The insulation was retaining water and leaking into the vertex room.

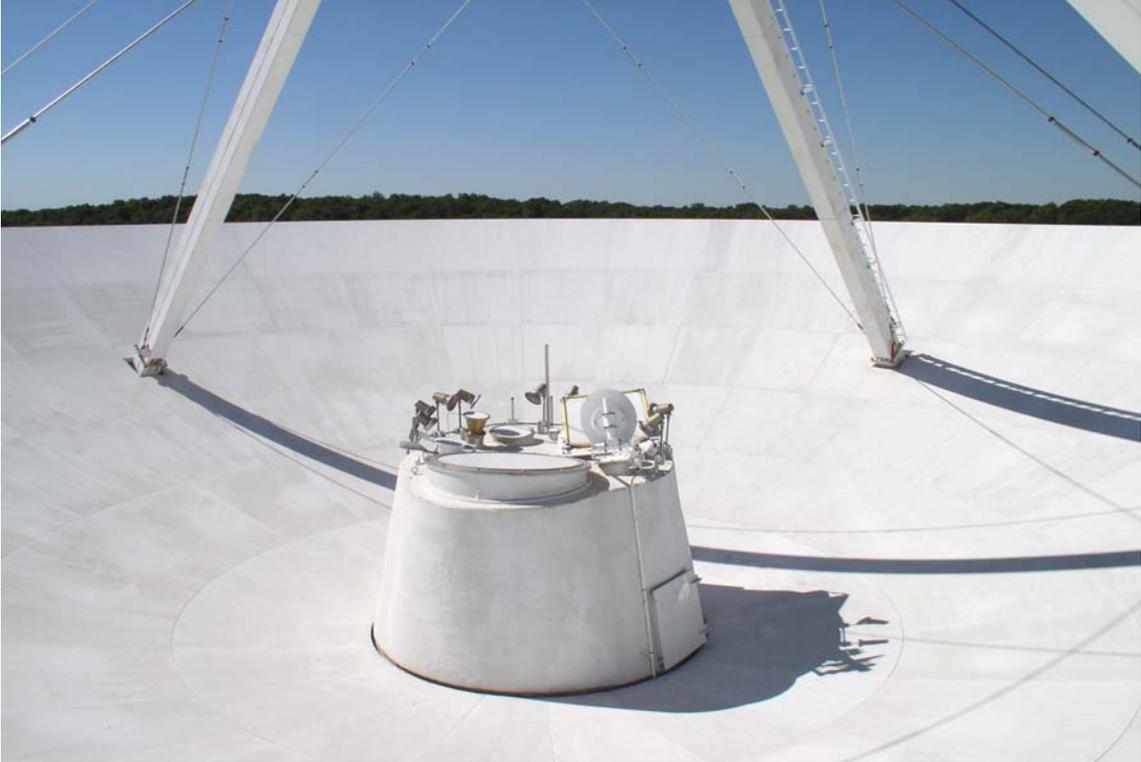
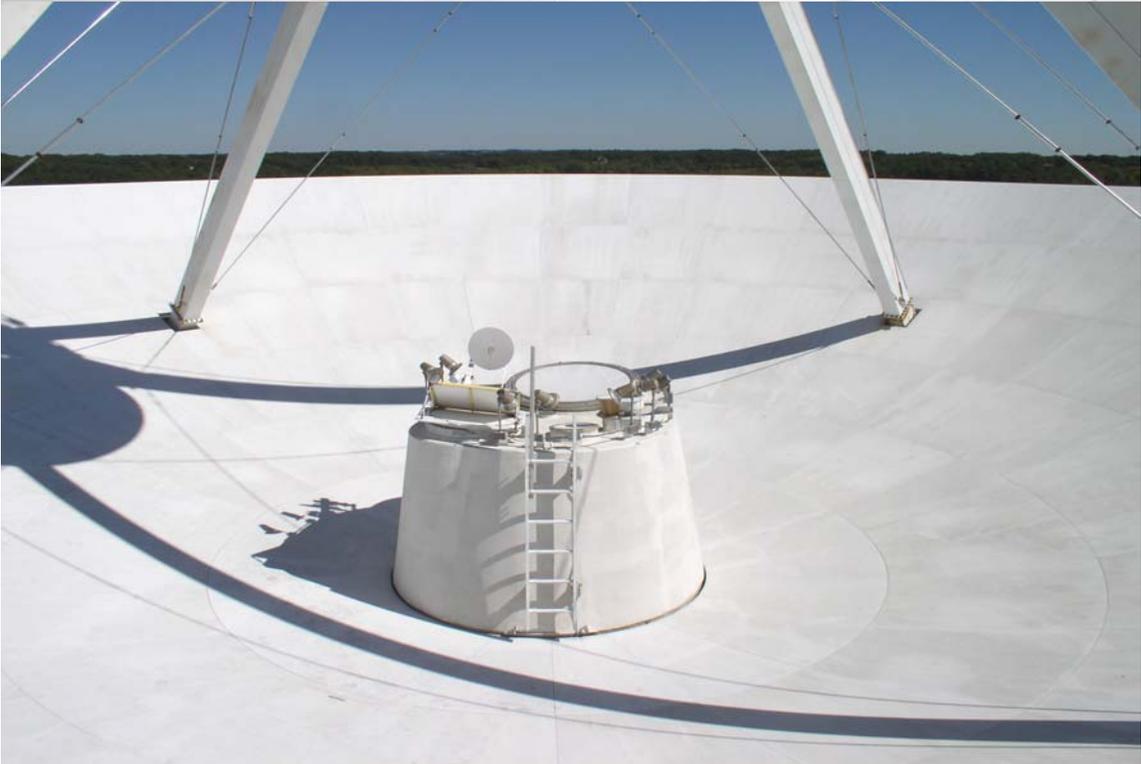
Dish panels are in good condition. Quad legs and guys wire have surface rust. Quad leg bases should be wire brushed and painted with chem-prime.

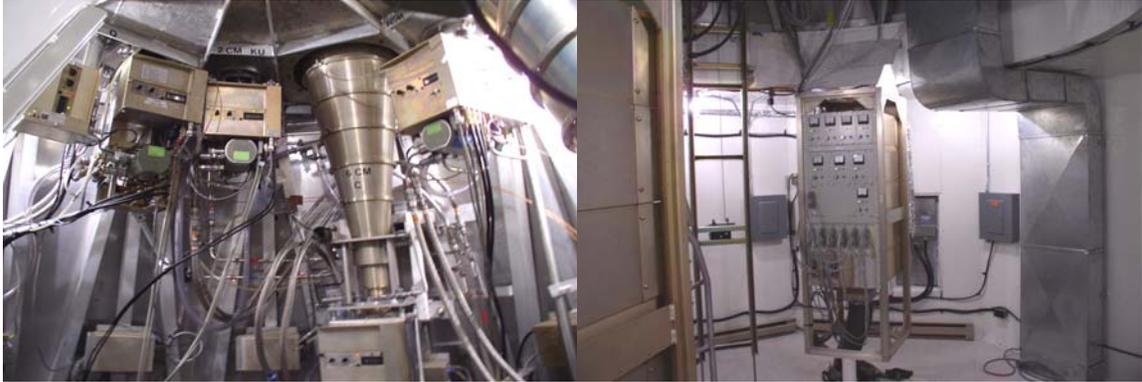
Feed cone and vertex room. FE and rack cables are neat, orderly and secure.

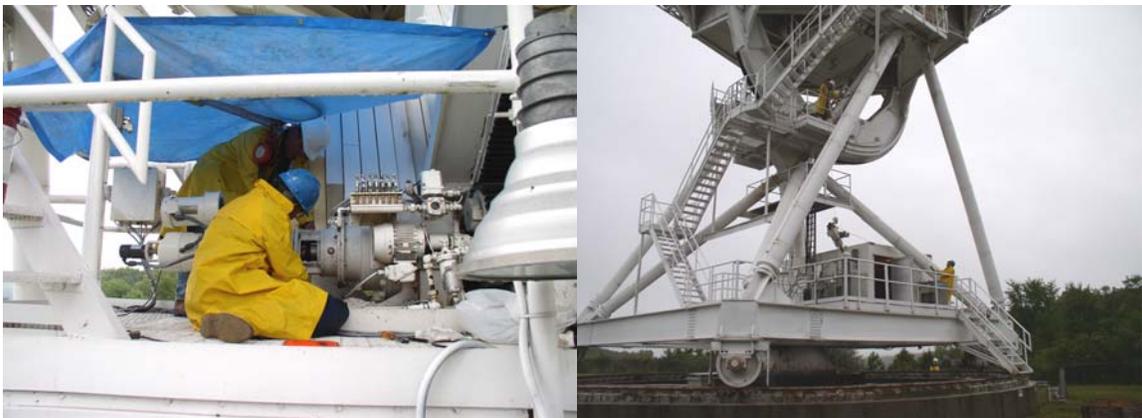
Elevation #1 motor was replaced. Ken and Steve lowering the old motor.

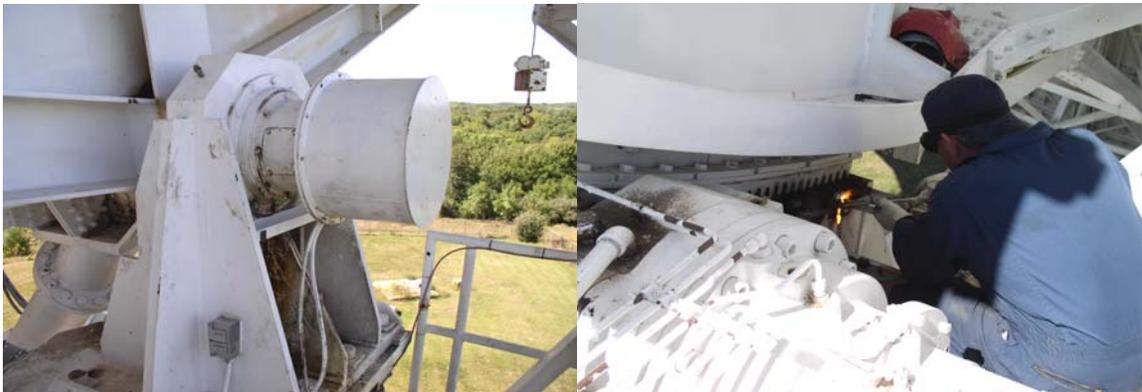
Elevation bearing grease trays were installed. A new stow pin tray and interlock switch were installed.

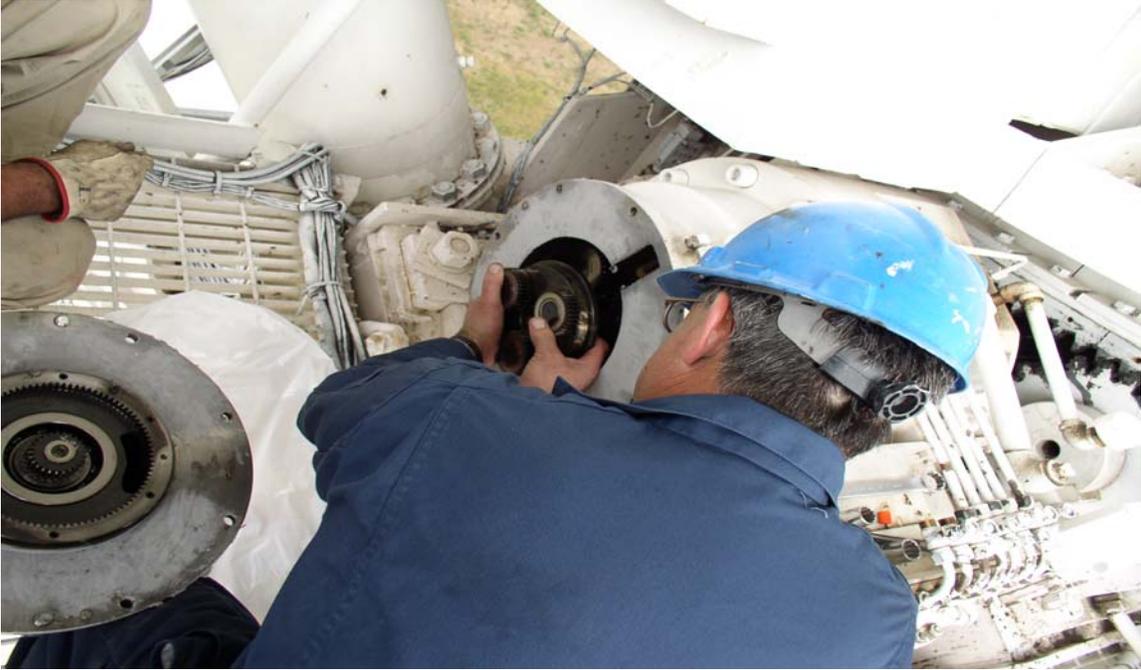
Elevation #1 gearbox, 1st and 2nd stage gear inspection.

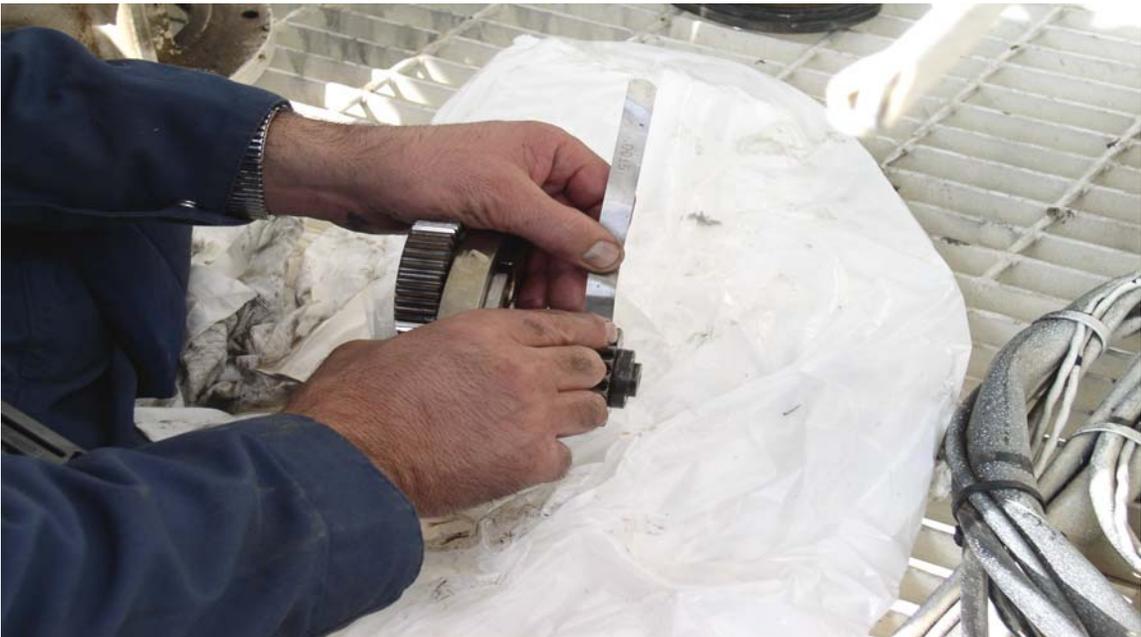
Steve measures $\sim .0015$ of wear with a feeler gauge. Elevation #1 gearbox is in good condition. Both elevation gearboxes oil was changed. Fish eyes and flow gauges were cleaned. Elevation #2 was not opened for inspection.

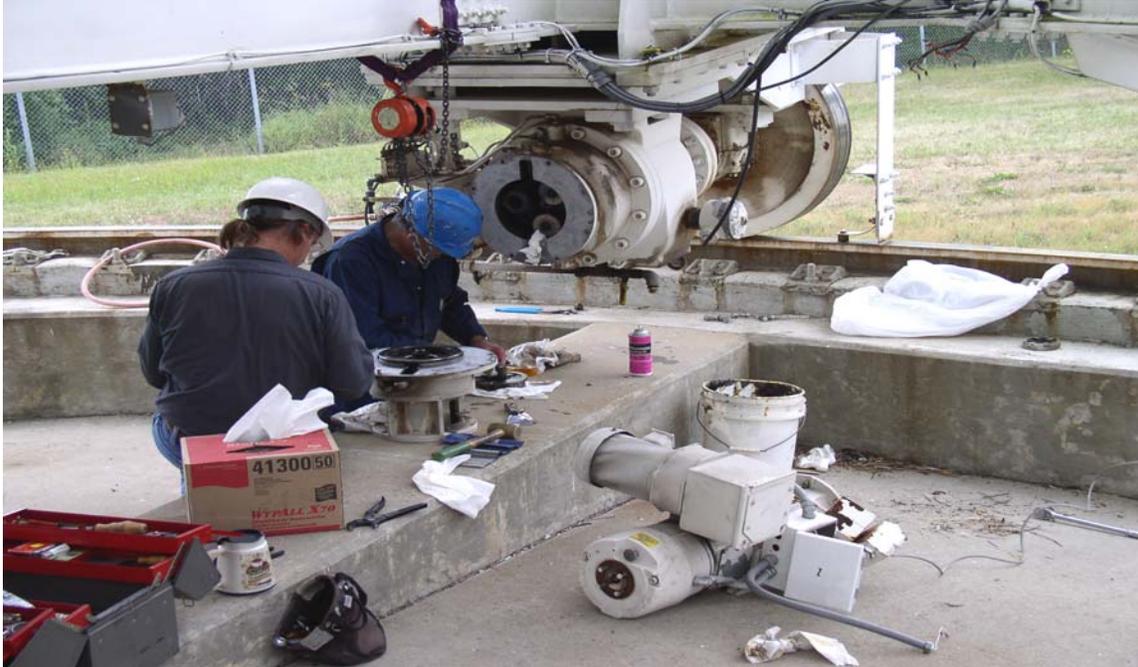
Azimuth #2 gearbox, 1st and 2nd stage gear inspection.

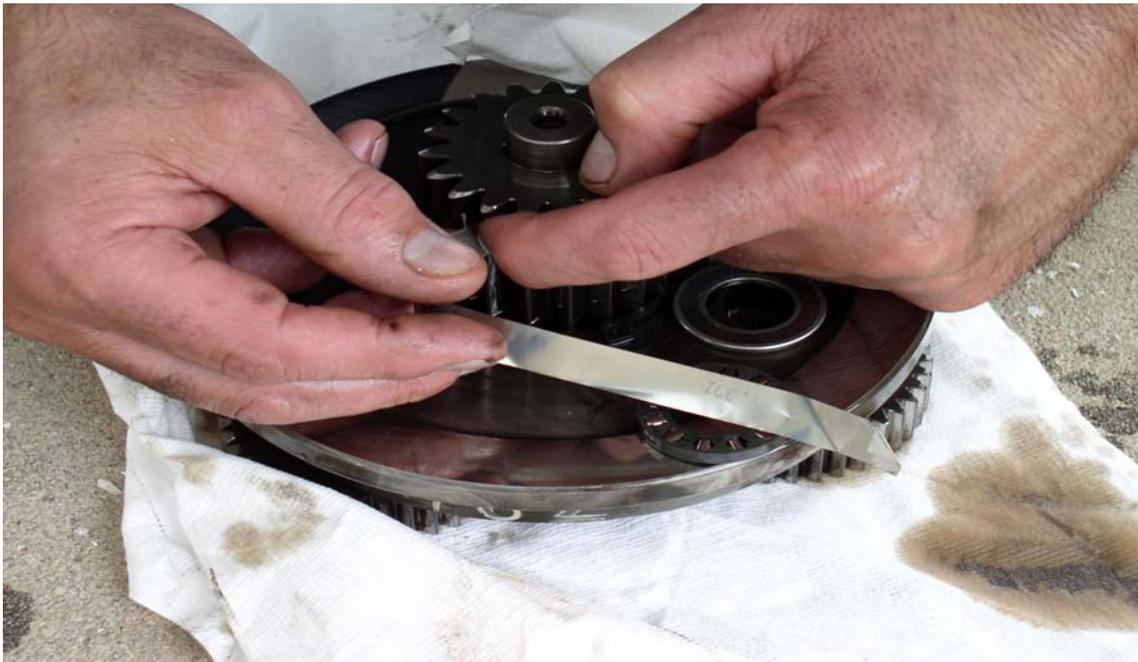
Steve measures $\sim .001$ of wear with a feeler gauge. Azimuth #2 gearbox is good condition. Both azimuth gearboxes oil was changed. Fish eyes and flow gauges were cleaned. Azimuth #1 was not opened for inspection.

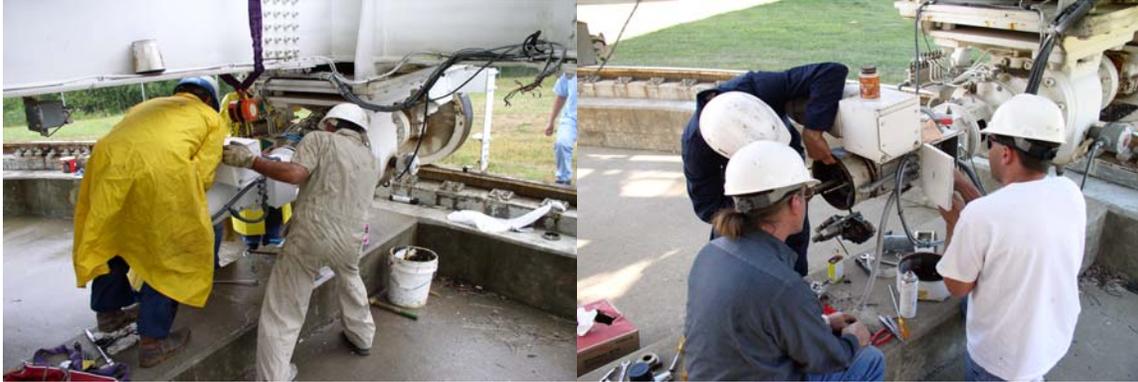
AZ #2 motor was replaced. AZ# 1 rear motor bearing seal was replaced.

INNER BEARING	OUTER BEARING
D1	Clean, smooth races.	Clean, a few metal flakes.
D2	Dark, with metal glitter.	Dark, with metal glitter.
I1	Clean, small hole in race.	Clean, smooth races.
I2	Clean, linear scratches on race.	Clean, smooth races.
Azimuth drive #2 wheel assembly needs to be replaced.

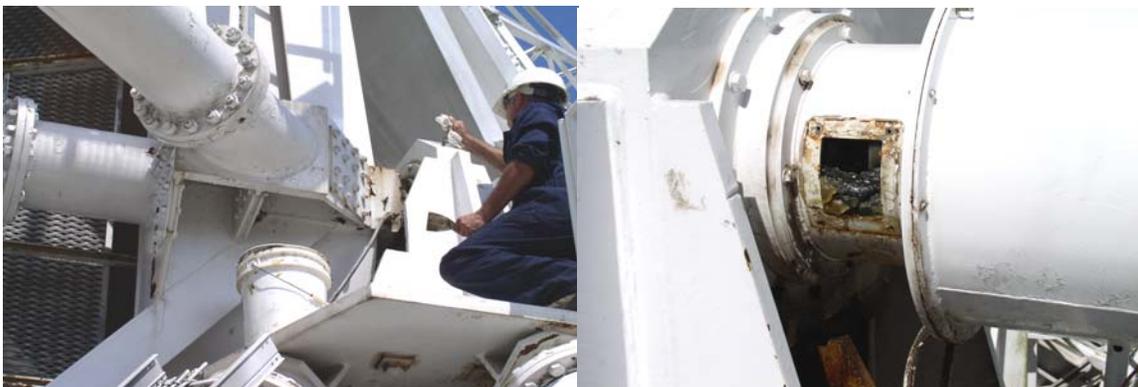
Encoder	Good grease with no metal flakes.
Synchro	Good grease with no metal flakes.

Elevation bearings are well lubricated. Site Techs should remove grease from the encoder side bearing more frequently to keep grease out of encoder electronics. Elevation axle has no visible signs of cracks. Pintle bearing is well greased with no metal flakes.

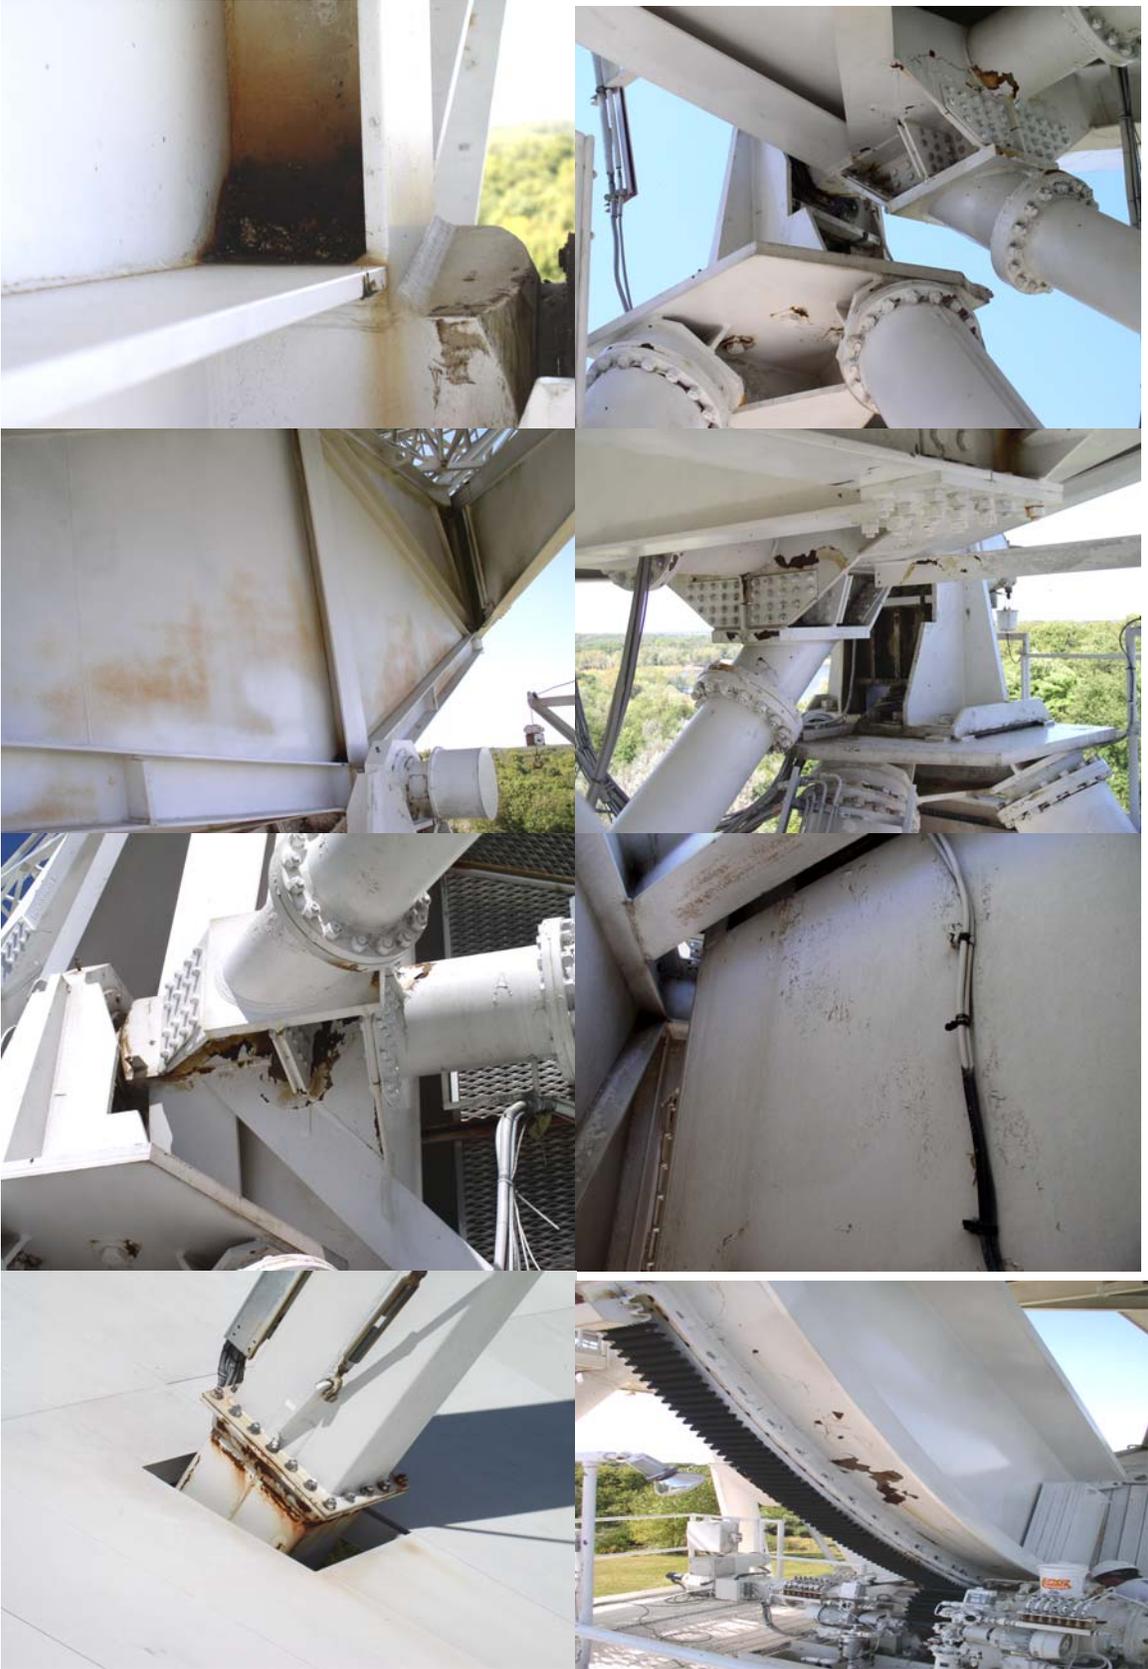
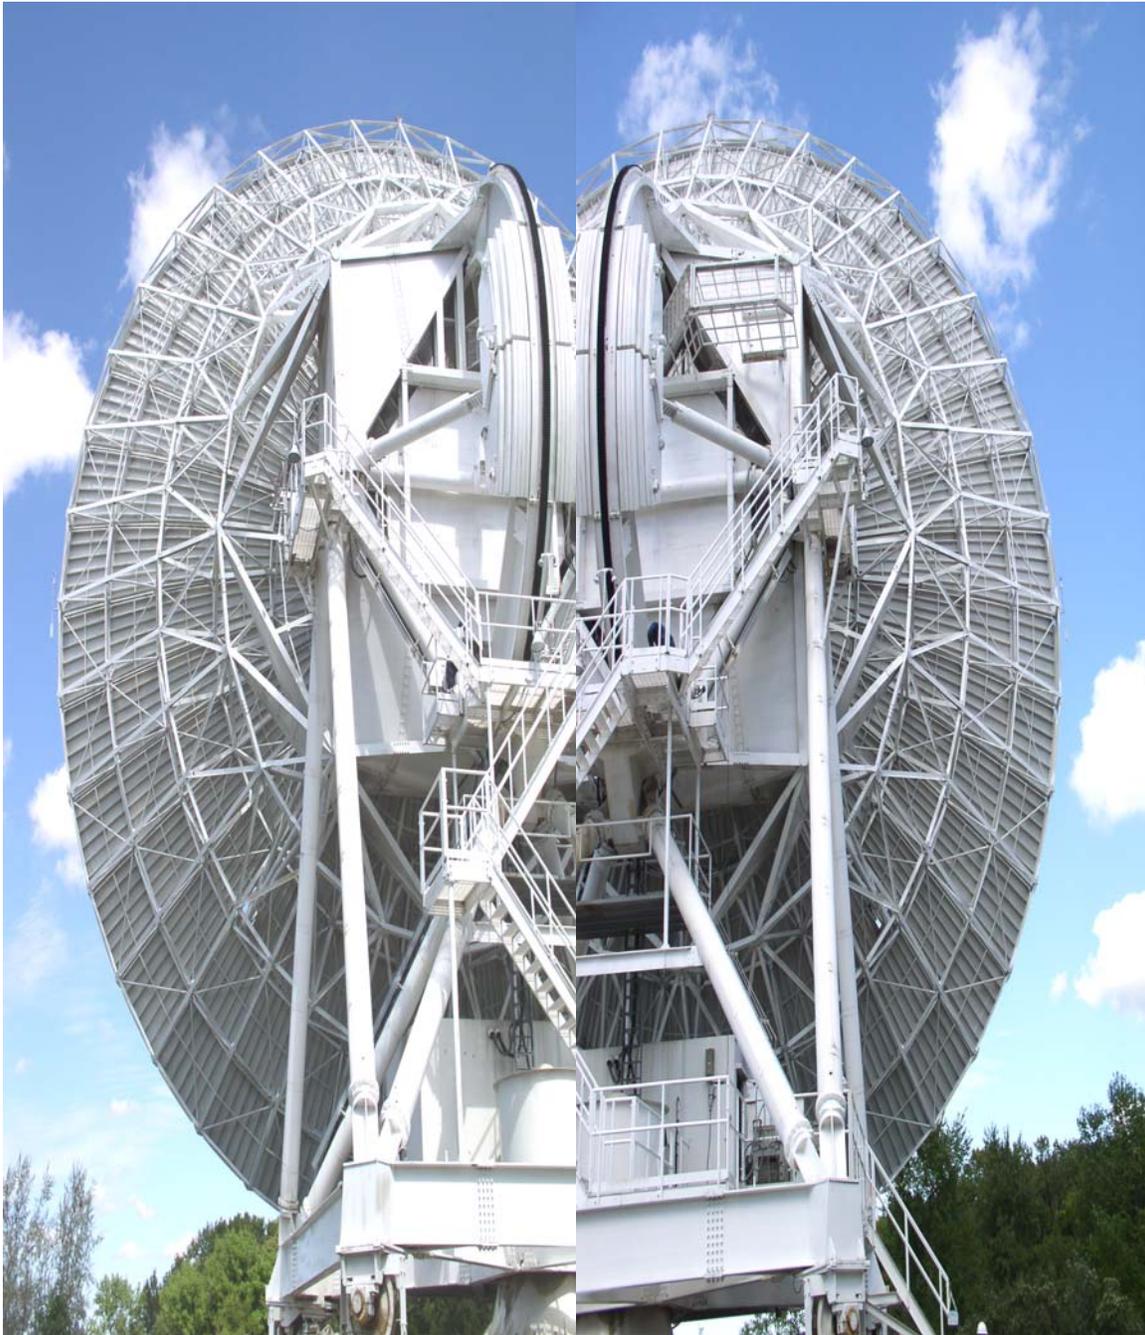
The antenna has a lot of rust and peeling paint almost everywhere you look. This summer the Site Techs should clean up and spot paint affected areas they can safely get to with chem prime. VLBA OPS should also dump water out of the antenna before an observation as recommended by Ramon and Jon for the SCVLB antenna.

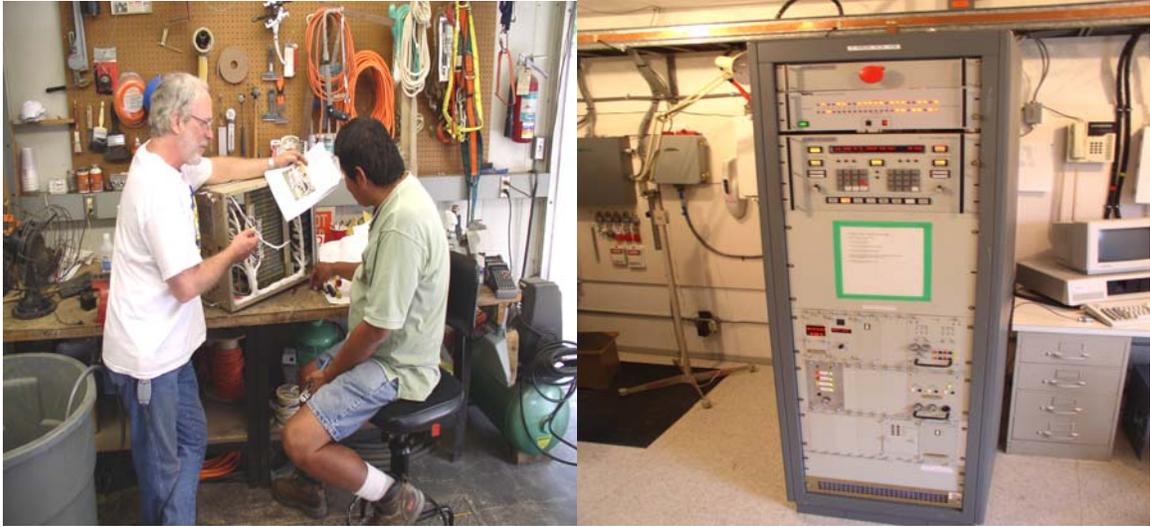
DJ and Nelson retrofitted the ACU with the new power supply upgrade.

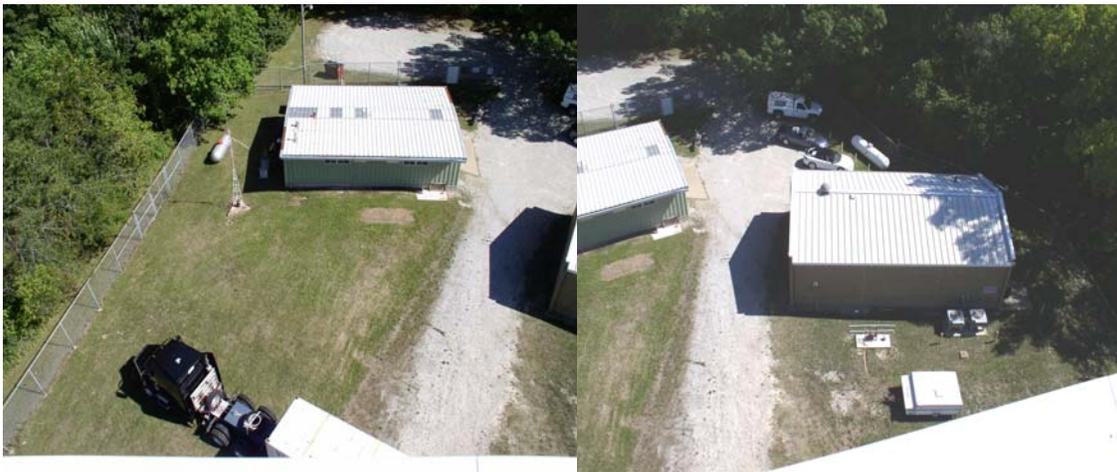
The area inside the fence is neat and orderly.

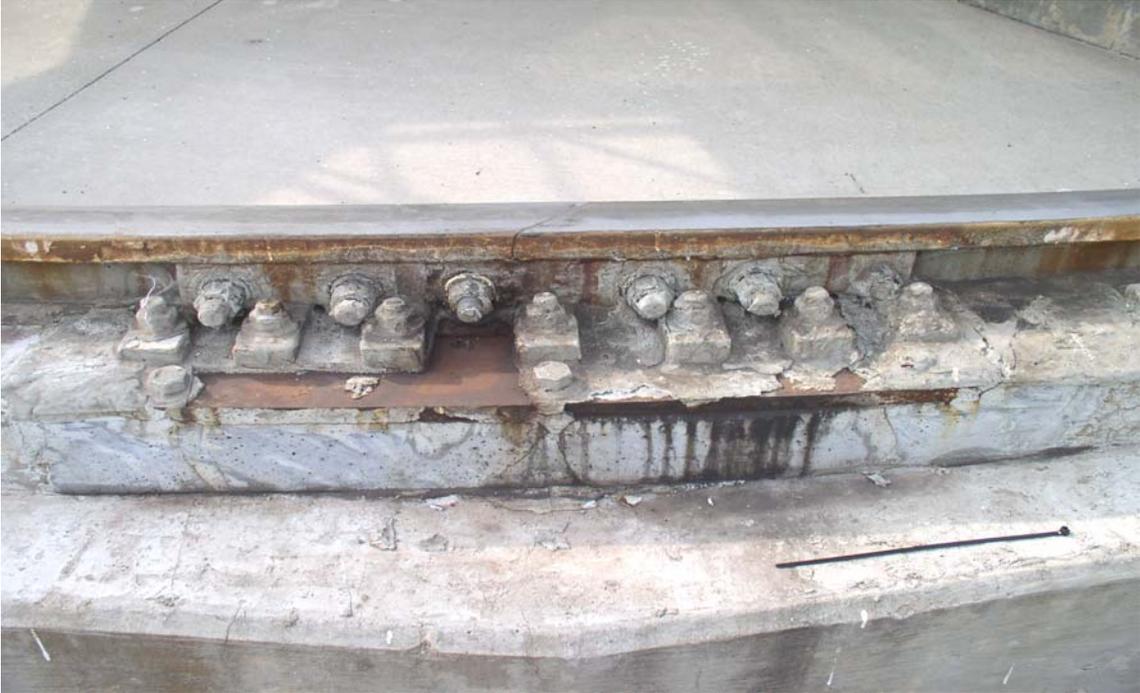
Vulchem is rapidly deteriorating from this rail splice and all the others.

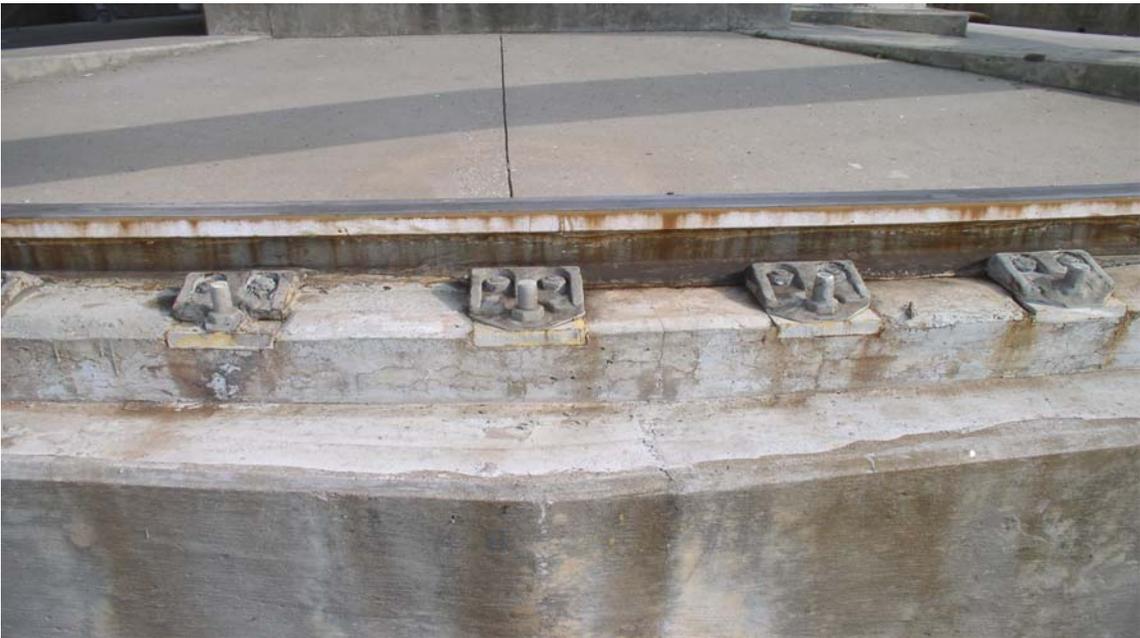
Rail is in good condition. Vulchem is deteriorating off all of the rail clips.

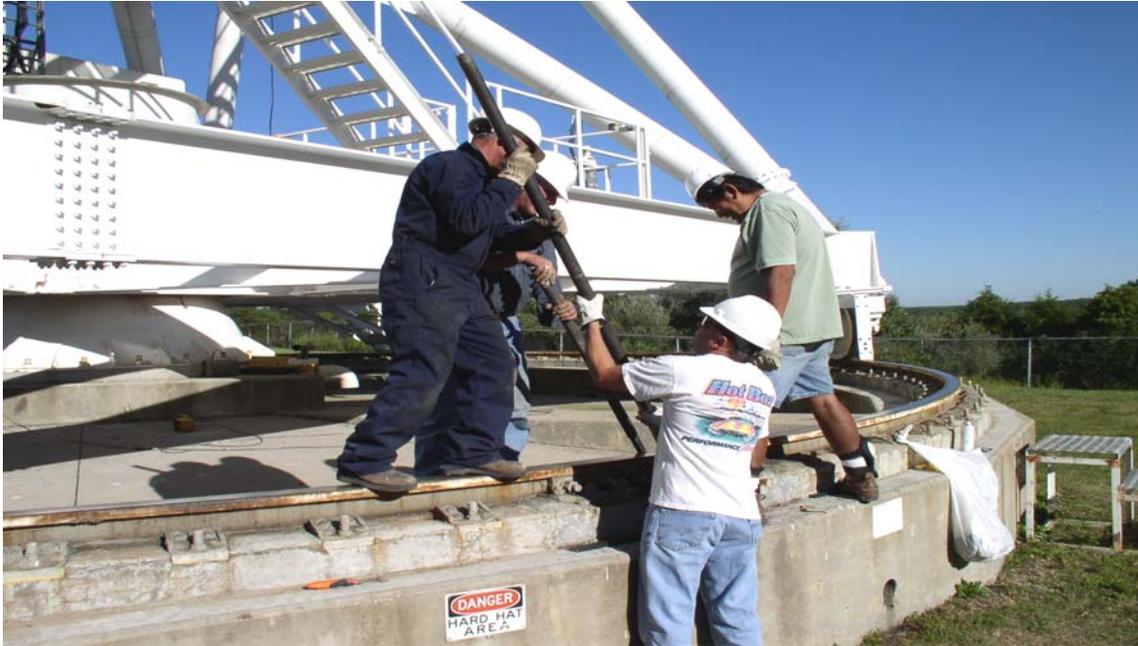
The guy's tightening loose rail splices. All splices were loose.
