National Radio Astronomy Observatory
Socorro, New Mexico

VLBA Antenna Memo #56

Brewster, WA. VLBA Maintenance Visit July 28th thru August 8th 2004.

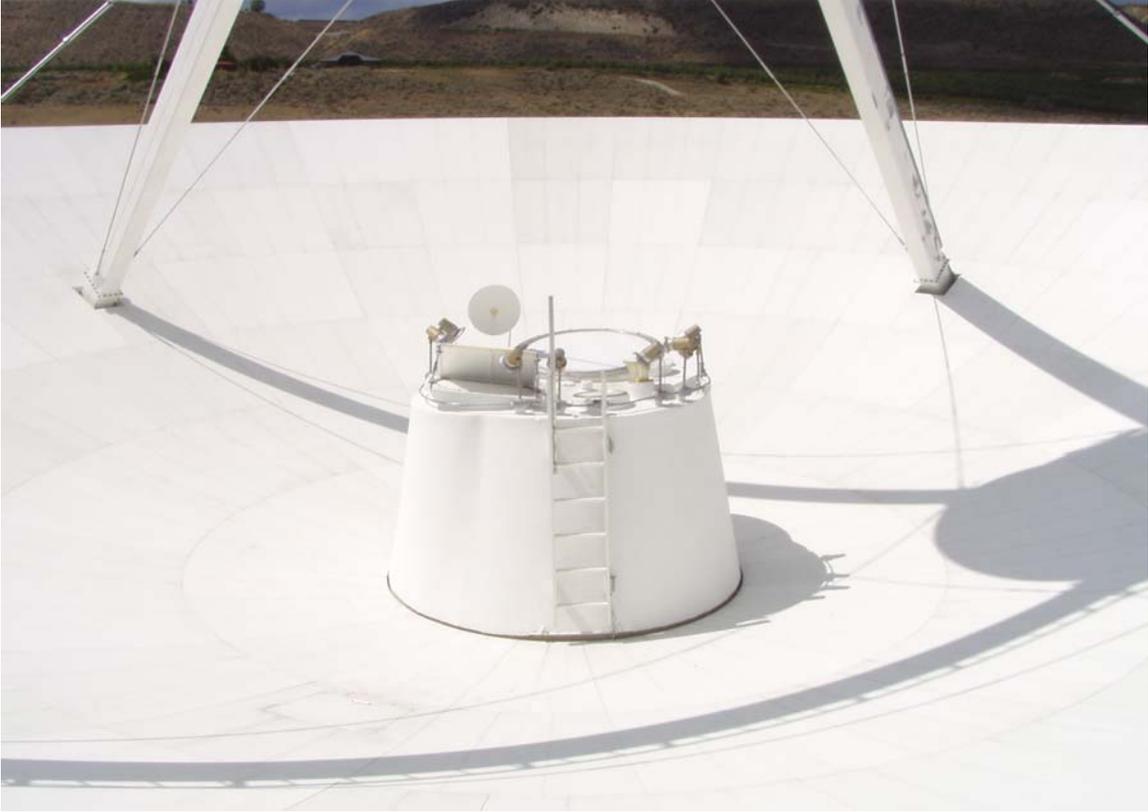
Dish panels are in good condition. Panels paint is in good condition. Quad legs paint and guy wires are in good condition.

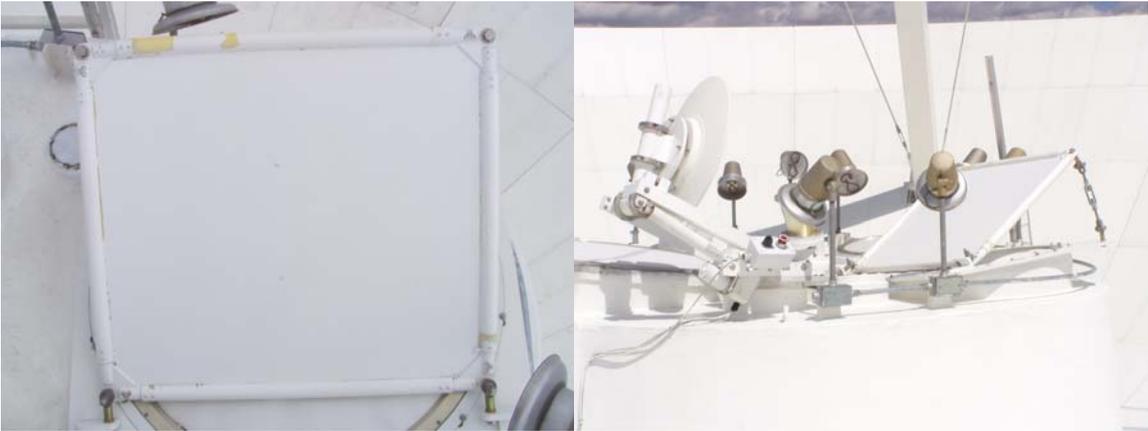
Dichroic reflector is good condition. Elipsoid reflector is in good condition.

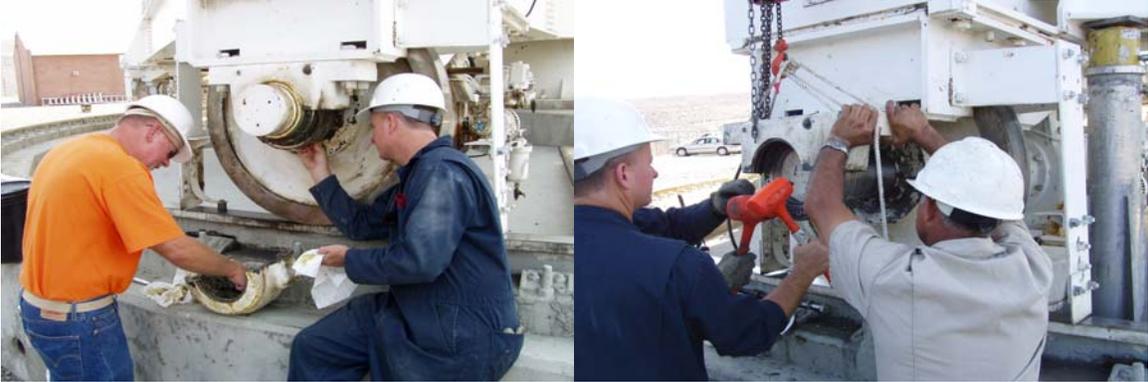
INNER BEARING	OUTER BEARING
D1	No metal found/rollers scratchy	REPLACED
D2	NEW WHEEL	NEW WHEEL
I1	No flakes/race a little scratchy	No flakes/good races
I2	Few brass flakes/smooth race	No flakes/race a little scratchy
All bearings were very well lubricated.

AZ bearings were inspected. AZ drive #1 outside bearing was replaced.

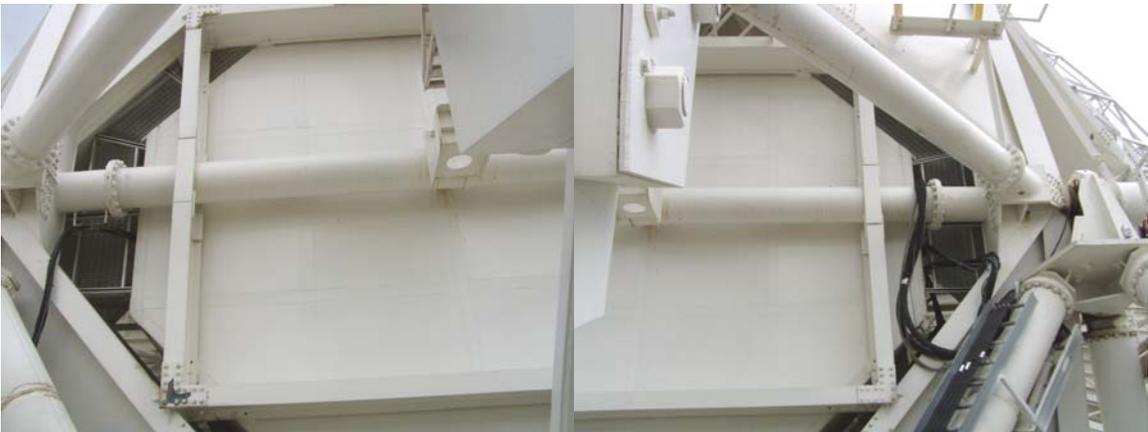
Elevation axle has no visible signs of cracks. Paint is good condition. Pintle bearing is well greased with no metal flakes.

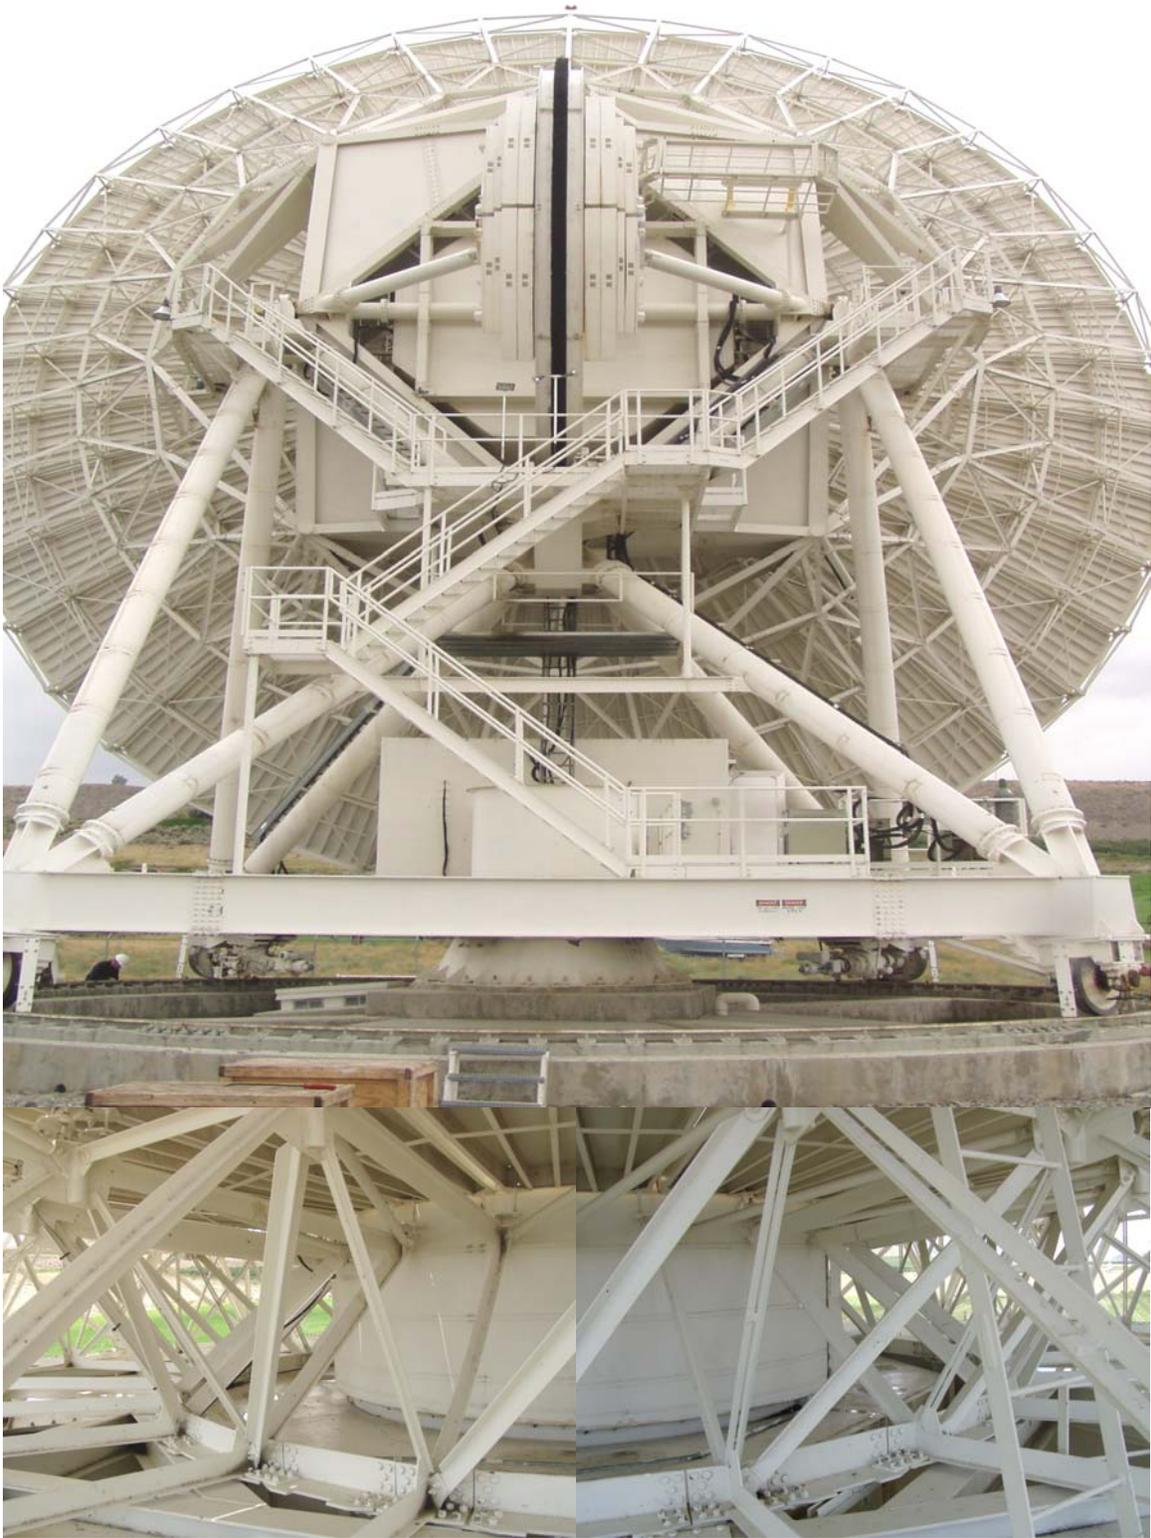
The antenna paint is in good condition.

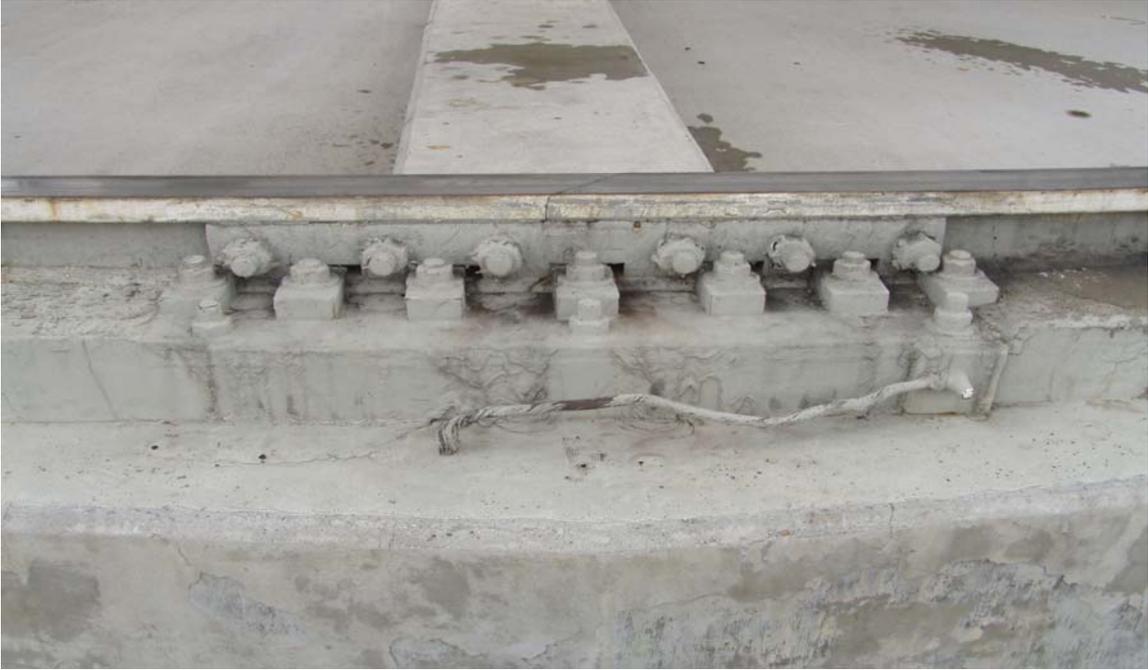
Vulchem is beginning to deteriorate from this rail splice and all others.

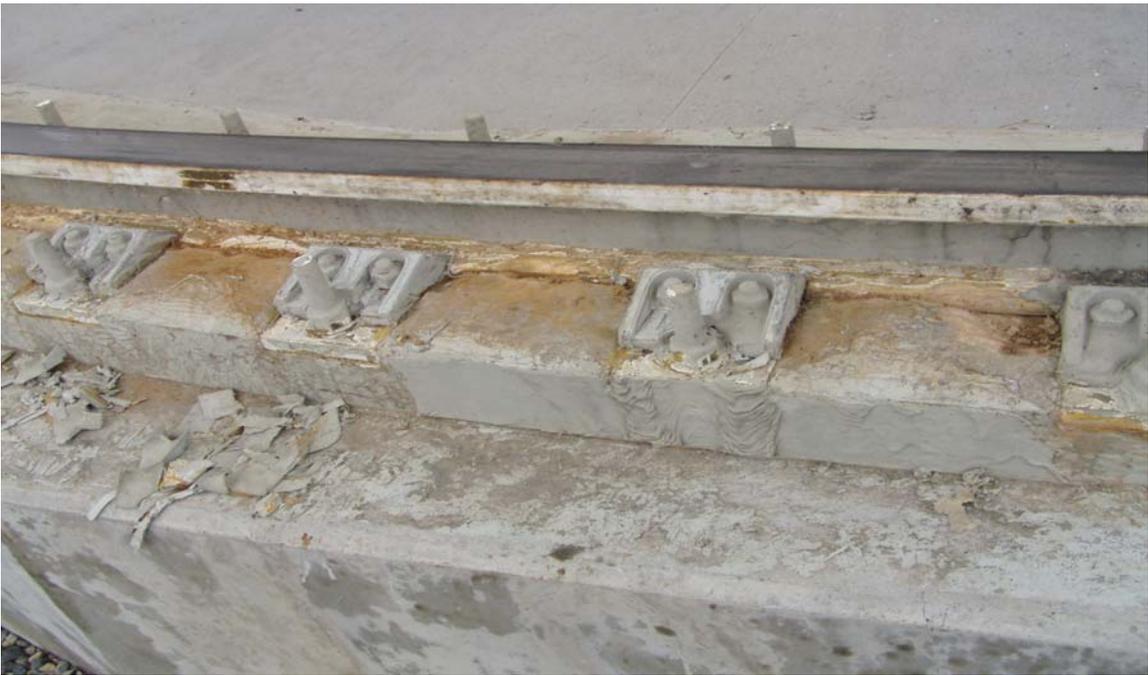
The rail is pulverizing the grout in many spots. Vulchem is deteriorating all over the rail. Site Techs began removing vulchem while the maintenance team was on site and will continue removing vulchem until it is all removed.

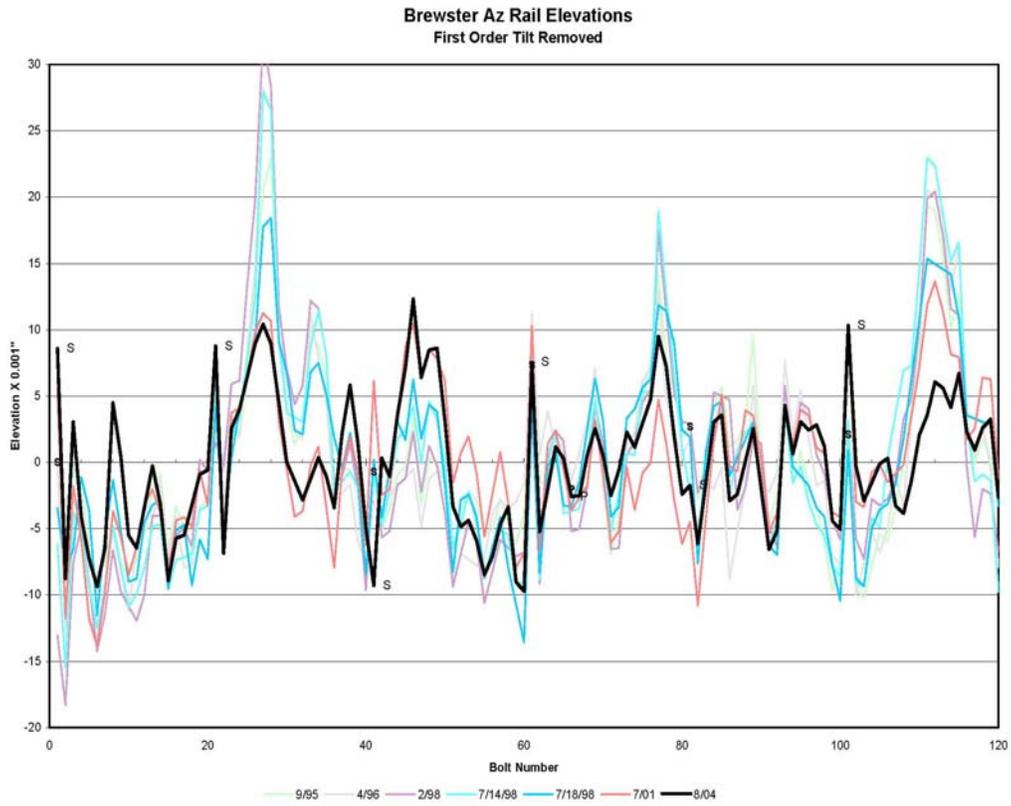
The Brewster rail is very flat with less than .025\"/>
