National Radio Astronomy Observatory
Socorro, New Mexico
VLBA Antenna Memo #73

North Liberty, Iowa VLBA Maintenance Visit April 30-May 7, 2008.
Team members consisted of Steve Aragon, Eric Carlowe, Ray McFarlin,
and Phillip Sanchez. VLBA Site Technicians Mike Burgert and DJ Beard
assisted in all areas of antenna maintenance.

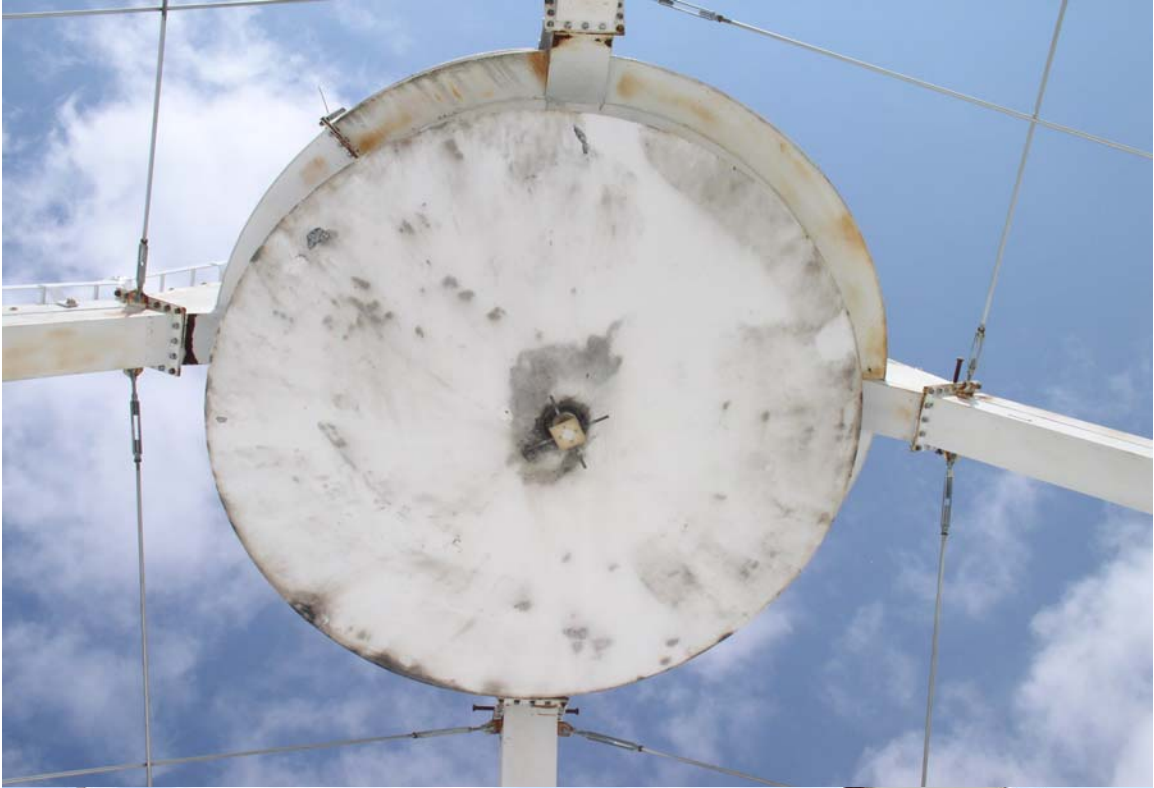
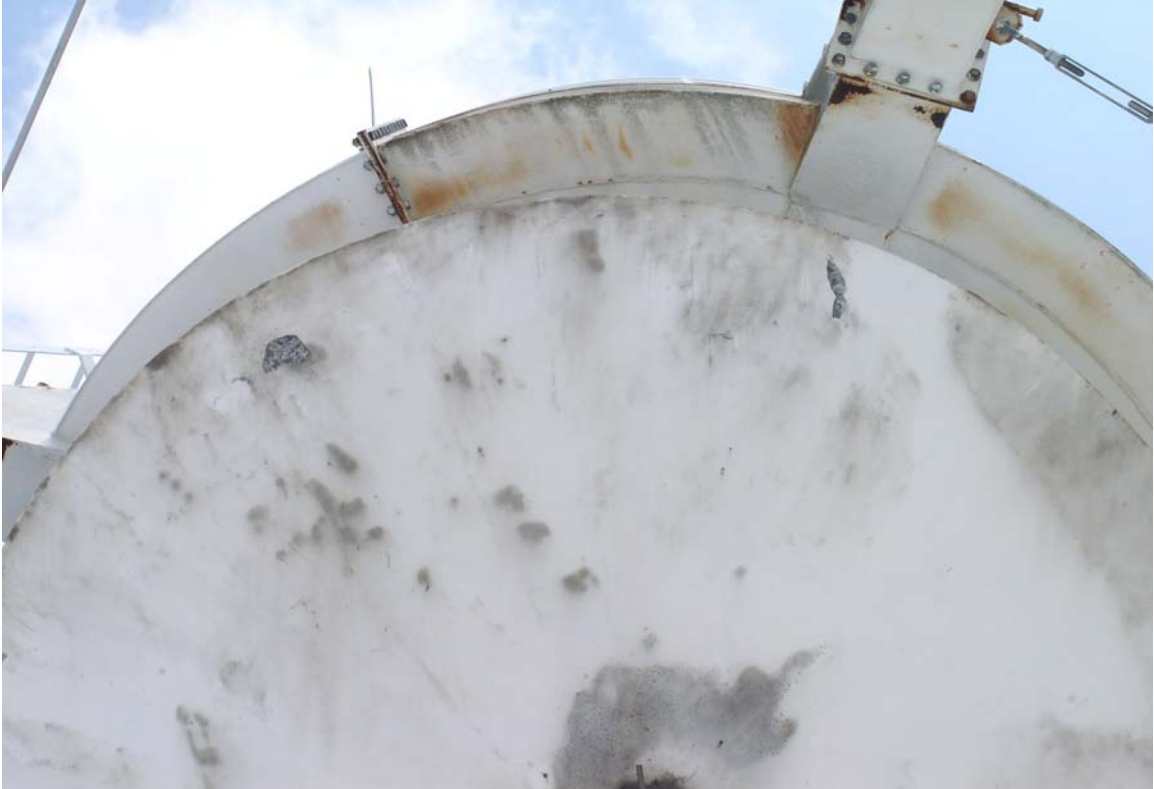
Sub reflector paint is beginning to flake off. FRM was given a thorough inspection. The focus flex was replaced. The FRM is well lubricated.

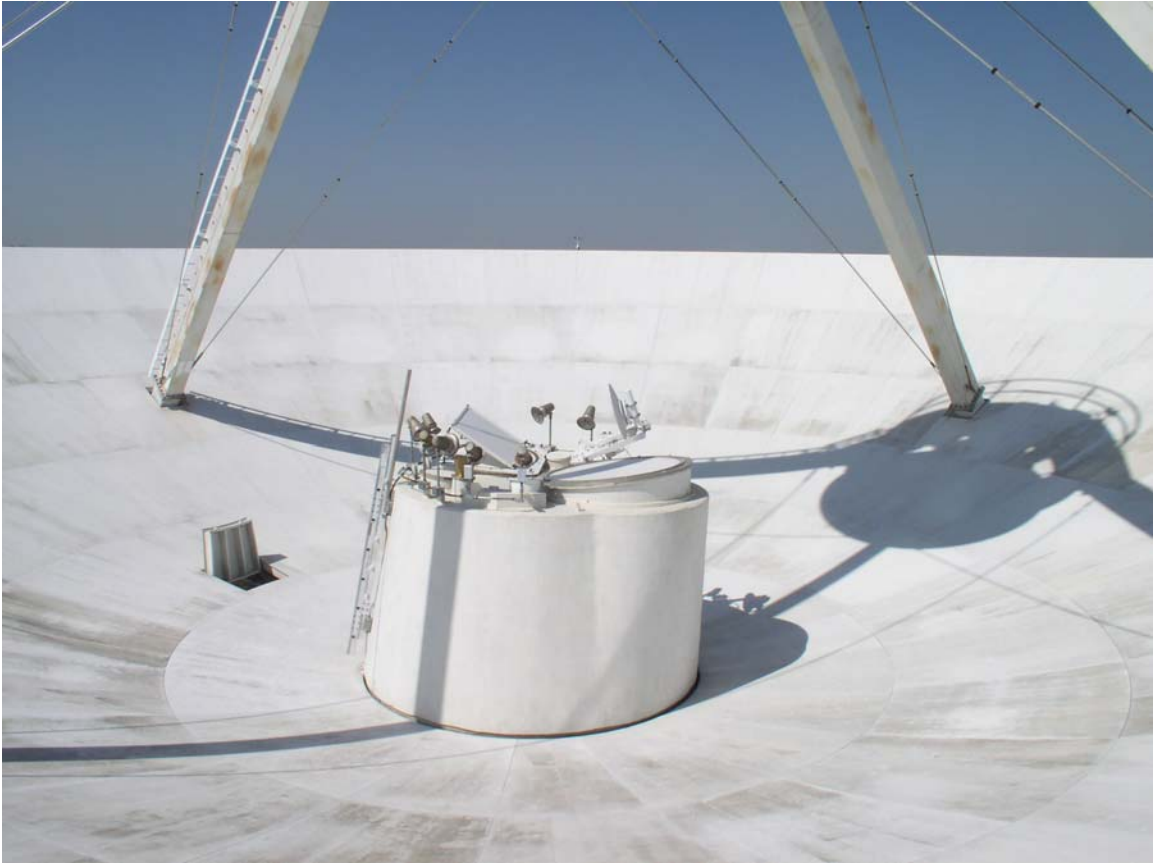
Dish panels are in good condition. The feed cone's elastomeric paint is holding up well. The feed cone was sealed and painted back in 9/2003.

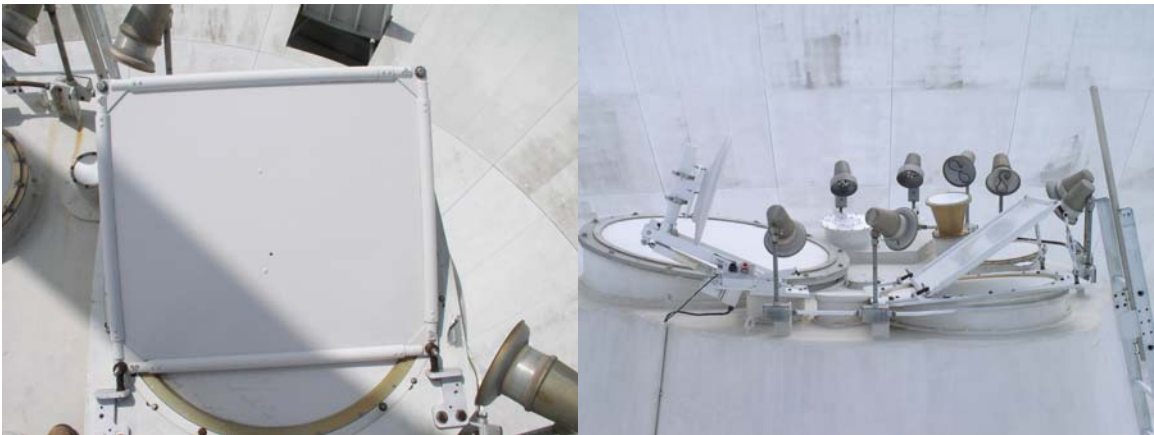
Dichroic reflector is in good condition. Ellipsoid reflector is in good condition. Dichroic reflector actuator operates correctly.

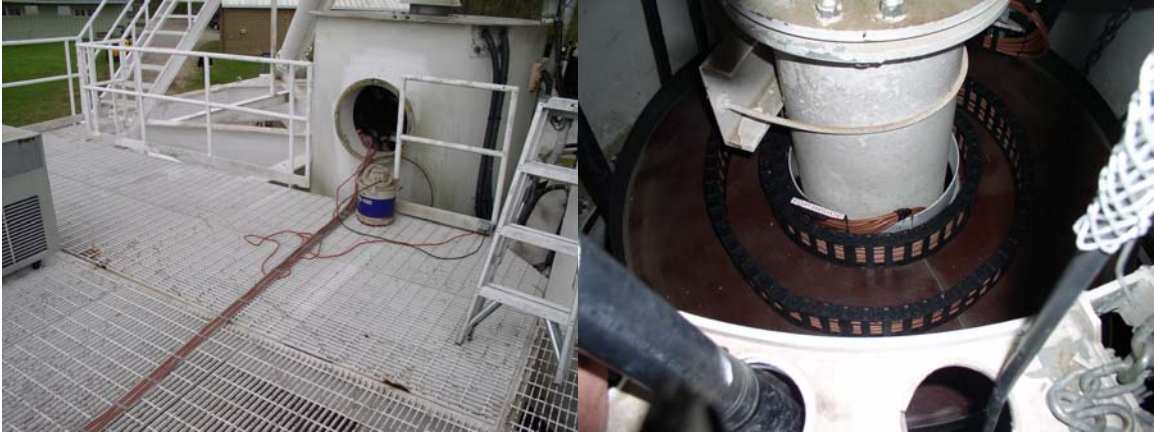
The new IF Cable Wrap was installed and tested.

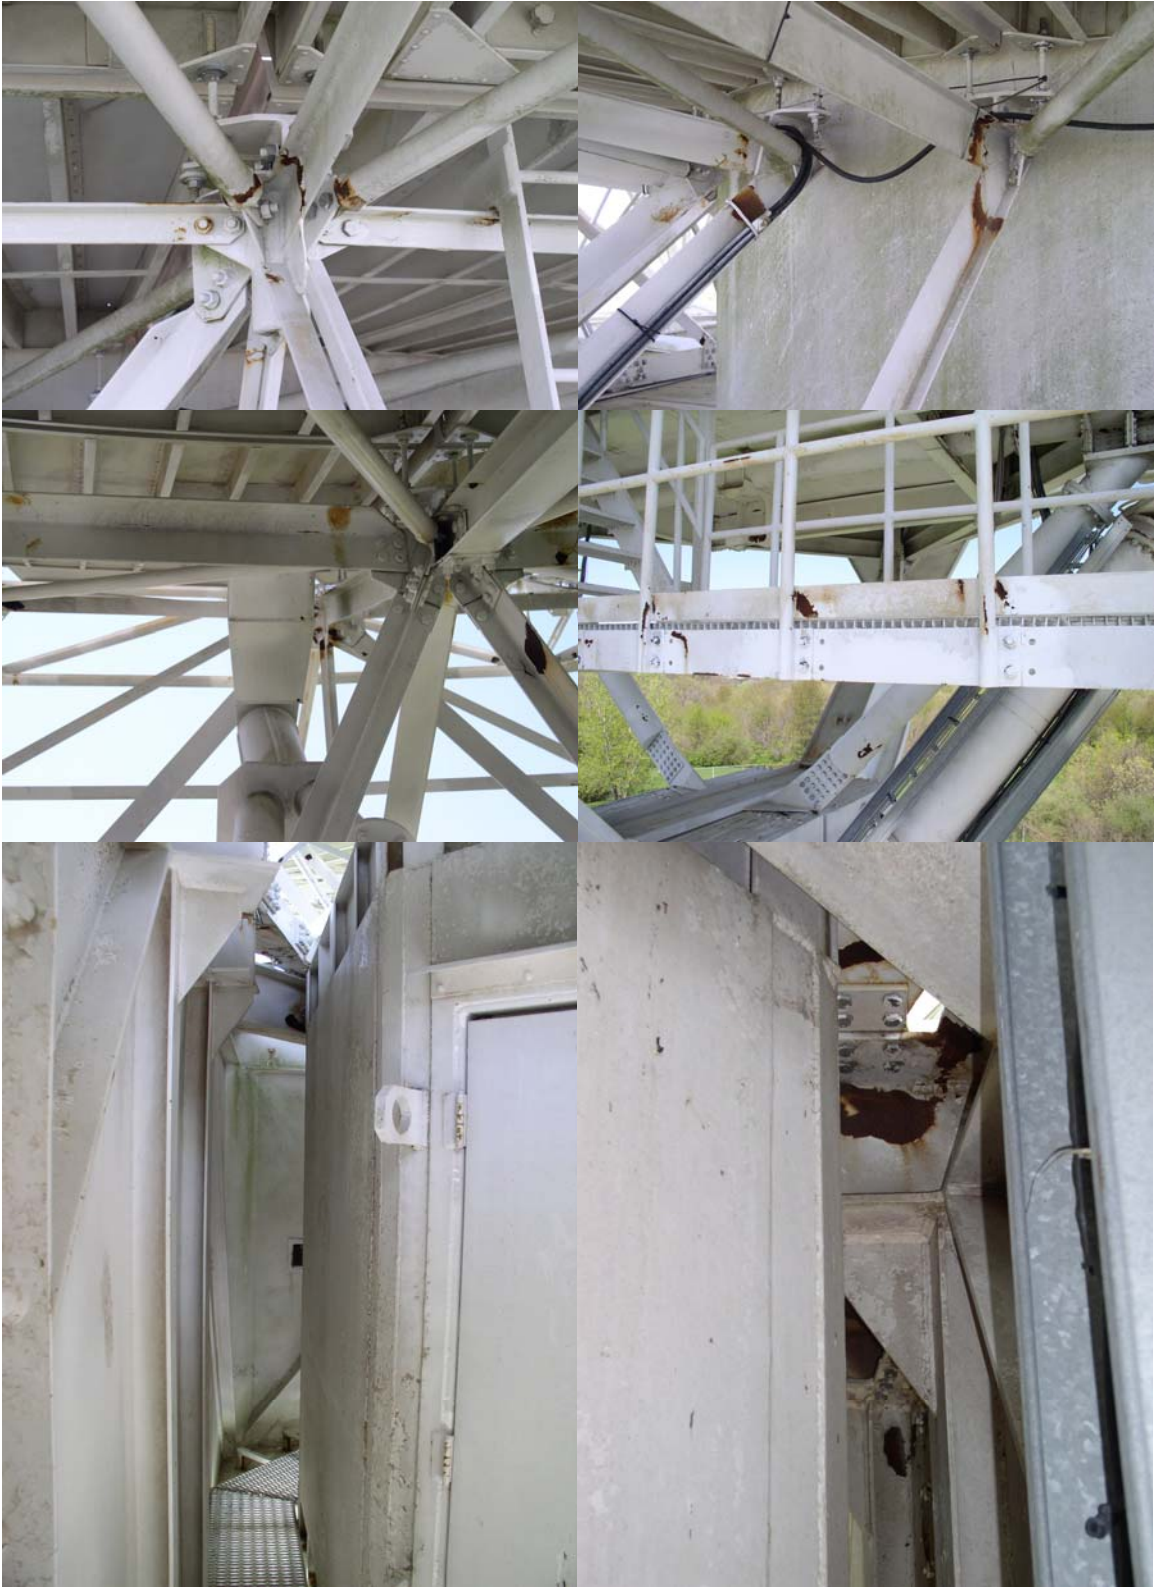
The Antenna could use a paint job. Paint is flaking off and surface rust is affecting most of the Antenna structure.

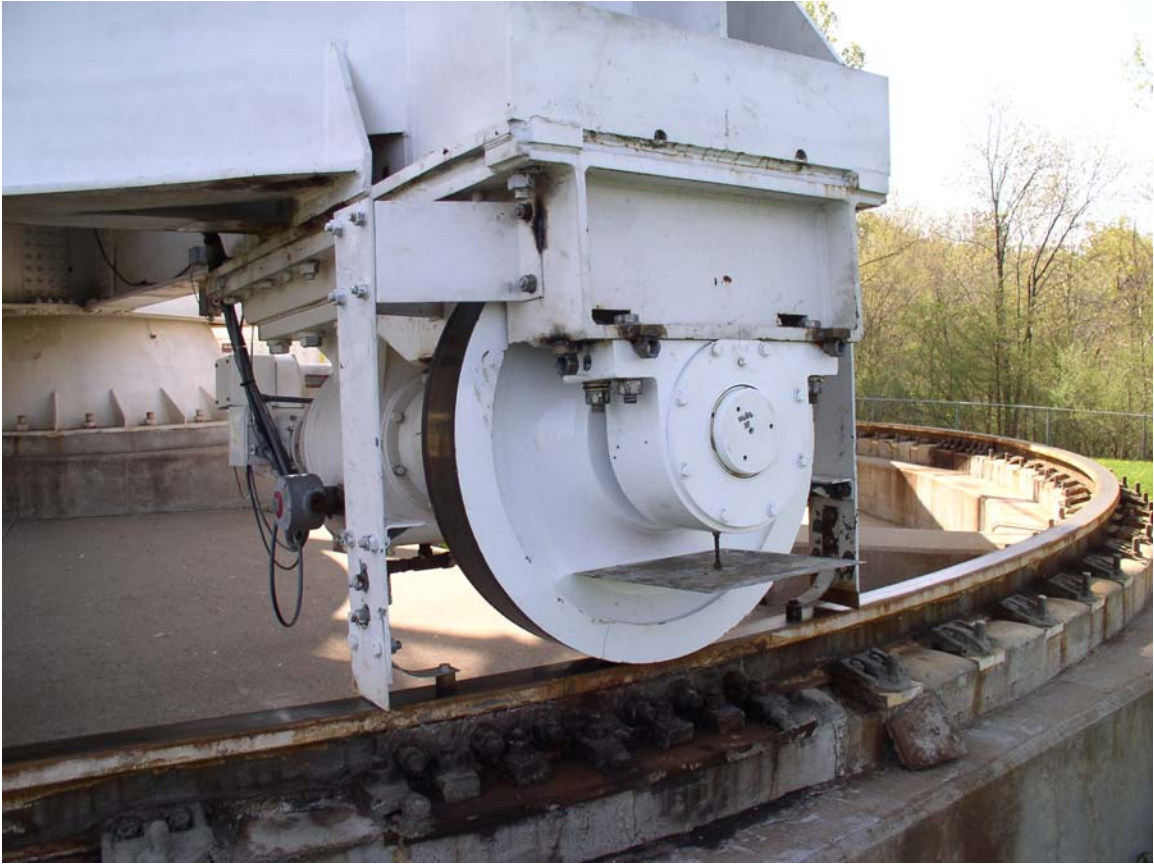
Azimuth #1 Wheel assembly was replaced. The new drive wheel assembly rotated smoothly without any popping or grinding noises.

MEASURED	SPECIFIED
Conic Radius	299.893	300.00 +/- .25
Coupling Runout	.001	<.005
Vertical	93.463	93.440 +/- .023
Horizontal	.004	<.023

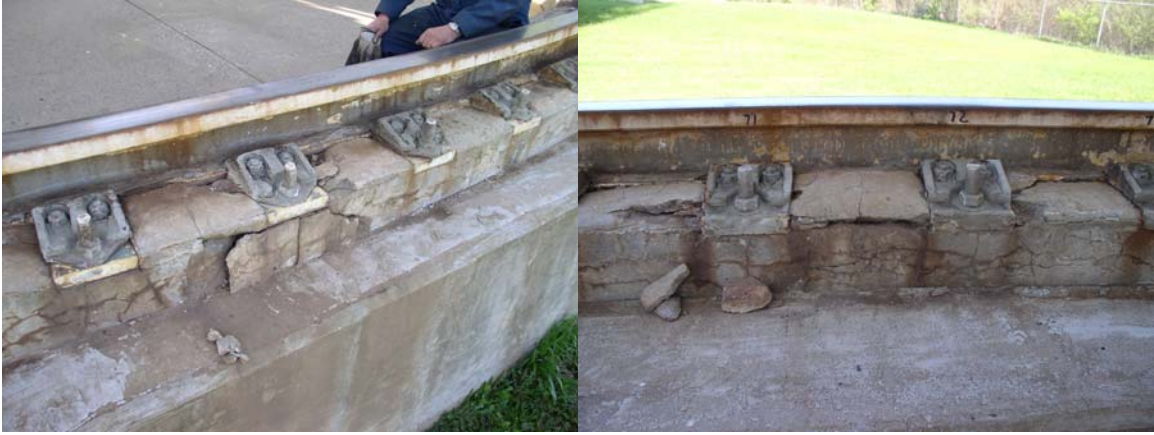
Grout is beginning to break up fall out from under the rail at bolt numbers 71 and 72.

North Liberty's Rail Elevations. The Rail at bolt numbers 71 and 72 is failing and should be repaired before this upcoming winter.

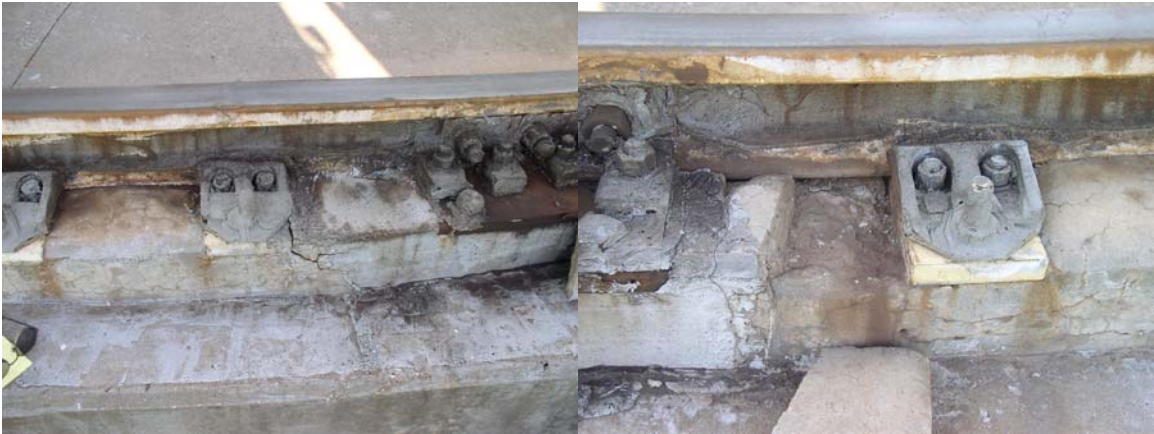
Grout is cracking and has fallen out at both ends of this rail splice. Bolt numbers 65 and 62.

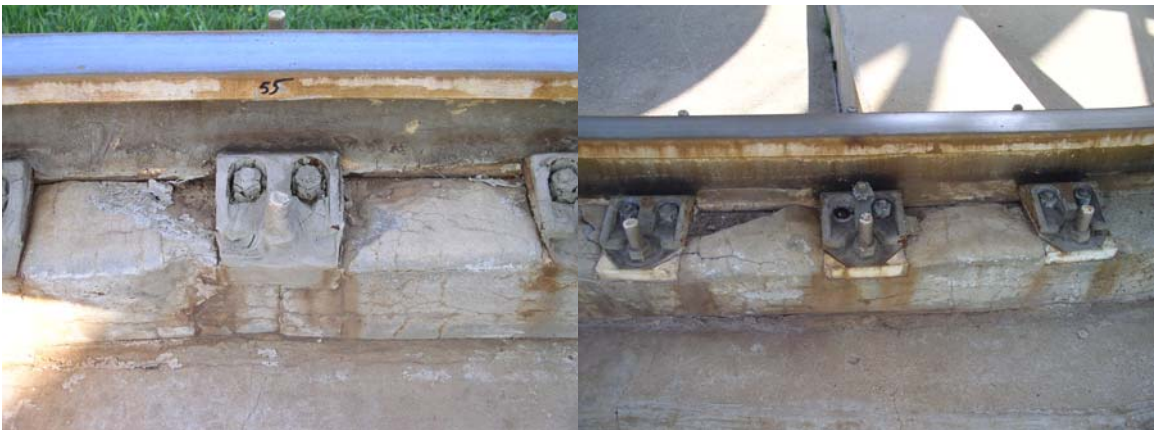
Grout has deteriorated from under the rail at bolt numbers 55 and 54. Rail clip bolts are broken at 34, 39 and 54.
