National Radio Astronomy Observatory  
Socorro, New Mexico  
VLBA Antenna Memo #82

Brewster, Washington VLBA Maintenance Visit July 12- July 21, 2010.  
Team members consisted of Eric Carlowe, Ramon Gutierrez, Ken Lakies,  
Ray McFarlin, Tommy Montoya and Adrian Zamora. VLBA Site  
Technicians Mark Hofmann and Dave Alderman assisted in all areas of  
antenna maintenance.

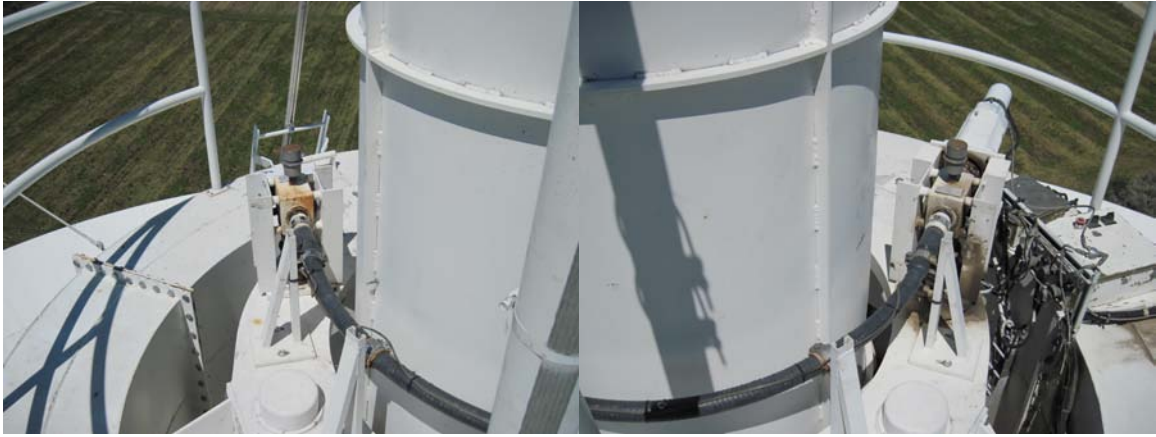
FRM was given a thorough inspection and the focus flex shaft was replaced.

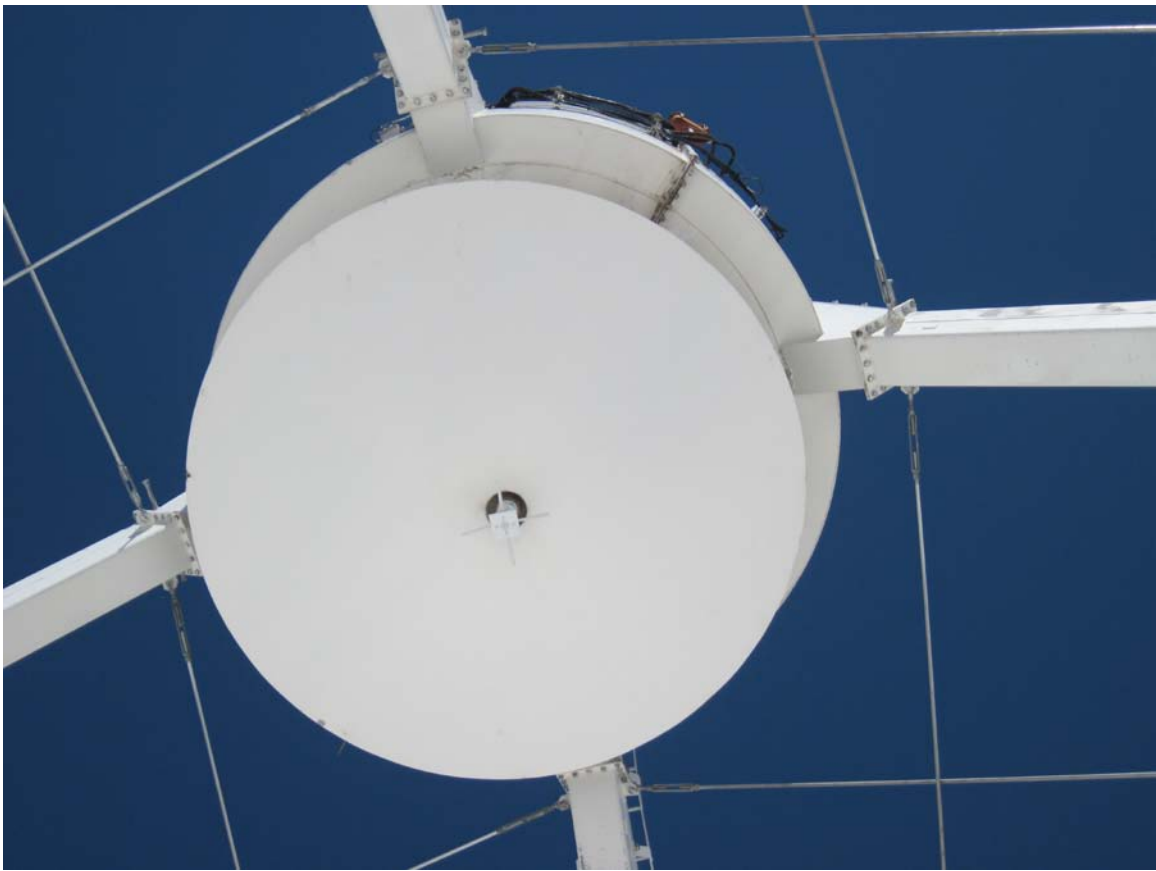
Sub reflector is in good condition.

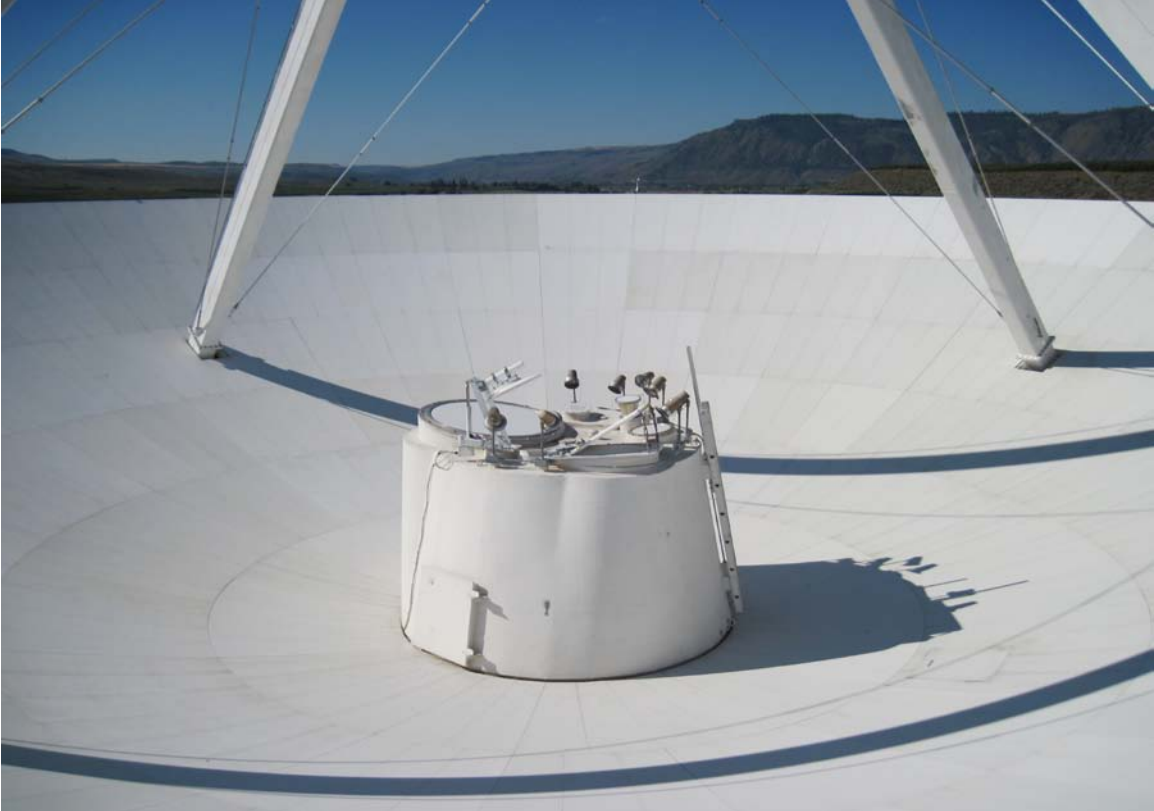
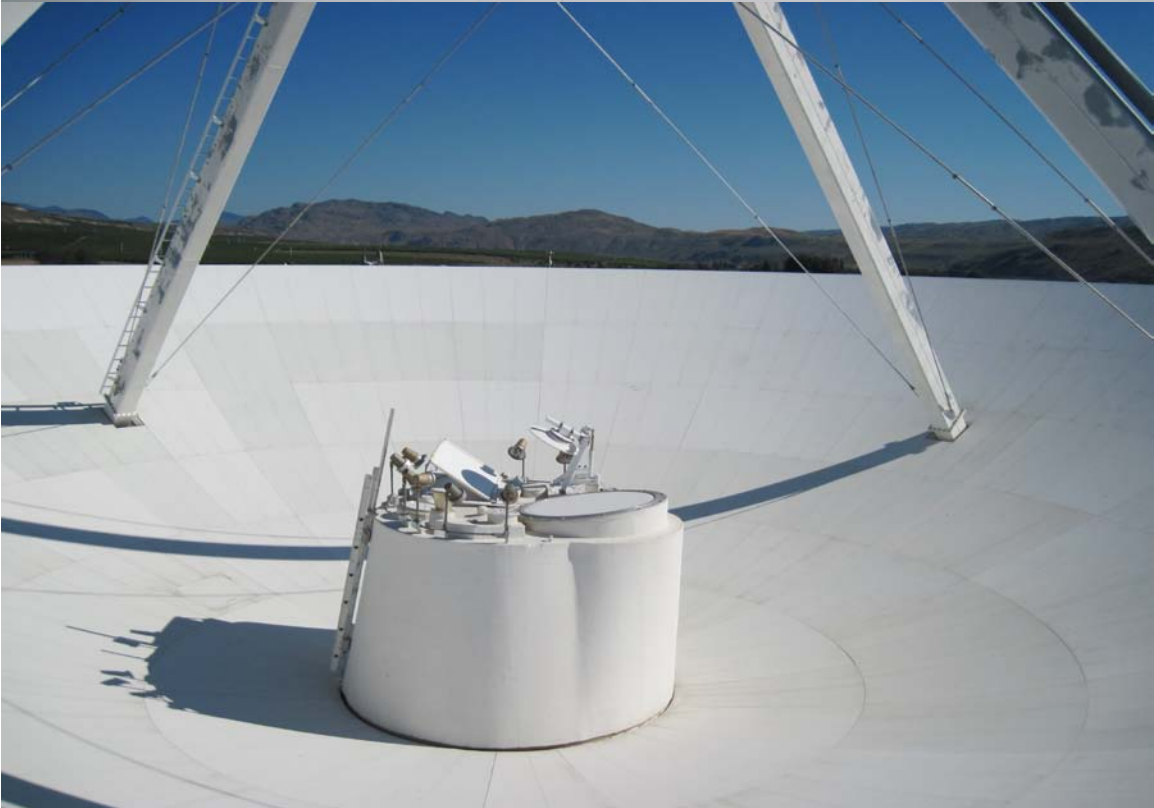
Dish panels are in good condition. The feed cone's elastomeric paint job is holding up well.

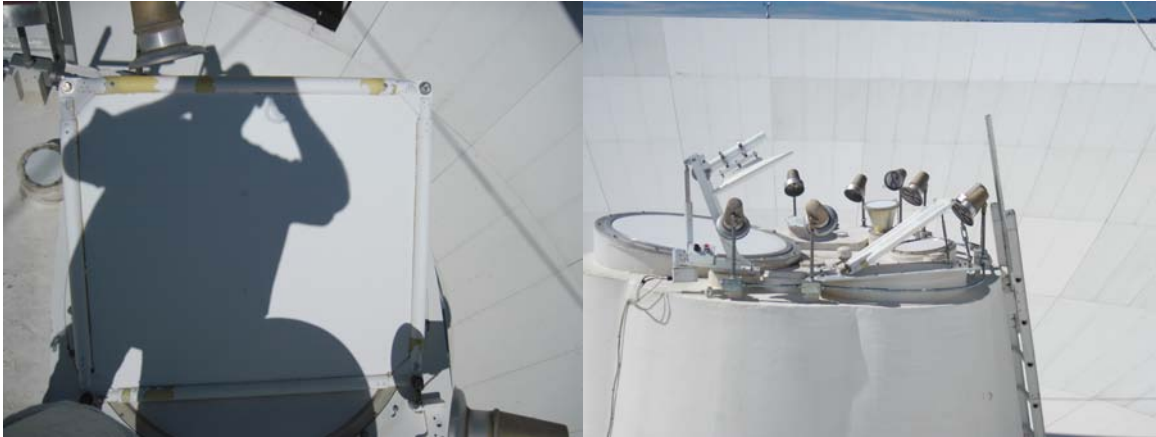
The Dichroic reflector is in good condition. The Ellipsoid reflector and actuator were tested and both are in good condition.

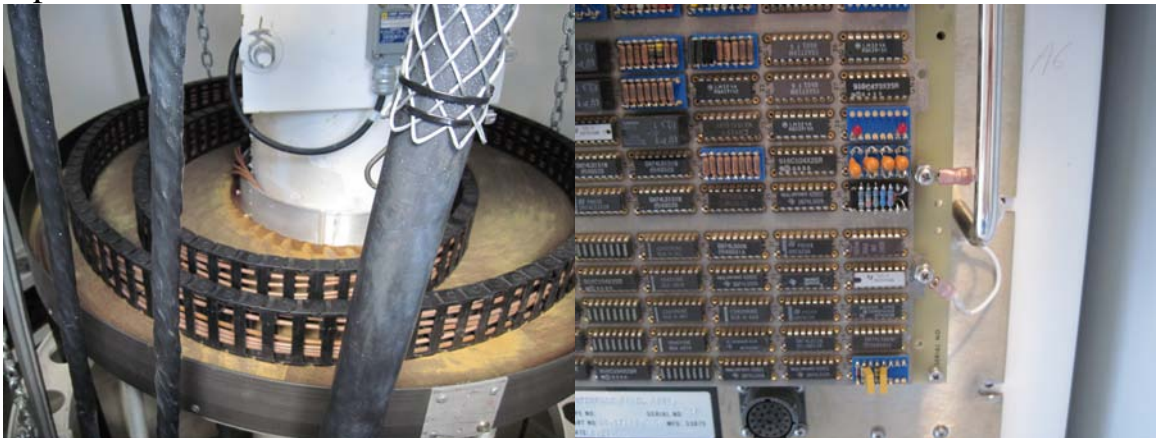
The new IF cable wrap is holding up very well. The Servo reverse pre-load mod was installed and tested for both AZ and EL.

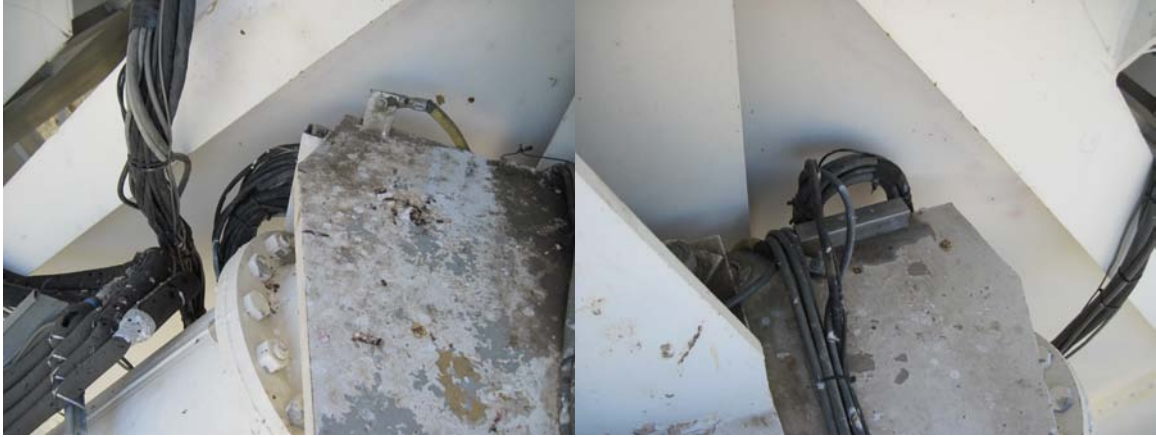
Both Elevation cable wraps are in good condition.

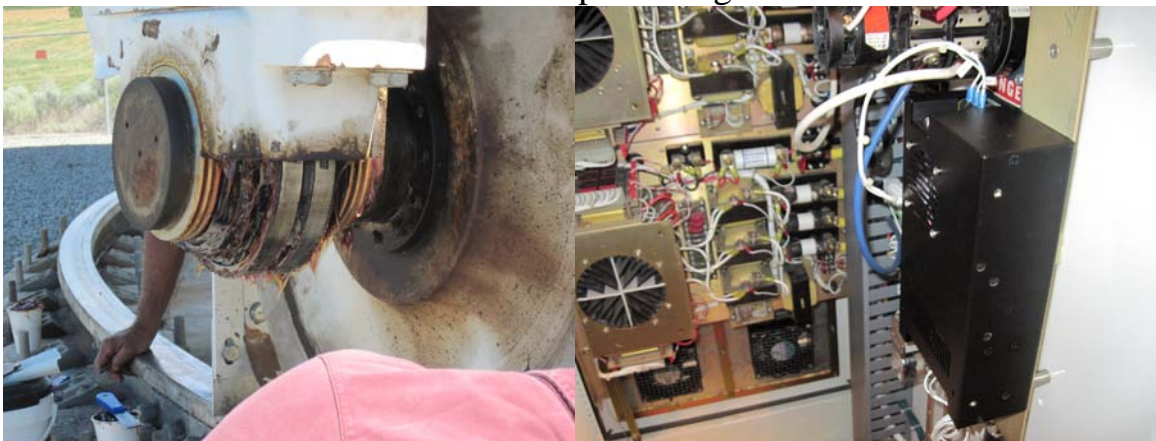
No azimuth idler wheel bearing needed replacing. The Site Techs had previously installed the new Servo Drive Cabinet power supply.

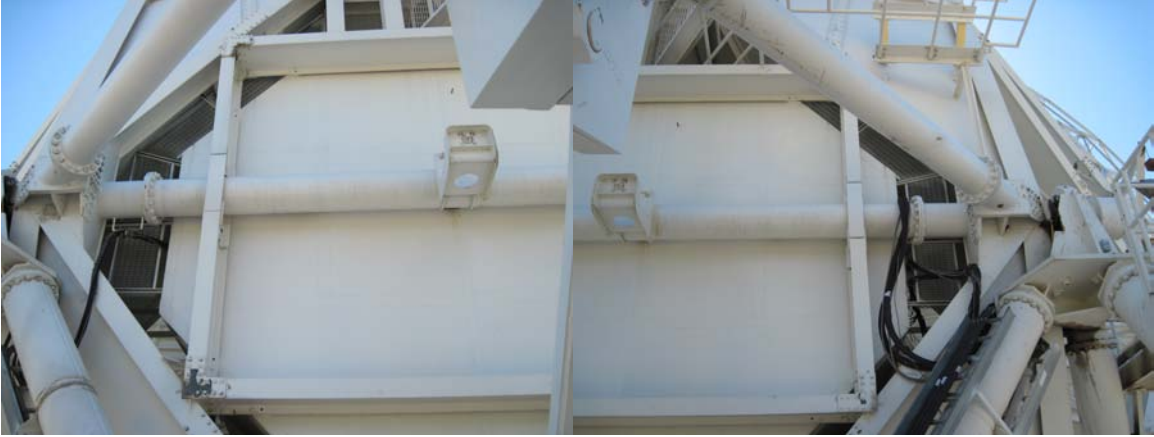
Elevation axle has no visible signs of cracks. Paint is in fair condition.

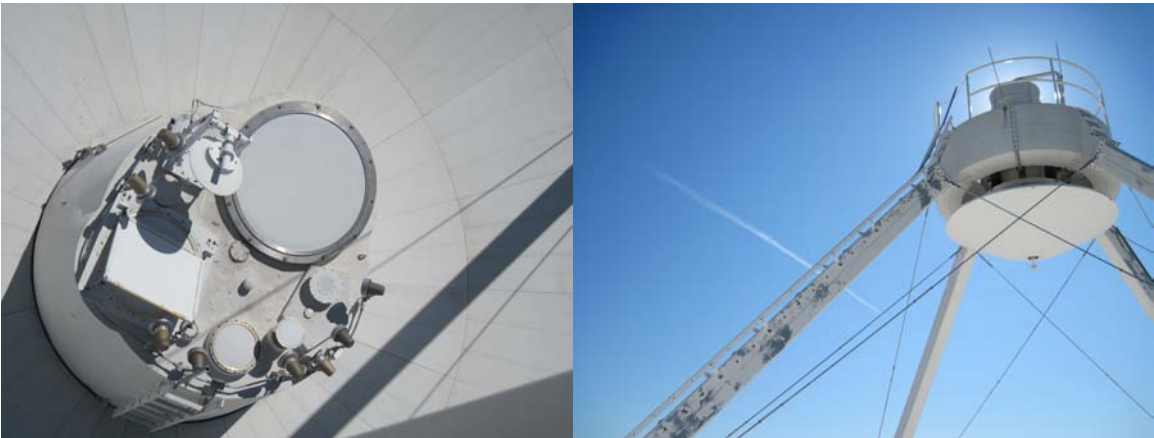
The feed heaters and FE windows are in good condition. Apex and Quad leg paint is in poor condition.

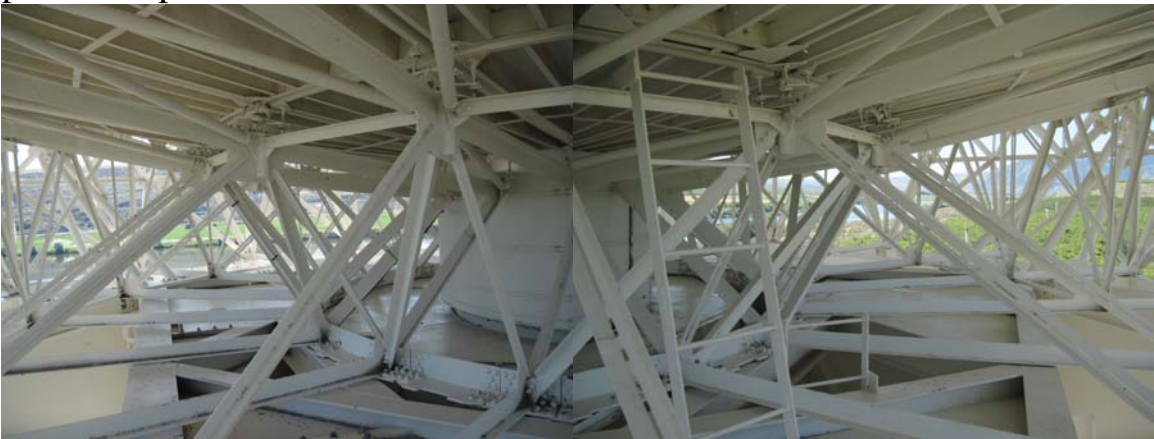
Antenna backup structure is in good condition. Paint is in fair condition.
