VLBA ACQUISITION MEMO #308

HAYSTACK OBSERVATORY

Subject: Tape Edge Abrasion by Contact with Reel Flange Rims

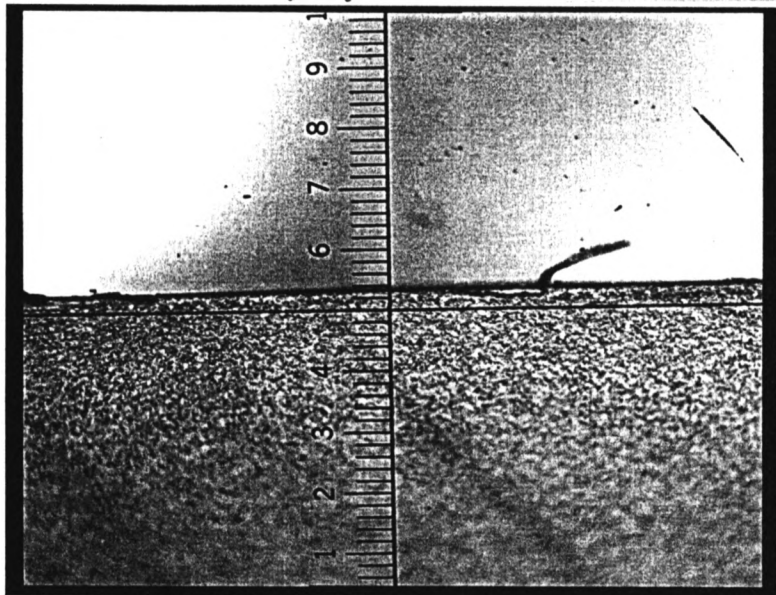
Some loose edge pieces - debris from
osc against reel flange??

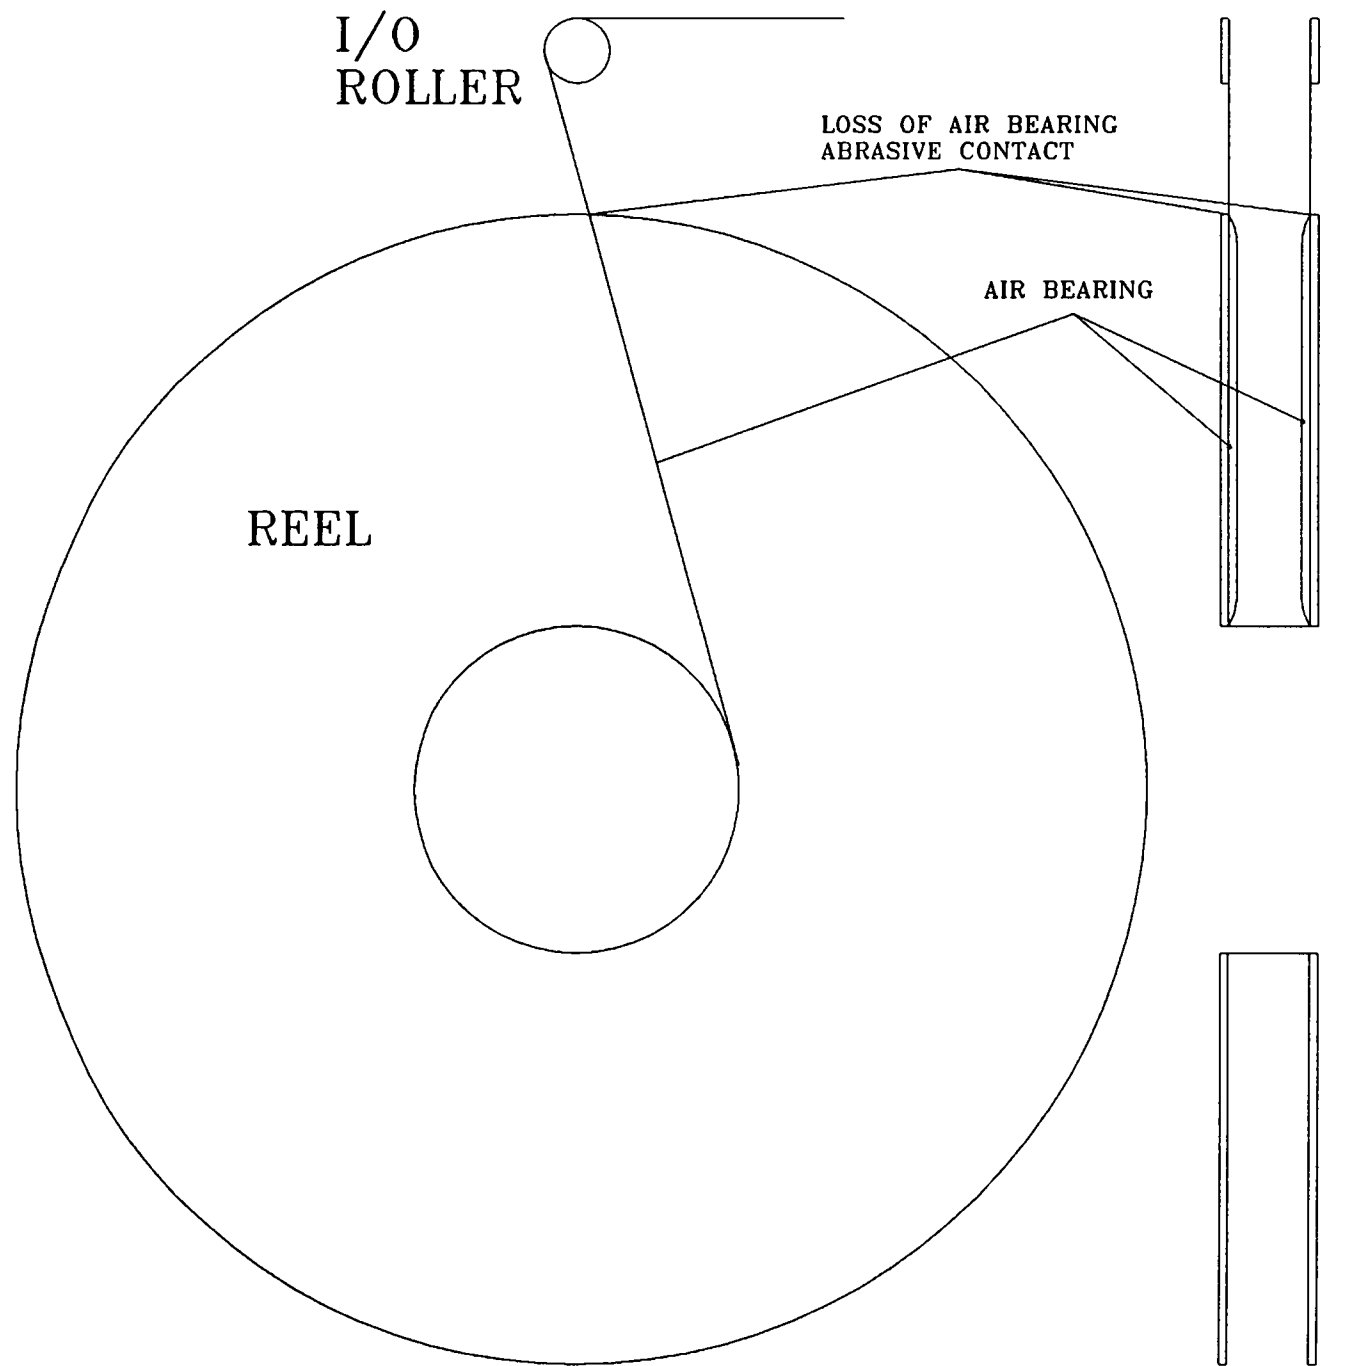
LOSS OF AIR BEARING
ABRASIVE CONTACT
