VLBA ACQUISITION MEMO # 320
 MASSACHUSETTS INSTITUTE OF TECHNOLOGY
 HAYSTACK OBSERVATORY
 WESTFORD, MASSACHUSETTS 01886

30 June 1992

To: VLBA Data Acquisition Group
 From: Alan E.E. Rogers
 Subject: Wear tests on short tapes

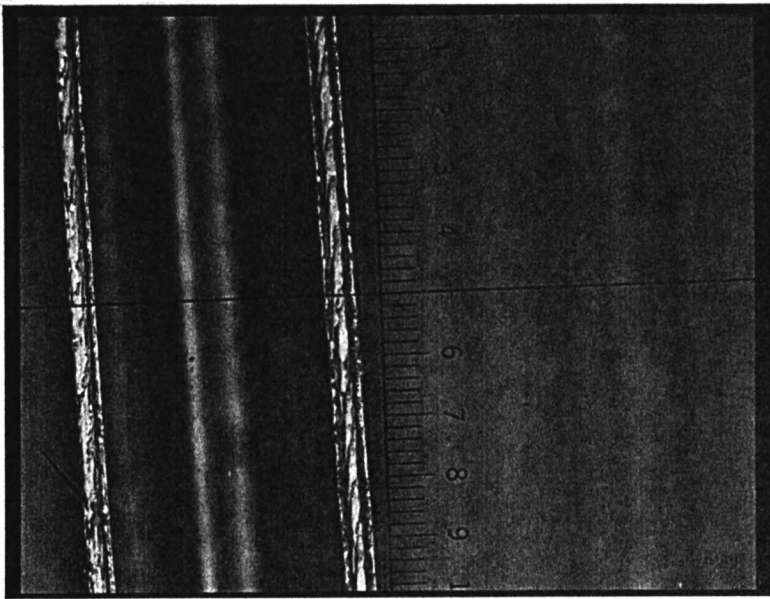
REM # 14

typical edge wear

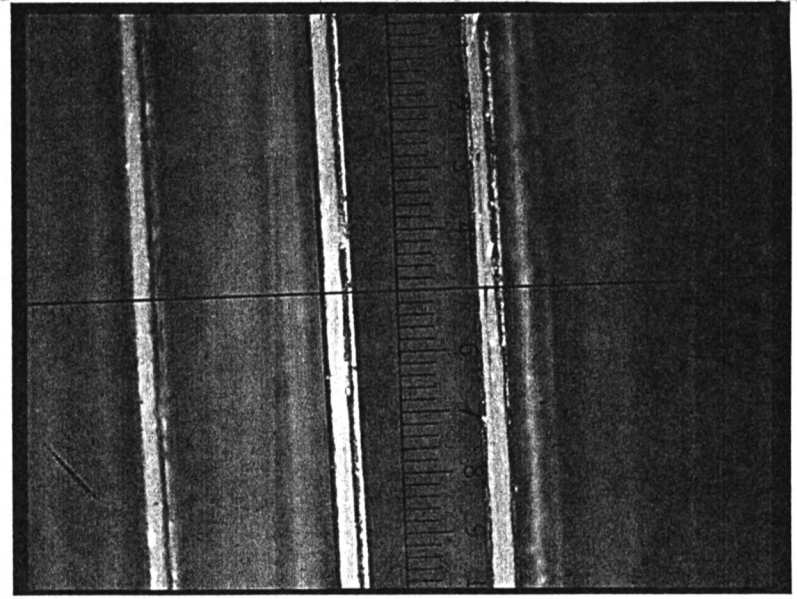
FRONT UNWORN

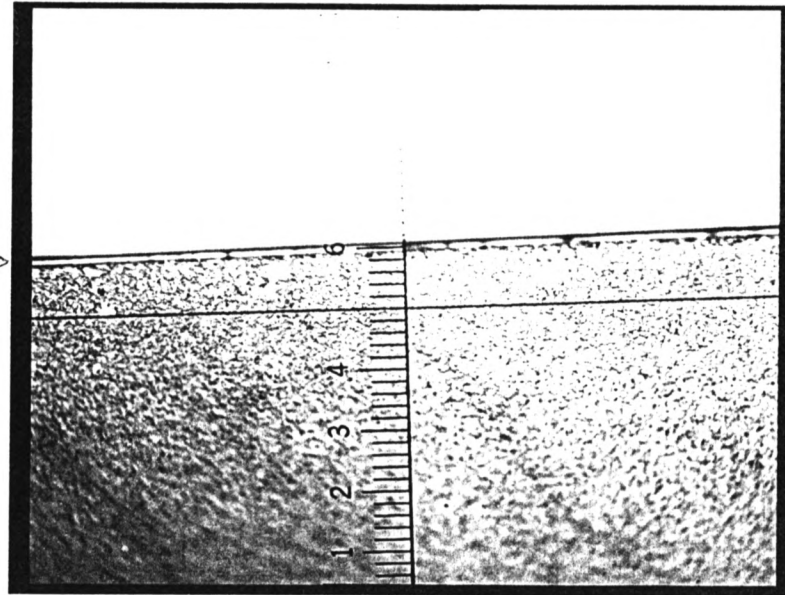
REM # 4 BACK DAT

melted edge

EDGE RUN AGAINST ALUMINA
