VLBA Electronics Memo No. 27

TO: Model 22 Users
FROM: H. Dill
SUBJECT: Symptom Notes for the Model 22

MODEL 22 REFRIGERATOR
SERIAL # 11693291

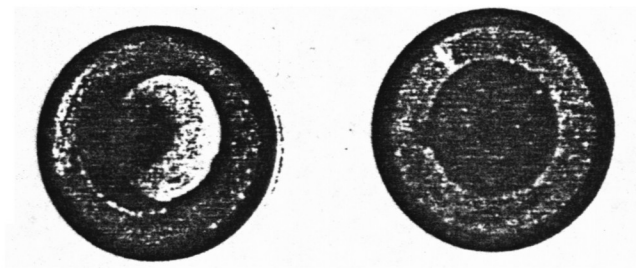
The bushings in one of our units were worn along the side that would be ten o'clock from the top view. The top bushing showed the most wear, and both bushings showed wear along the same side. In addition to wear on the bushings, there was also wear of the brass sealing cap that closes off the top bushing port. It is this wear that seems to be generating the brass debris.

The yoke and eccentric mount seems to rub as the yoke block pivots about the shaft axis. This wear dust, along with the carbon from the bushings and the brass dust, created additional abrasives to do more damage elsewhere in the system.

When disassembling a unit, there are several items to note. The first item involves the sealing cap. It should be marked with reference to the drive housing so that its assembled orientation can be determined after it is removed. The orientation of any wear inside the cap should be noted. This will aid in determining where the wear on the cap is in relation to the wear on the bushings. If the cap is causing the side loading, the wear on the cap would be opposite to the wear on the bushings, and if the cap and bushing are worn on the same side, then something else is causing the side loading.

The orientation of the bushing wear should also be noted. If this orientation varies from unit to unit, then the problem is probably due to an assembly error, but if the wear is in the same location, then the error is probably in the design.
