VLBA Electronics Memo No. 34

January 11, 1985

Subj: Report on CTI Model 22 Refrigerator Test

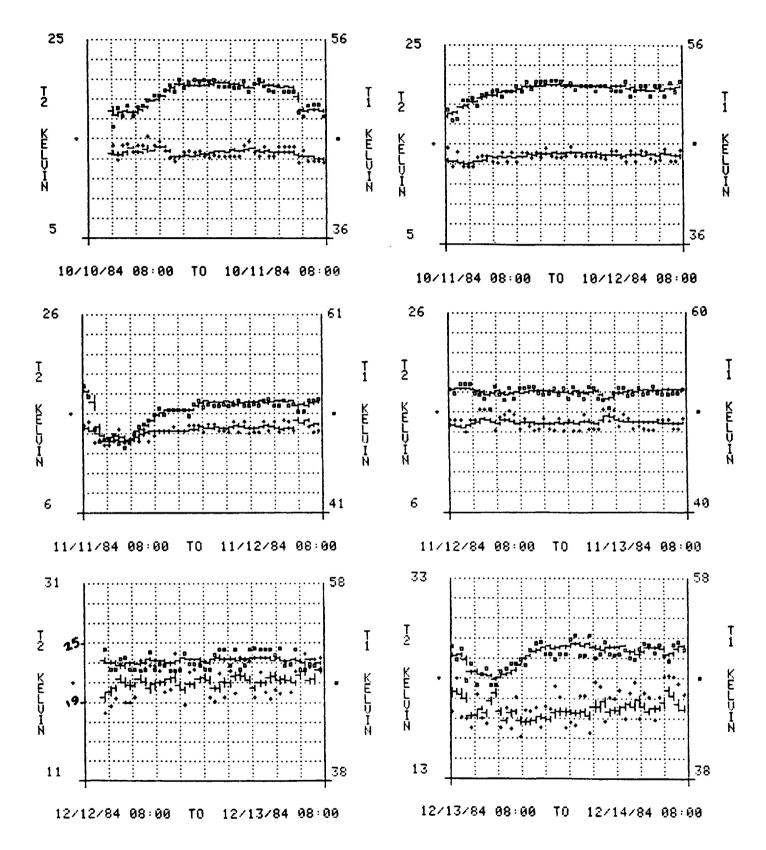
.FIGURE 1

The temperature of Dewar #0 began to increase notably in early December (Figure 1), until it reached an unacceptably high value with large variations. We also noted that the refrigerator motor had a difficult time in starting after it was turned off momentarily. On December 14, we cycled the refrigerator to room temperature and back. The temperature returned to a normal value and the motor starting problem disappeared. However, the temperature continues to exhibit occasional large variations (Figure 2).

We suspect that the problem with Dewar #0 was caused by some type of contamination in the cold head that was flushed out and dispersed in the rest of the system when the unit was warmed up. We will probably send a sample of the helium gas from this system off to be analyzed.

Typical temperature records of Dewar #0 over a three month period, showing the deterioration in performance. Note the shifts in the temperature scales. The deterioration first became noticeable on about December 1, 1984.

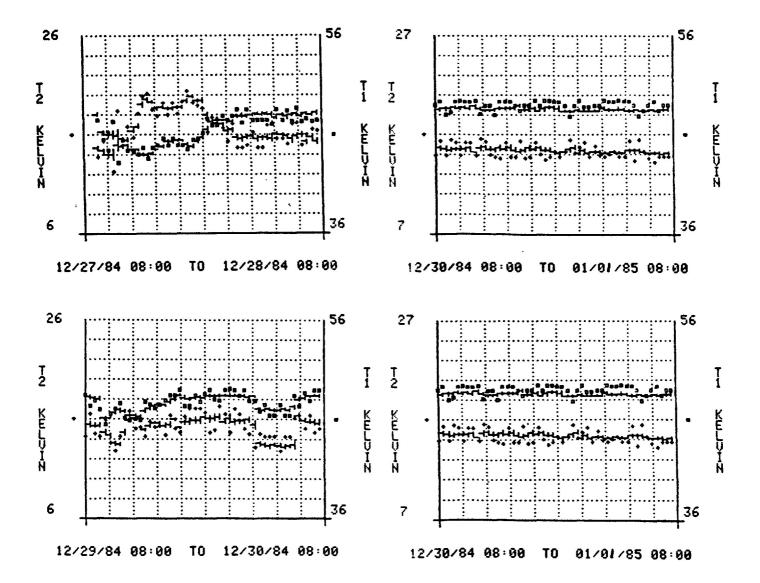
FIGURE 2

Temperature records of Dewar #0, after cycling the refrigerator to room temperature on December 14 for the first time since August 30. Note that the average temperatures have returned to reasonable values, but that the second stage is still exhibiting larger than desirable temperature variations.

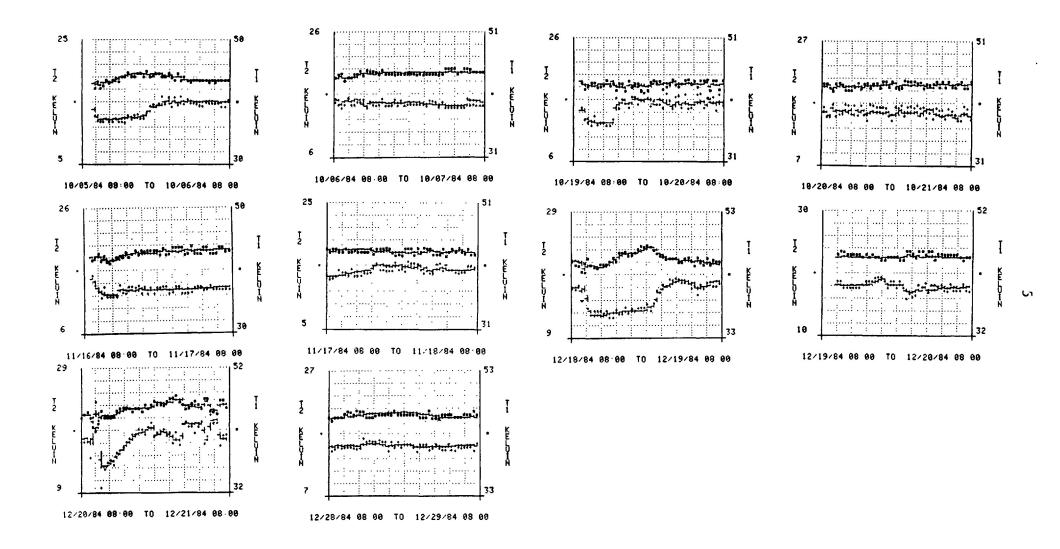
Dewar #3 continues to show the occasional large temperature variations noted in the previous memo (Figure 3).

Temperature records of Dewar #3 showing its inconsistent performance.
