VLBA Test Memo #63  
**Azimuth Drive Wheels**  
Jim Ruff  
11/18/99

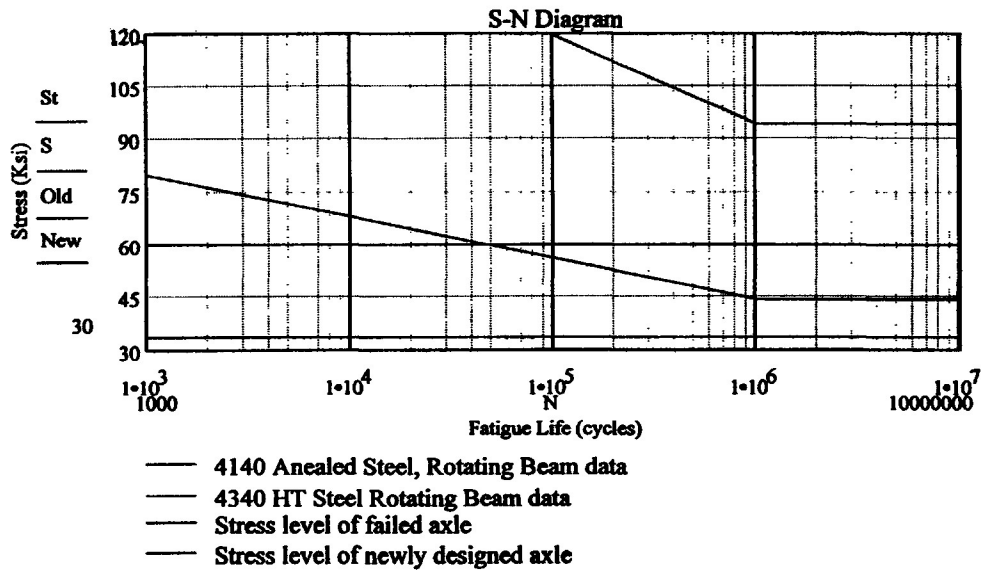
The statistical nature of fatigue failure makes it impossible to predict the life of the new shaft at Brewster with certainty.<sup>ii</sup> But, a reasonable life expectancy can be determined using the facts at hand. We know the original shaft lasted 12 months prior to failure. We also know the critical diameter went from 5.51 to 6.30 inches and the fillet radius went from 0.03 to 0.10 inches. Assuming the antenna rotates about 50,000 cycles per year, we can use the S-N Diagram below to put the effective stress at 60 Kips. For the original shaft, the stress concentration was that corresponding to  $D/d = 1.3$  and  $r/d = 0.006$ , which is in excess of 3.0. So, the nominal stress on the shaft was  $60000/3 = 20$  Kips.

Increasing the diameter reduced this stress. Bending stress for a round shaft is a function of  $d^3$ , so the nominal stress for the new shaft should be  $20 * 5.51^3 / 6.30^3 = 13.4$  Kips. The stress concentration expected for the new shaft corresponds to  $d/D = 0.91$  and  $r/d = .016$ , something less than 2.5. The new effective stress is therefore 33.6 Kips, which is below

the endurance limit for the shaft. A similar calculation starting at 10000 cycles per year yields an effective stress of 45 Kips, which should last the life of the project.

The analysis above, as well as a more extensive analysis performed by Jon Thunborg, indicates that the new axle at Brewster can be left in service with a high level of confidence.
