THE 12-METER TELESCOPE  
A PERSISTENT PROFILE ERROR NEAR SENSOR #6

John W. Findlay  
February 20th 1983  
-----

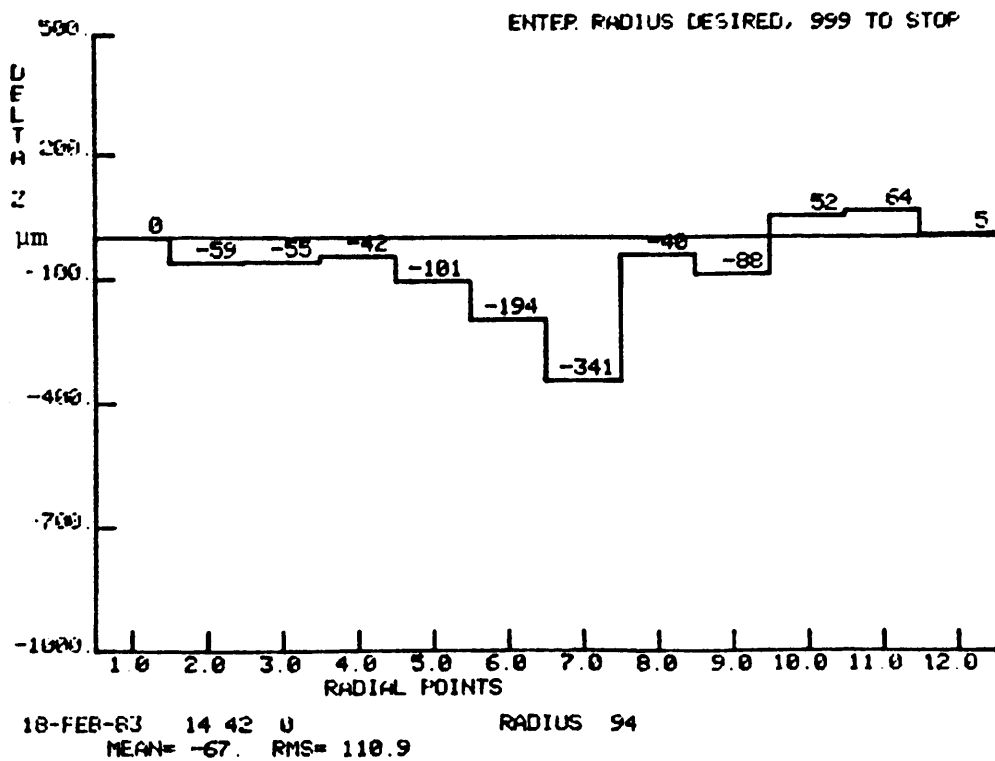
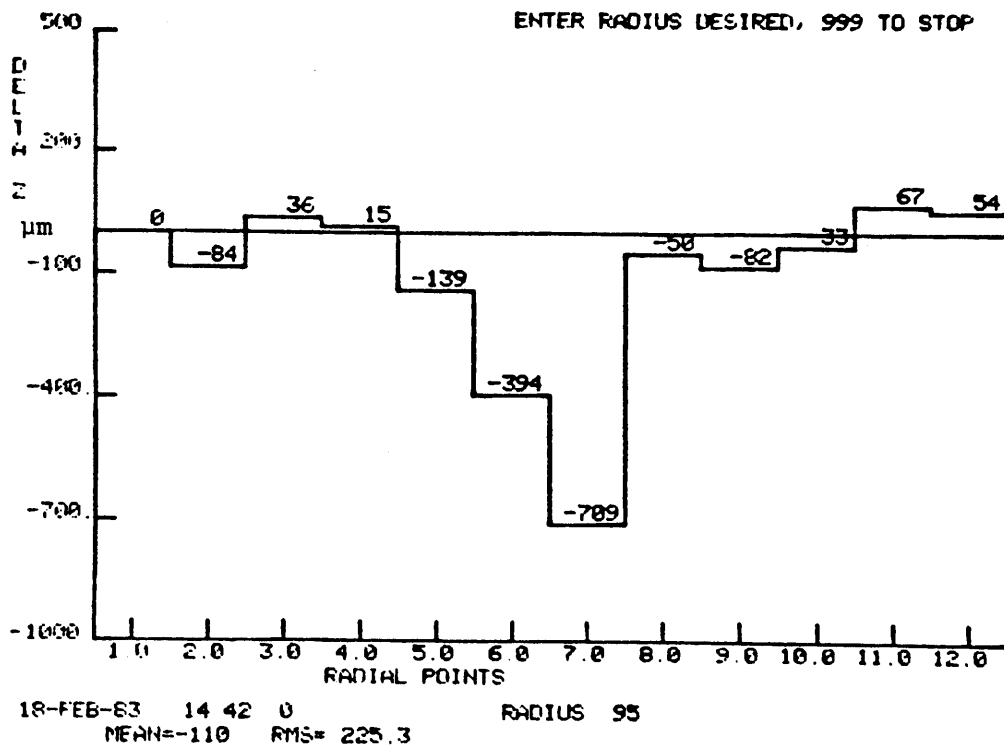
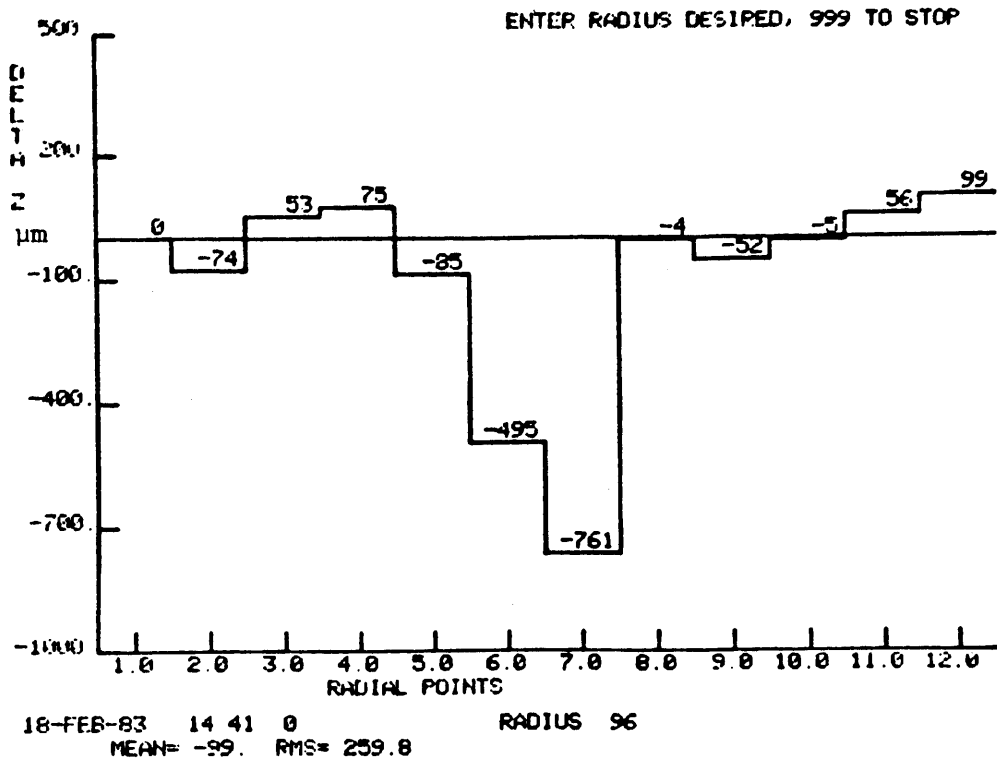
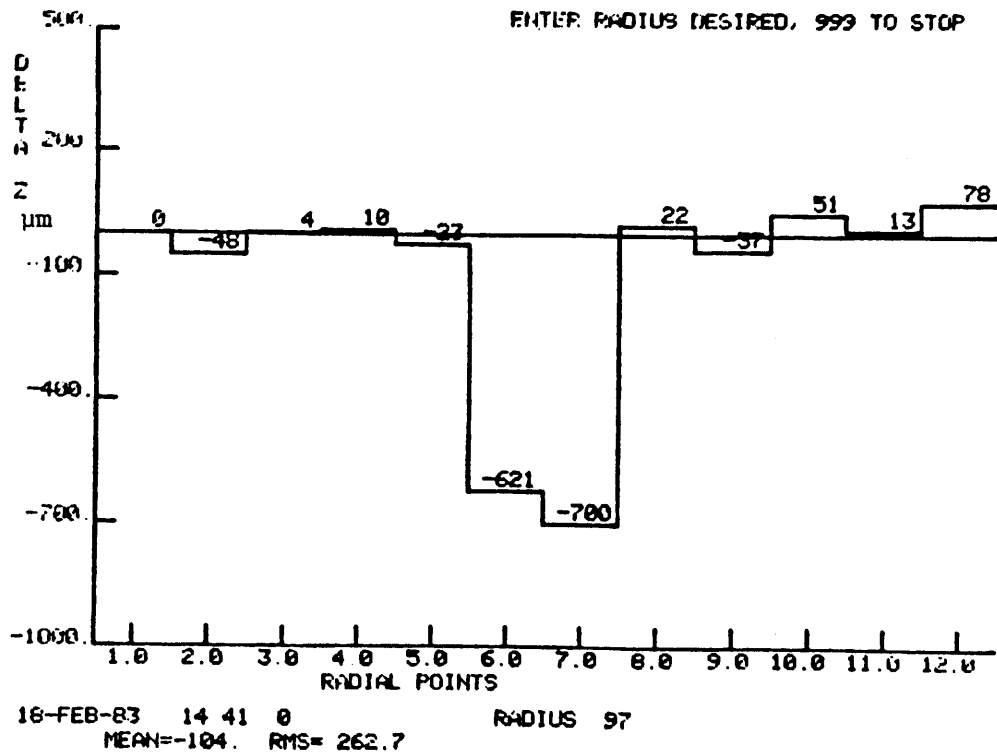
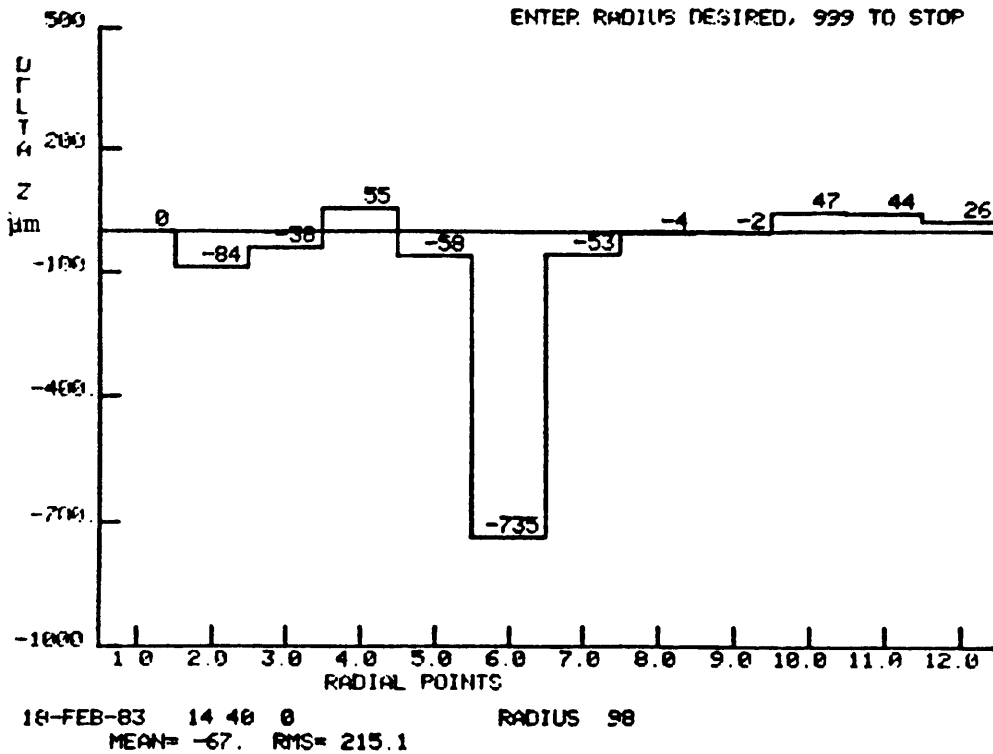
FIGURE 1

Figure 1 shows the profiles of five radii on one inner panel. These plots are from the Stobie programs in the PDP 11/40. As we measure the surface the raw voltage data from the 12 sensors is read via a 16-bit A/D converter to the PDP\*. Betty Stobie then corrects this data for gravity, edge-ball heights and the measured shape of the R/J and the voltages read when the template is mated with the R/J. It seems certain that the measurements in Figure 1 show a badly deformed panel. All the data from the present surface have been sent to Lee King and he will soon produce a map of the deviations from the best-fit surface. All these numbers are available to me from the Stobie print-out, so I have examined the readings from sensor #6 all around the surface. I took as a test value the criterion that I would "star" any panel where #6 was 100  $\mu$ m low, or lower, on one or more radii. I put

a "star" against 46 radii, spread over 14 inner panels. We shall wait for the map, but we clearly have a most unpleasant low zone around the dish. And a look at Figure 1 suggests that it is not going to be easy to "best-fit" our way around this one.

Profiles taken on Radii #94 through #98. Radius #93 is a full panel edge, with a mean elevation of  $8\mu\text{m}$  and an RMS of  $56\mu\text{m}$ . The profiles show the differences between the "desired" profile and the measured profile. When the display which gives the differences between the measured and the "best-fit" is called, the errors become somewhat less. Had the Delta Z in 1(e) above been zero at Sensor #6, the RMS would have dropped to  $47\mu\text{m}$ . Radius #98 is the other full panel edge.

We tried briefly to release the panel shown in Figure 1, to see if it would recover, but it showed no desire to do so. I therefore suggest that we remove the whole panel, replace it with a spare, and send it back to ESSCO for them to re-measure. Depending on the result, we should know what to do next.

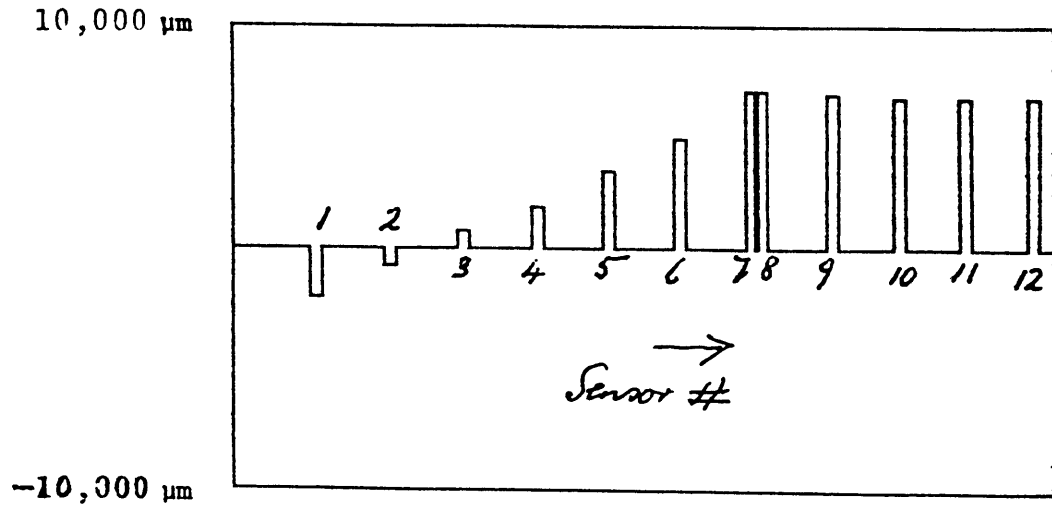
FIGURE 2

One sees at once that on this radius the outer panel was not bent much out of shape. It was set uniformly almost 1 cm too high, but not bent. The inner panel was, however, badly bent. Sensor #1 is 3 mm too low, while #7 is almost 1 cm too high. I suggest that this stress caused the panel to take a set from which it did not recover. The shape error supports this theory; the magnitude of the set has only to be about 10% of the actual bend imposed to explain what we find.

Radius # 97. Measured 1430 October 13th 1982

The shape to which Radius #97 was first set. The errors are the differences between the measured shape and the design shape. A positive error is a high panel.
