THE 12-METER TELESCOPE
PROFILE ERROR NEAR SENSOR 6
Comments on MEMO NO. 217

Memo 217 Section 4 "How did it happen?"

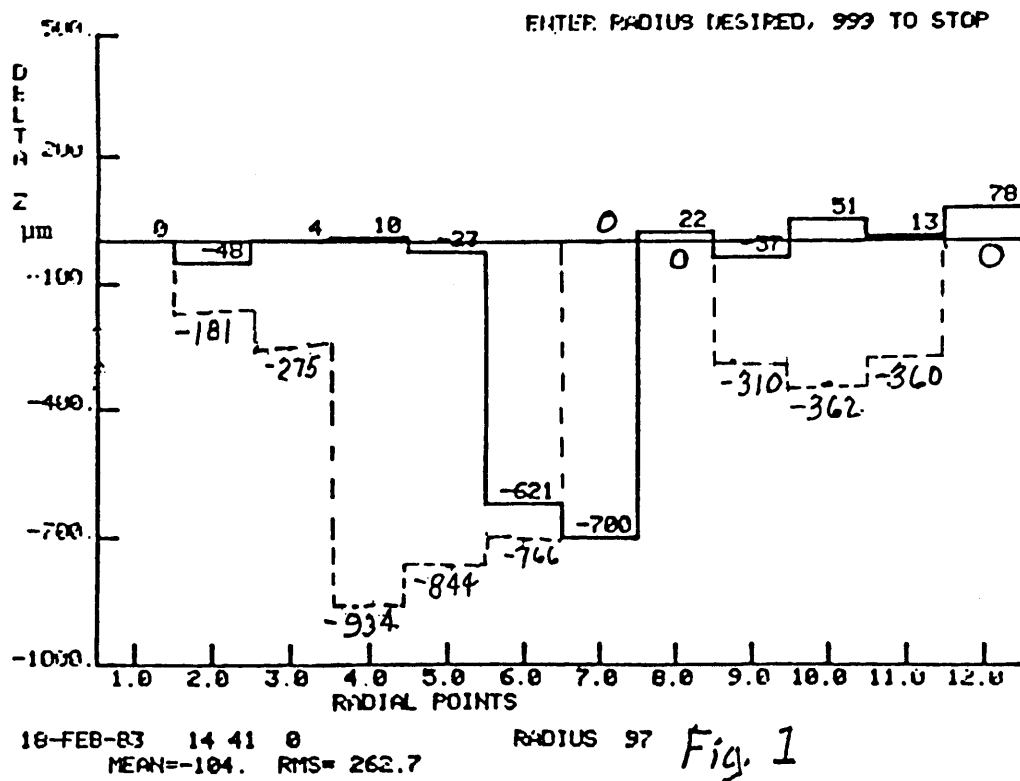
Figure 1(d)

Figure 1 following shows figure 1(d) of Memo 217 with the transformed error readings of radius 97 superimposed in dotted line.

It would appear to me that the data on radius #97 taken Oct. 13, 1982 does not show a badly bent panel but does show an effect due to the supports at sensors 3, 5 and 10 not being adjusted at installation to take the gravity deflection out of the panel when it is supported at the end supports.

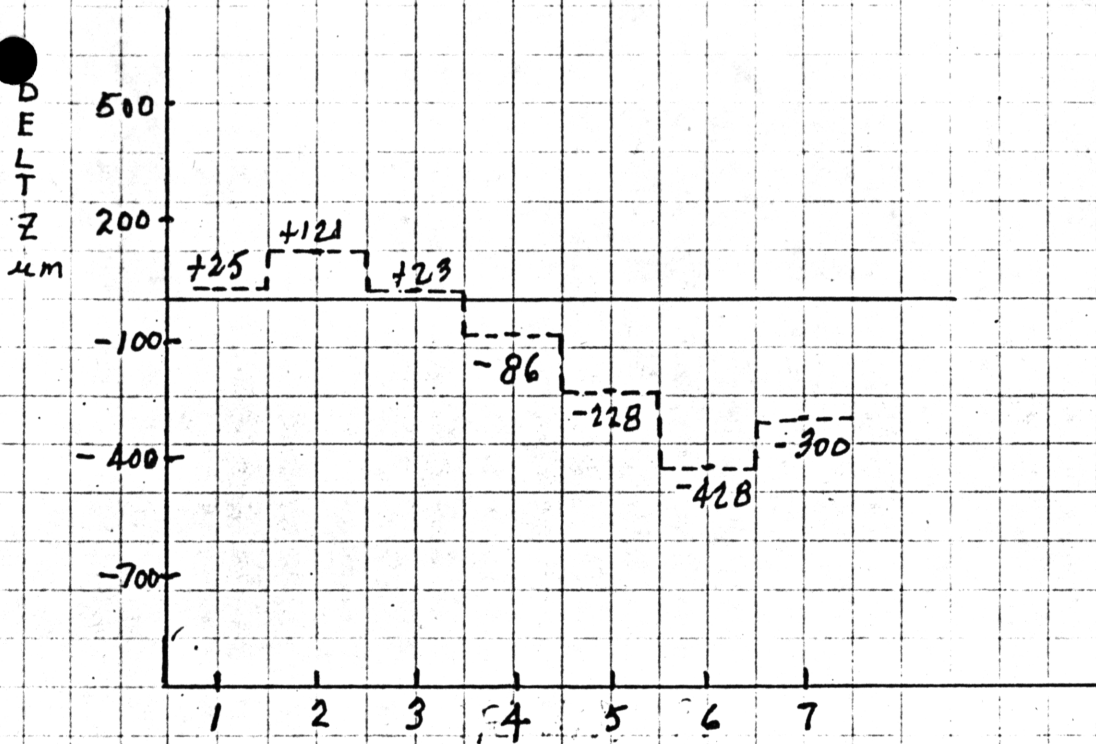
Figure 1(f)

Since I wanted to transform the panel as a rigid body I took an average of the Sensor 1 readings and an average of the sensor 7 readings to calculate the amount of translation (+2031M) and the amount of rotation (0.158101°) and then calculated the Sensor error value for each sensor in each radii. The transformation was only done in the longitudinal direction. I was later informed by Lee King that the radii numbering might have been changed but since Memo 217 indicates that Radii 97 of Oct. 13 is the same as Radii 97 of 18 Feb. I have used the radii as being the same. Following is a plot on Figures 1 (a) through 1 (e) of the transformed data of Oct. 1982 plotted in dotted line on Radii 94 through 98 of Feb 19, 1983. I have included a plot of Radius 93 since it was not included in Memo 217. Again I am not sure that these reading clearly indicate that a badly bent panel existed in Oct of 1982.
